Inspection Photos
Location Name: Southern Ute #5-7
API: 05-067-08483

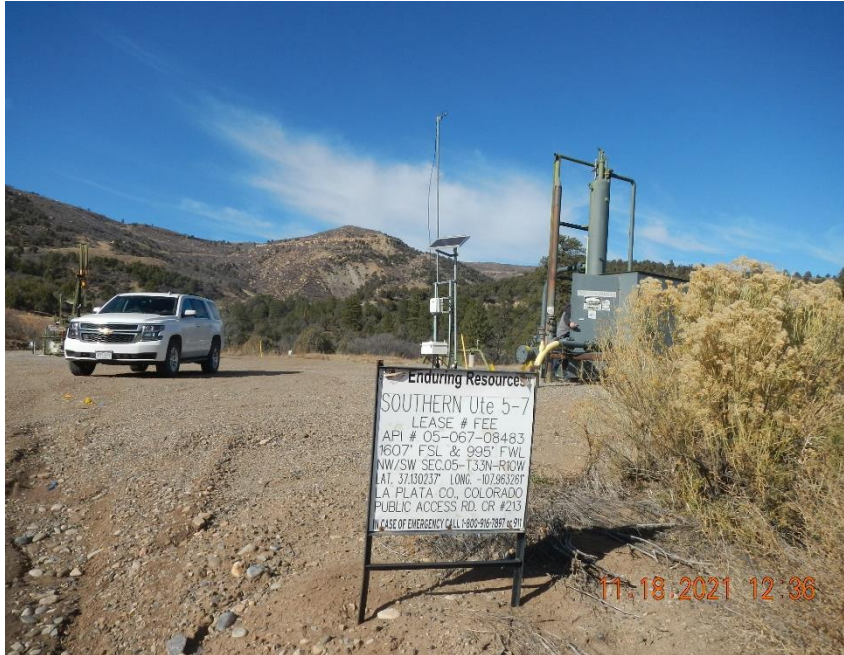
Southern Ute #5-7 location photo. Erosion evident along access road.

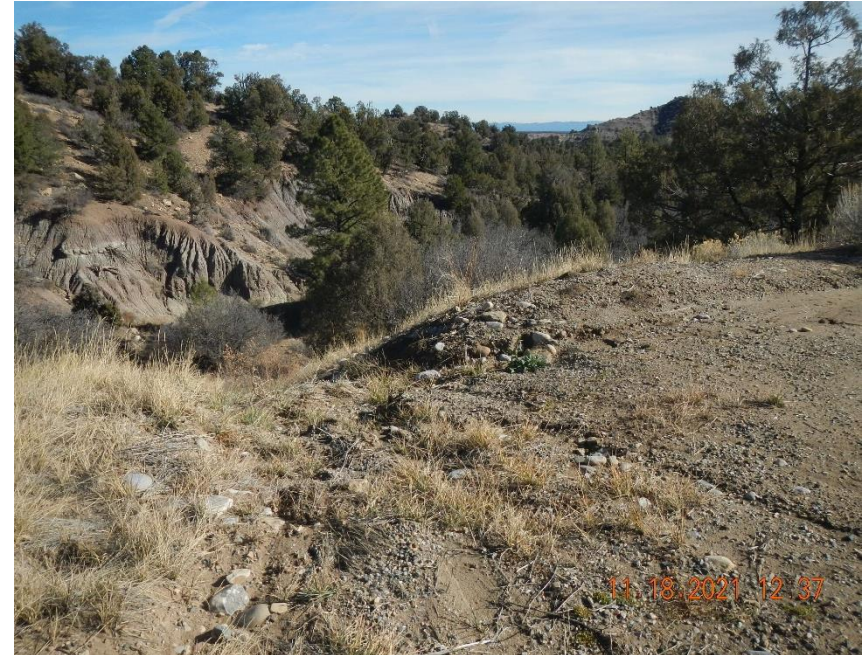
Erosional channels present along northern edge of location.

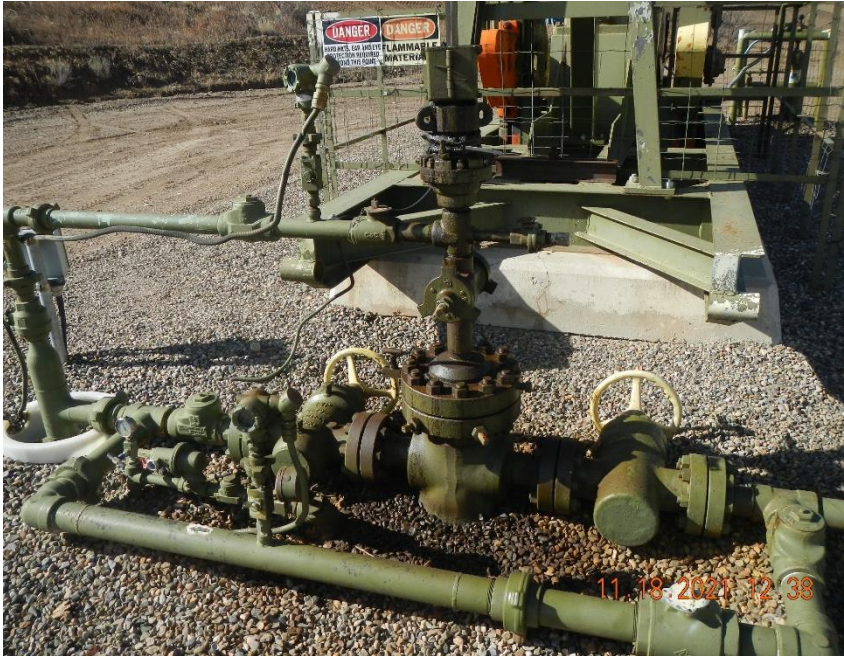
Southern Ute #5-7 well head. Well head and surrounding area are stained and wet.

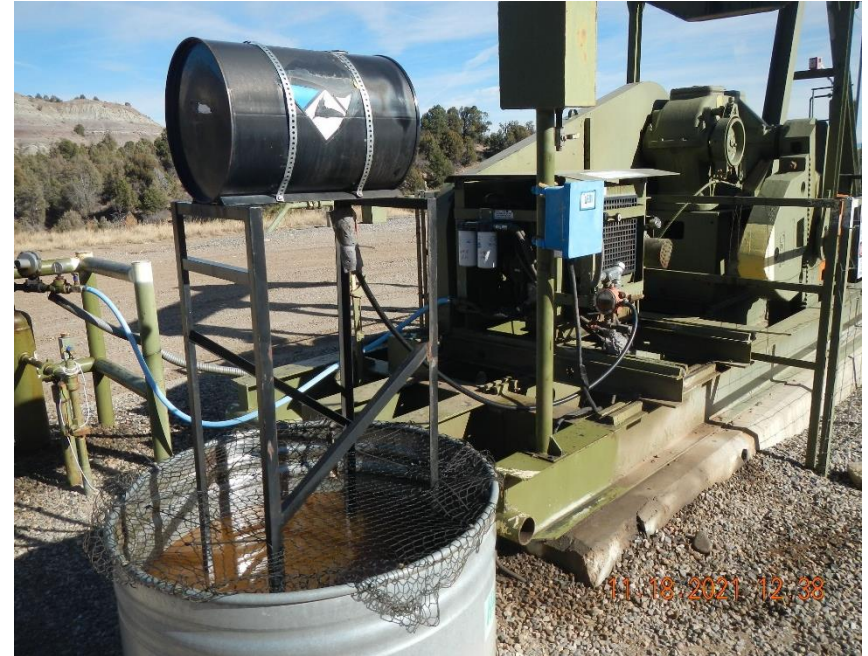
Pump jack skid and surrounding area are wet and stained.

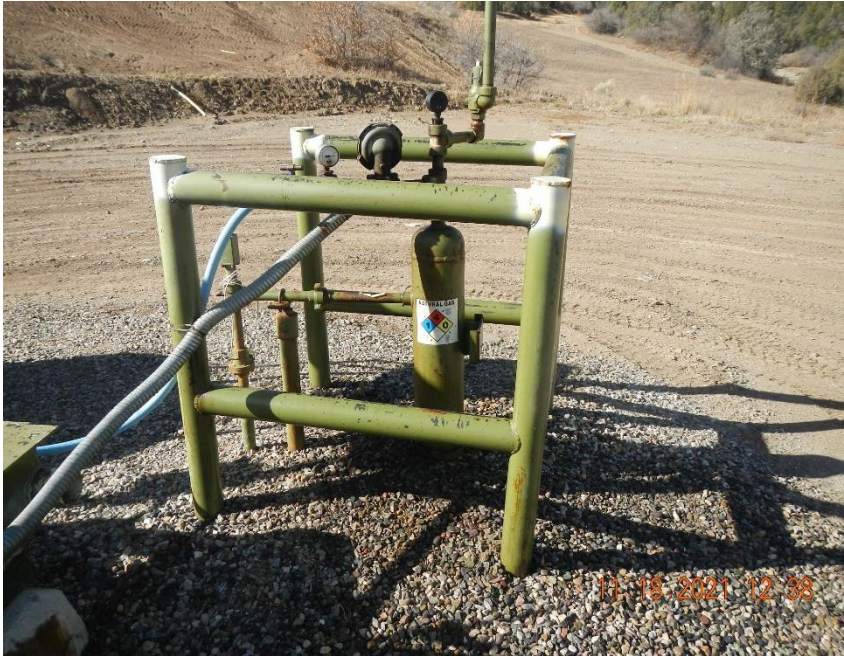
Wet and stained area near drop out tank.

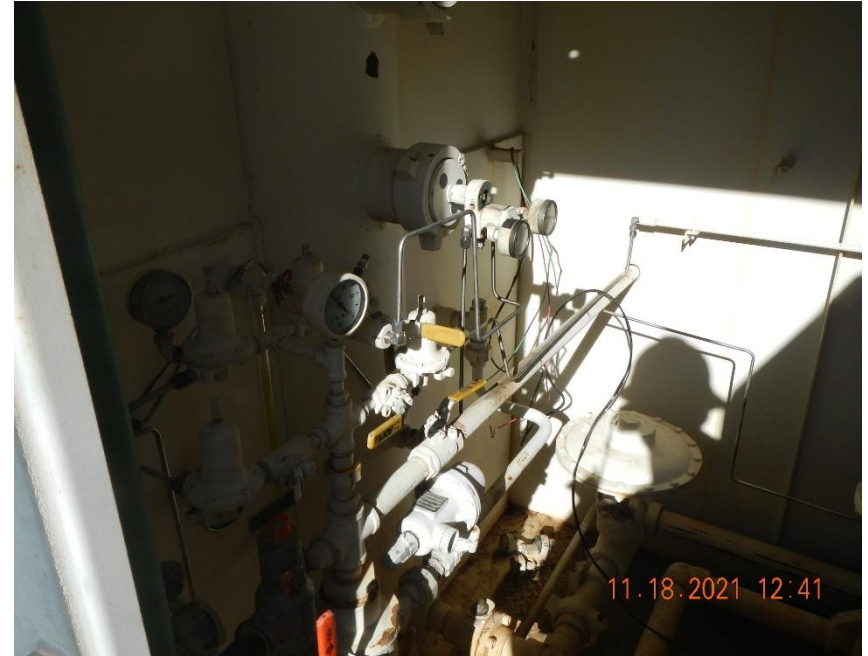
Audible leak from valve in separator shack during this inspection.
