Inspection Photos
Location Name: Amoco Energy Smits Unit C1
Location ID: 311287

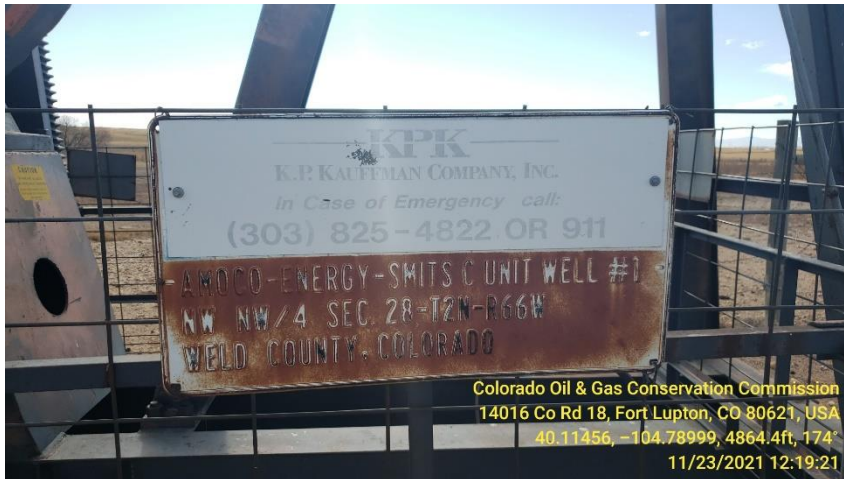
Photo 1 WH sign

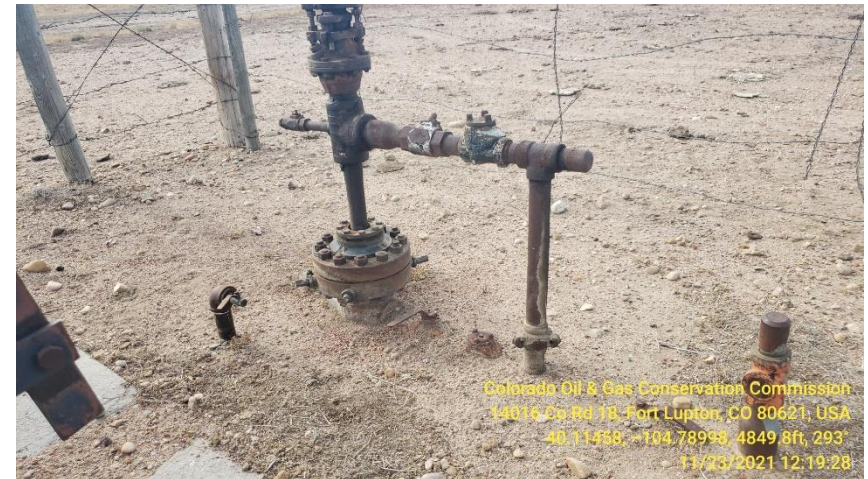
Photo 2 WH

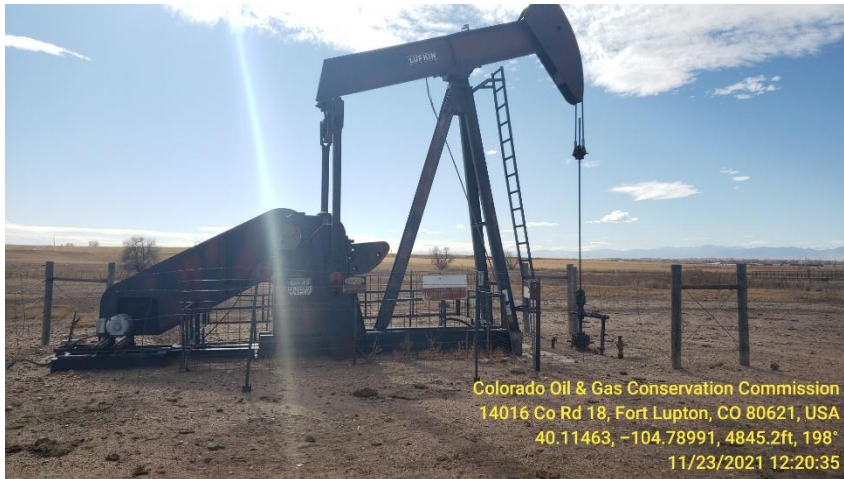
Photo 3 Pump Jack

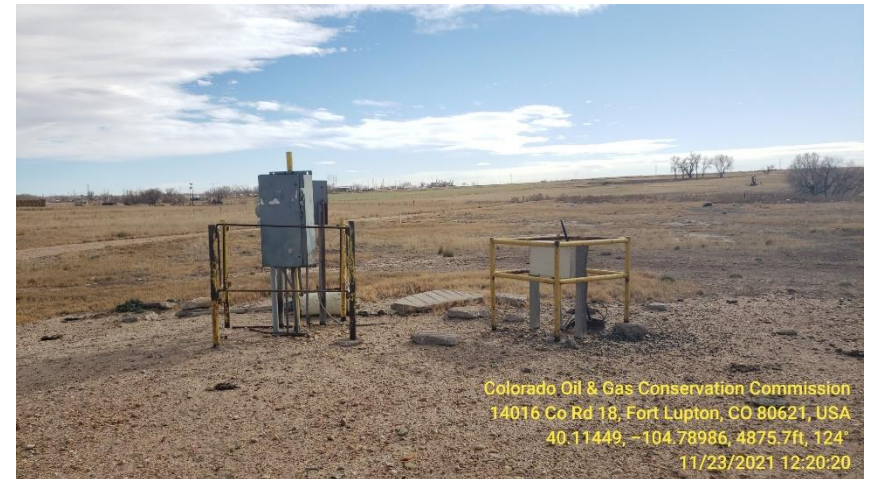
Photo 4 ancillary equipment

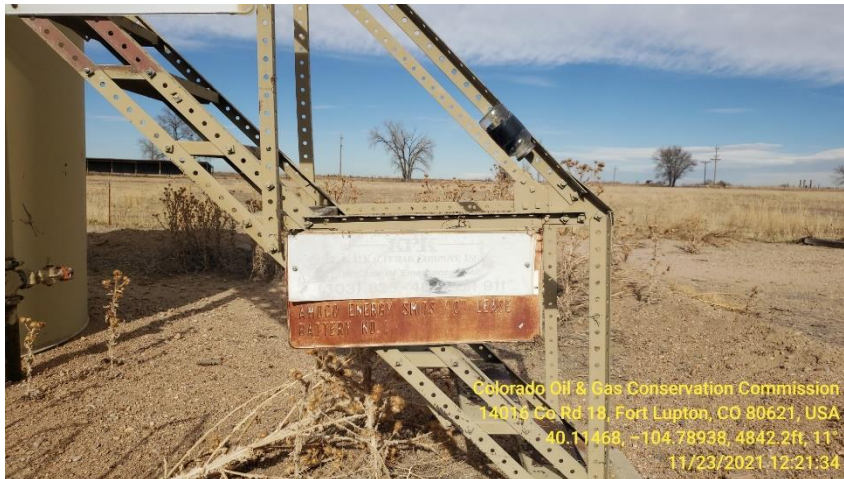
Photo 5 TB sign

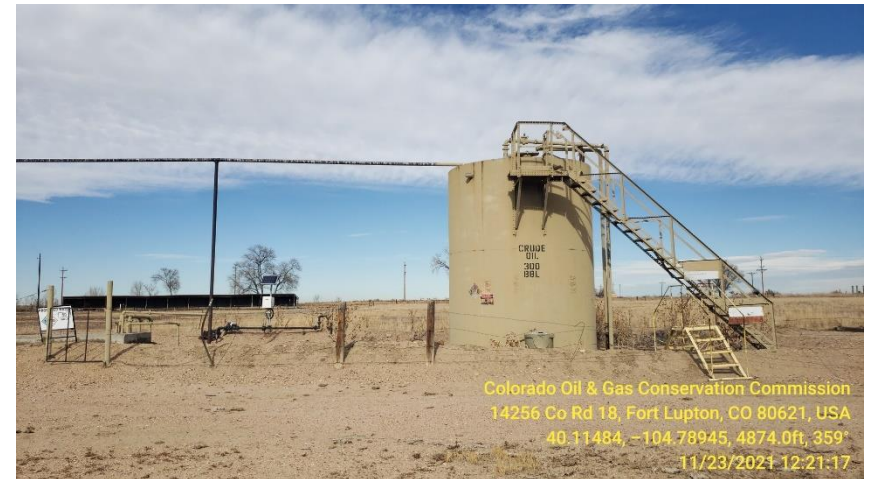
Photo 6 TB

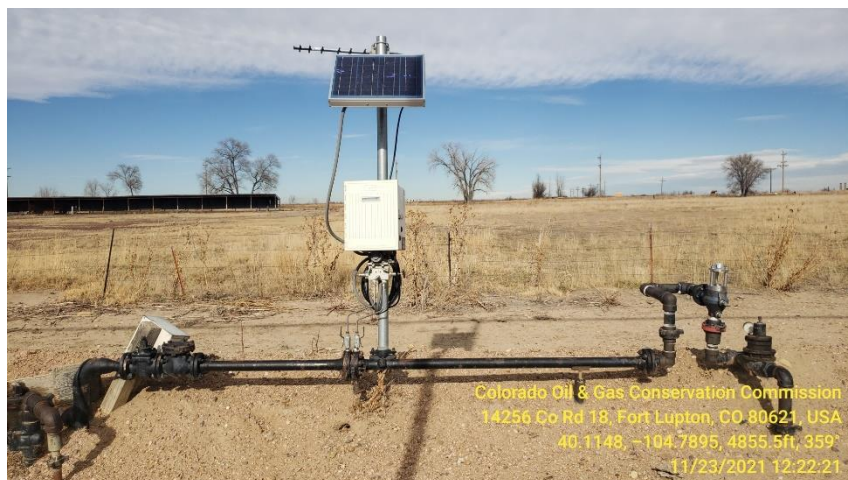
Photo 7 Gas Meter Run

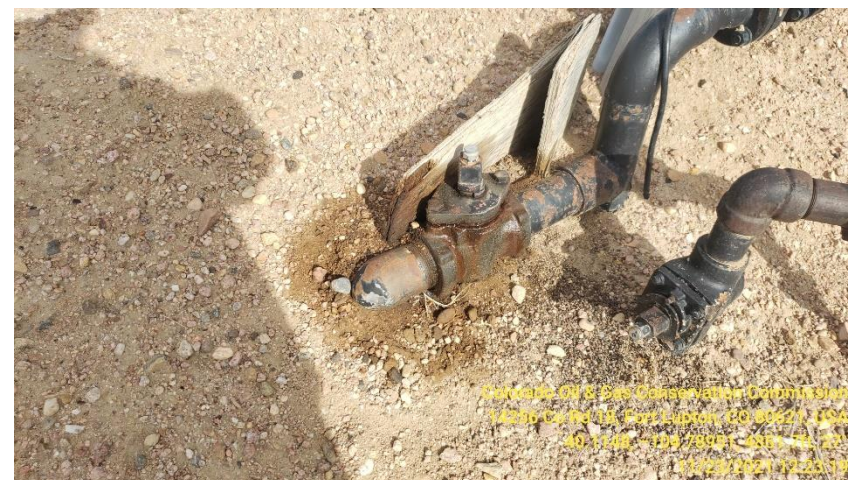
Photo 8 Stained soil by Gas Meter Run Flow line

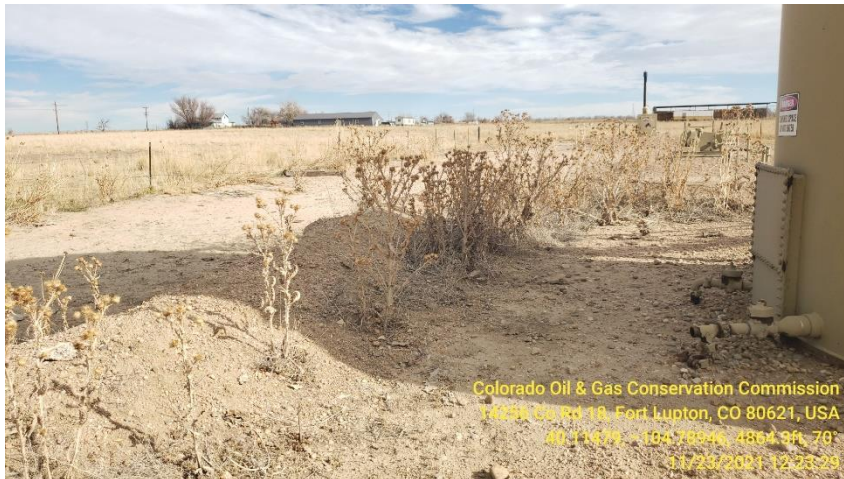
Photo 9 Dead thistle inside and on TB berm

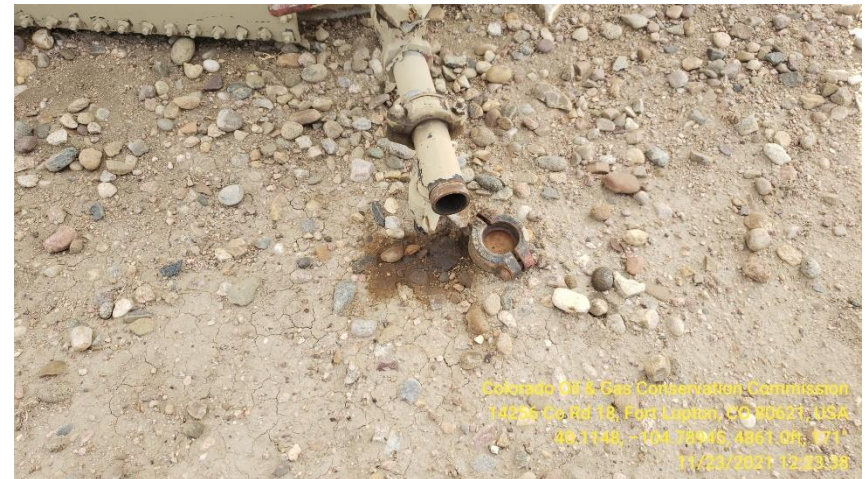
Photo 10 Stained soil on north side of crude tank by the Flow line

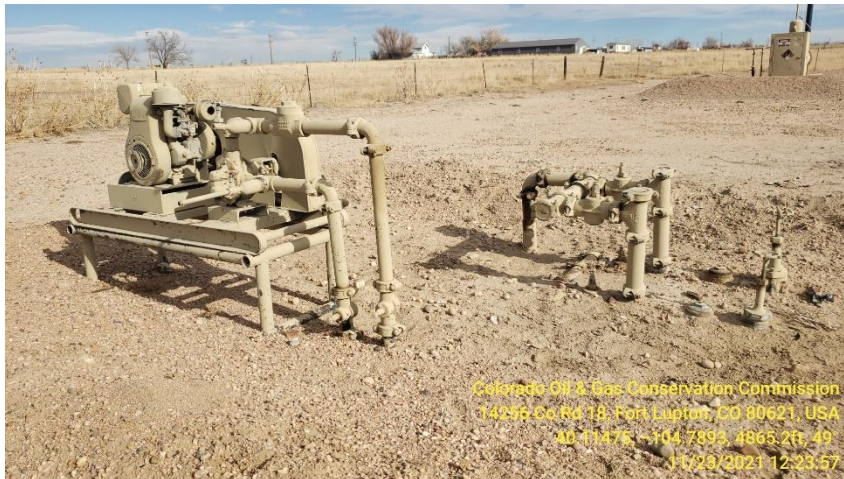
Photo 11 flow line manifold and aux. pump

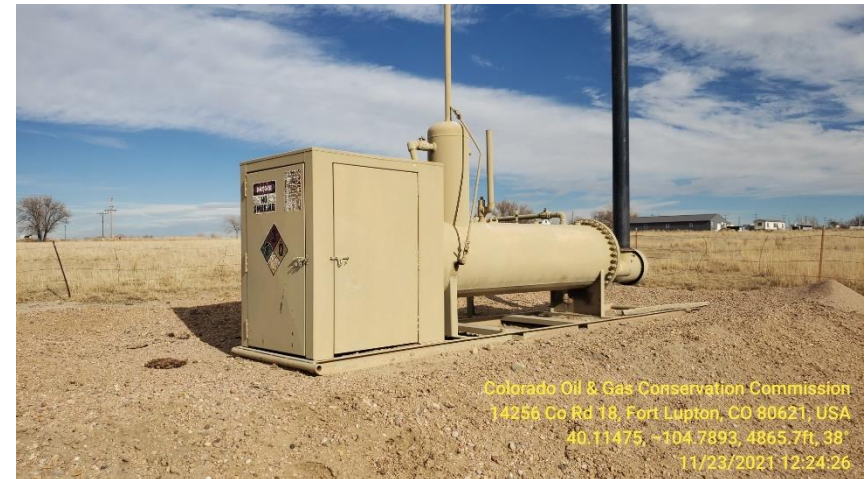
Photo 12 Horiz. Heated Sep.
