Inspection Photos

Operator: TEP ROCKY MOUNTAIN LLC #96850

Location ID: 335542

Garfield County, CO

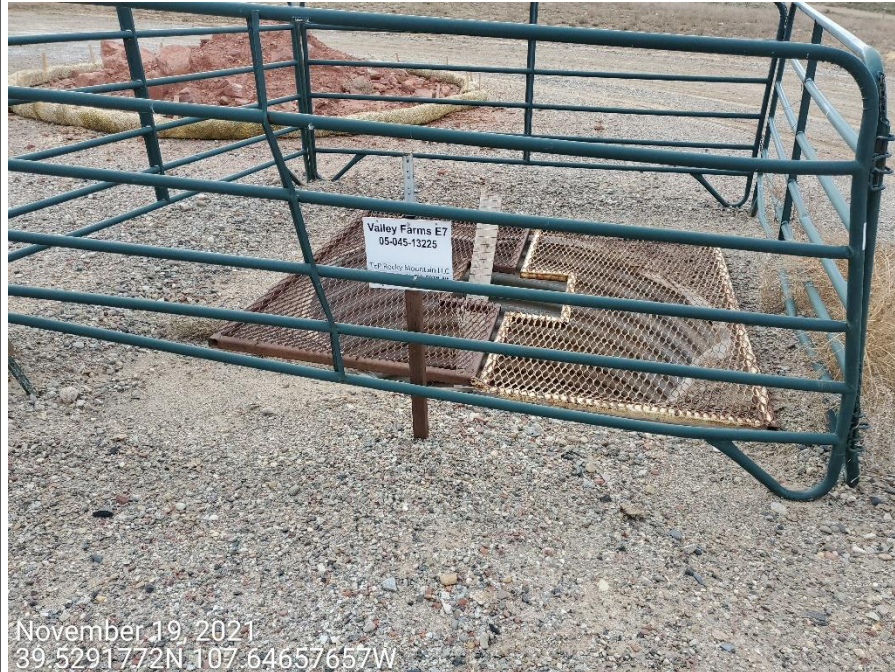
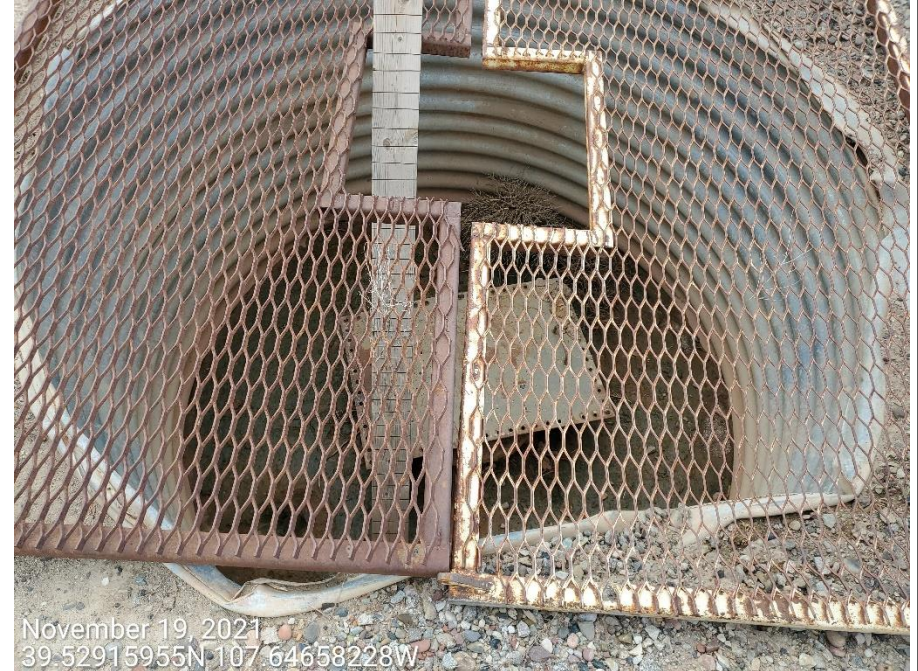
Photo 1: Photos shows fence and cover at cellar has been replaced; plate placed onto conductor pipe. Wildlife ramp installed.

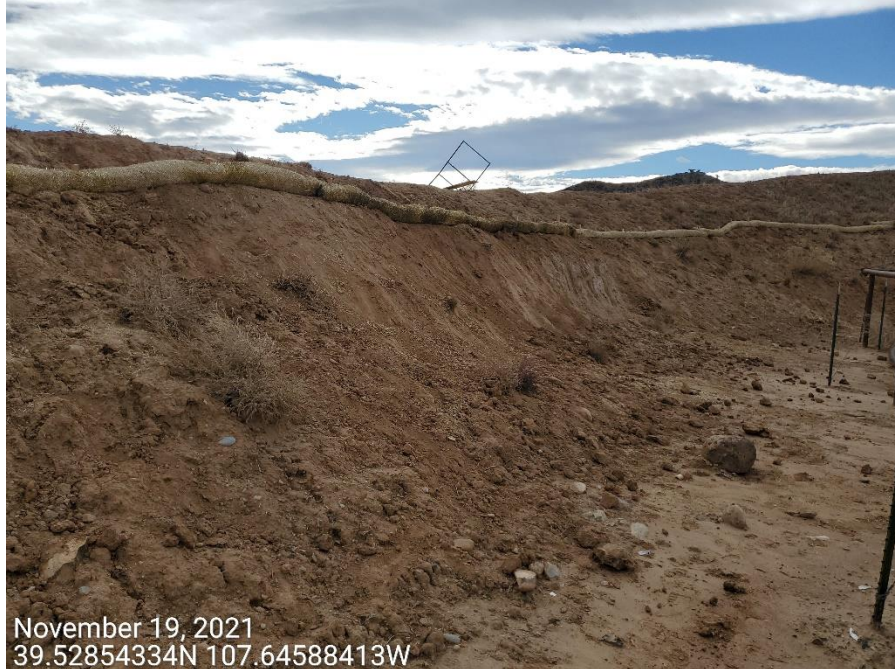
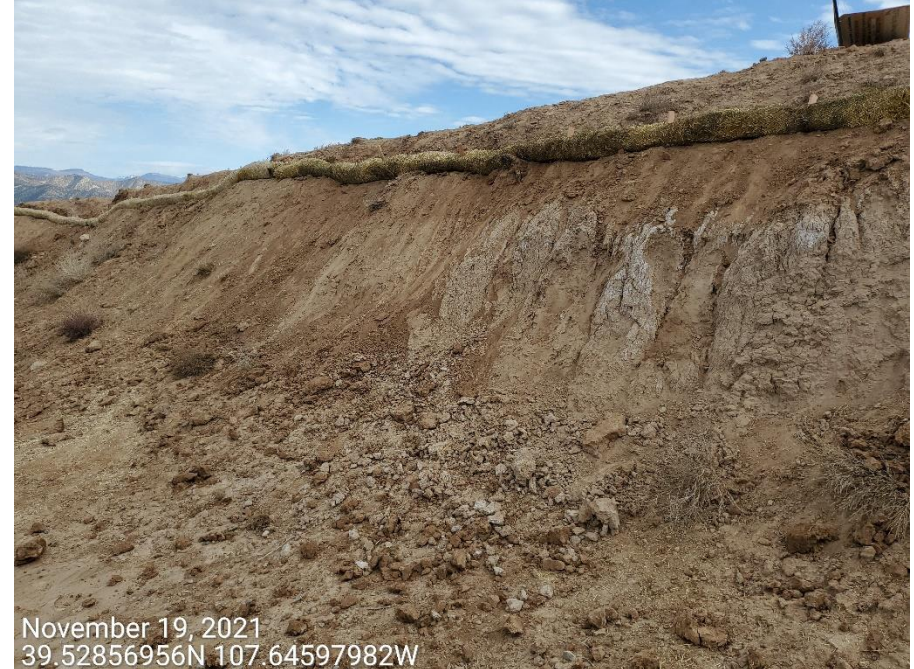
Photo 2: Photos provide examples of the cut slopes on the Location; control measures to protect and stabilize the cut slopes remain missing or insufficient per good engineering practices; erosion degradation evident.

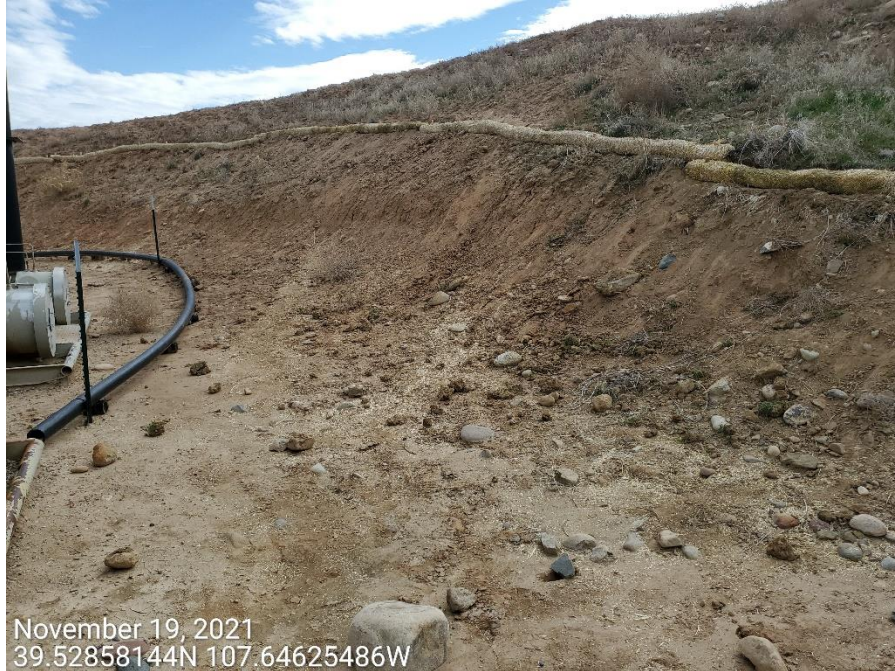
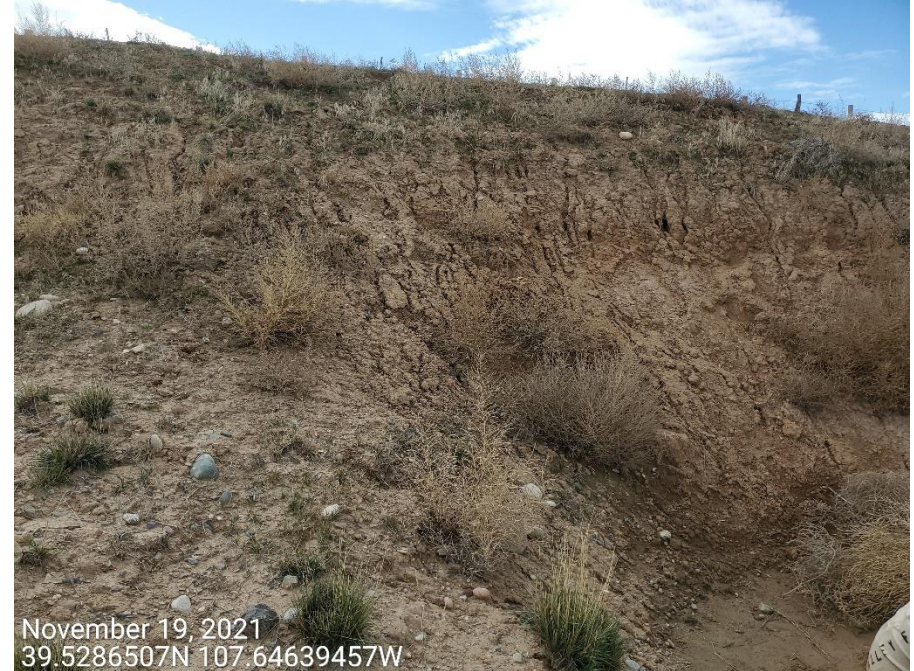
Photo 3: Photos provide examples of the cut slopes on the Location; control measures to protect and stabilize the cut slopes remain missing or insufficient per good engineering practices; erosion degradation evident.

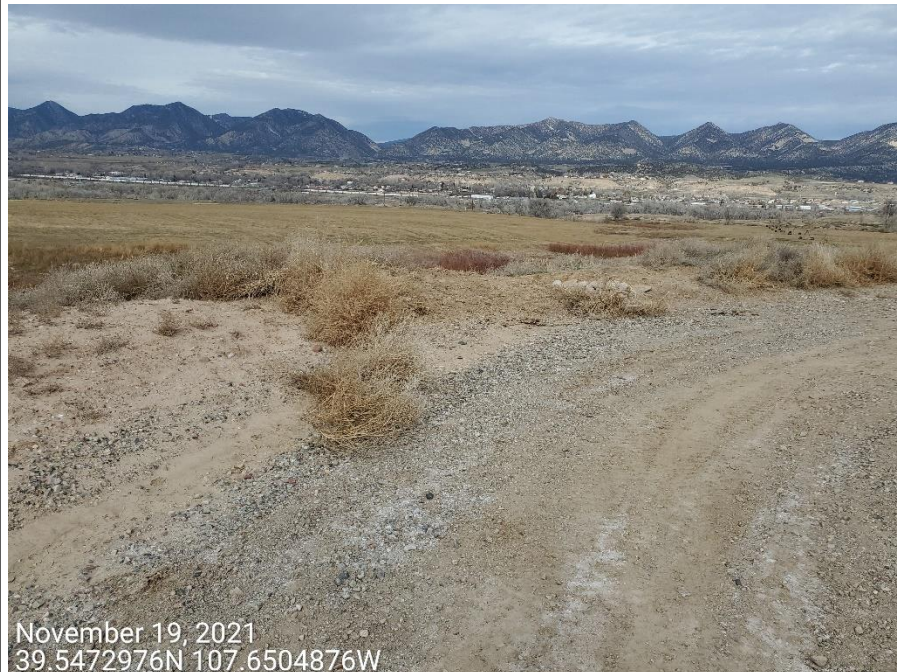
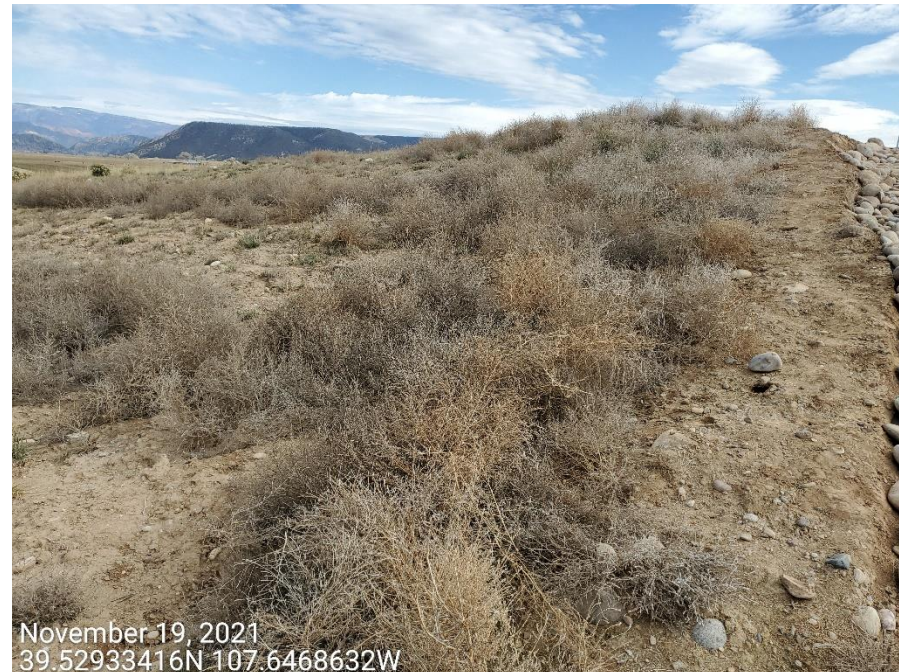
Photo 4: Photos show undesirable plant species / weed debris has not been removed from the Location per corrective actions.

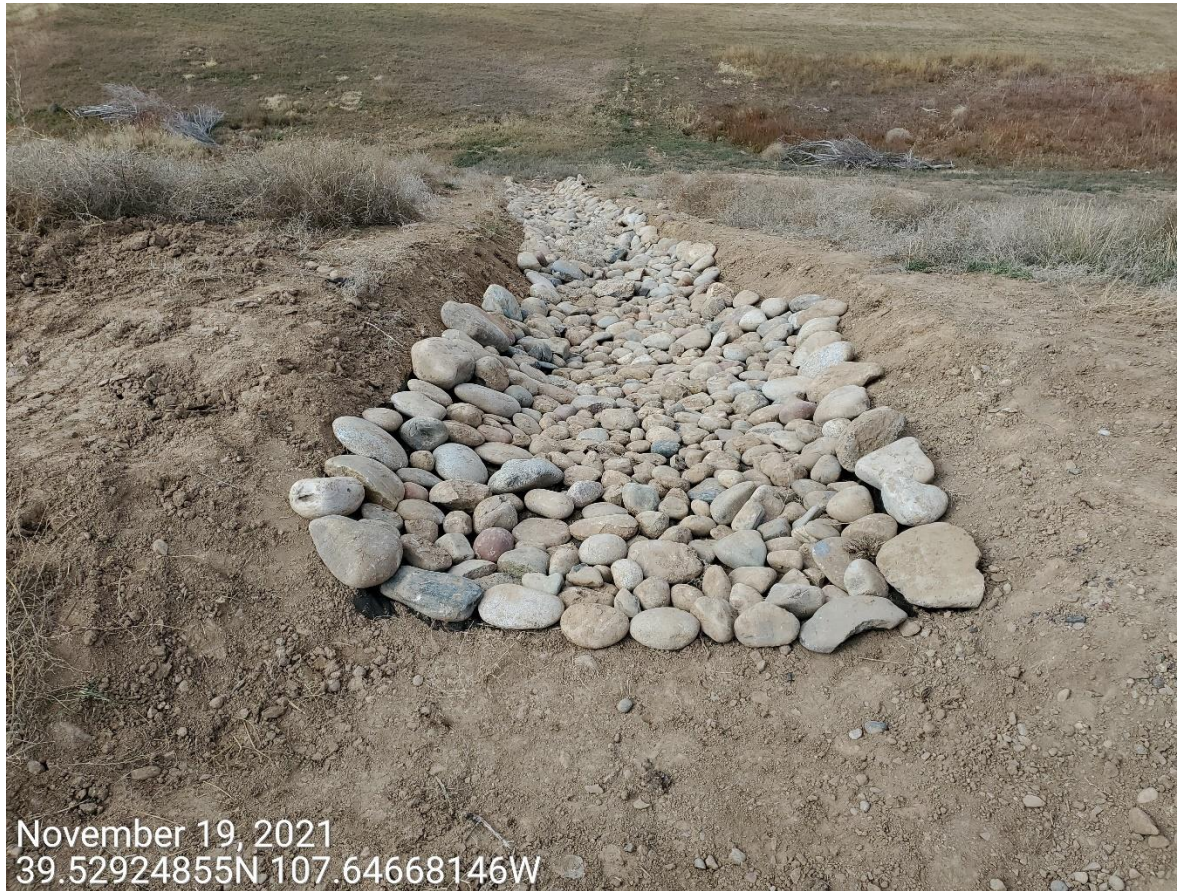
Photo 7: Photo shows stormwater outlet on the northwest end of the Location. Erosion degradation at outlet on the northwest end of the Location has been repaired; outlet has been reinstalled with use of geotextile lining, though Operator has used smooth rocks (such as river stone) rather than angular rock material per good engineering; smooth stones will accelerate stormwater, where as angular rock will dissipate velocity. No other controls have been implemented in conjunction with the outlet to allow for sediment laden-free stormwater discharge; unclear if outlet alone will be adequate to allow for proper stormwater discharge from the Location.
