# Inspection Photos

API: 071-09244

Operator: EVERGREEN NATURAL RESOURCES

Inspection Date: 11/12/2021

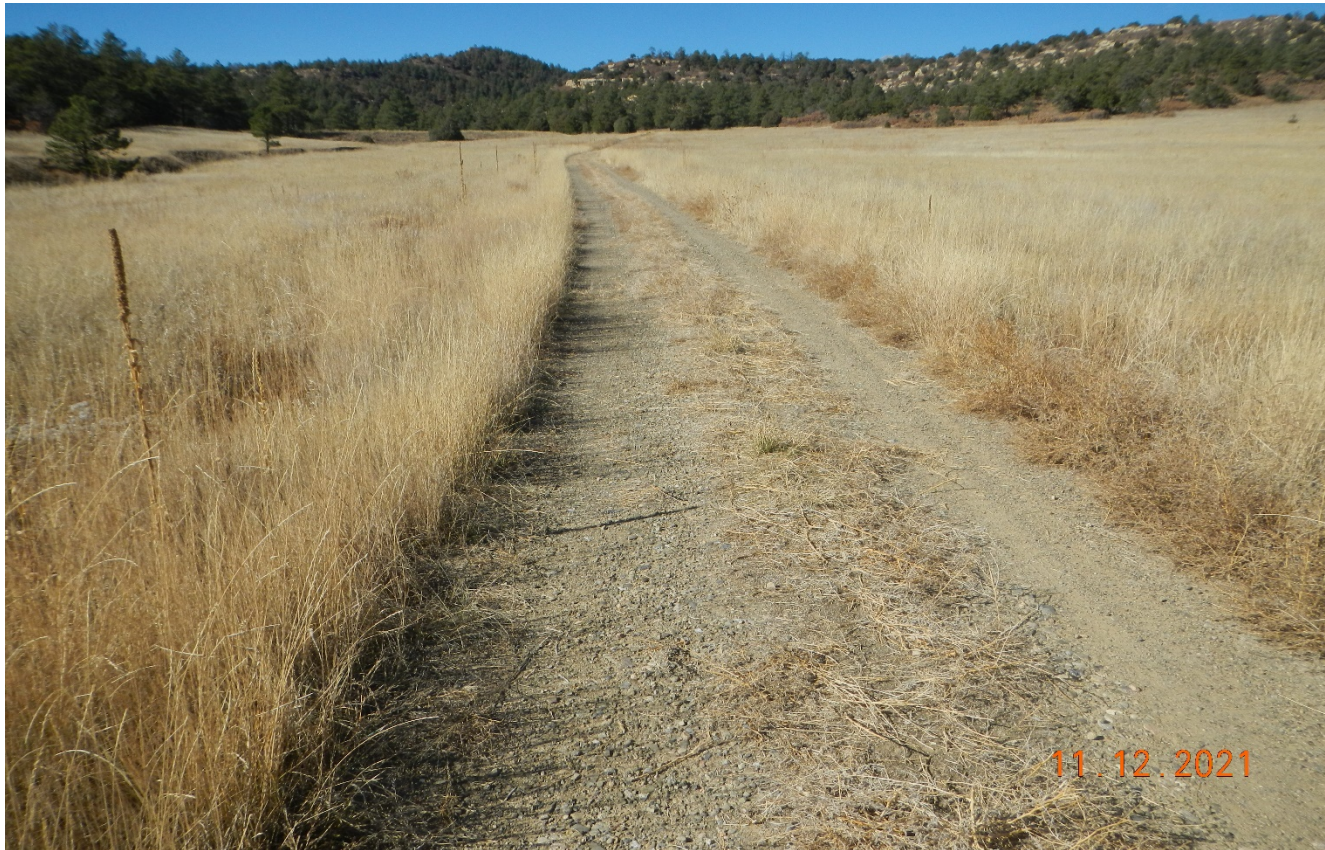
**Photo 1.** Facing northwest along the access road which has not been reclaimed.

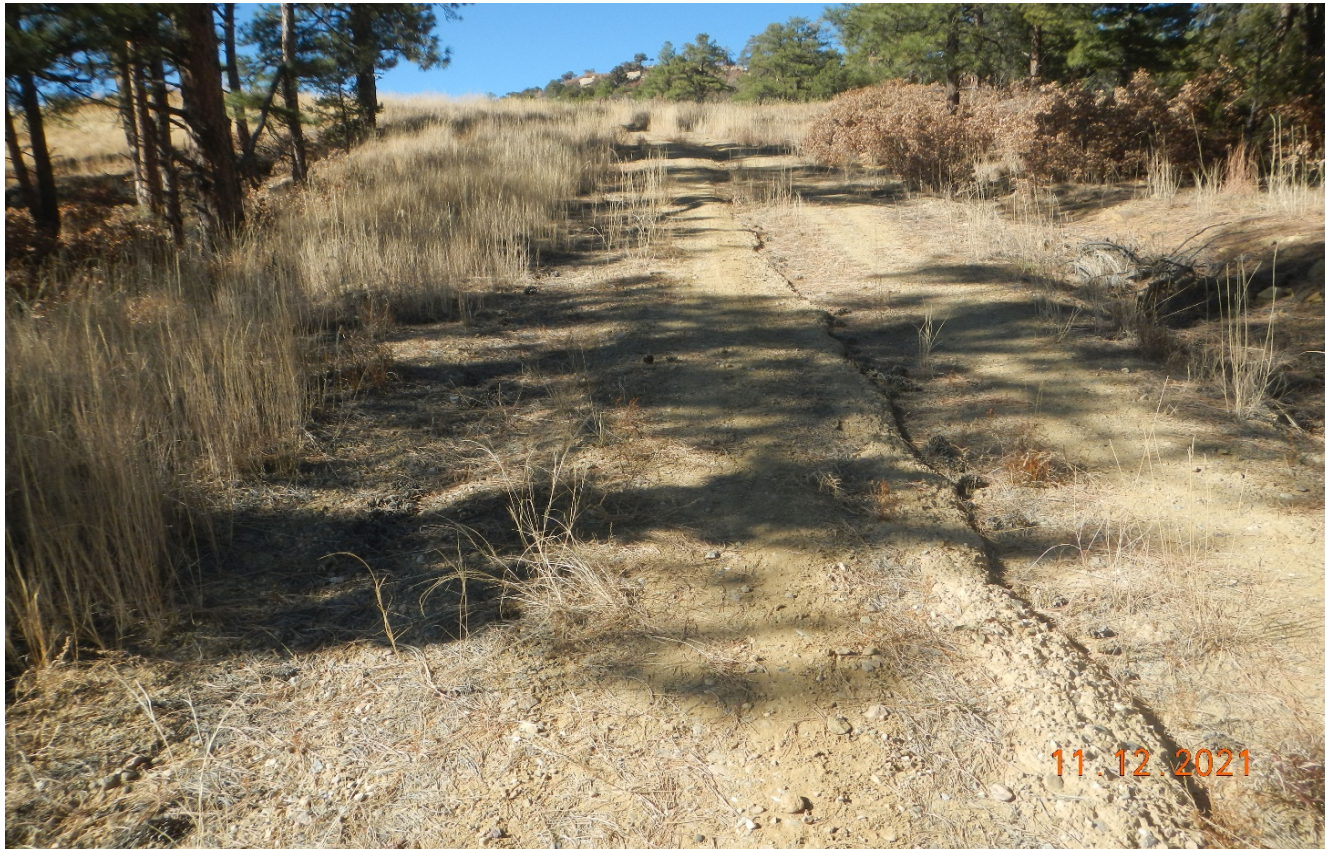
**Photo 2.** Facing northwest along the access road which has not been reclaimed. There are signs of erosion as the road ascends to the location.

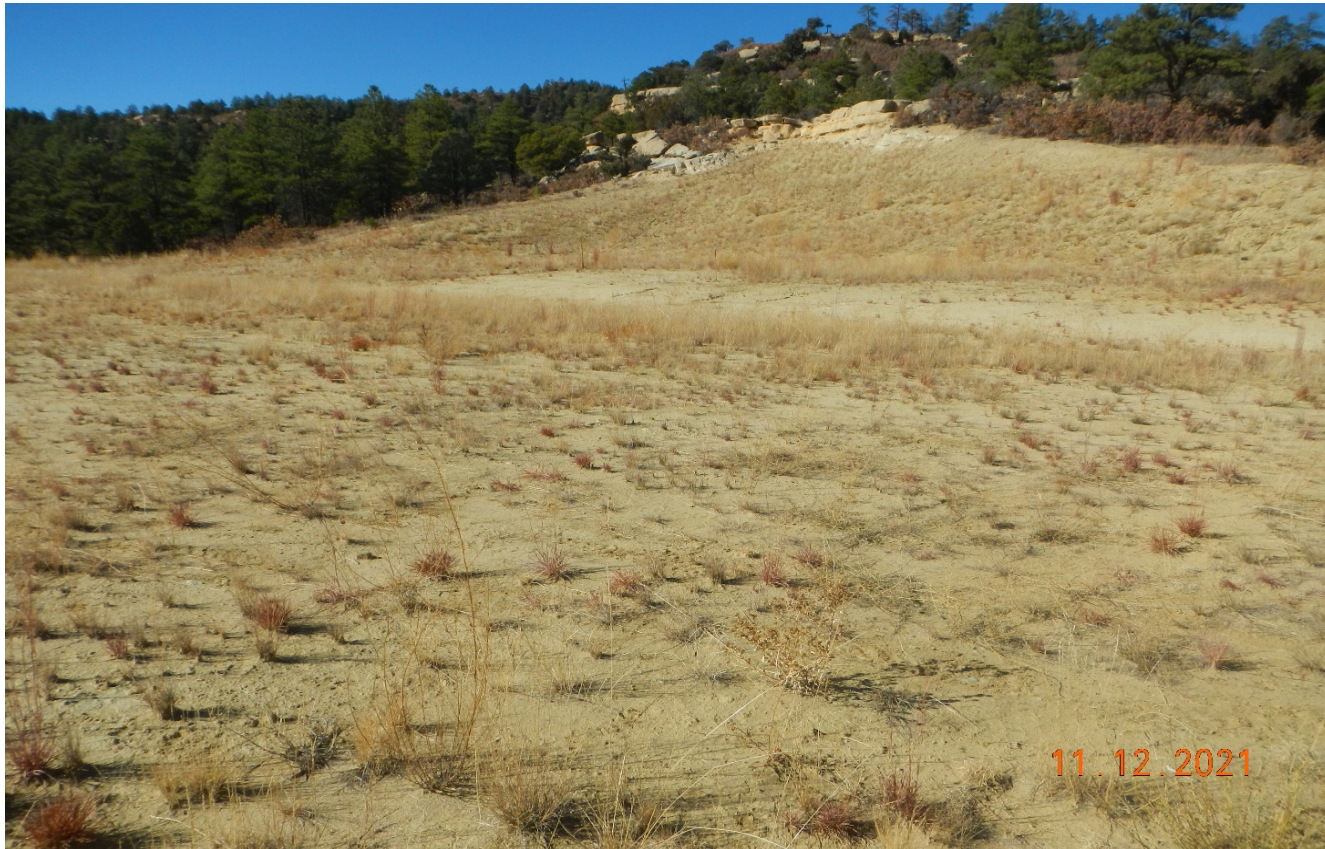
**Photo 3.** Facing northwest toward the location. The location has not been recontoured and reclaimed.

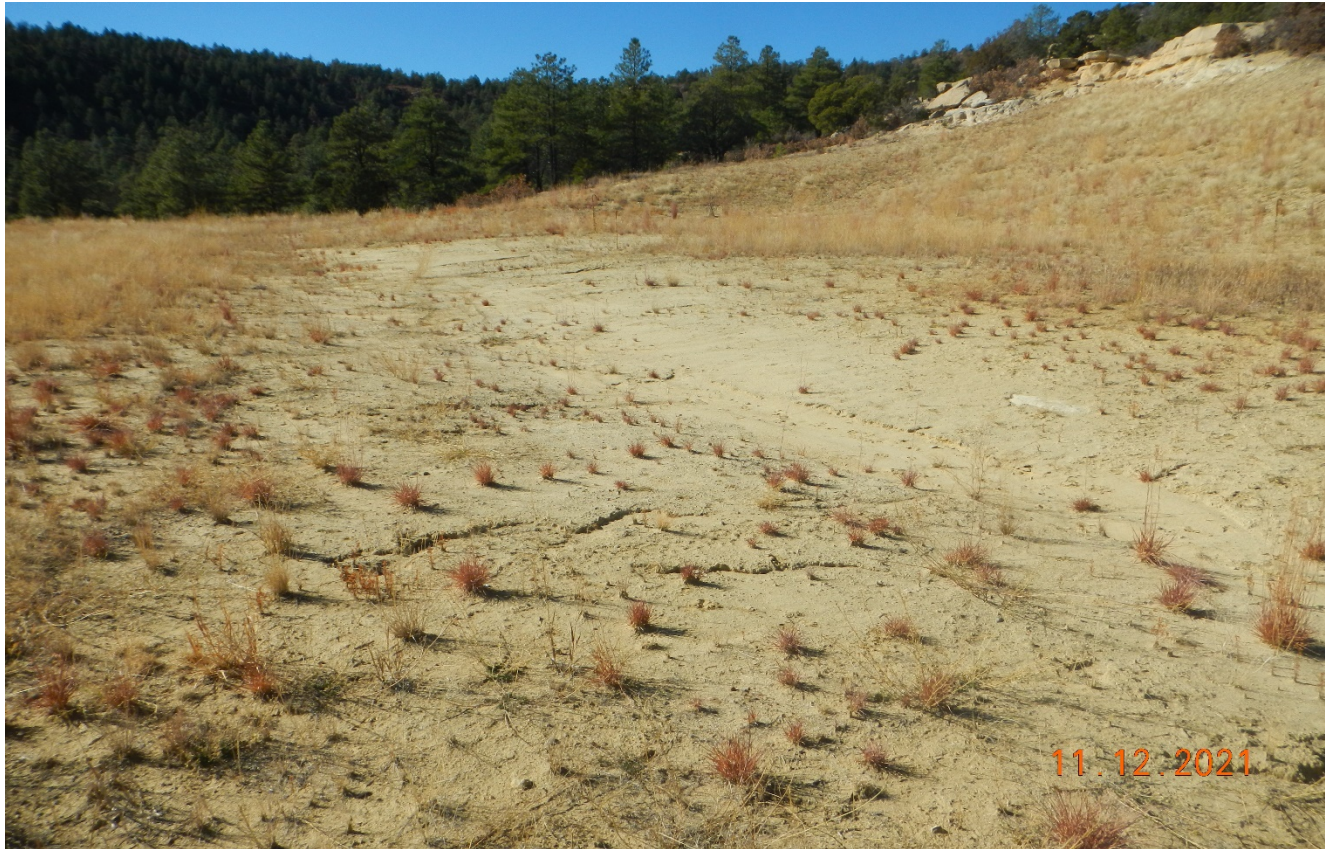
**Photo 4.** Facing west at the location. The soils are not stabilized and there are signs of erosion.

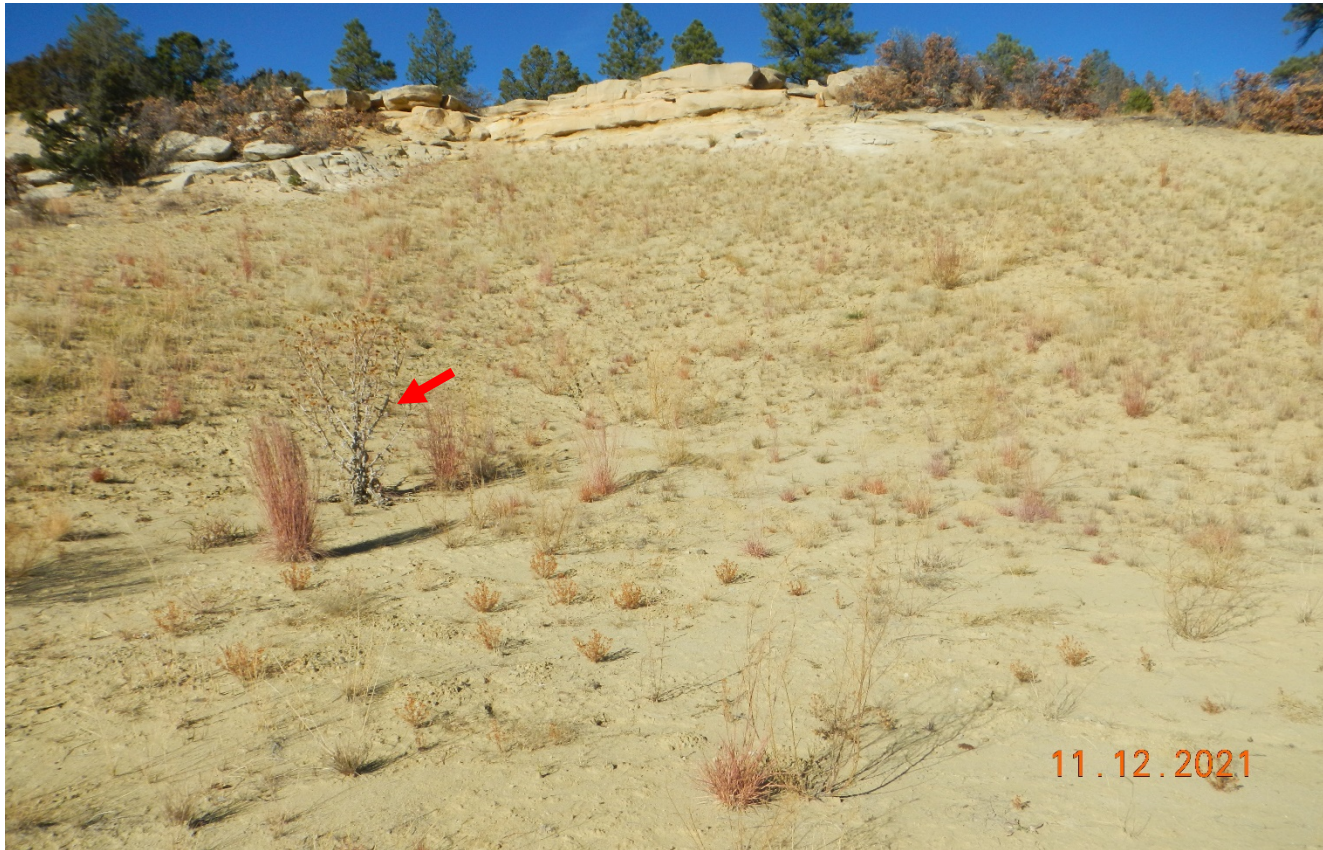
**Photo 5.** Facing toward the northwest cutslope. There is a noxious weed shown at red arrow (Plumeless thistle).

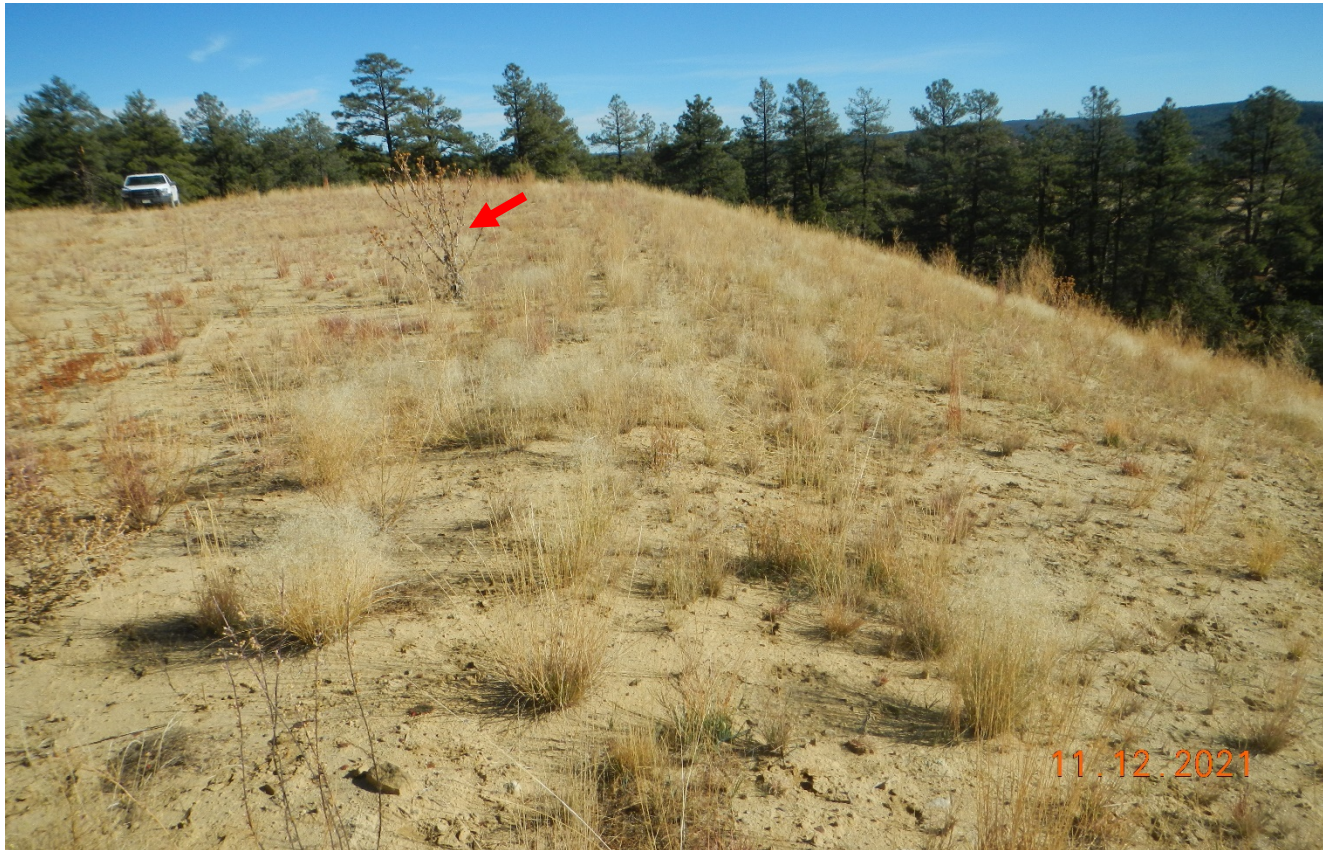
**Photo 6.** Facing southeast toward the fill slope. There is a noxious weed shown at red arrow (Plumeless thistle).

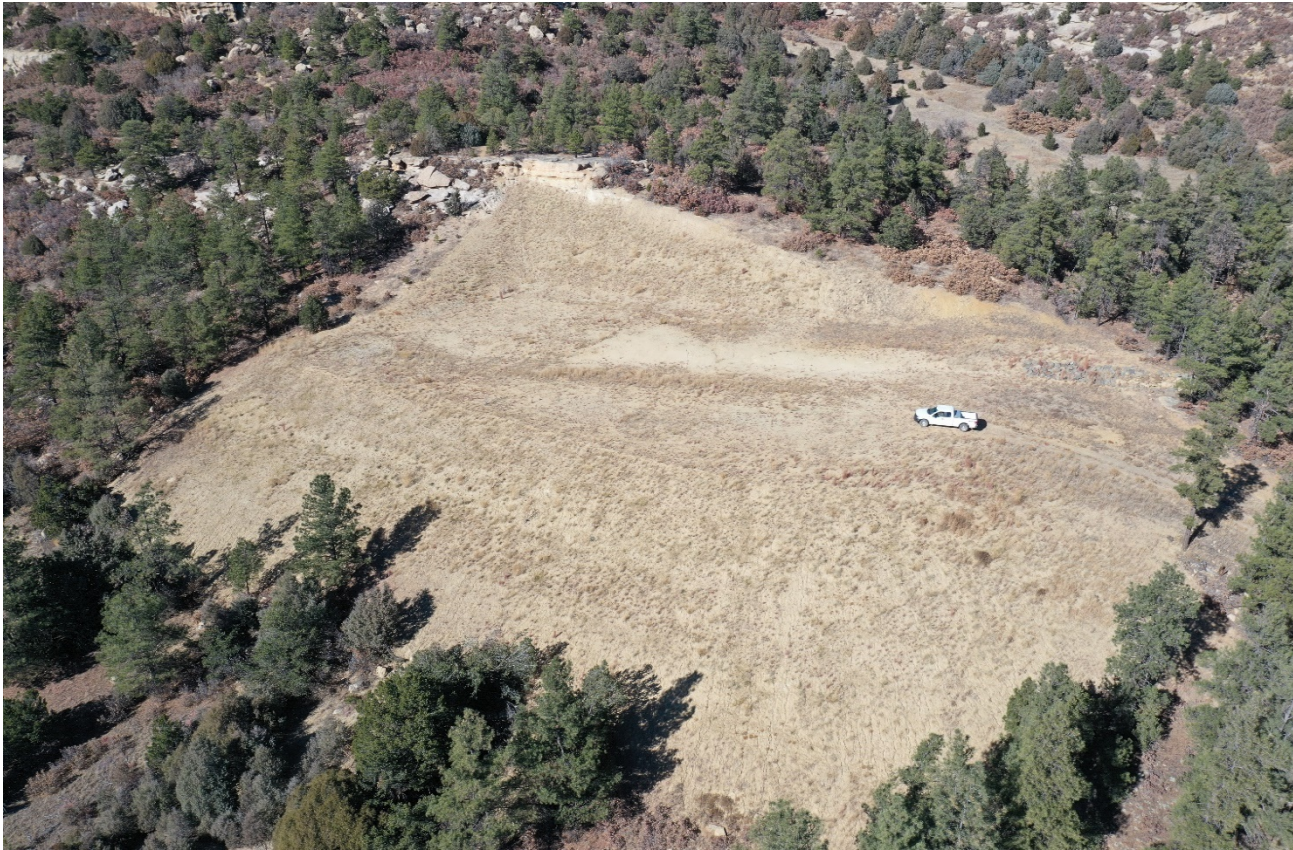
**Photo 7.** Drone aerial photo facing north toward the location.

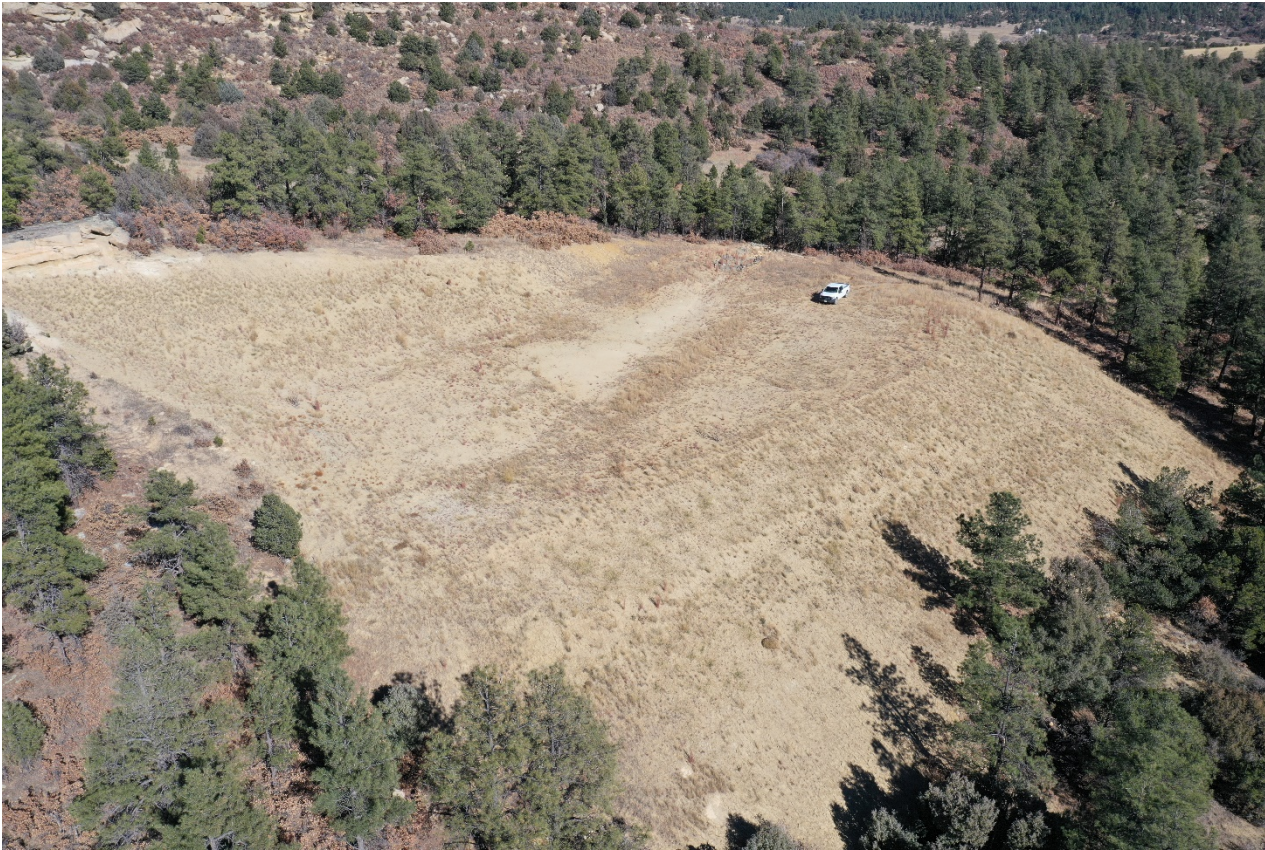
**Photo 8.** Drone aerial photo facing northeast toward the location.

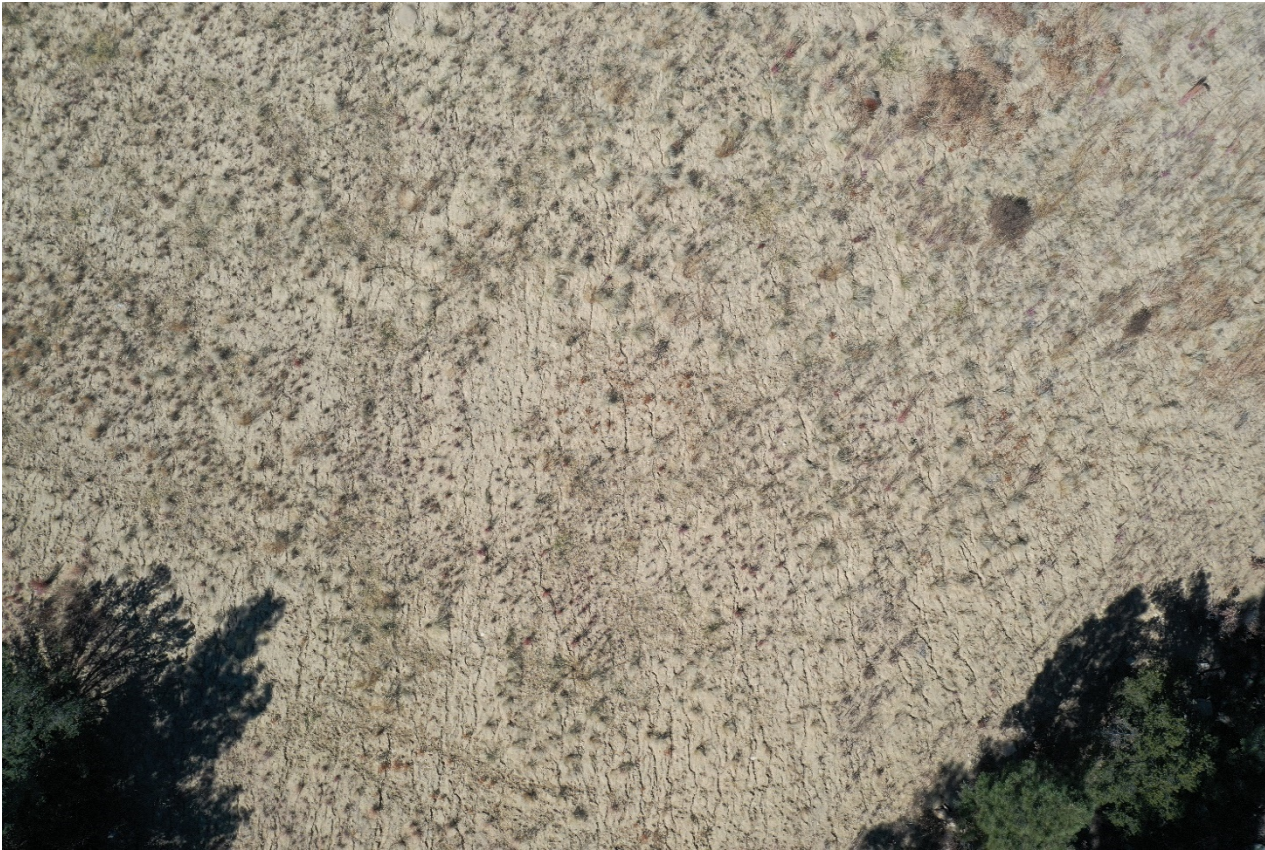
**Photo 9.** Facing down toward the fill slope. There are signs of rilling erosion along the fill slope of the location.

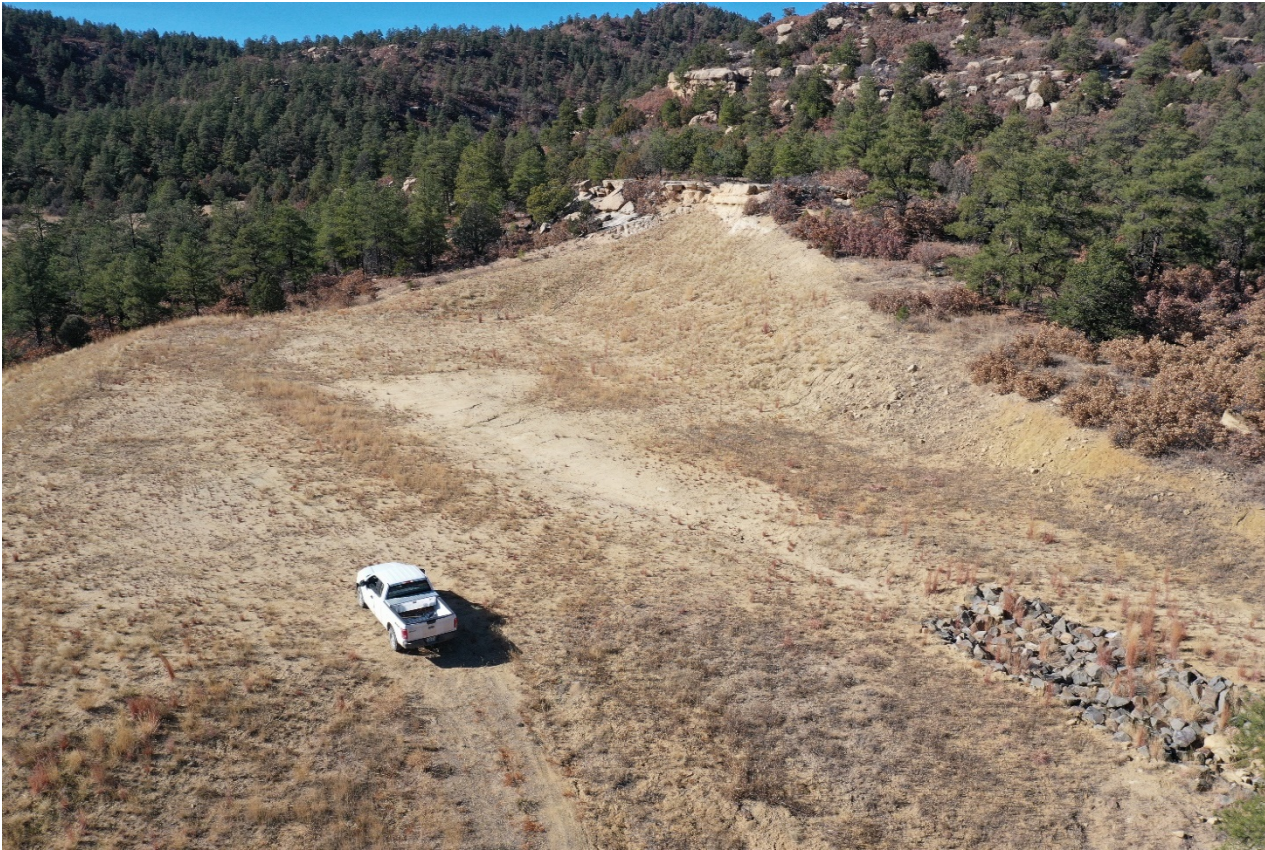
**Photo 10.** Drone aerial photo facing northwest toward the location.

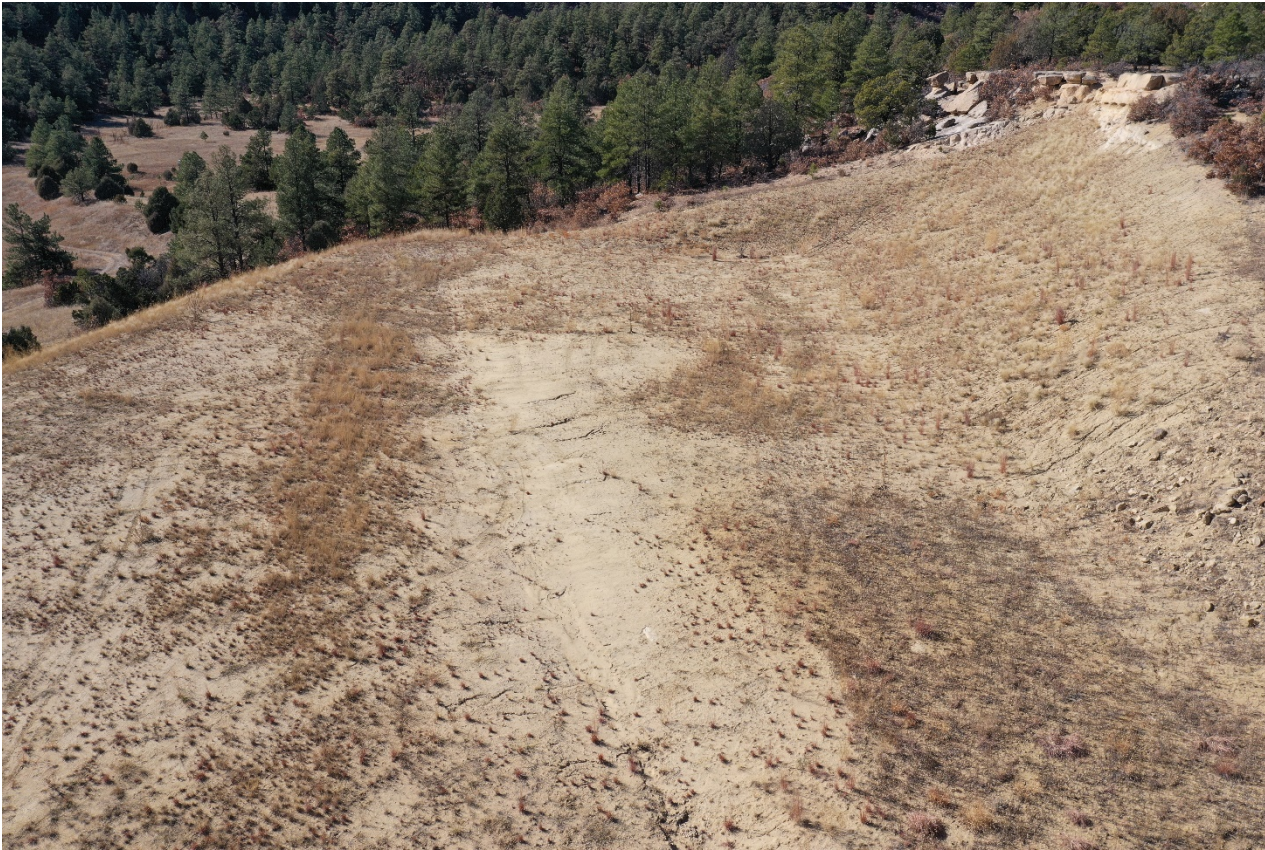
**Photo 11.** Drone aerial photo facing west toward the location.
