Inspection Photos

Location Name: CAERUS PICEANCE LLC CASS-GARBER-68S96W /1NWNE

Location ID: 334129

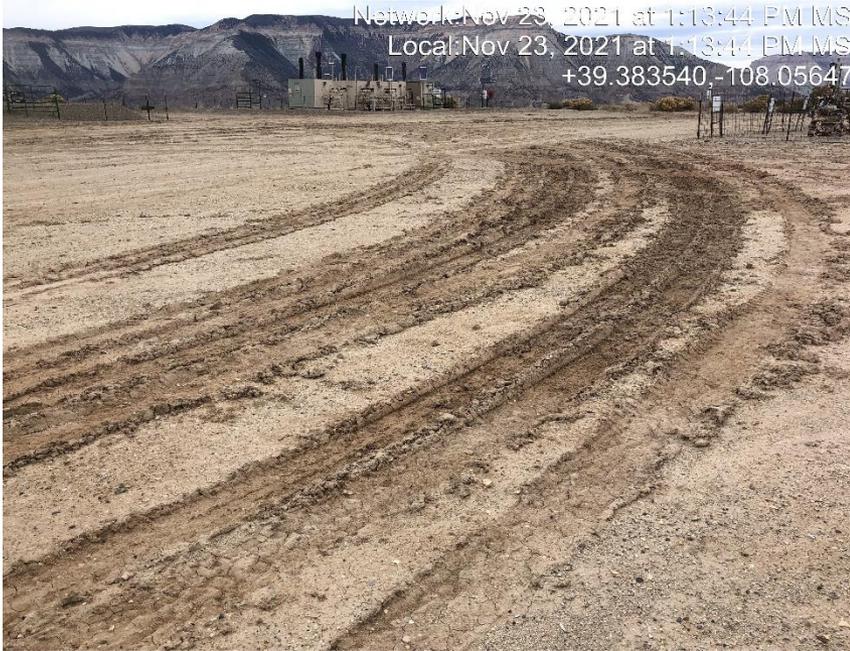
Photo #5238 Location lacks stabilization.

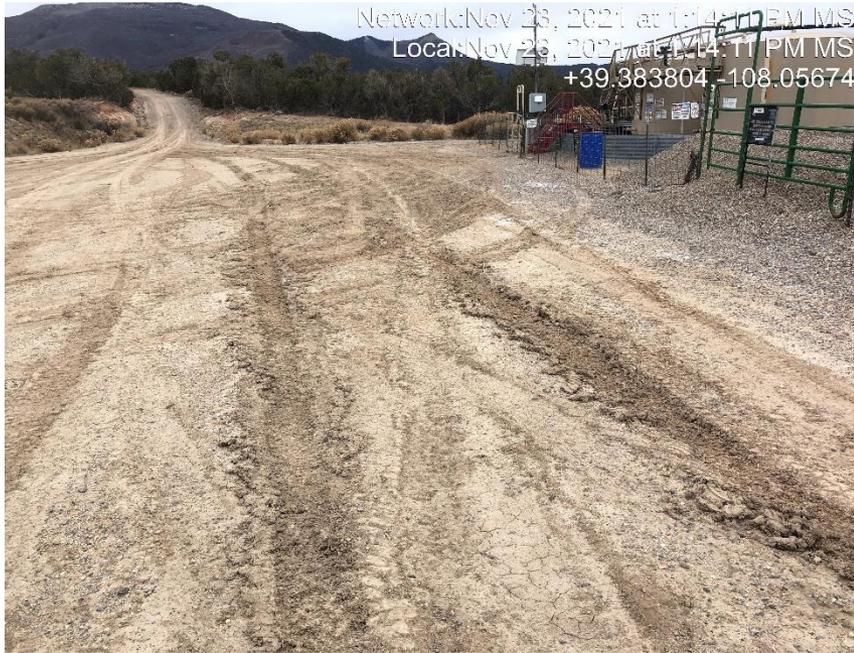
Photo #5239 location lacks stabilization.

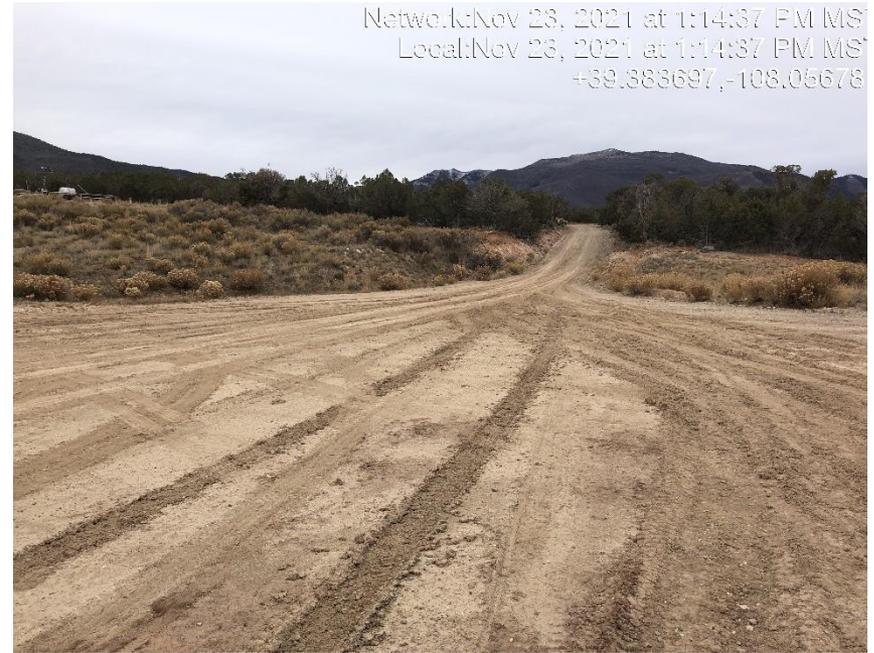
Photo #5240 No form of tracking BMP located at entrance to location.
