## Inspection Photos

Location Name: TEP ROCKY MOUNTAIN LLC GR /23-11V

Location ID: 323872

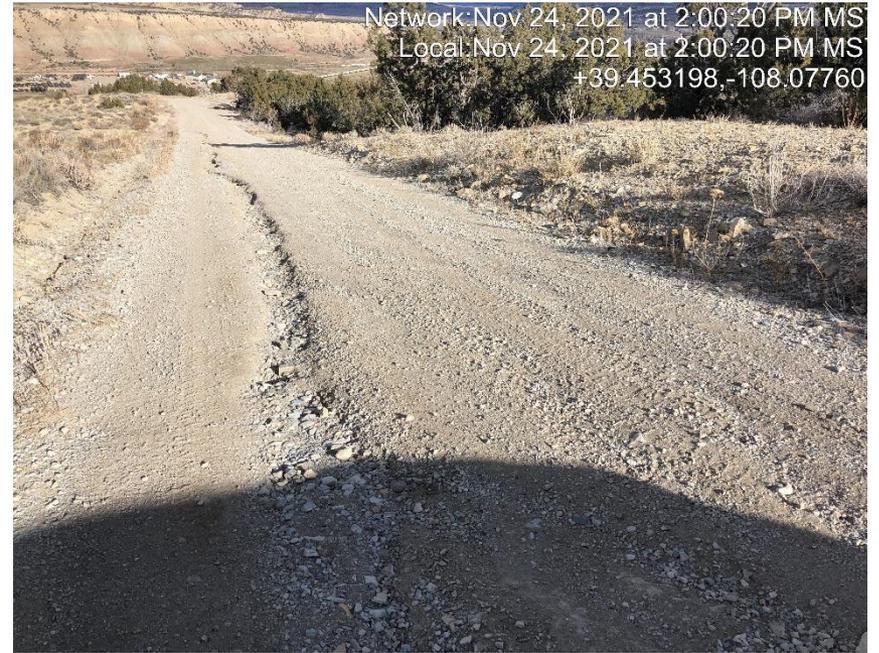
Photo #5255 Rill erosion occurring in access road.

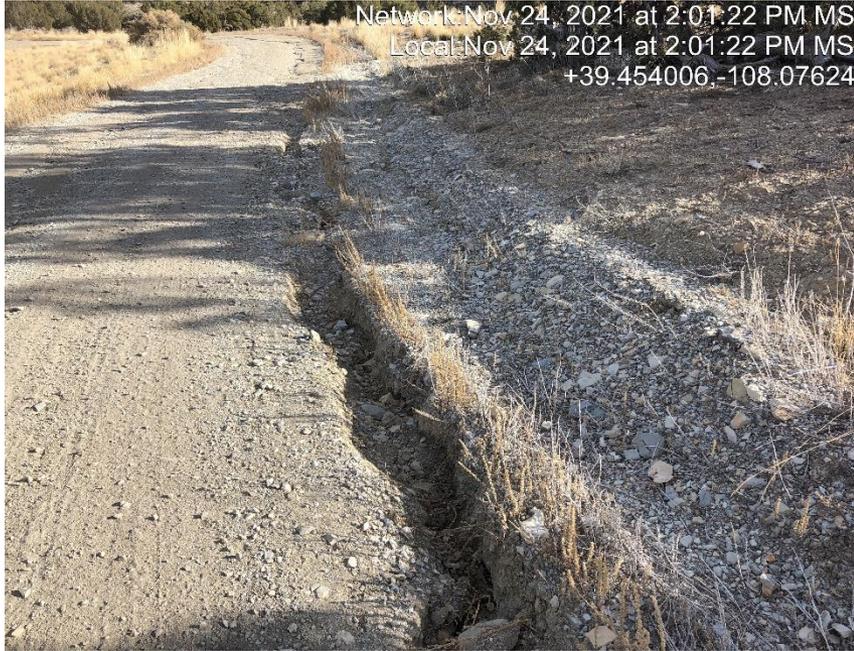
**Photo #5256 Insufficient velocity checks in ditches.**

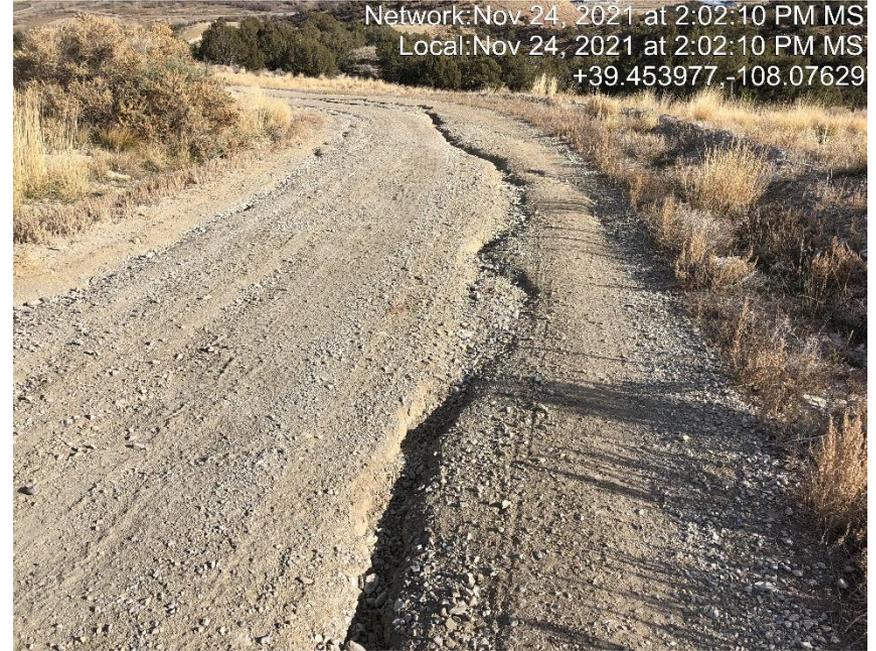
**Photo #5257 Rill erosion occurring in access road.**
