Inspection Photos
Operator: Simcoe
API: 067-06841
Date: 11/17/2021

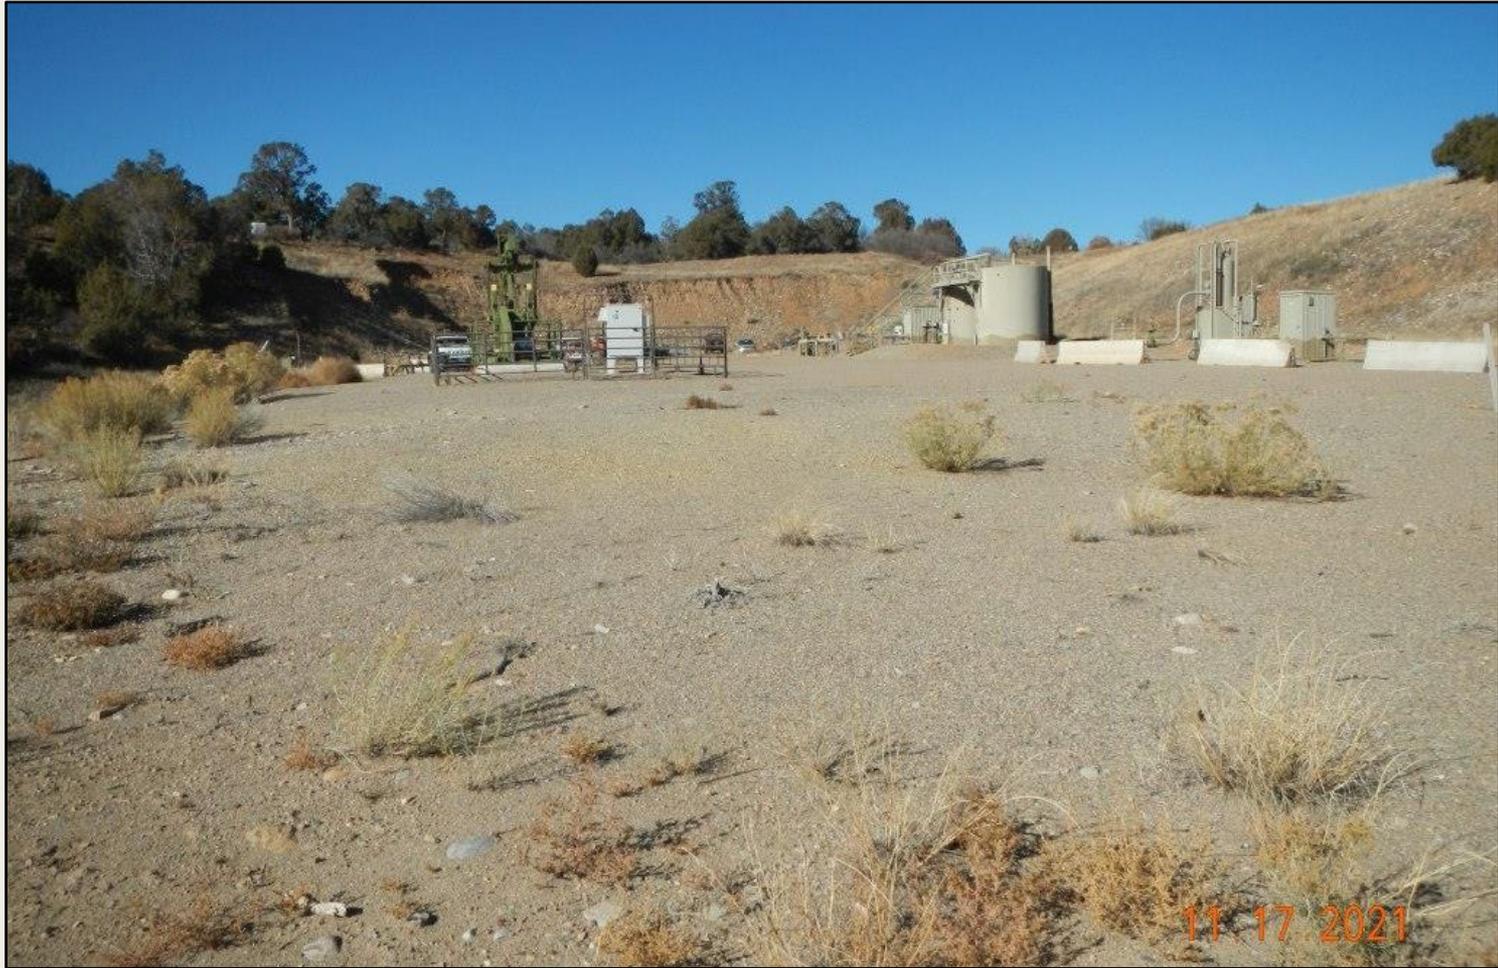
Photo 1. View of the project area from the southeastern corner of the working area facing center.

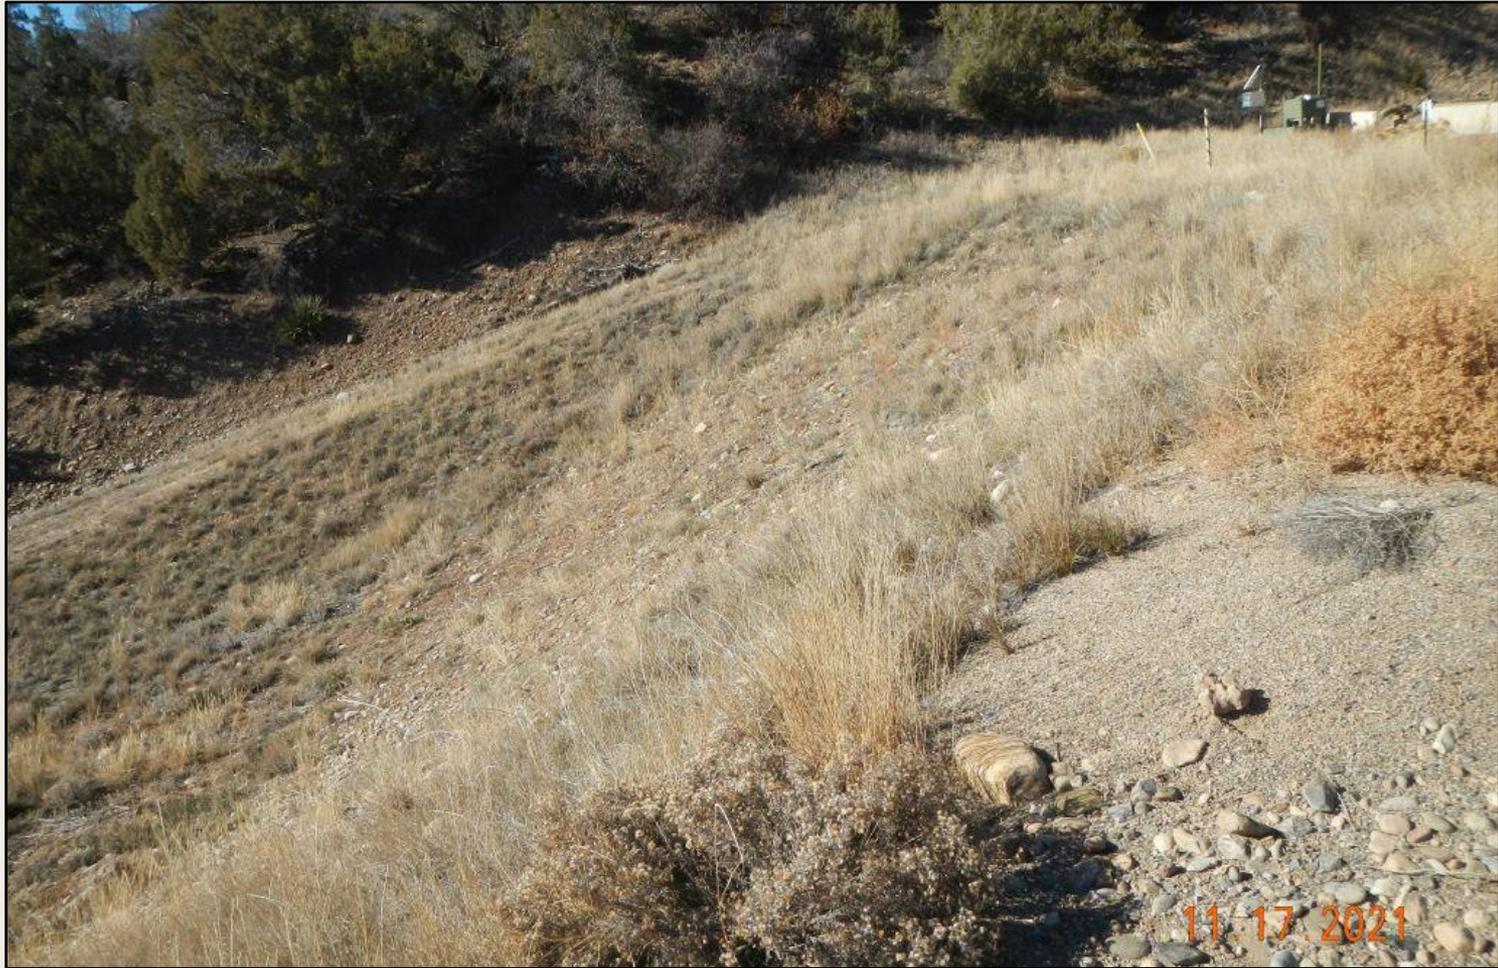
Photo 2. View of the southern project area from the southeastern corner facing westard. Revegetation is progressing with western wheatgrass and sand dropseed.

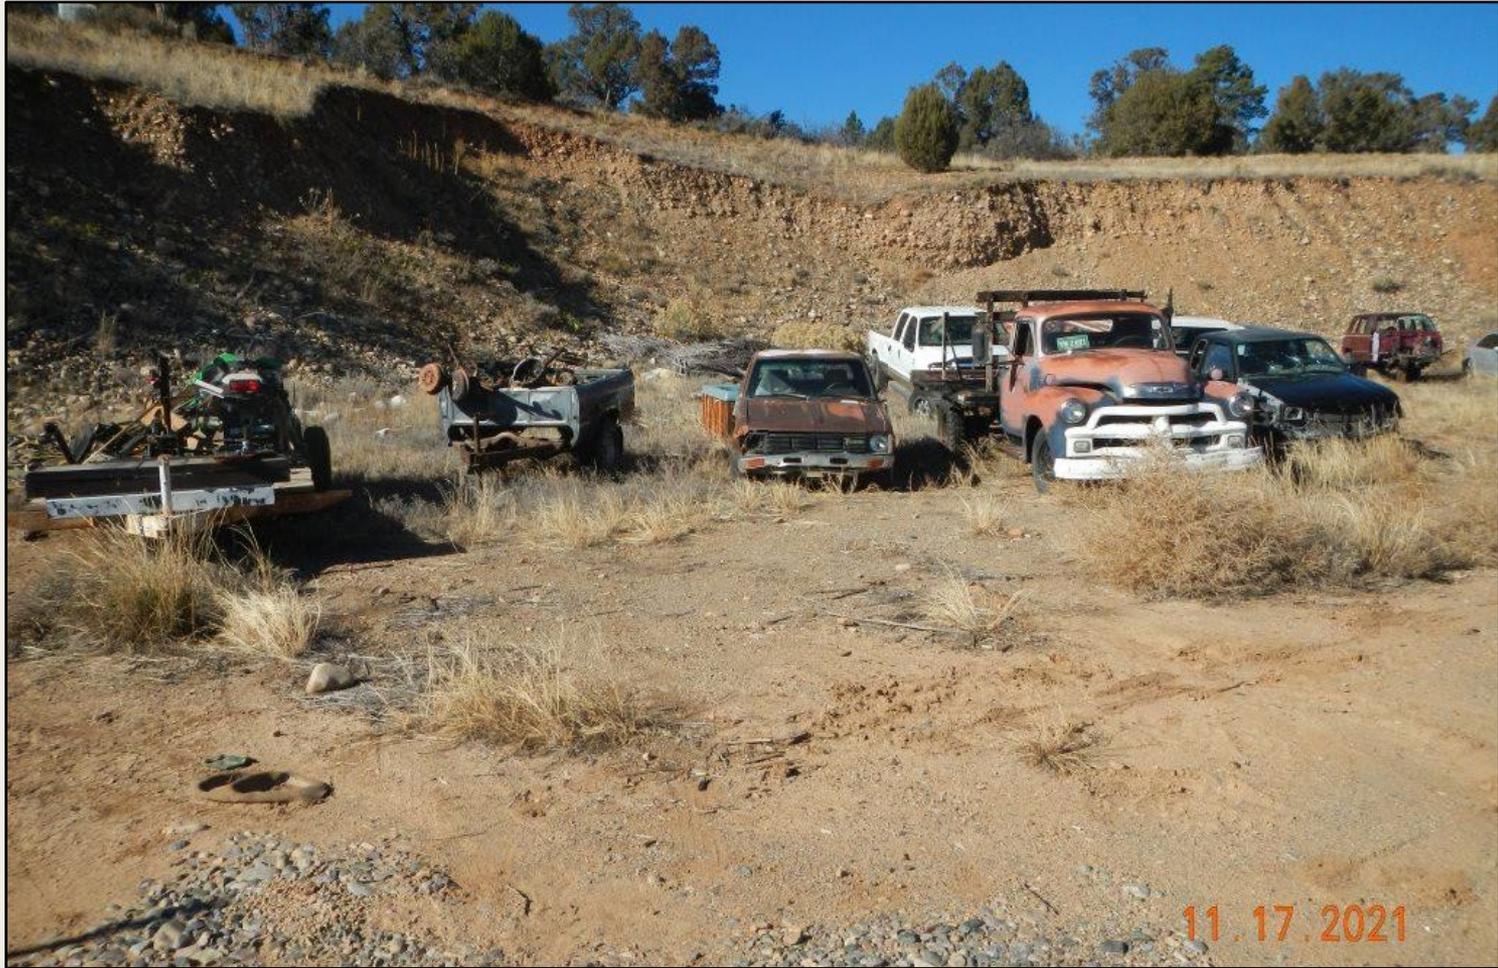
Photo 3. View of what appears to be surface owner cars and material stored in the western project area, needs to be removed. Site needs to be managed to prevent disposal of equipment and debris.

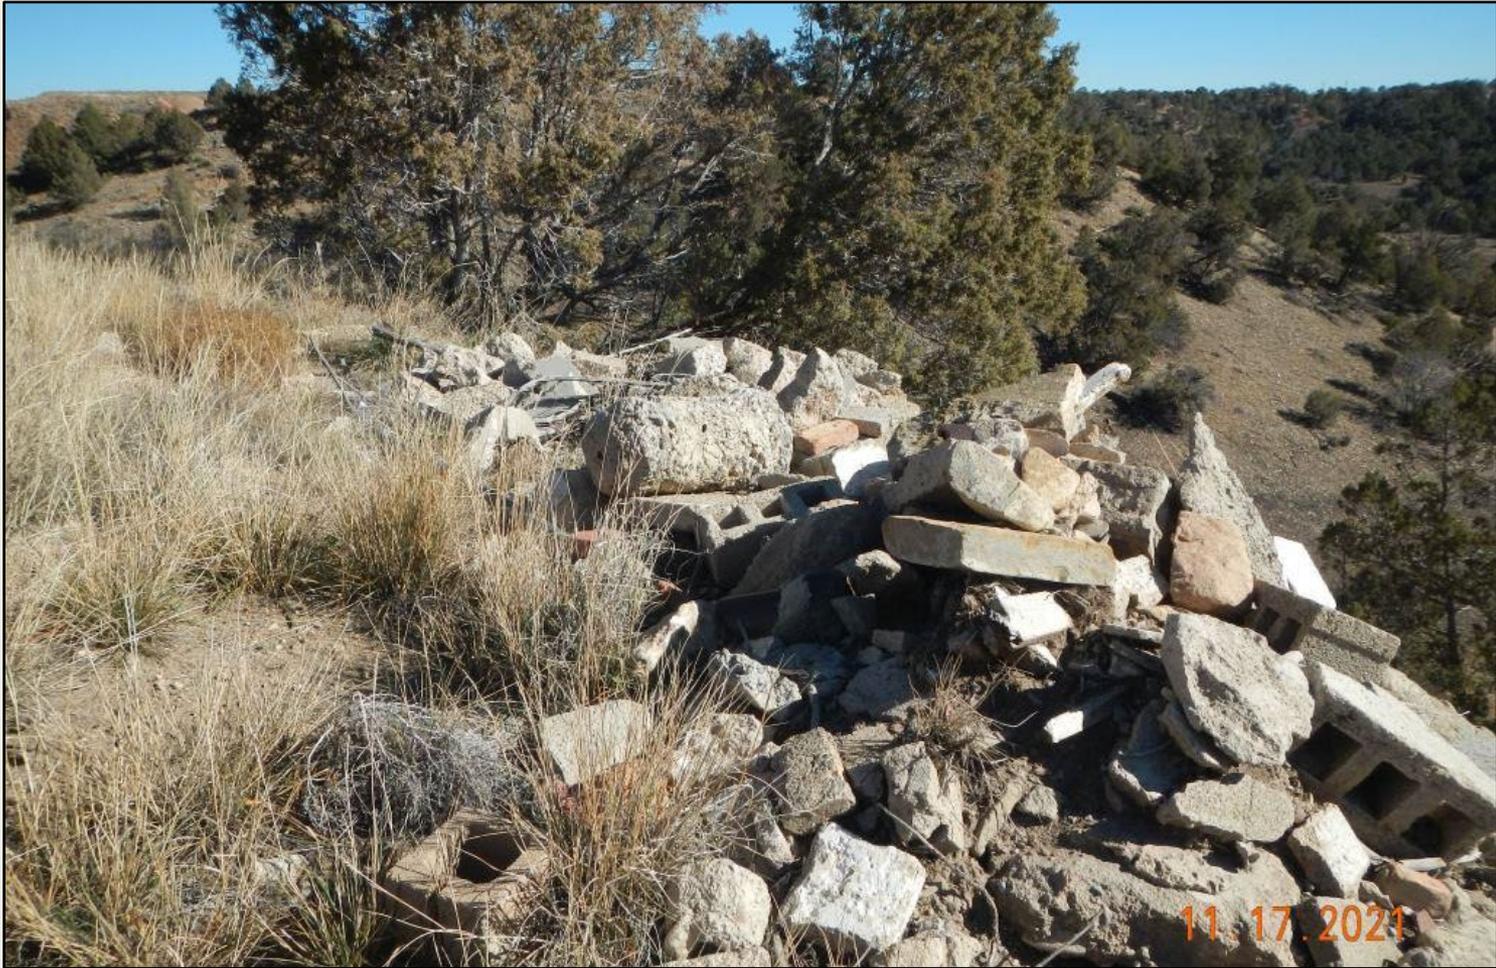
Photo 4. View of pile of cement debris observed within the southeastern project area.

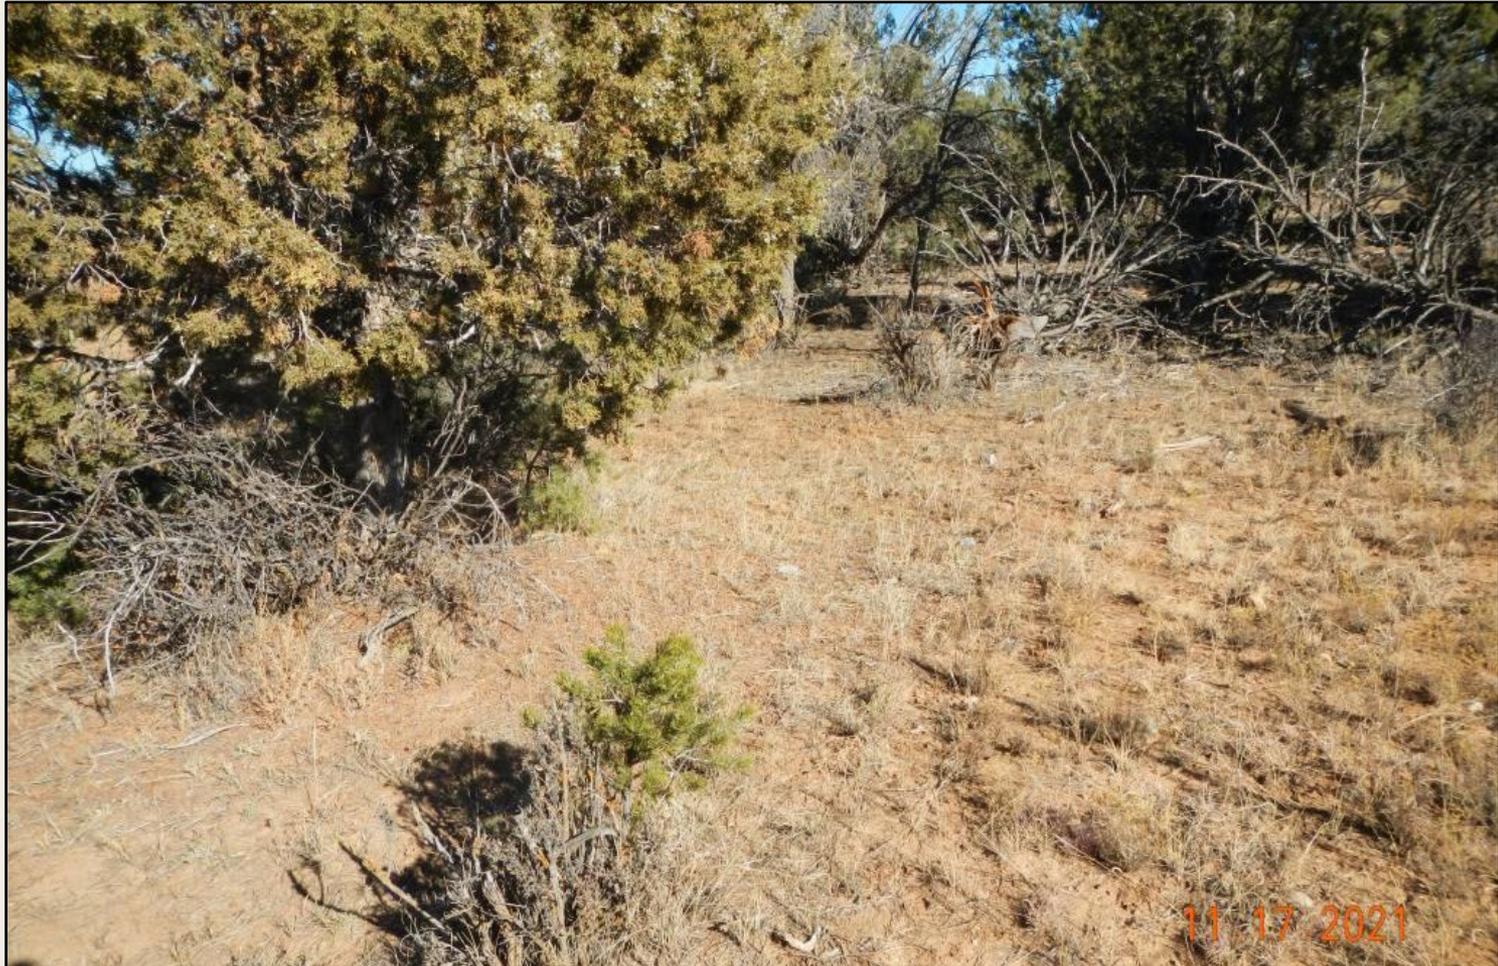
Photo 5. View of reference area comprised of pinyon and juniper woodland with gambel oak, western wheatgrass, and mountain mahogany in the understory.
