Inspection Photos

Location Name: CAERUS PICEANCE LLC CHEVRON-66S96W /17SESW

Location ID: 335780

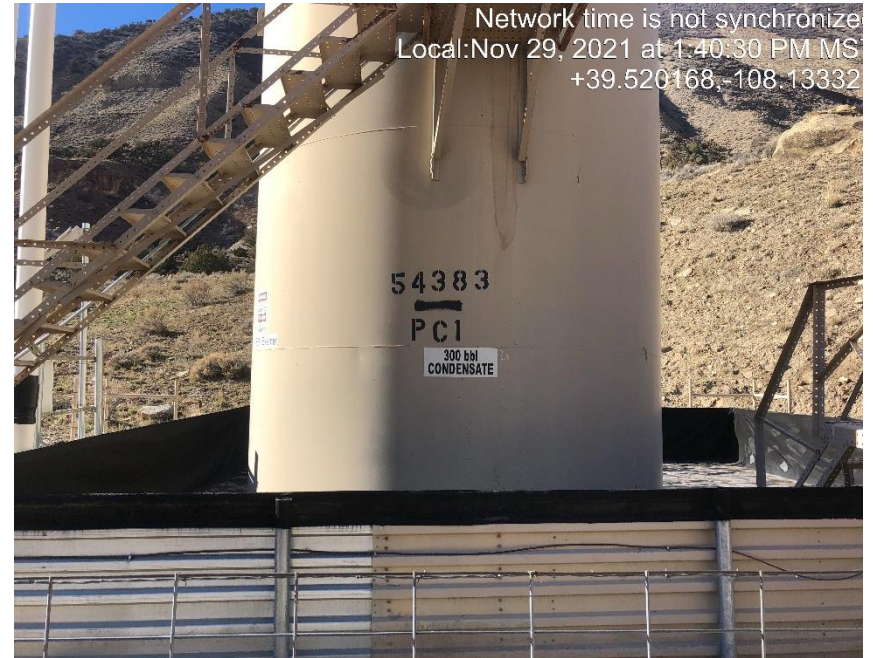
Photo #5279 Condensate tank missing required information.

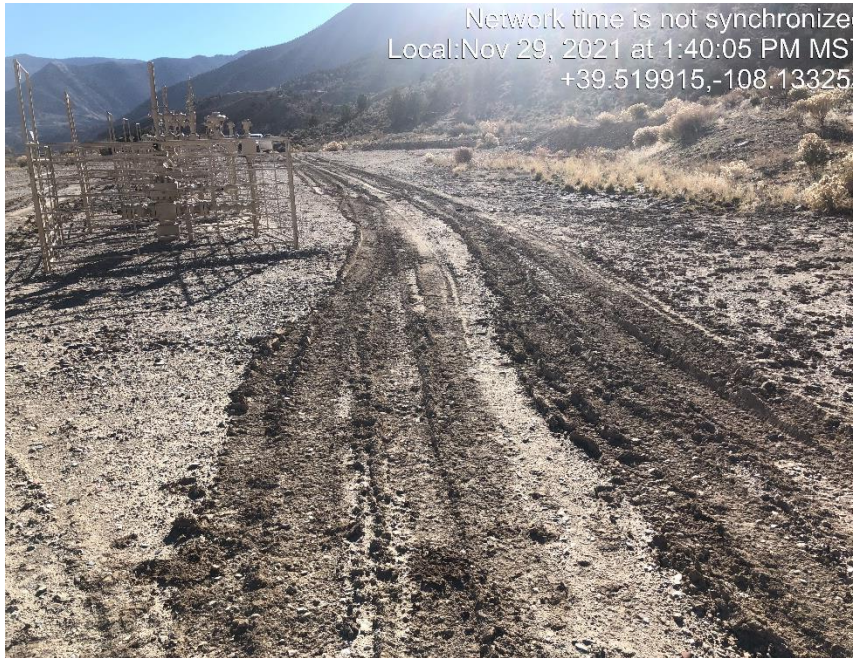
Photo #5278 Location lacks stabilization.

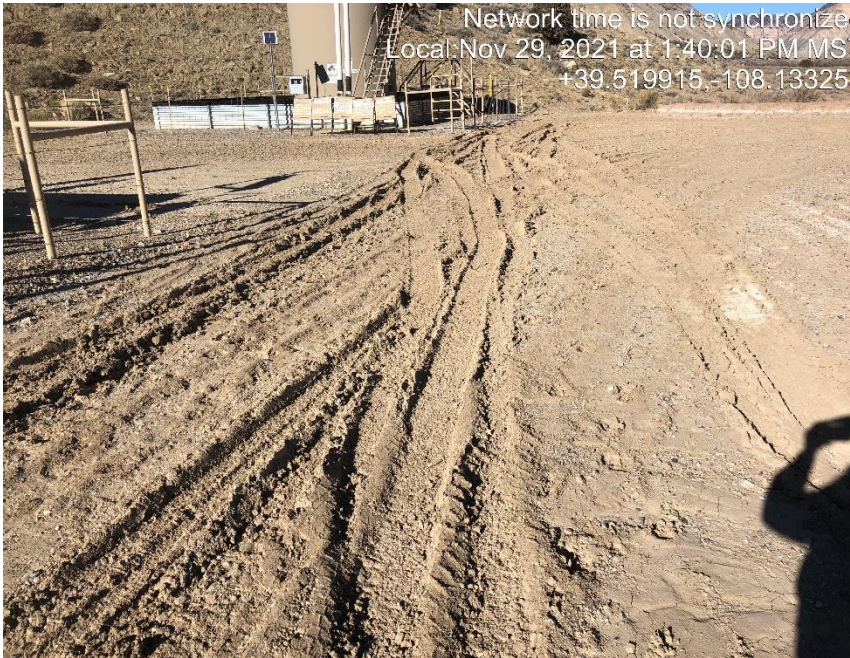
Photo #5277 Location lacks stabilization.

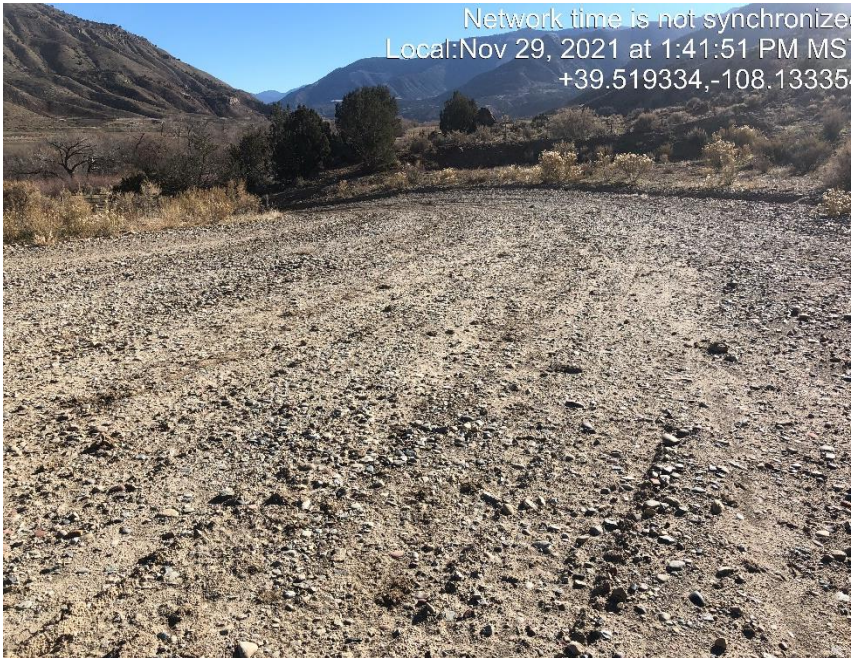
Photo #5280 No form of tracking BMP at entrance to location.
