**Inspection Photos**  
**Operator: Arkoma Operations**  
**API: 067-05464**  
**Date: 11/30/2021**

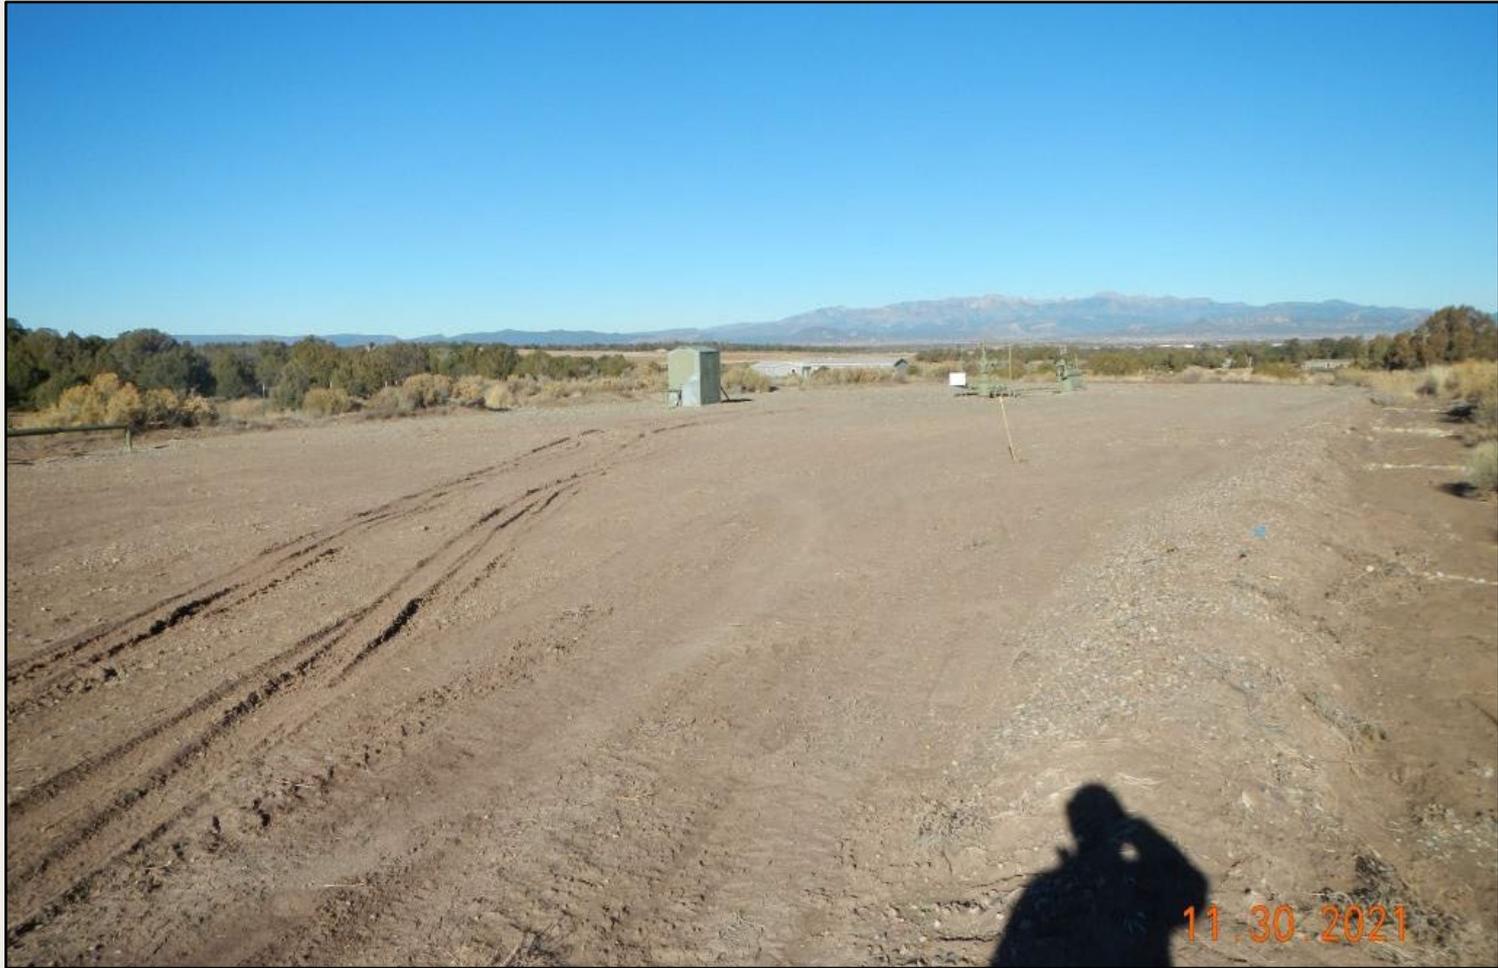
Photo 1. View of the project area from the southwestern corner facing center.

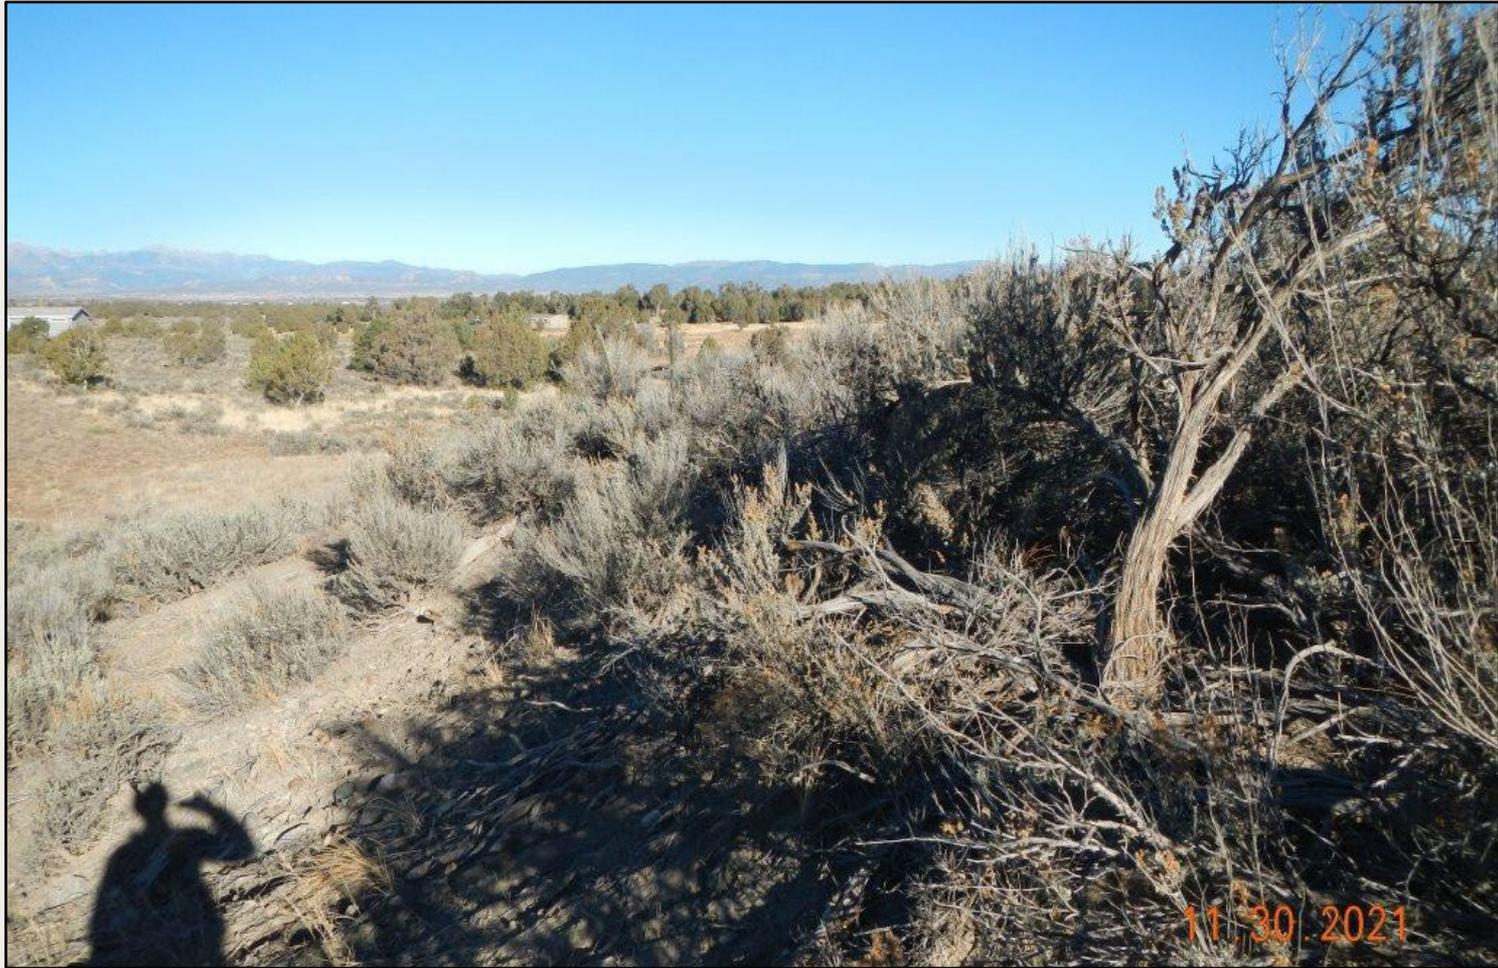
Photo 2. View of the western fill slope, from the southwestern corner facing northward. Revegetation is progressing with sagebrush, western wheatgrass, and Indian ricegrass.

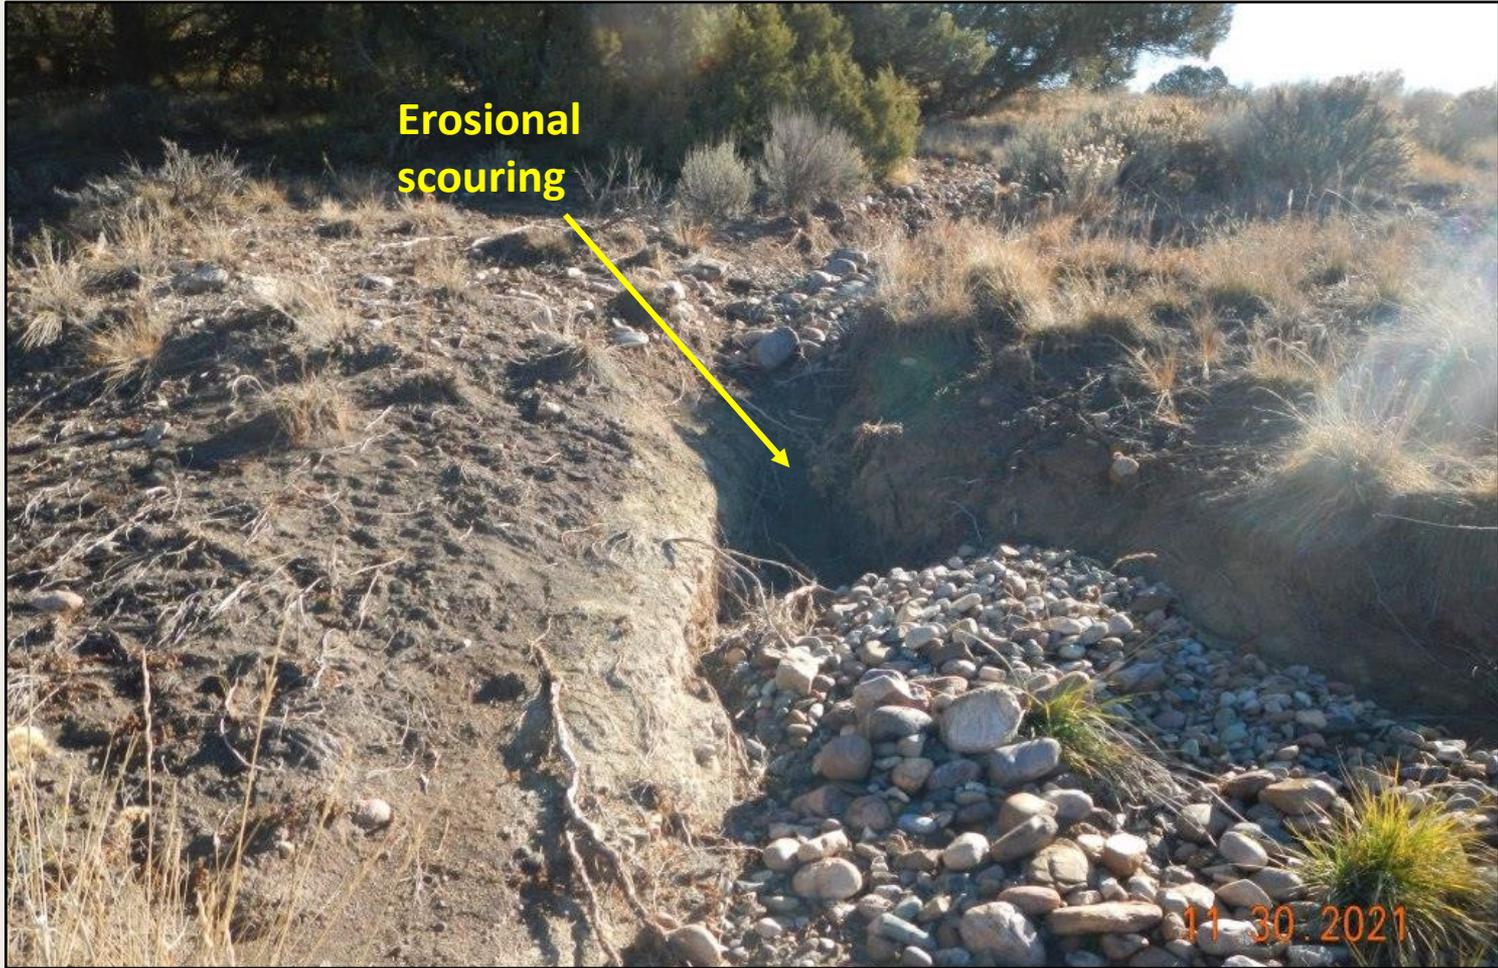
Photo 3. View of erosional scouring within diversion channel in southeastern project area. Cobble and sediment are washed down-slope from the diversion.

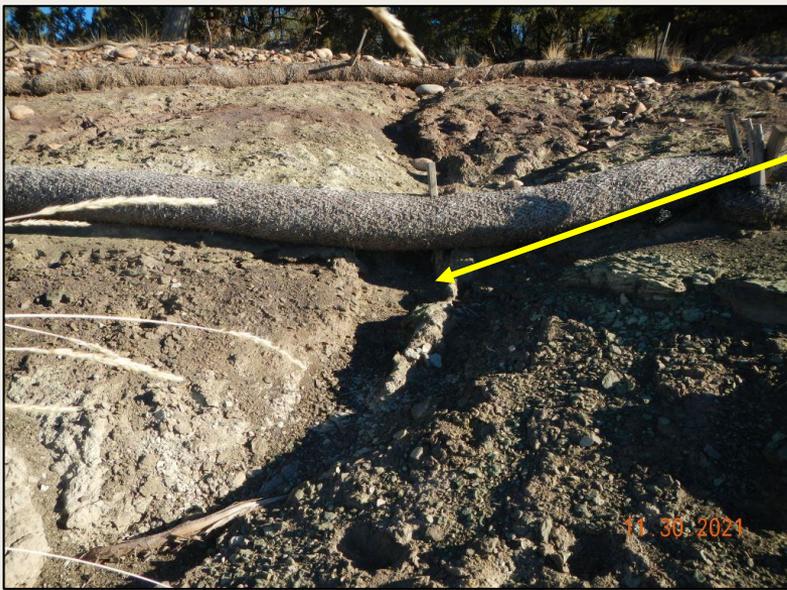
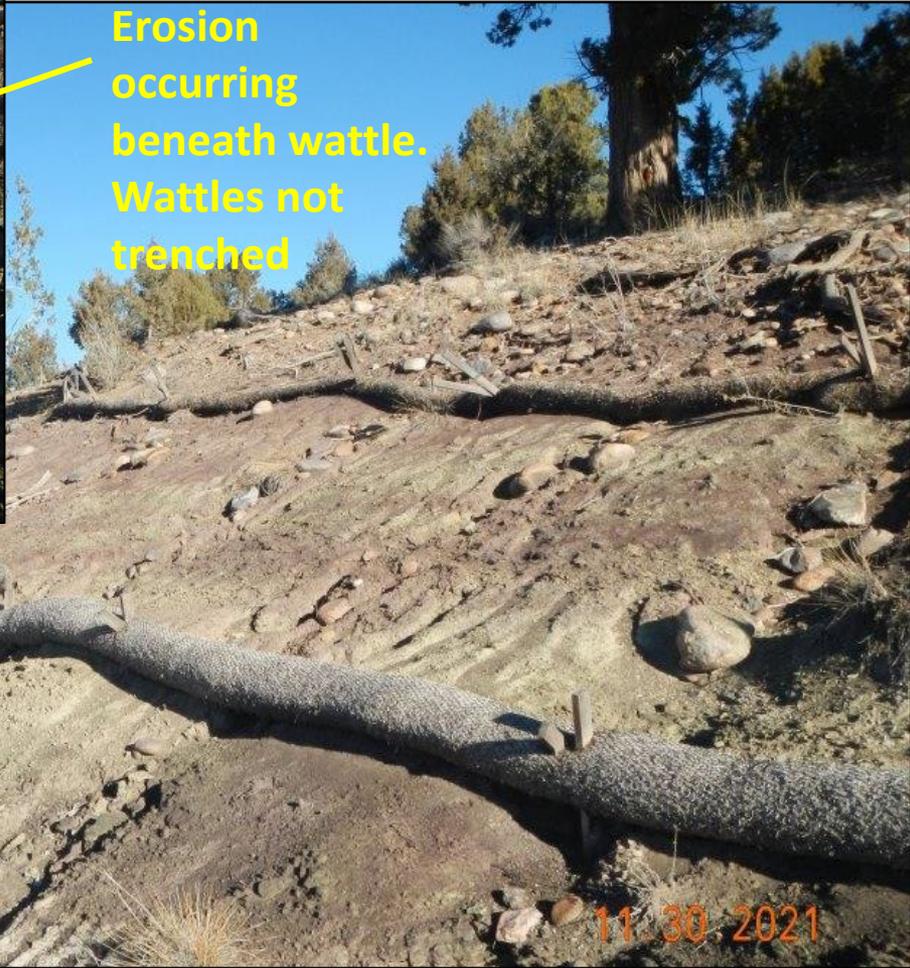
Erosion occurring beneath wattle. Wattles not trenched

Photo 4. View of bare/unstabilized soils on the eastern cut-slope. Wattles are not adequate BMPs here.

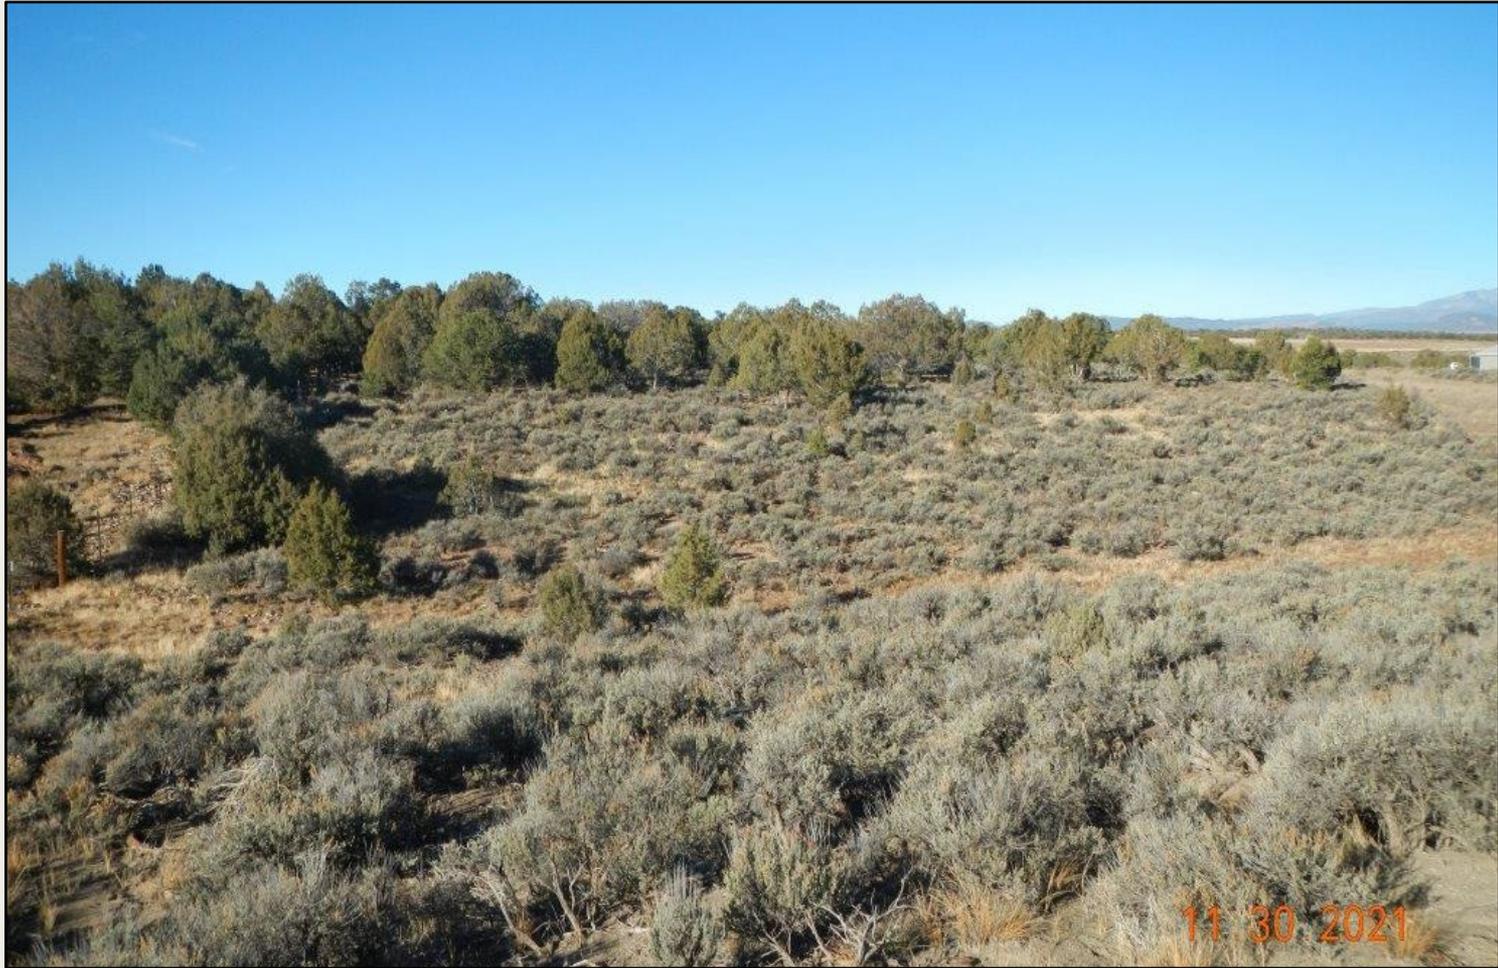
Photo 5. View of reference area comprised of sagebrush shrubland, with snakeweed, buckwheat, western wheatgrass, Indian ricegrass, purple threeawn, and squirreltail.
