Inspection Photos
Operator: Logos Operating
API: 067-08094
Date: 11/30/2021

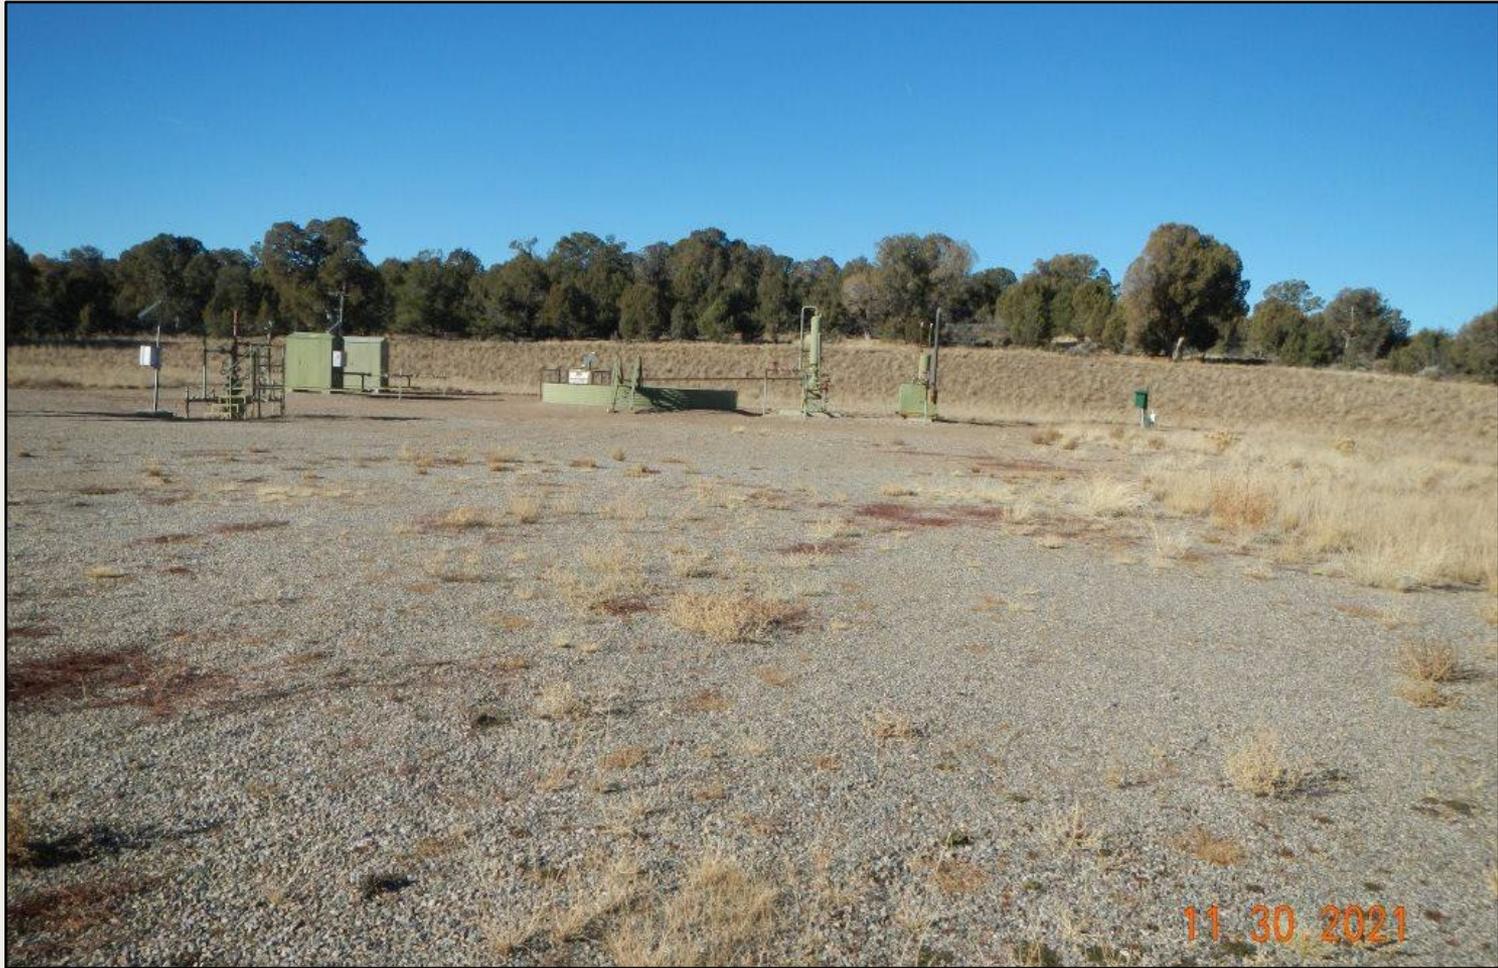
Photo 1. View of the project area from the southeastern corner facing center.

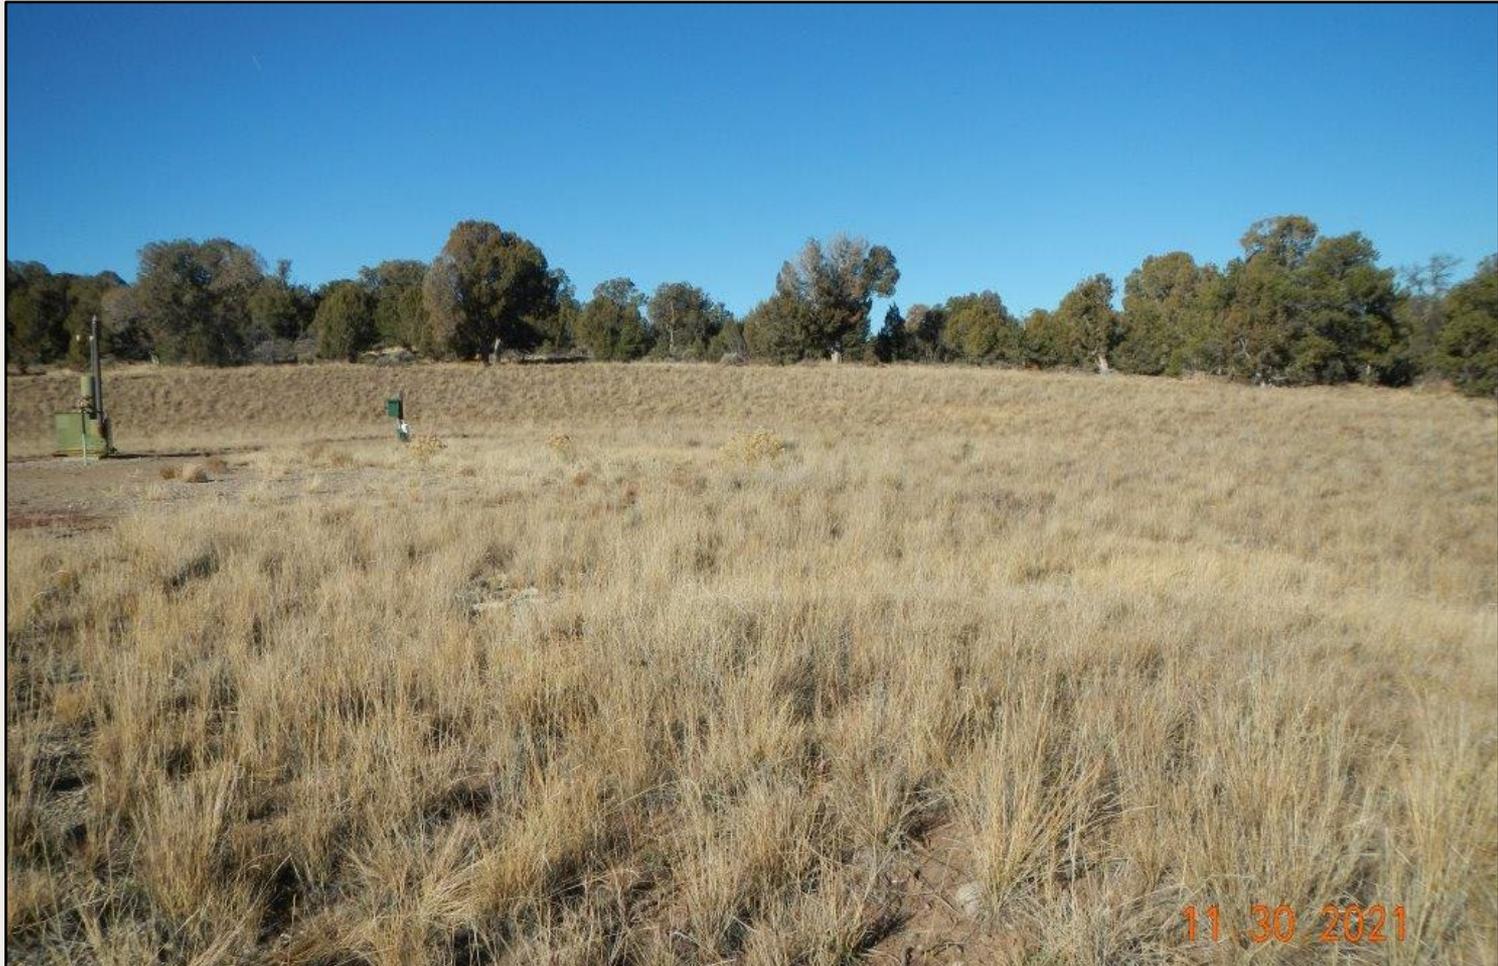
Photo 2. View of the eastern fill slope, from the southeastern corner facing northwestward. Revegetation is progressing with western wheatgrass, crested wheatgrass, and sand dropseed.

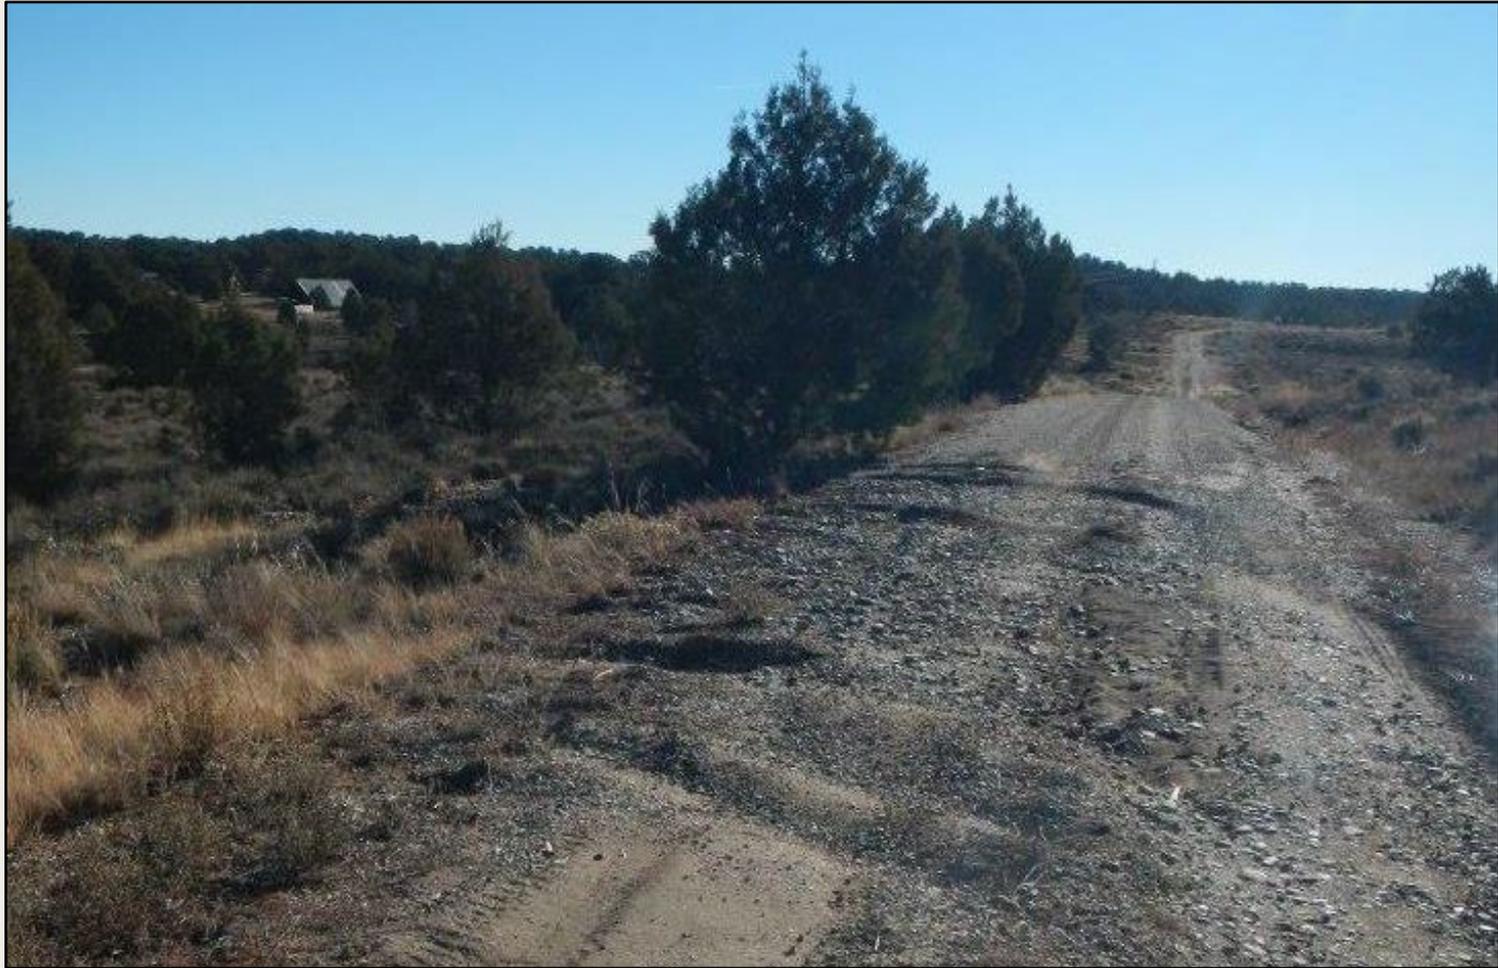
Photo 3. View of erosional scouring and erosion on the access road where stormwater flows are improperly diverted. Approximately 4-6 inches deep of material is eroded off of the road and down-slope.

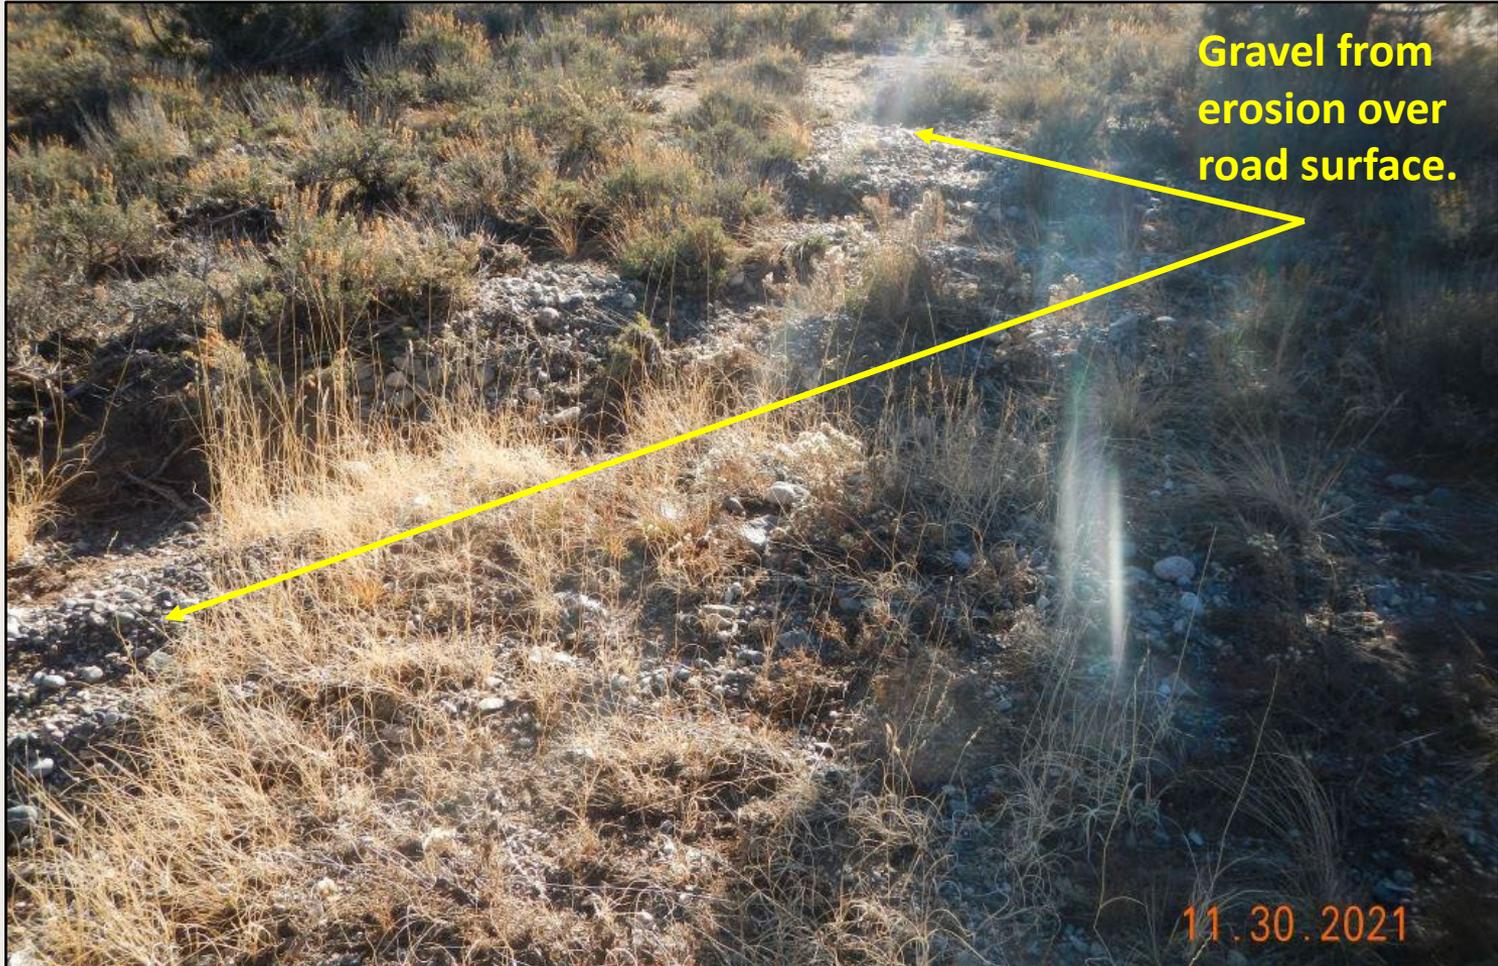
Photo 4. View of area down-slope of erosion on road observed in Photo 5. Stormwater flows have resulted in erosion and gravel deposition.

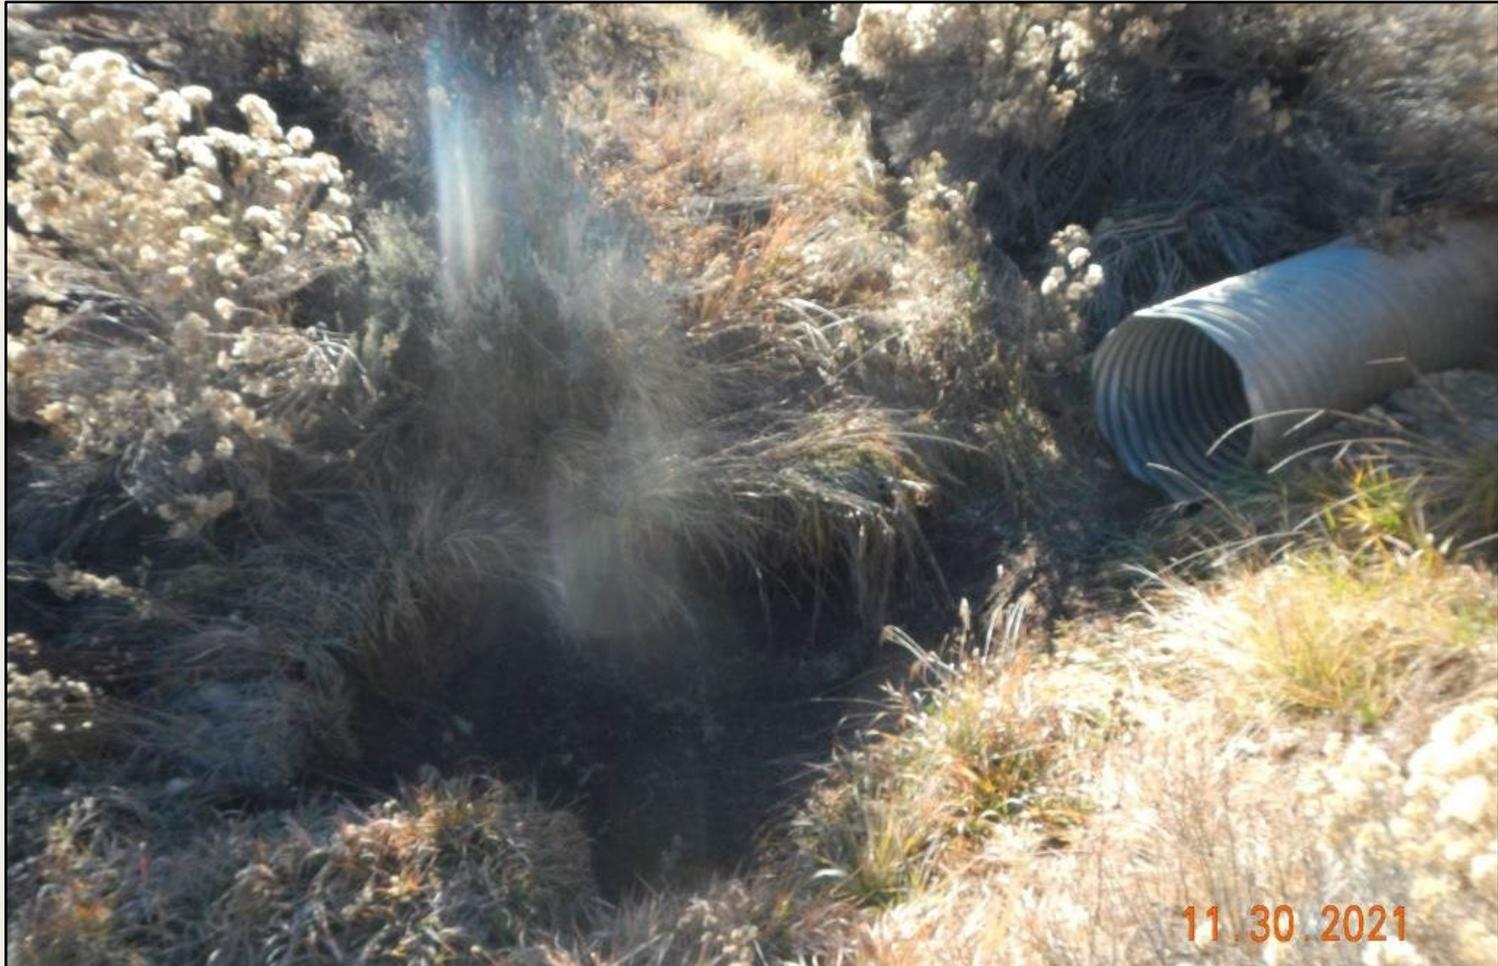
Photo 5. View of erosion occurring at culvert outlet along access road, approximately 3 feet deep, where concentrated stormwater flows out of culvert and eroding soil and vegetation. Erosion observed around culvert indicates that it is not stabilized.

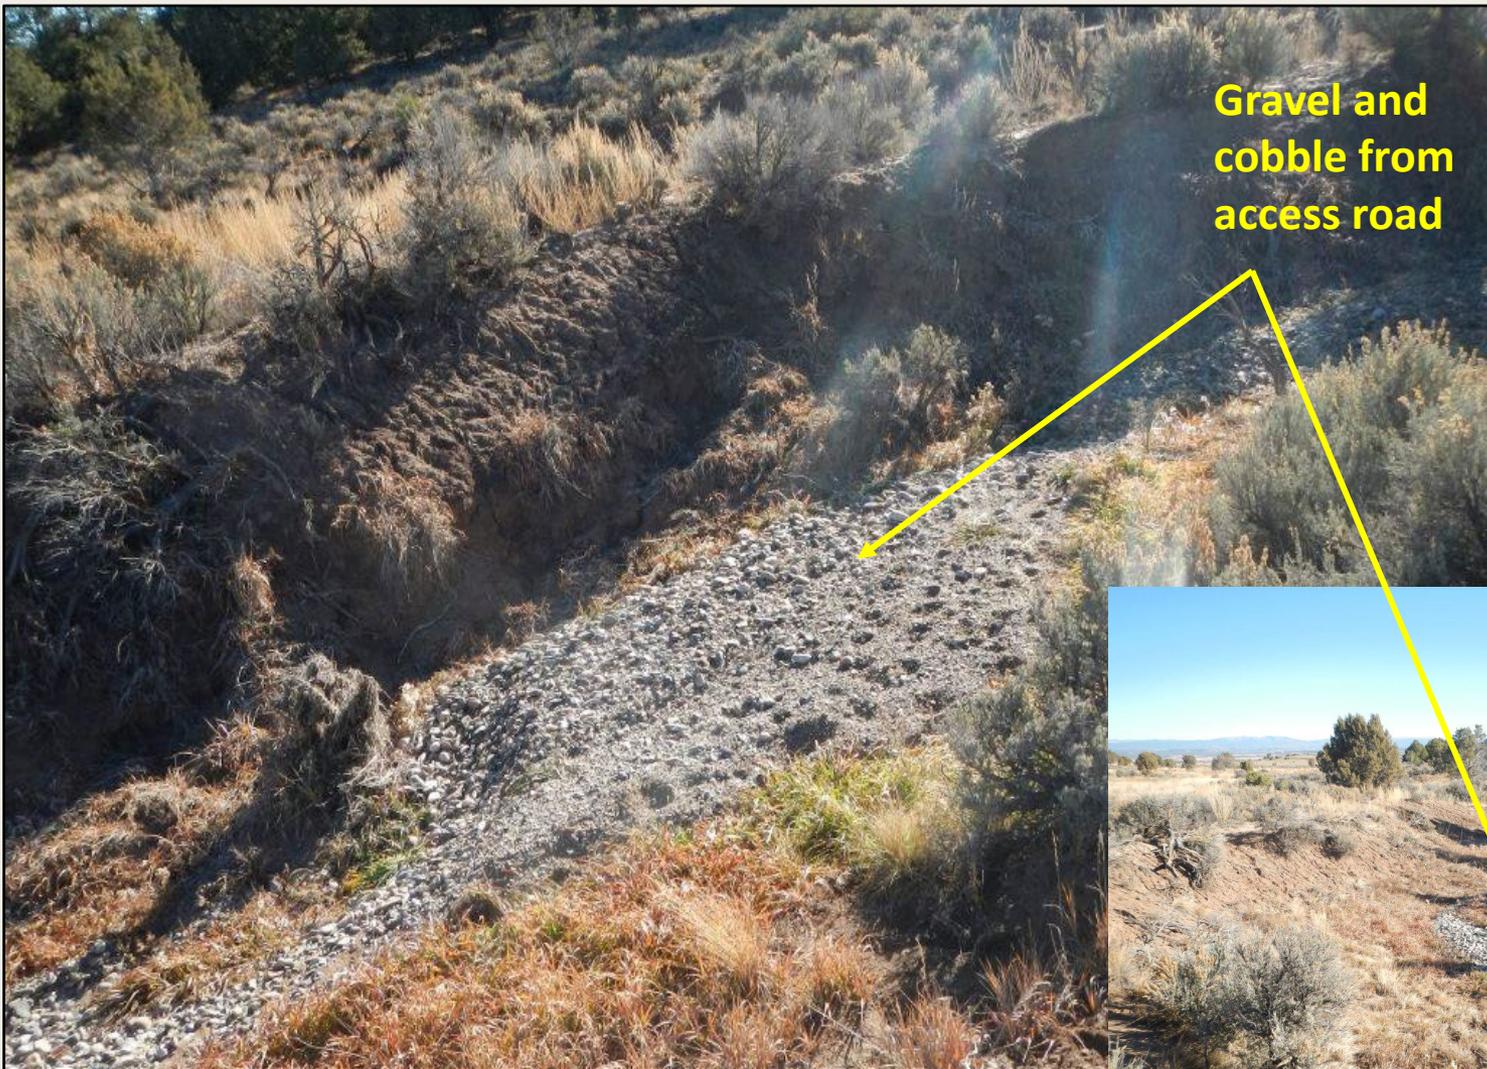
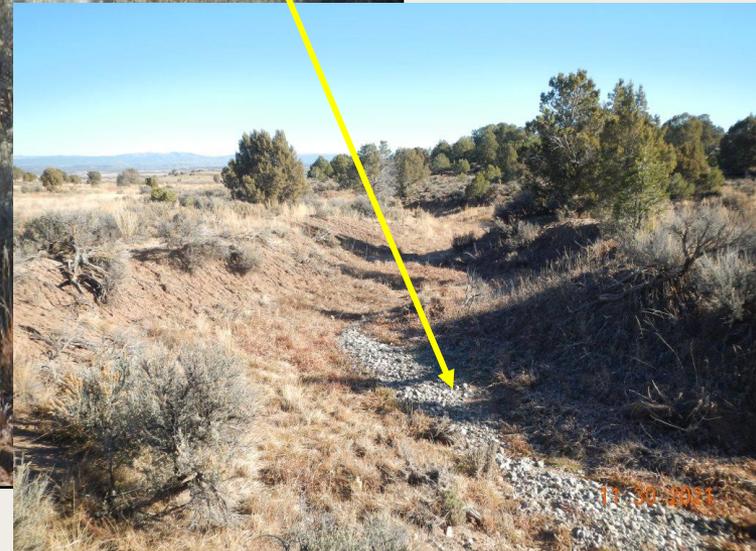
Gravel and
cobble from
access road

Photo 6. View of area approx. 50 ft down-slope of culvert outlet, where significant volumes (approx. 75ft long, 4-6 ft wide, and 4-6 inches deep) observed within the streambed.
