Inspection Photos
Operator: Logos Operating
API: 067-08272
Date: 11/30/2021

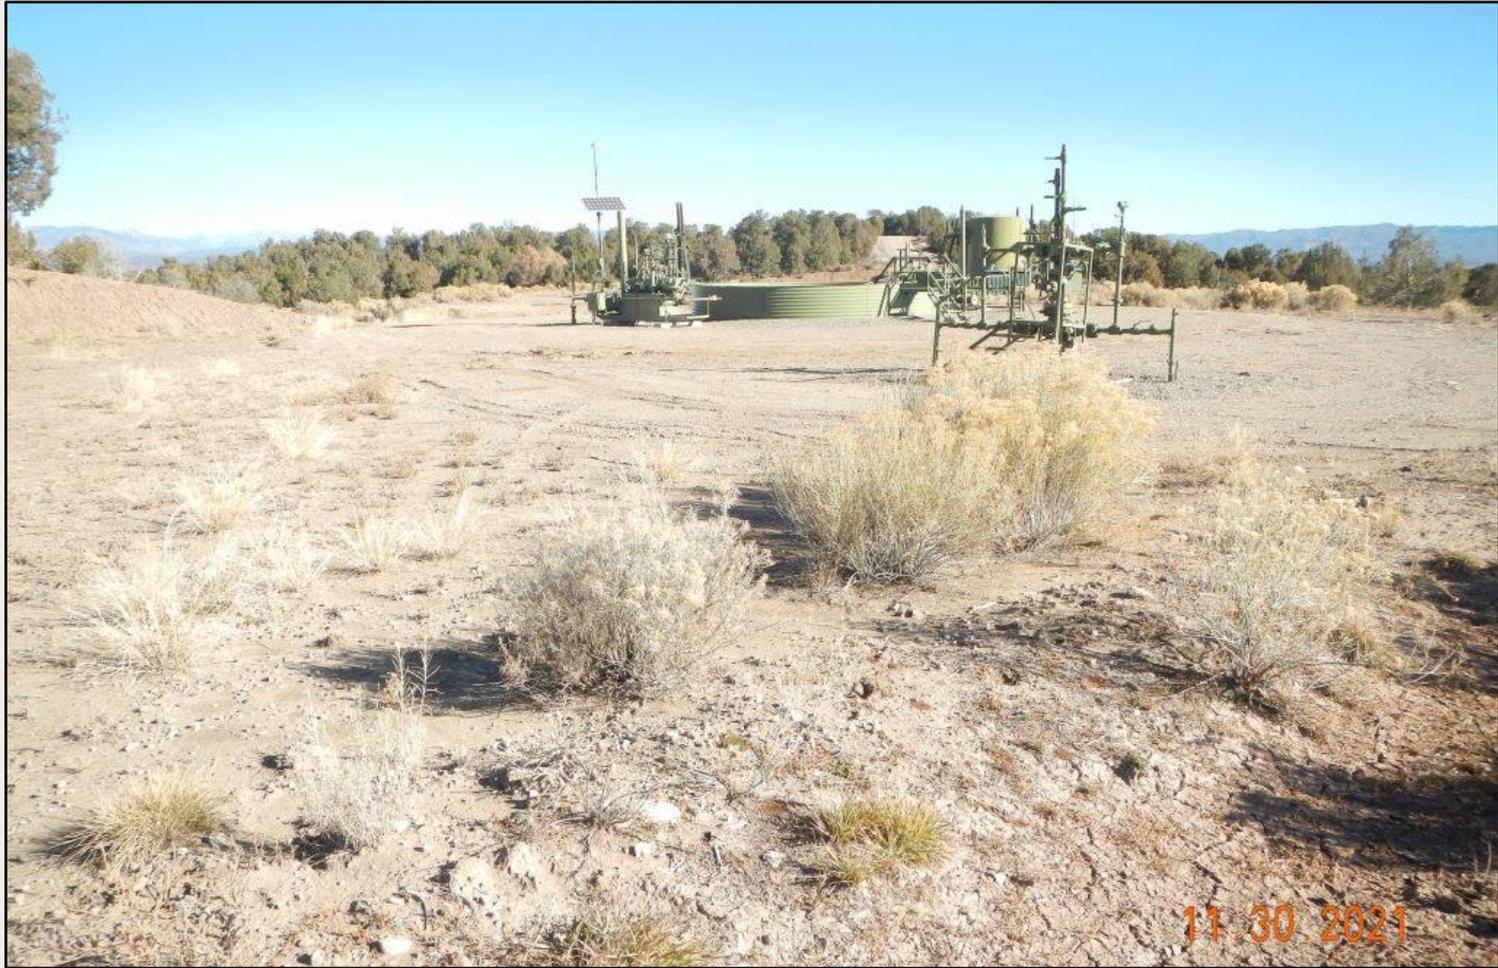
Photo 1. View of the project area from the southwestern corner facing center.

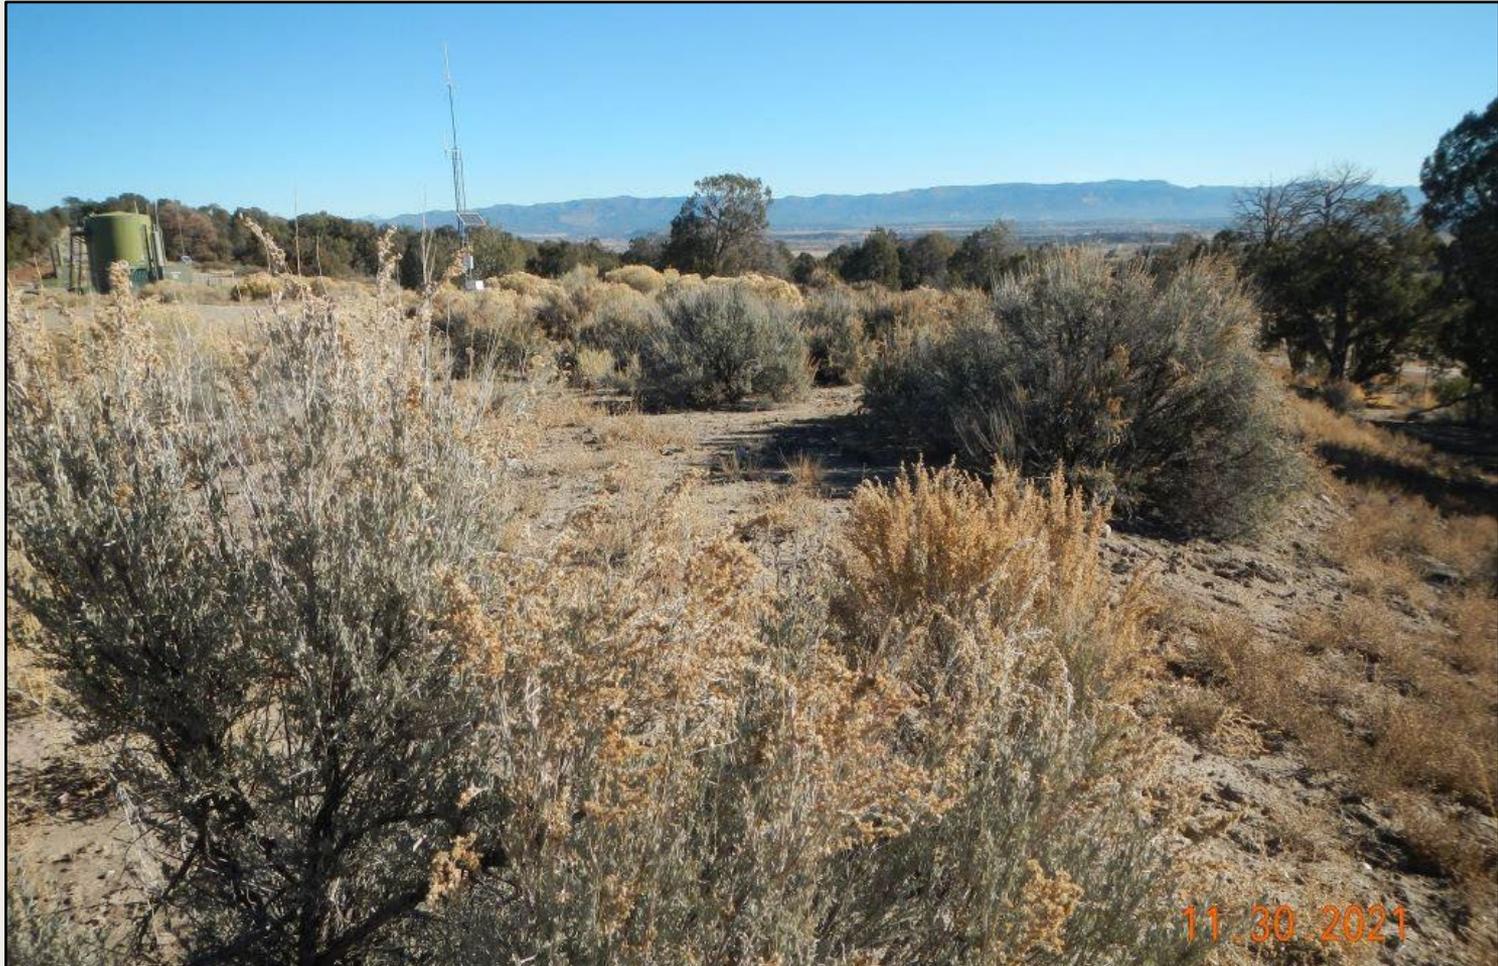
Photo 2. View of the southern fill slope from the southwestern corner facing eastward. Revegetation is largely progressing here with sagebrush, western wheatgrass, and sand dropseed. Portions of the fill slope remain weedy and rilling observed.

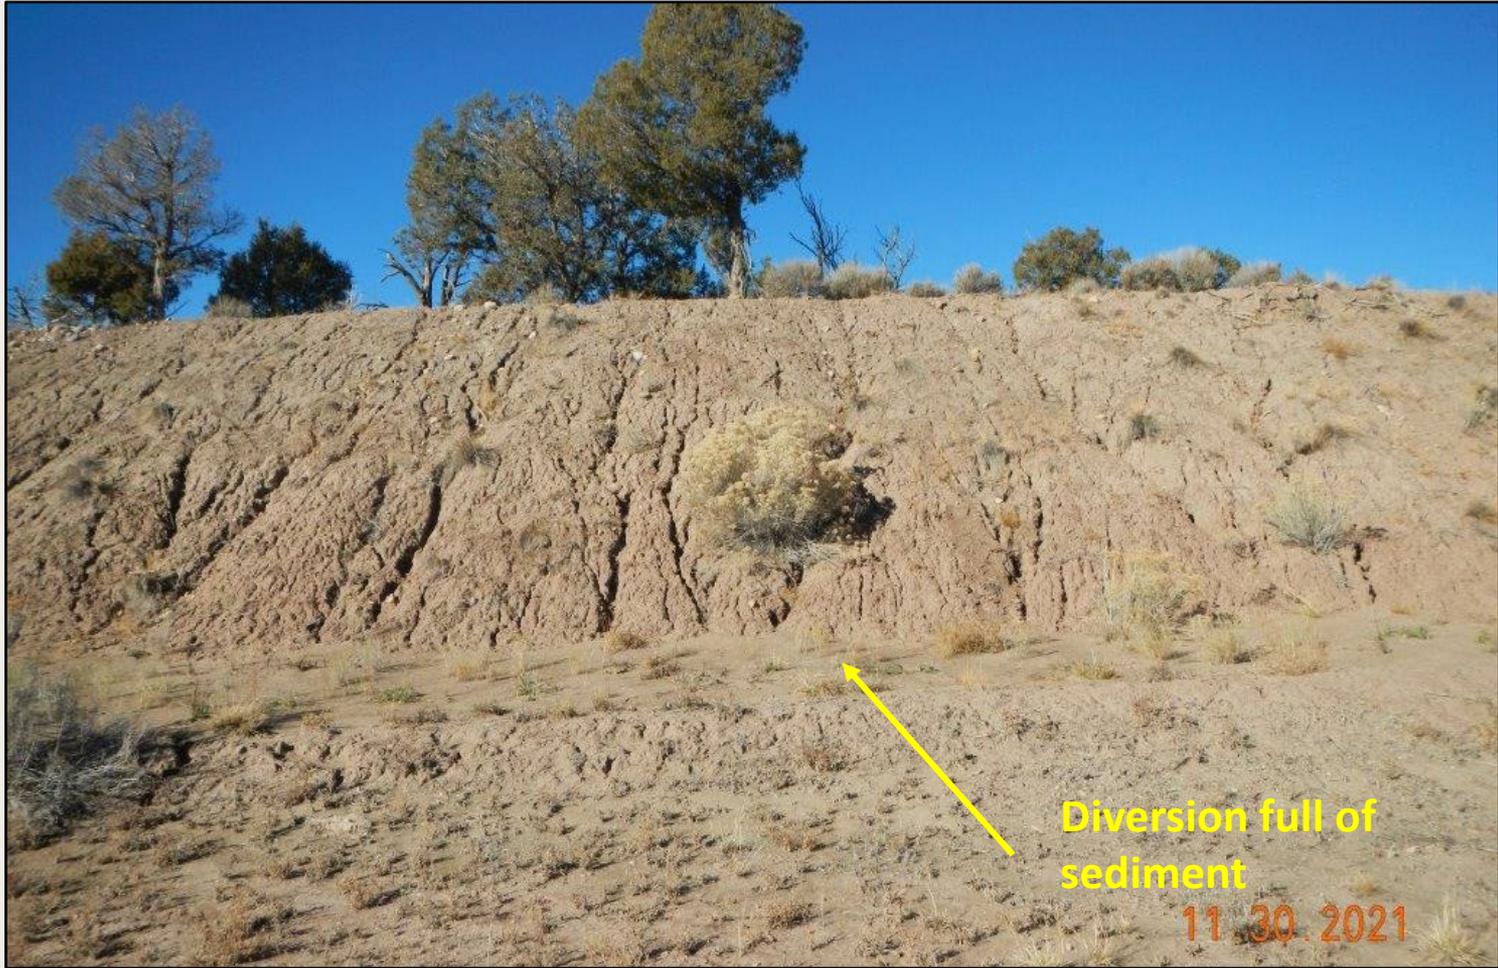
Photo 3. View of the western cut-slope. Slope is not stabilized, with rills approximately 8-12 inches deep. Diversion ditch is full of sediment.

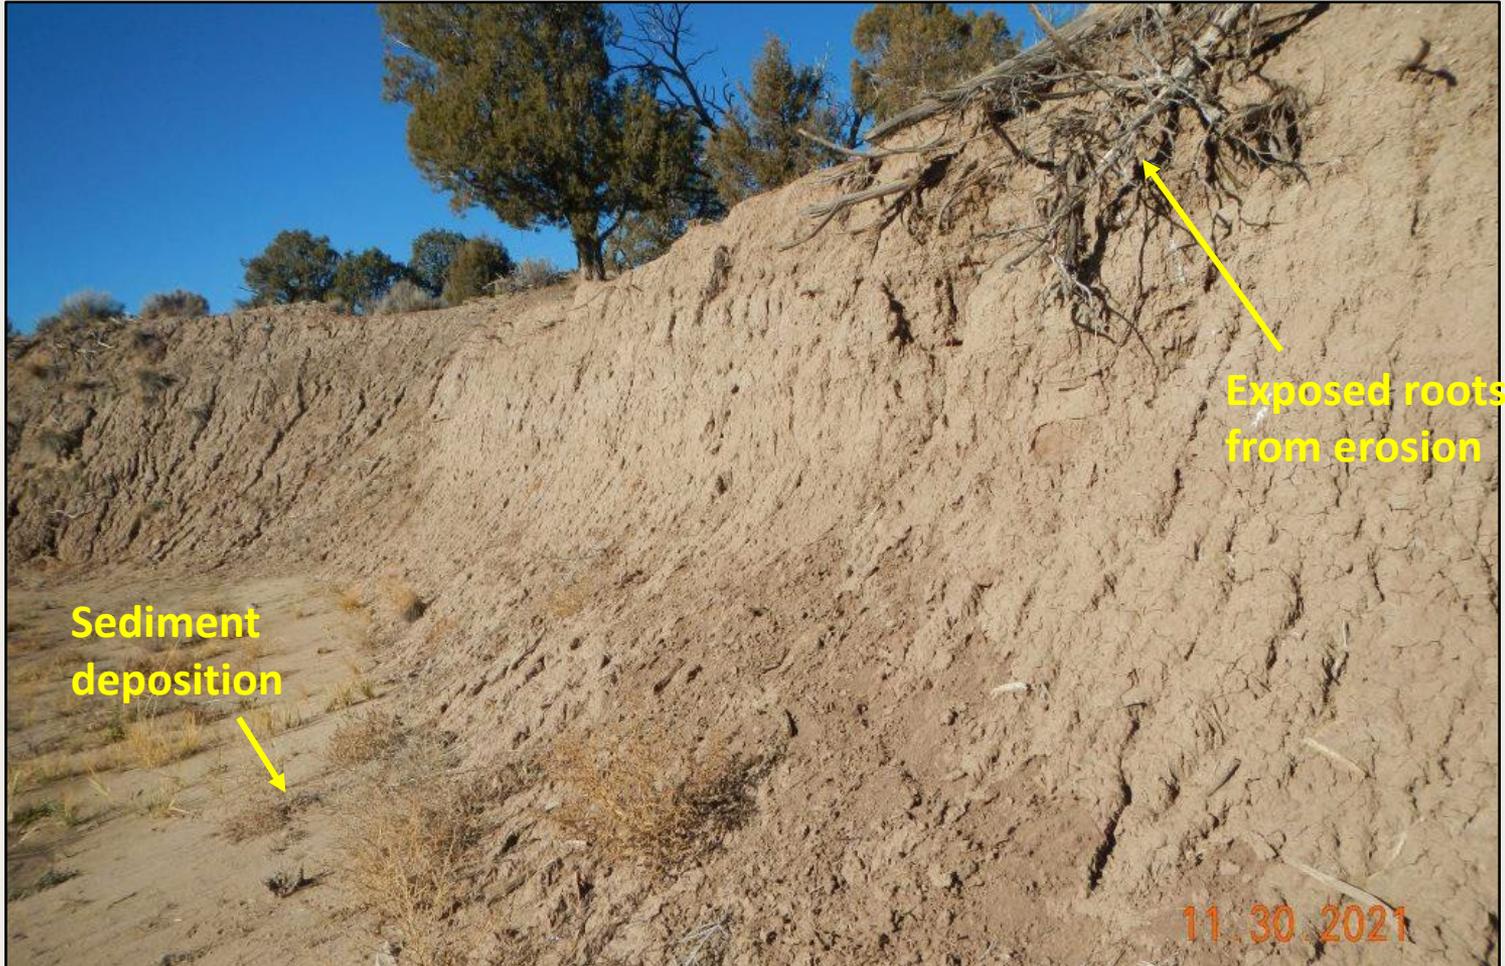
Photo 4. View of the northern cut-slope. Bare soils on steep slope need stabilization.

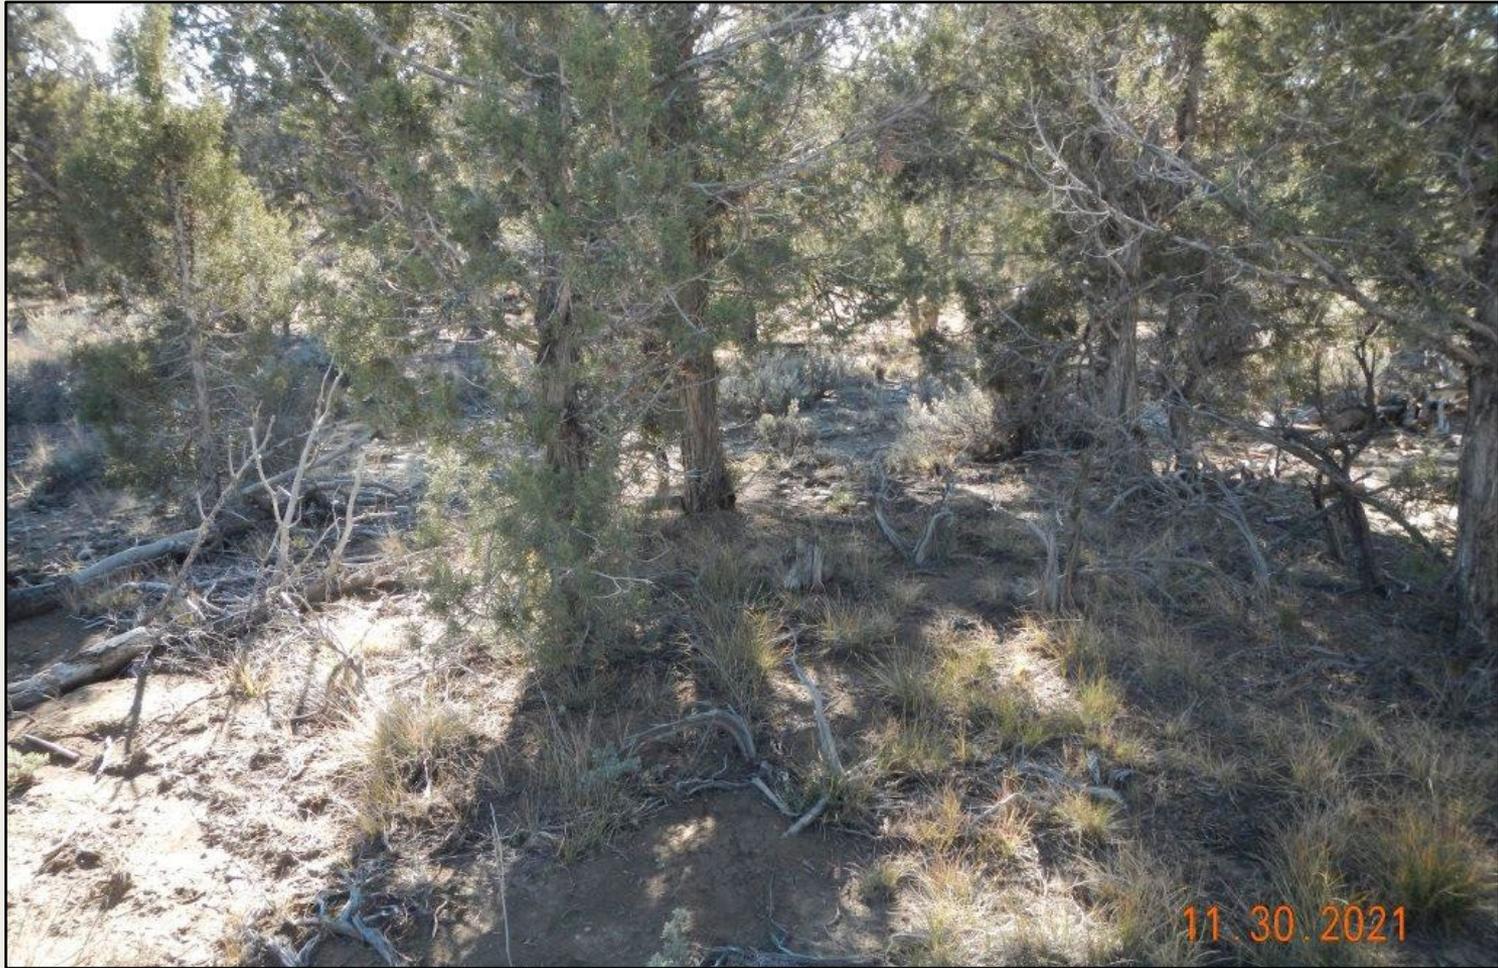
Photo 5. View of reference area comprised of pinyon and juniper woodland with understory of western wheatgrass, Indian ricegrass, black sage, prickly pear, and purple threeawn.
