TEP
Clough 31-23H
Location # 323919

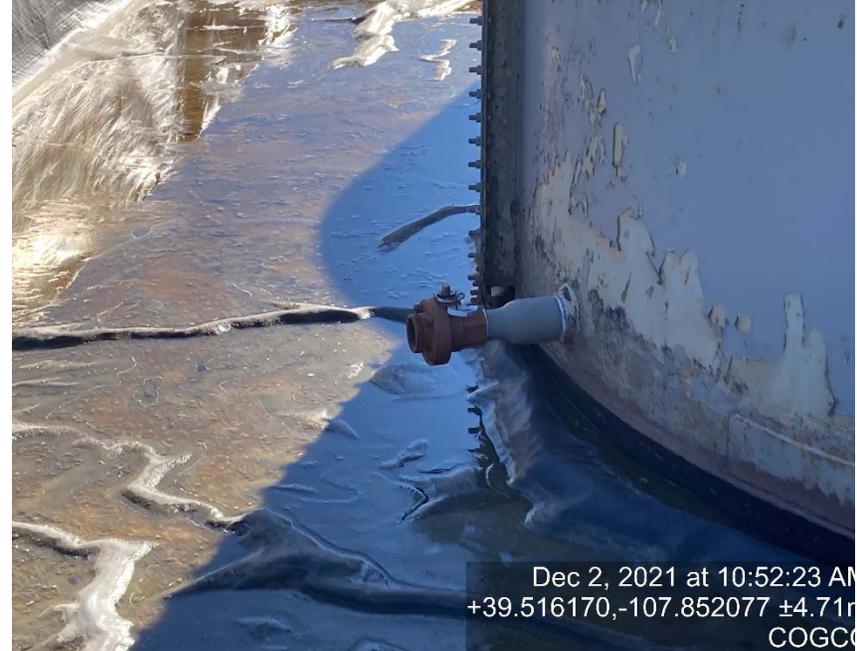
Load line missing bull plug/cap

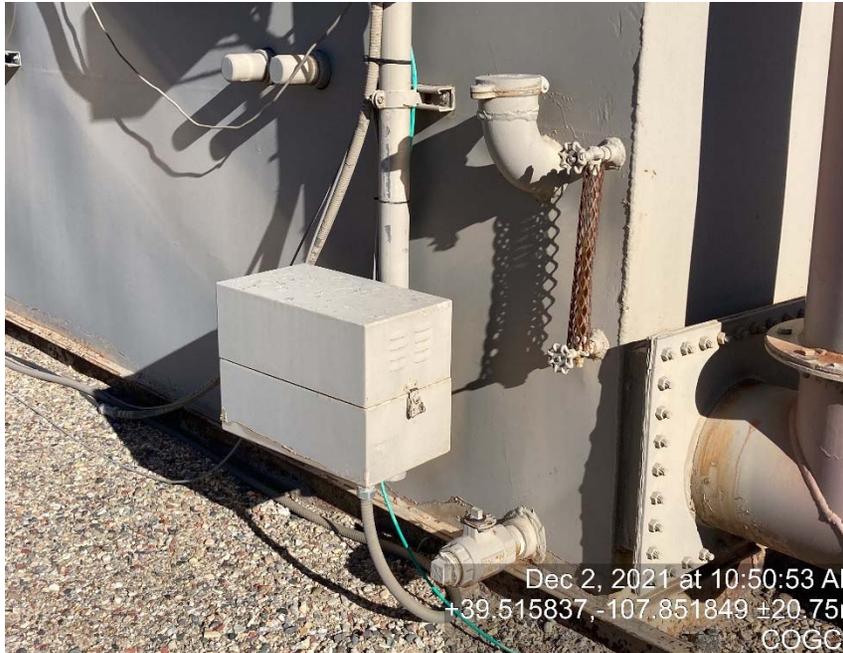
Glycol vessel lacking labeling

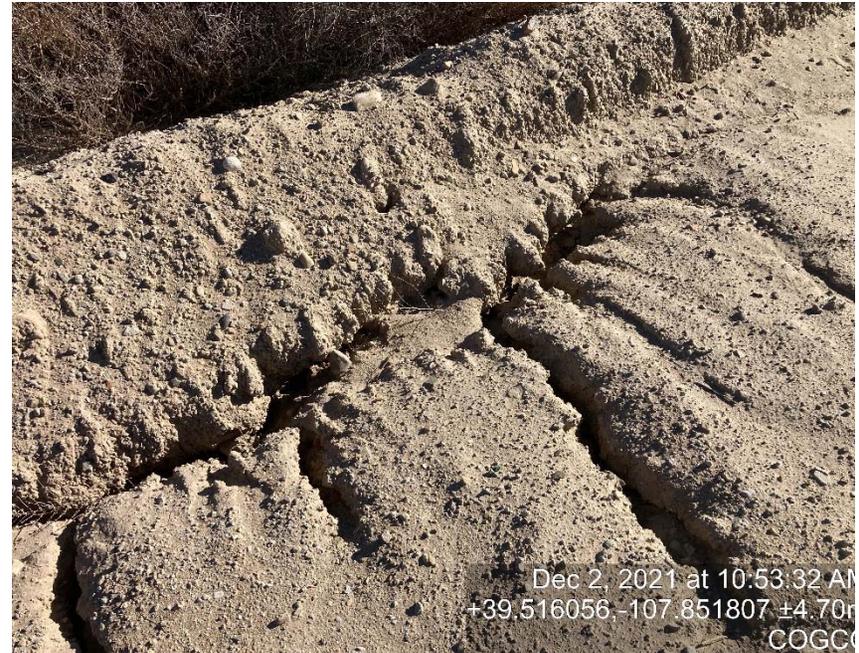
Erosion leading to the tunneling under berm.

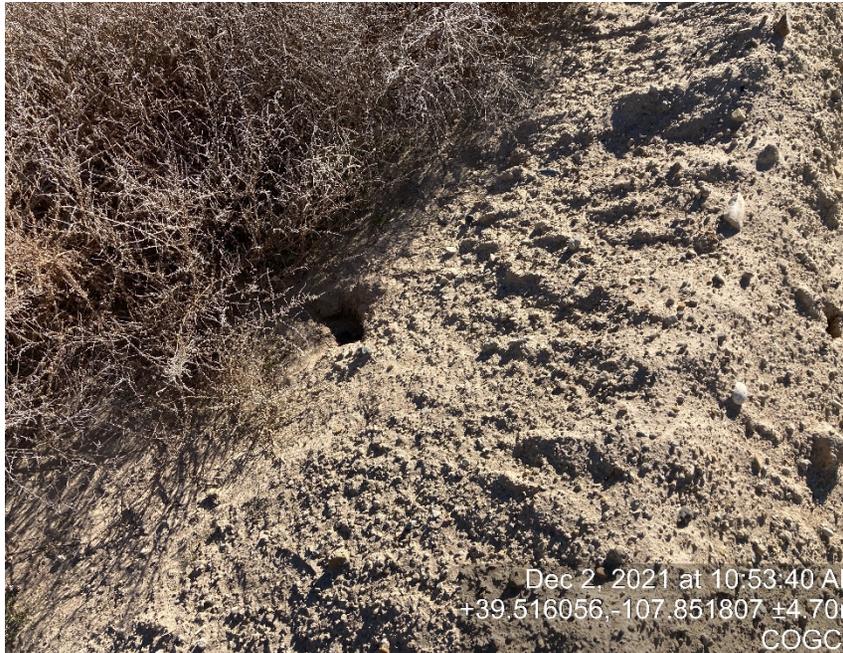
One spot of the outlet side of tunneling through berm

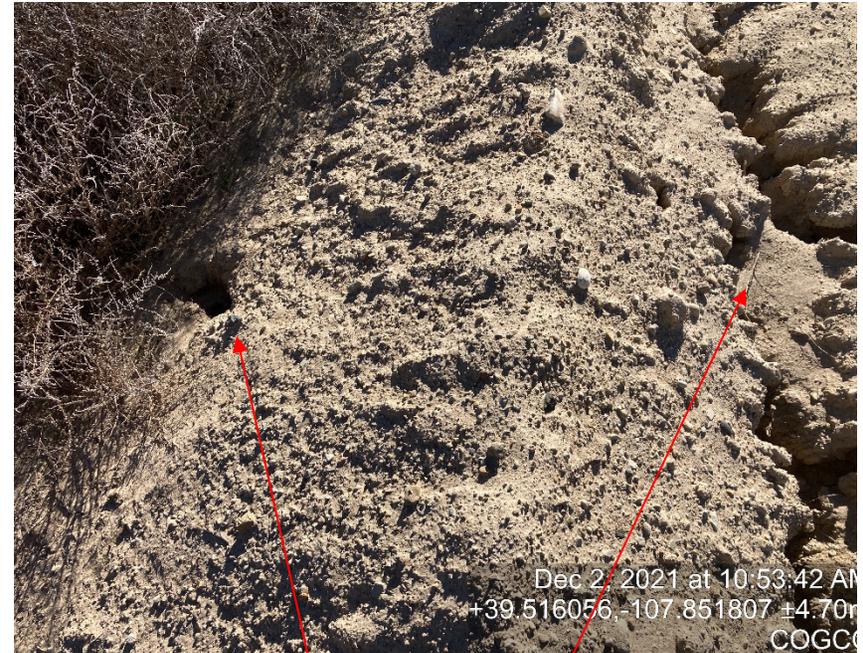
One spot of the outlet side and inlet of tunneling through berm

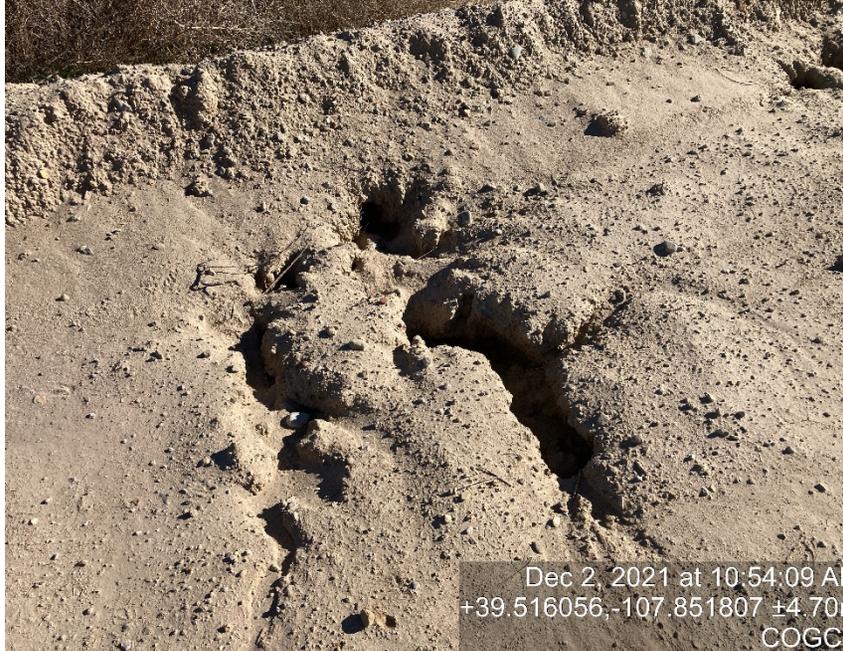
Erosion leading to the tunneling under berm.

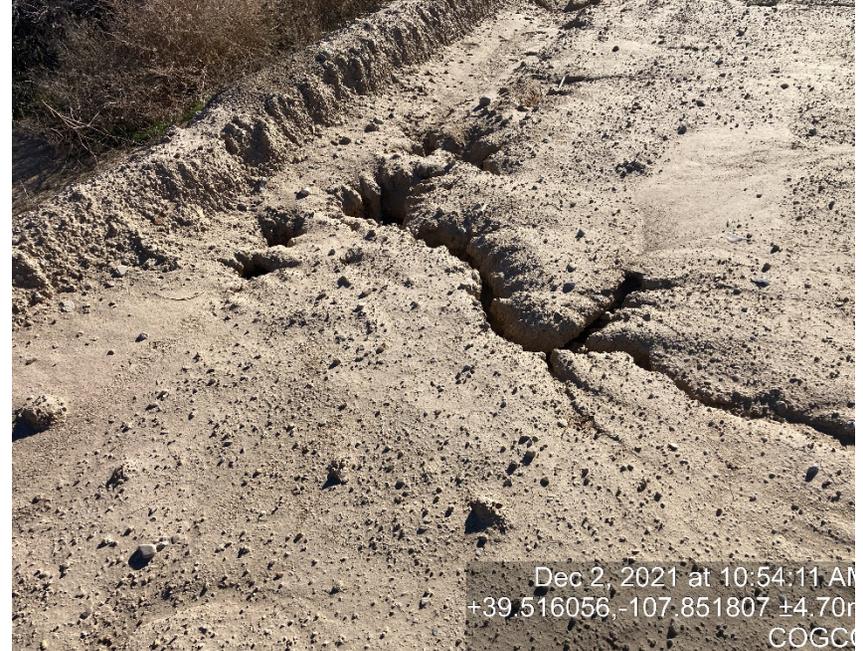
Erosion leading to the tunneling under berm.

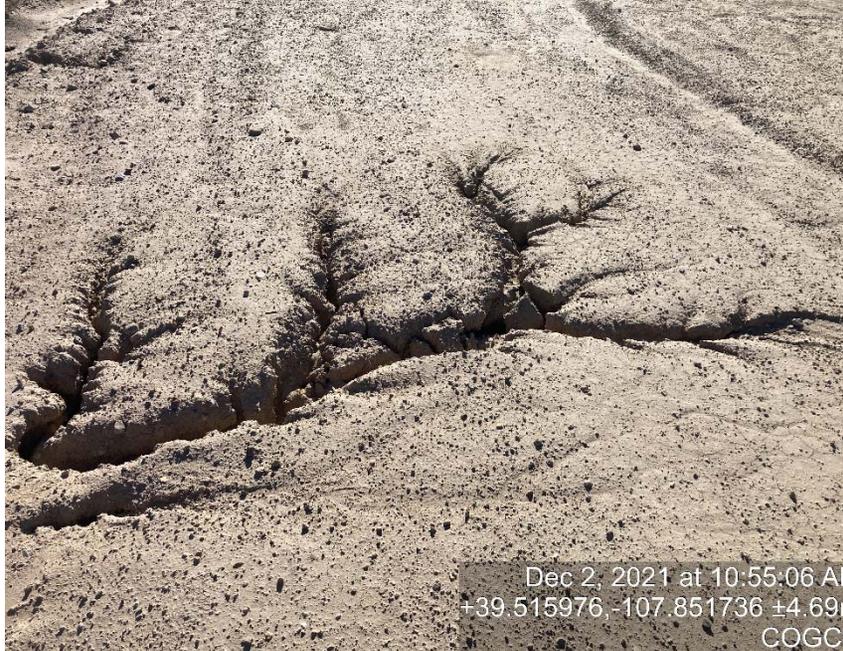
Erosion leading to the tunneling under berm.

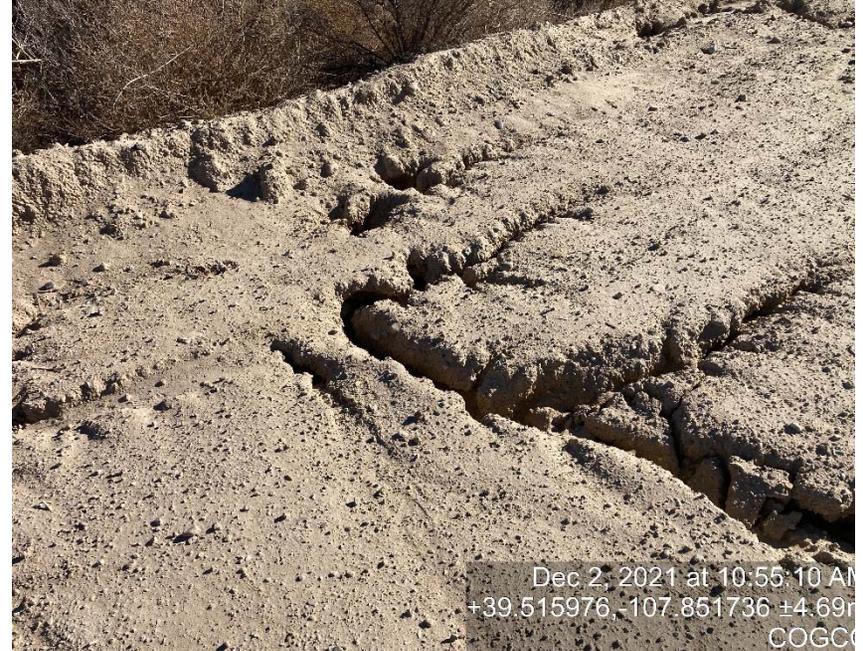
Erosion leading to the tunneling under berm.

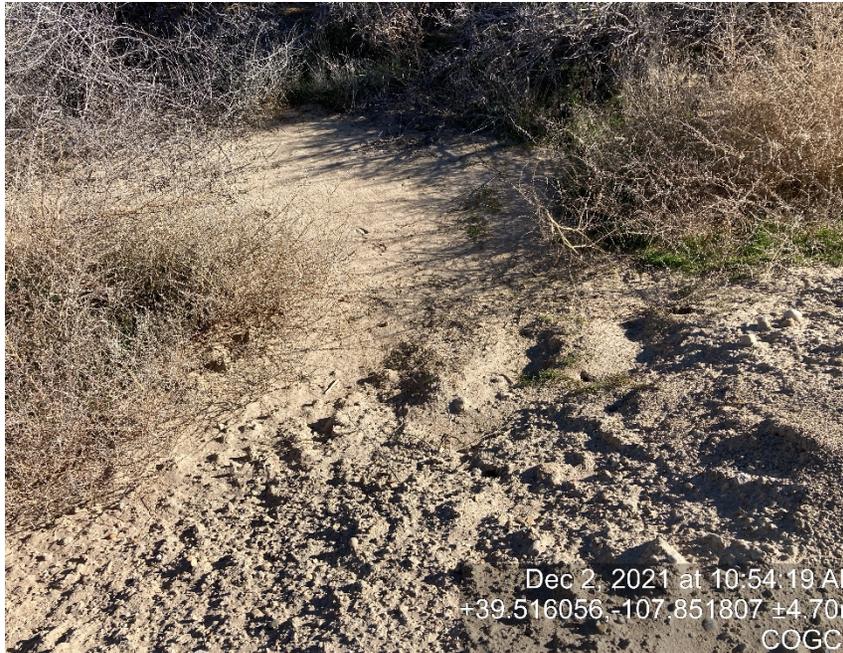
Sediment migration from the tunneling occurring.

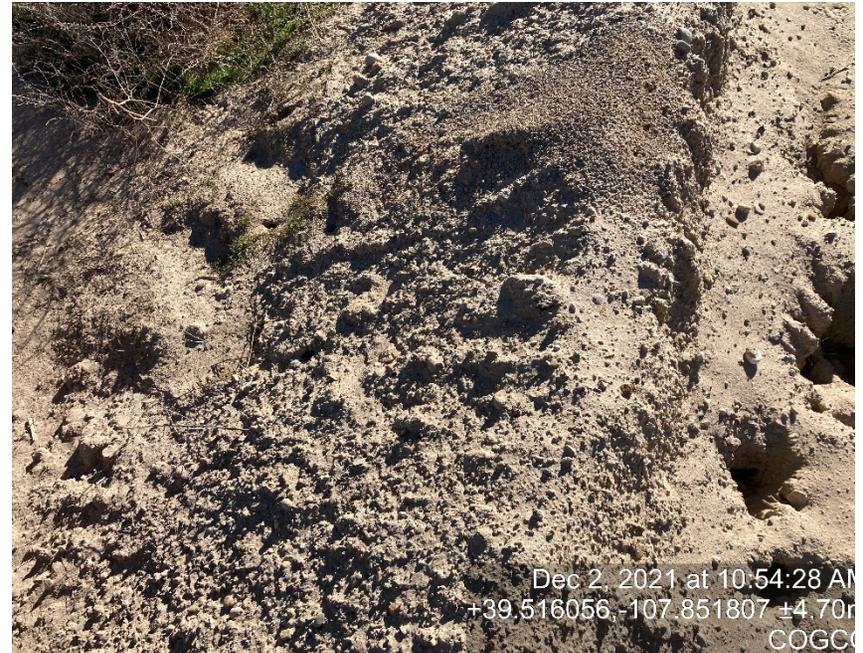
Sediment migration from the tunneling occurring.

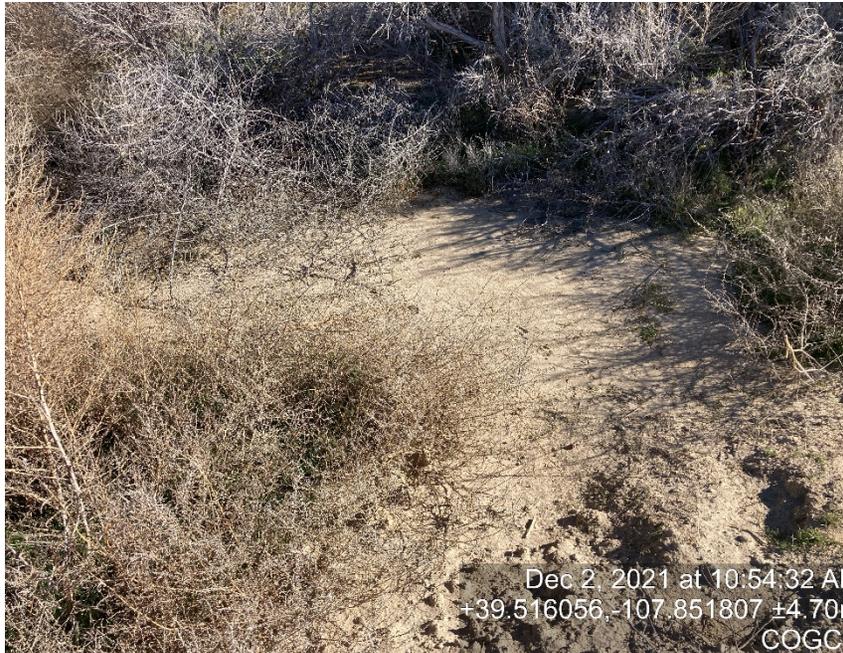
Sediment migration from the tunneling occurring

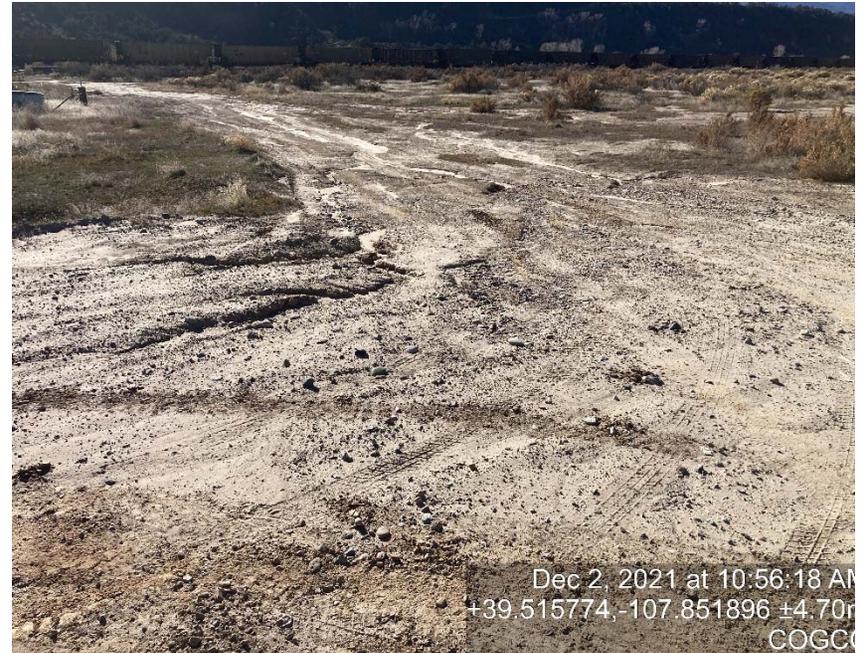
Sediment migration/erosion
