TEP
RWF 33-22
Location # 335367

COLORADO
Oil & Gas Conservation
Commission
Department of Natural Resources

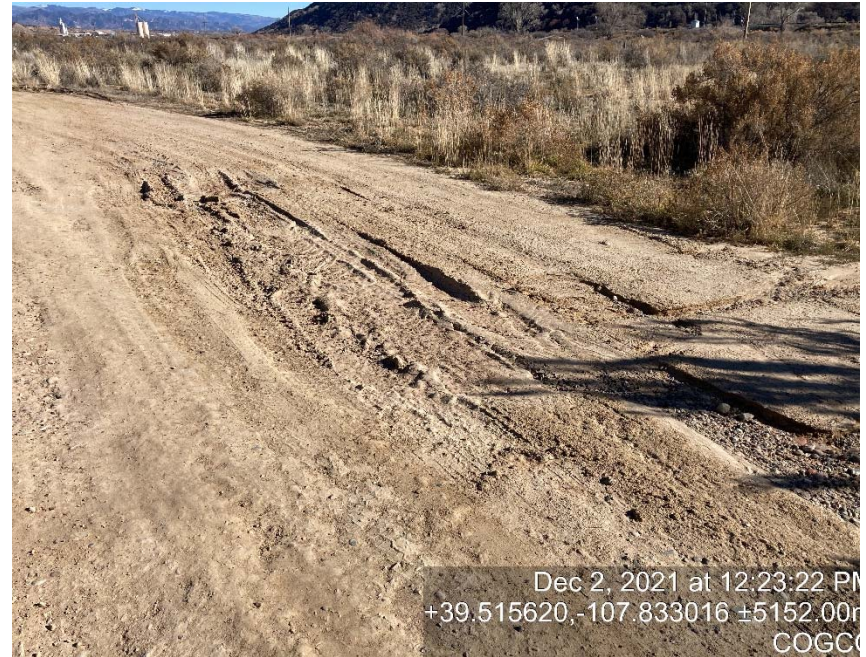
Lack of stabilization/erosion/sediment migration

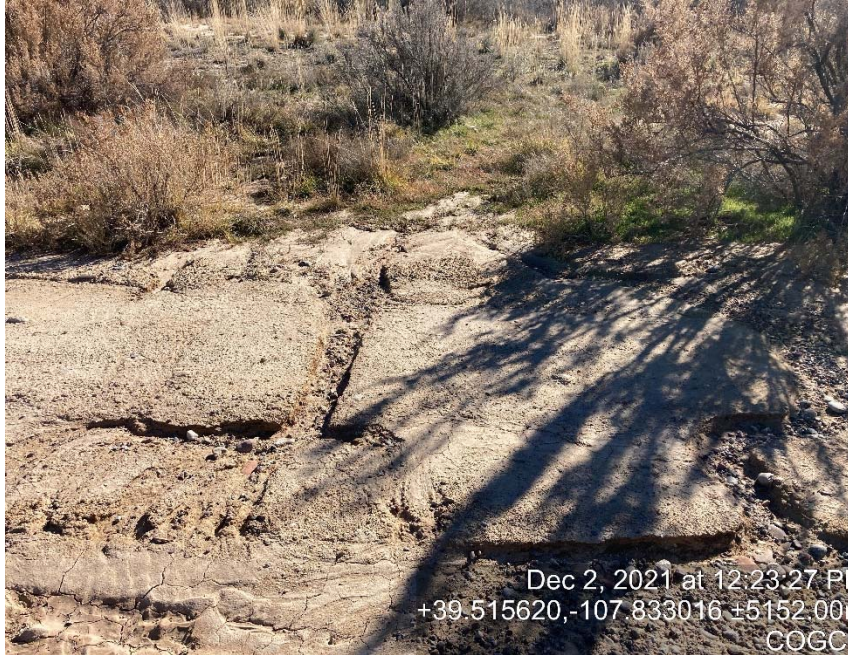
Lack of stabilization/erosion/sediment migration

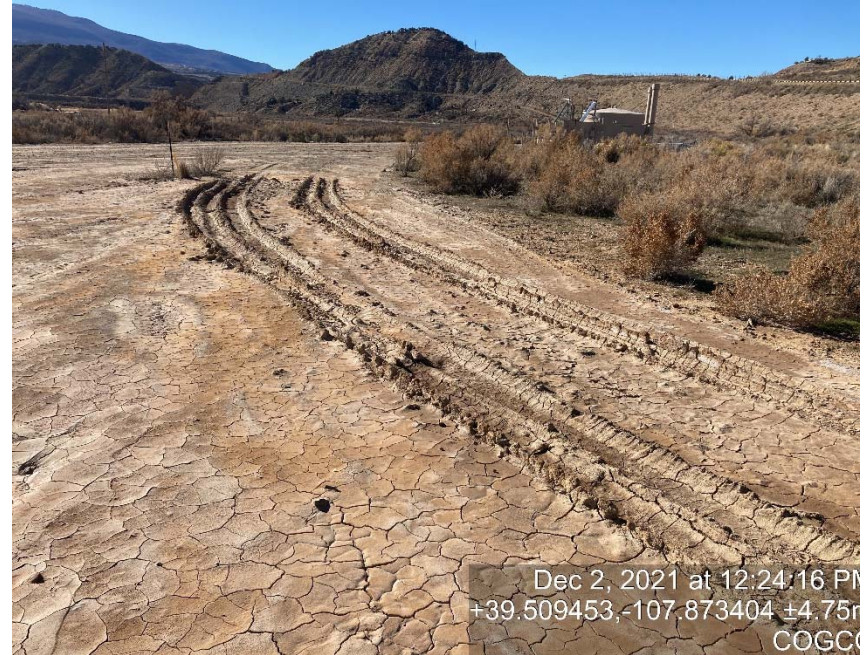
Lack of stabilization/erosion/sediment migration

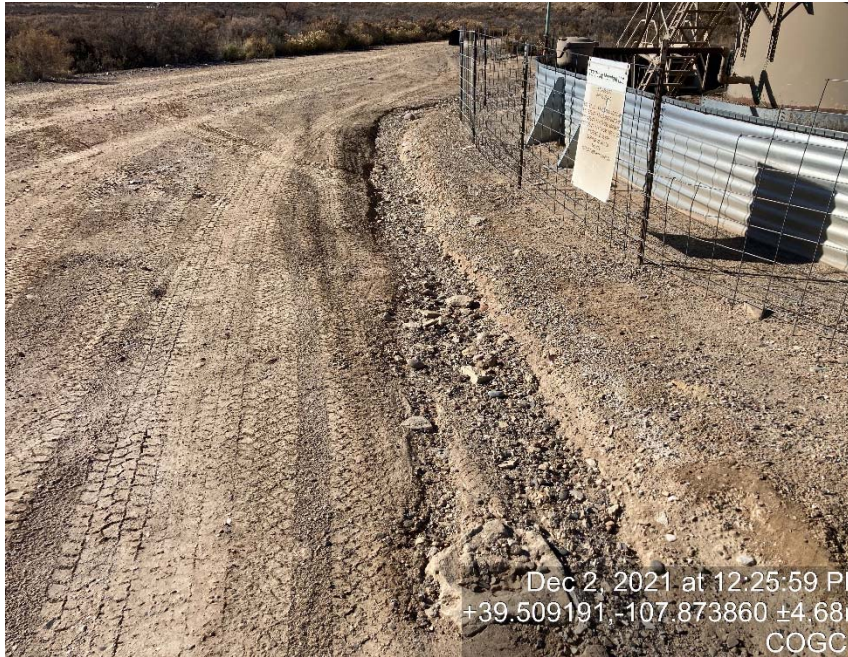
Lack of stabilization/erosion/sediment migration

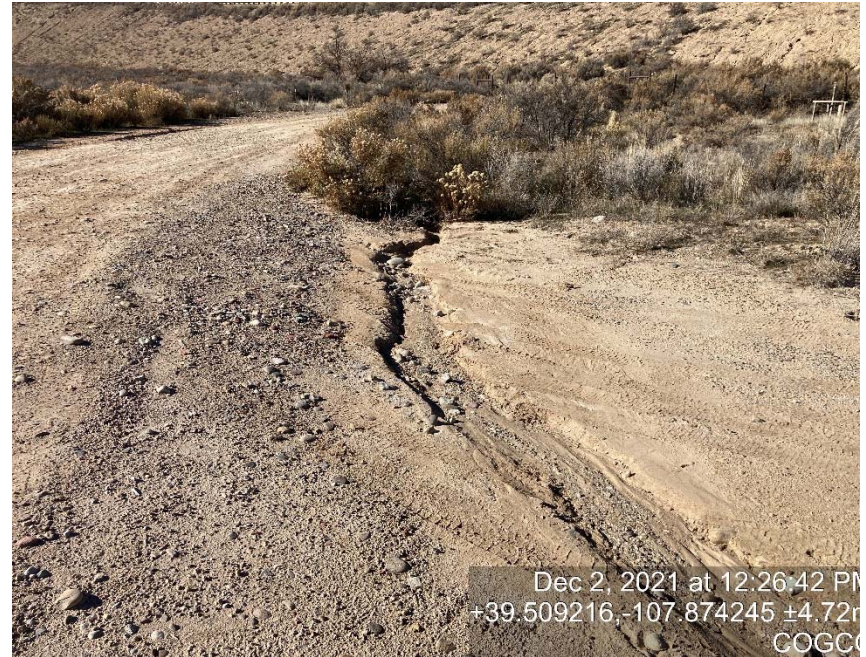
Lack of stabilization/erosion/sediment migration

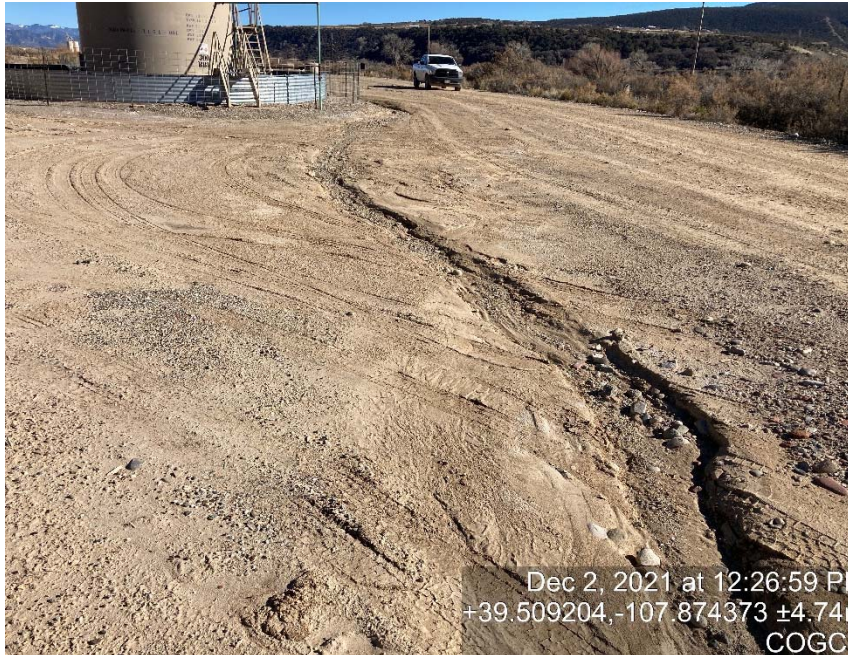
Lack of stabilization/erosion/sediment migration

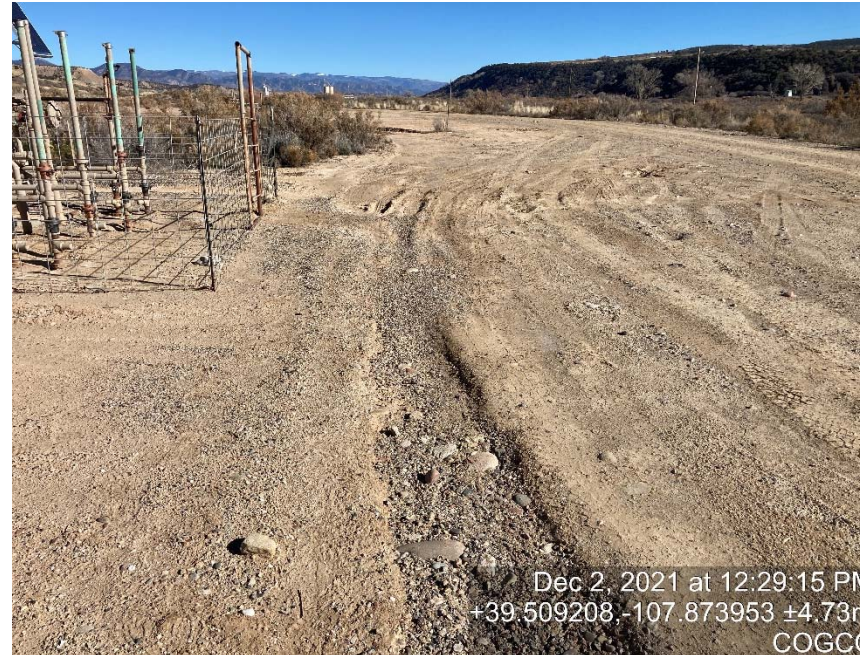
Lack of stabilization/erosion/sediment migration

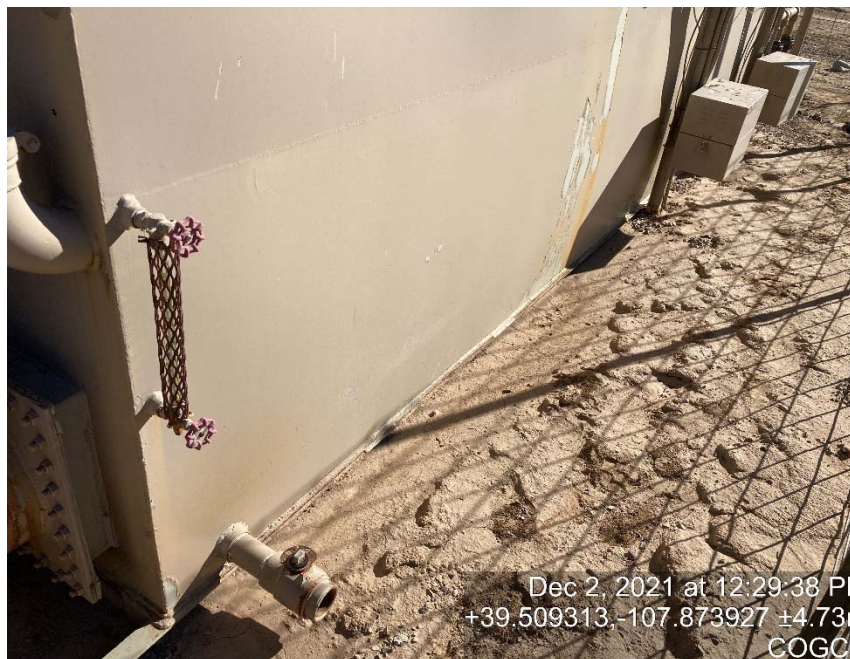
Glycol vessel lacking labeling

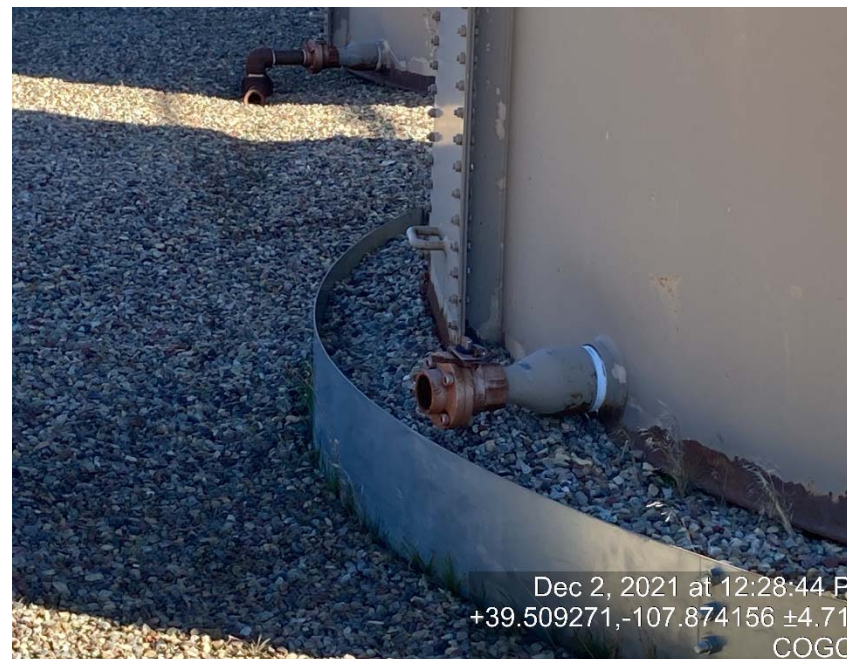
Load lines lacking bull plugs/caps
