Inspection Photos

12/01/2021

Operator: LARAMIE ENERGY LLC # 10433

Location ID: 335647

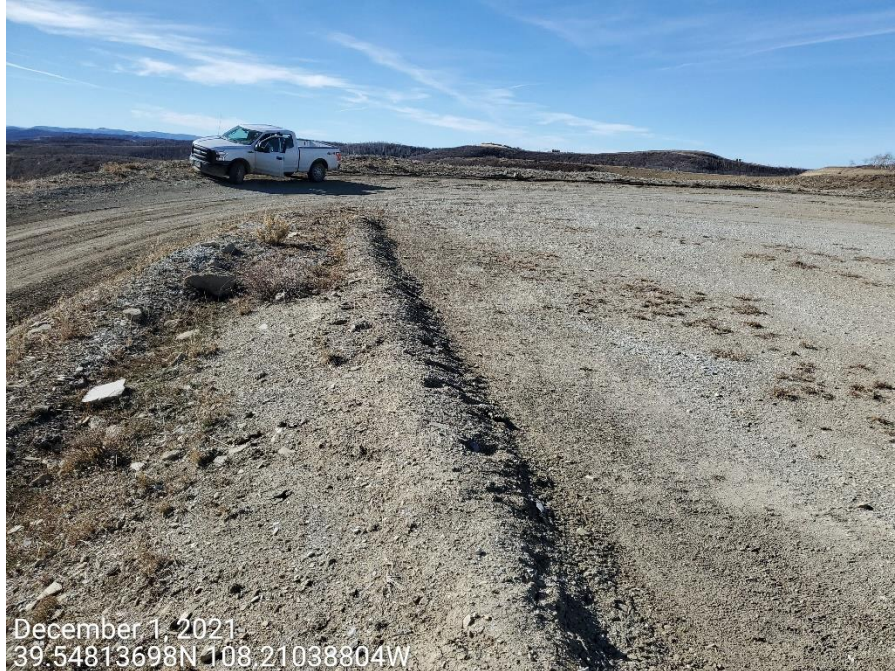
Photo 1: Photos 1-2 taken from the southwest end of the Location. Photos provide overview of the Location from southwest, west, north to northeast. Photos also shows areas on the southwest end of the Location not necessary for production, including the second access road on the southwest end of the Location, have not been reclaimed in accordance with 1003 rules and corrective actions.

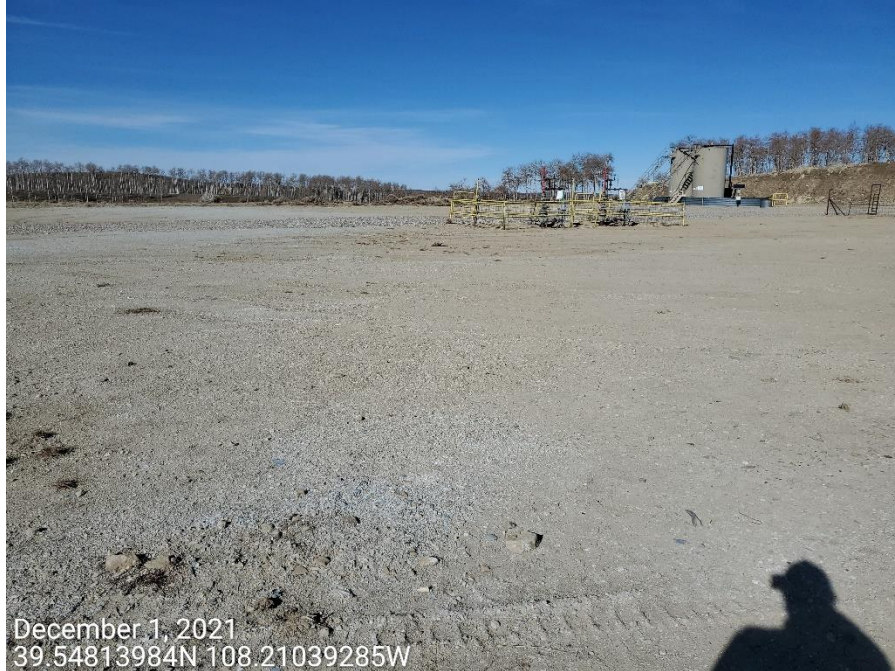
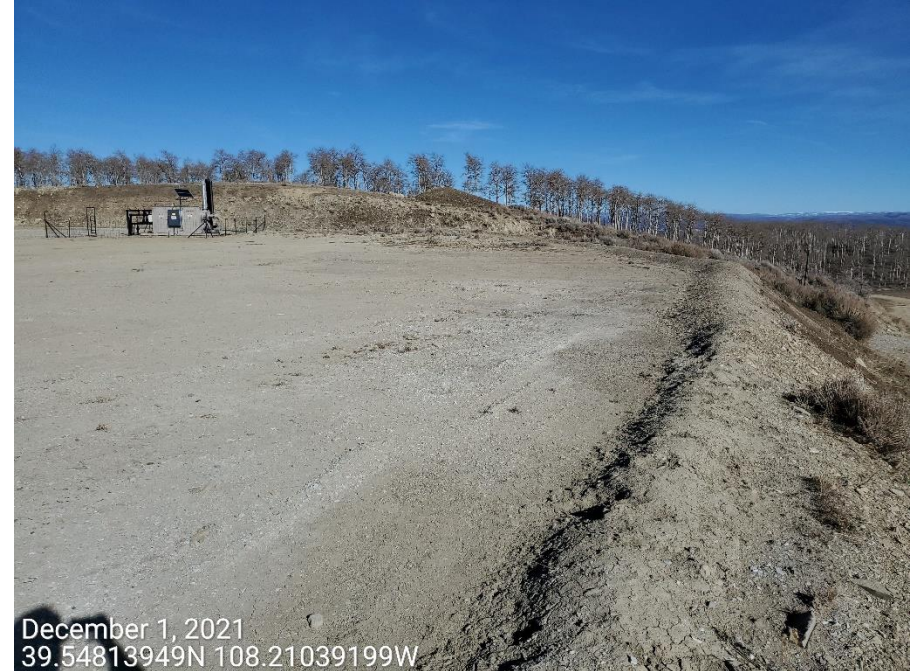
Photo 2: See comments under photo 1.

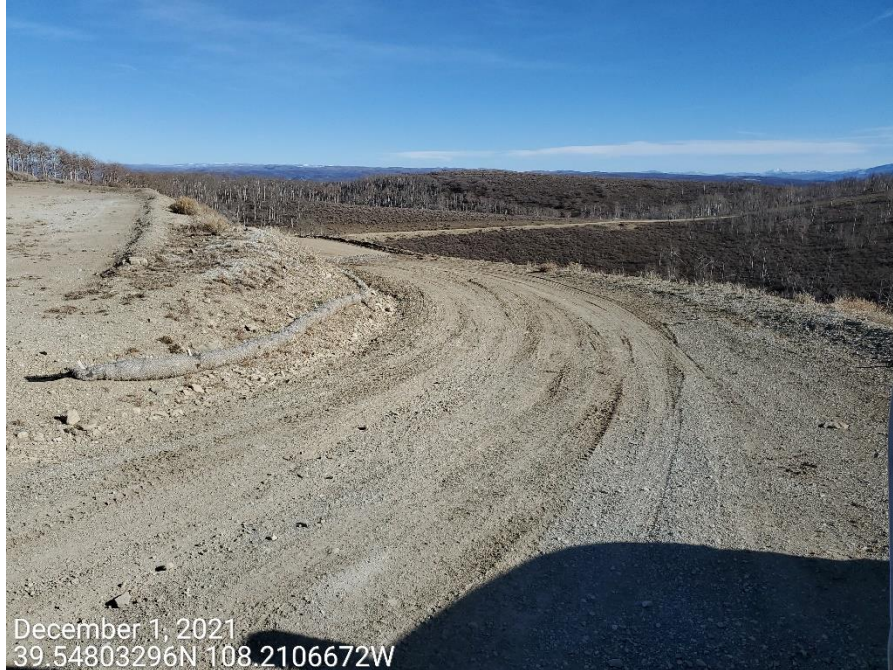
Photo 3: Photo shows the second access road on the southwest end. Areas on the southwest end of the Location not necessary for production, including the second access road on the southwest end of the Location, have not been reclaimed in accordance with 1003 rules and corrective actions

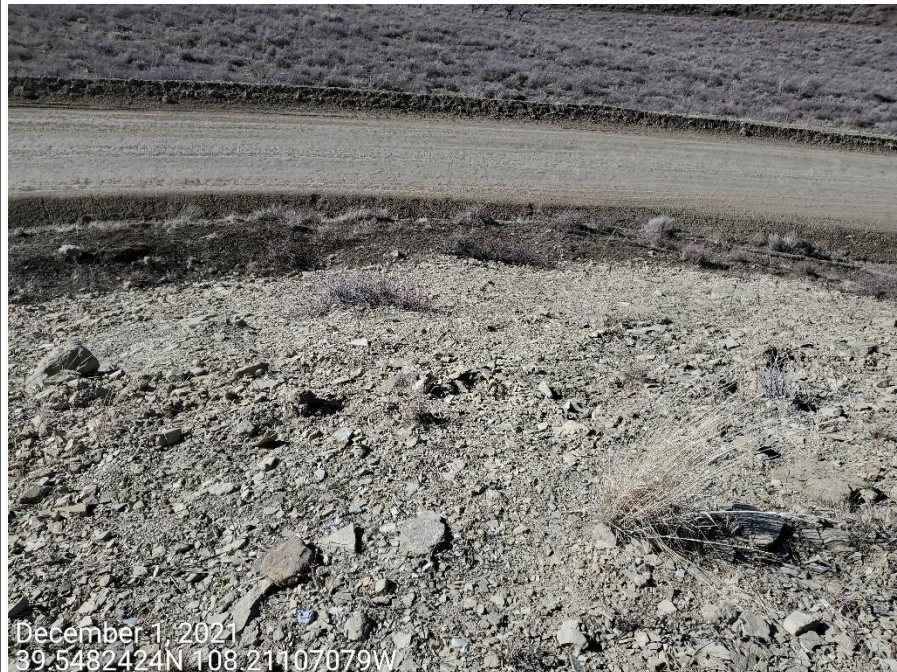
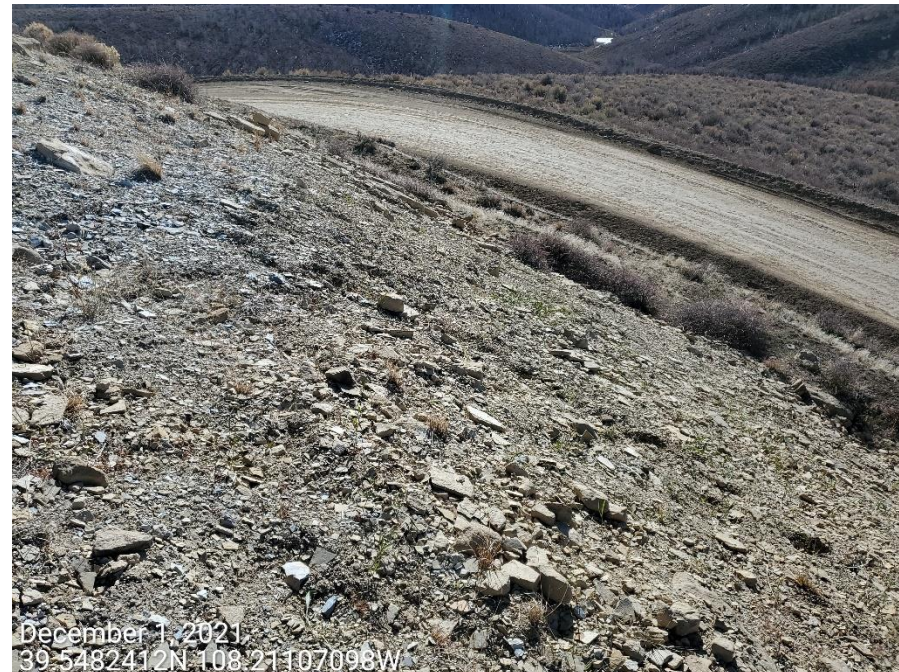
Photo 4: Photos example showing control measures to protect/stabilize slopes of the Location remains missing or insufficient.

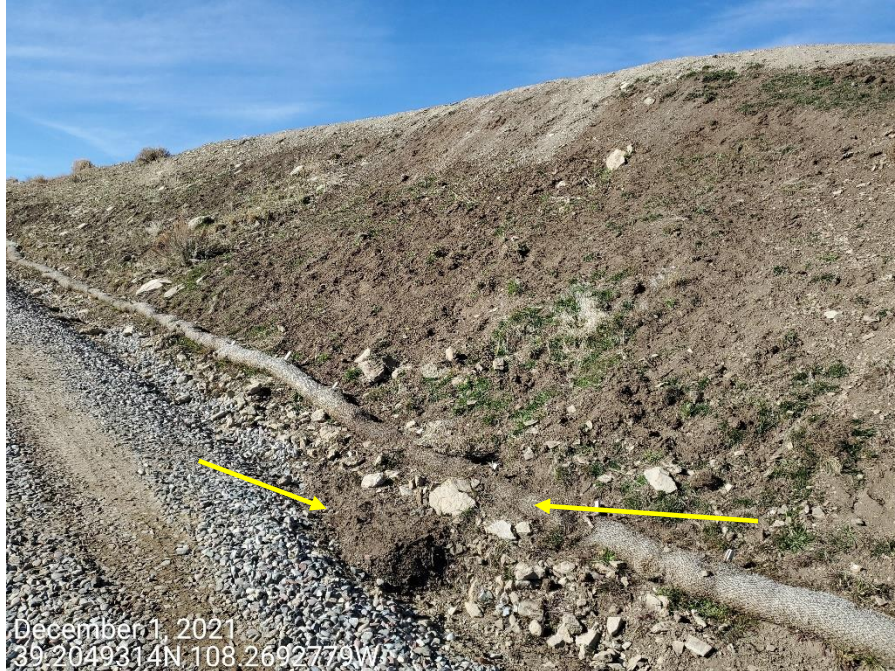
Photo 6: Photo taken from the slopes on the southeast end of the Location. Though rill erosion previously observed appears to have been repaired, control measures to protect and stabilize the slopes remaining missing or insufficient. Arrow shows sediment discharge due to un-stabilized slopes.

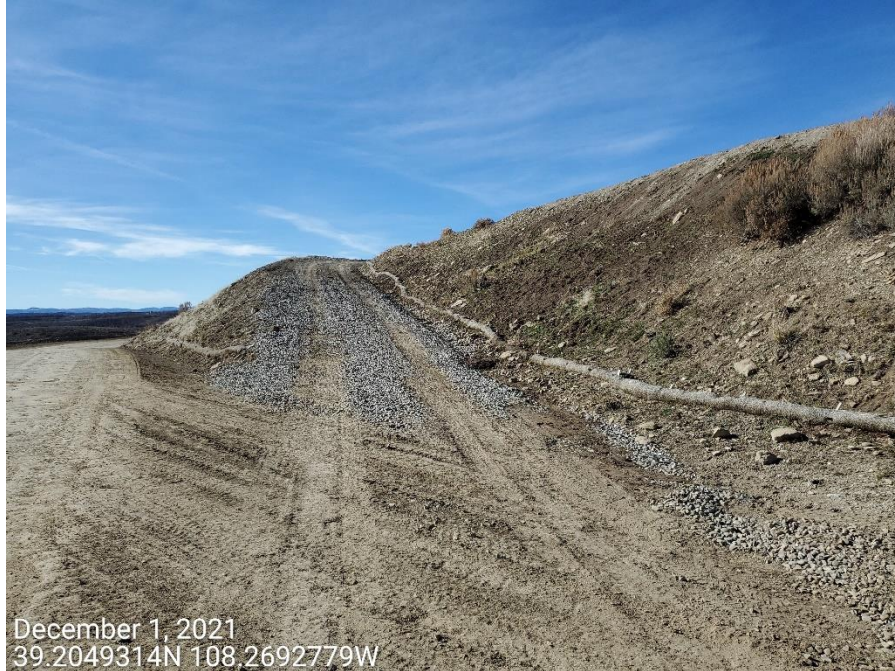
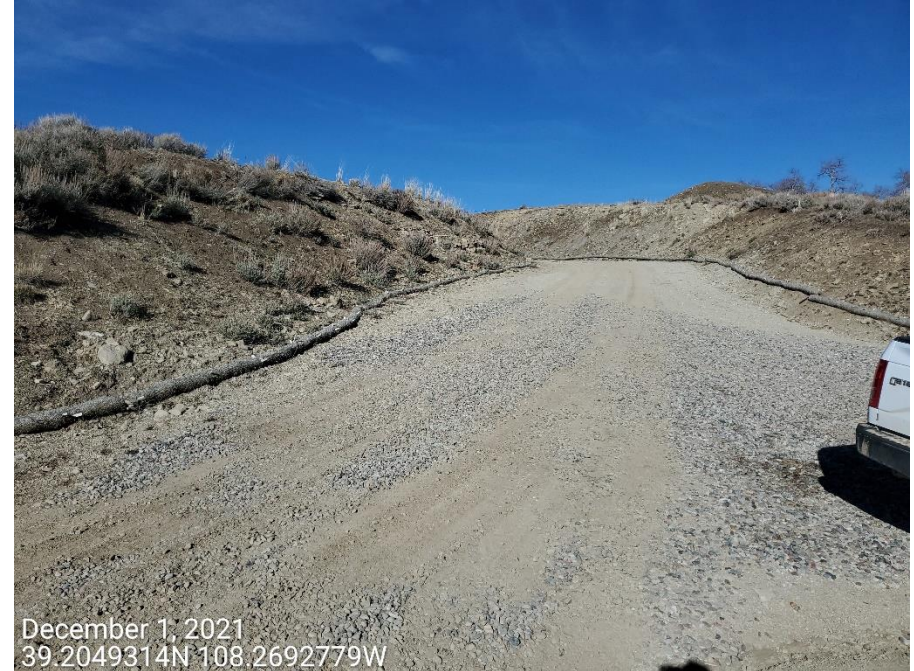
Photo 8: Photos taken from the two access road entrances on the southeast end of the Location. Photos examples showing control measures to stabilize the Location, and minimize tracking and offsite sediment transport are inadequate, and have not been installed/maintained in proper functioning condition per good engineering practices; tracking and sediment transport observed. Photo left also shows second access road has not been reclaimed.
