Inspection Photos

12/01/2021

Operator: LARAMIE ENERGY LLC # 10433

Location ID: 452807

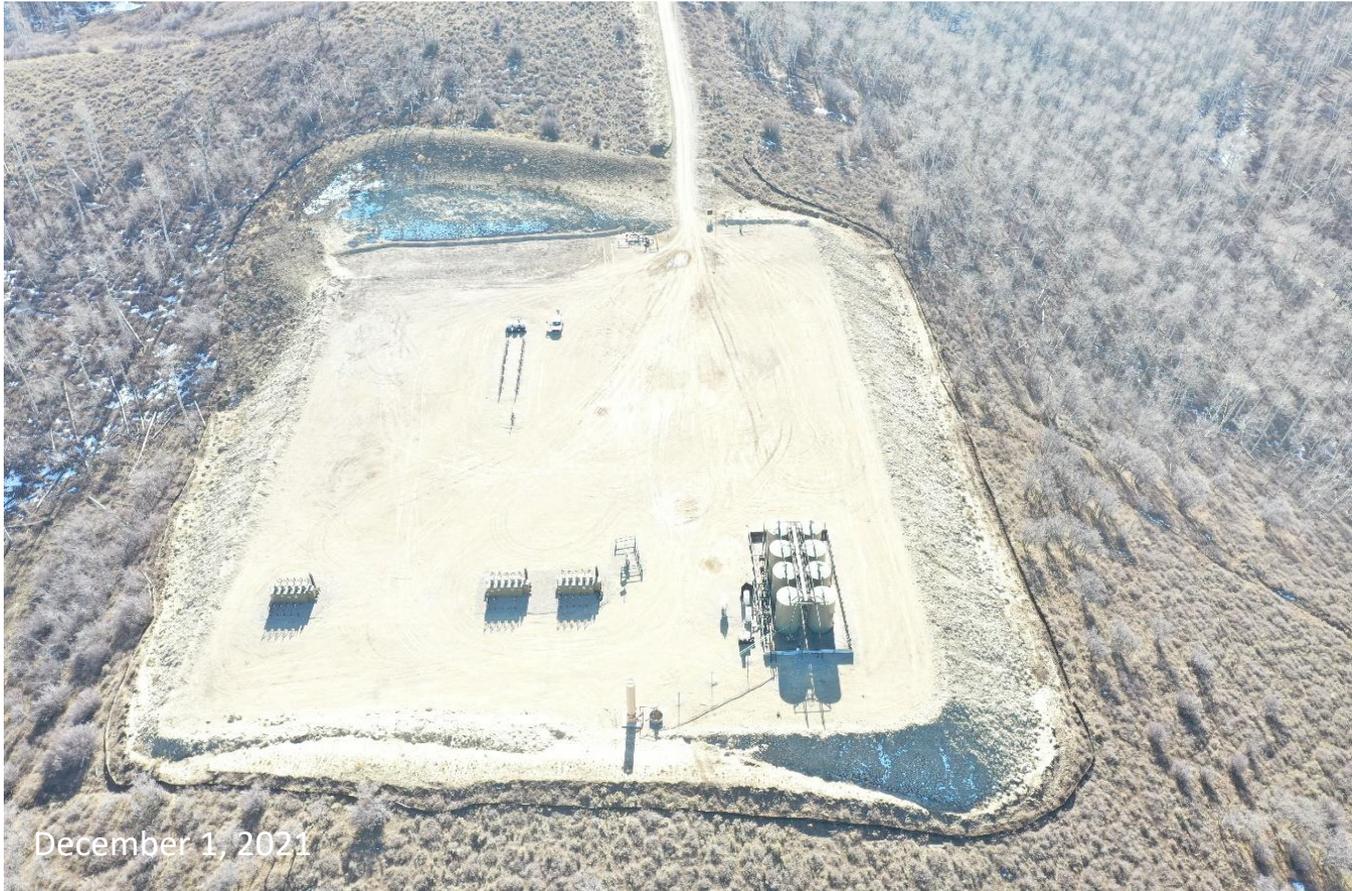
Photo 1: Photos 1-4 provide an aerial overview of the Location; Location disturbance ~6 acres. Photos show areas not needed for production have not been decompacted, recontoured/regraded and reclaimed; Location has not been reduced to 2 acres per the 2A Location Permit #401387622.

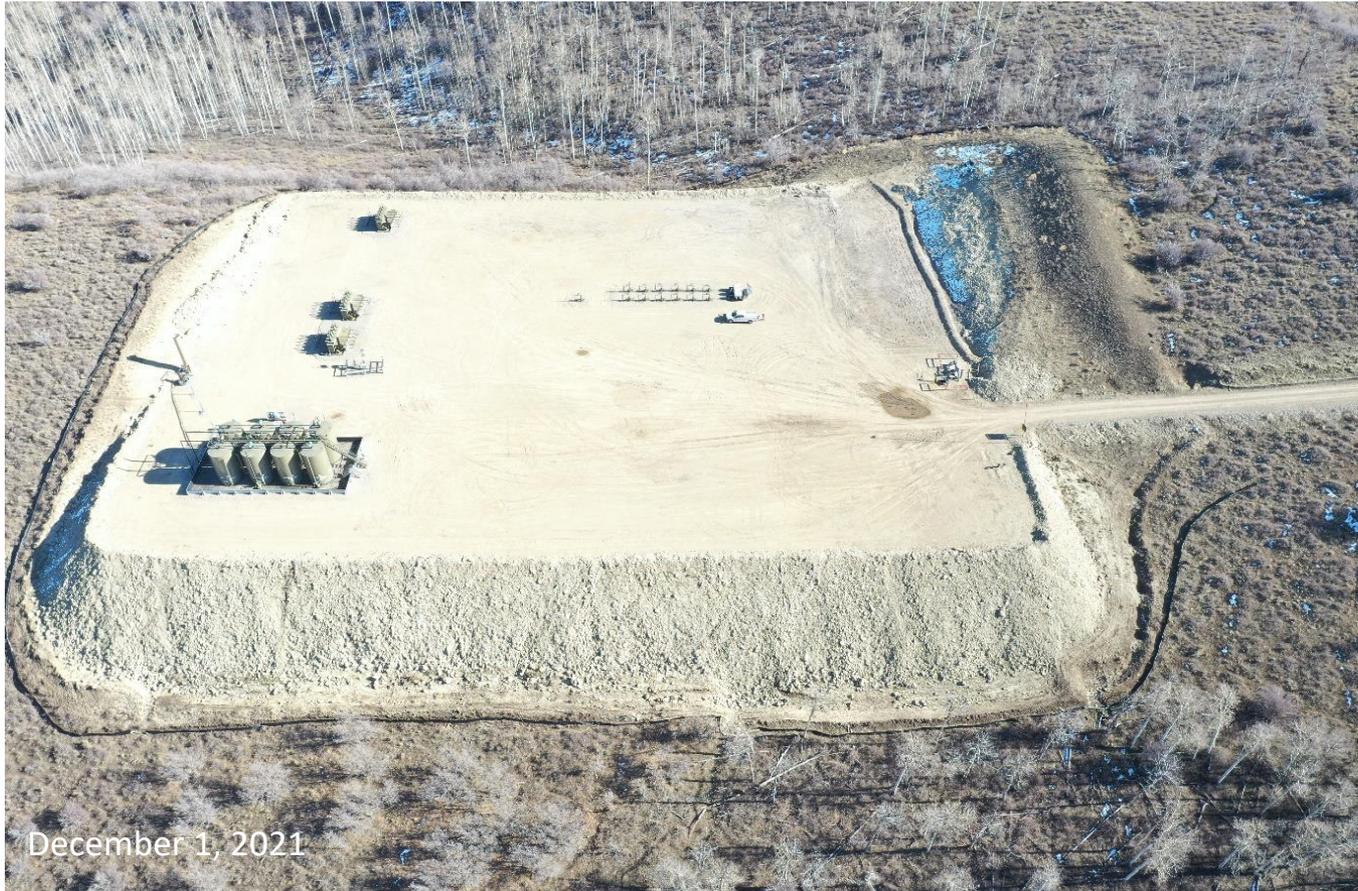
Photo 2: See comments under photo 1.

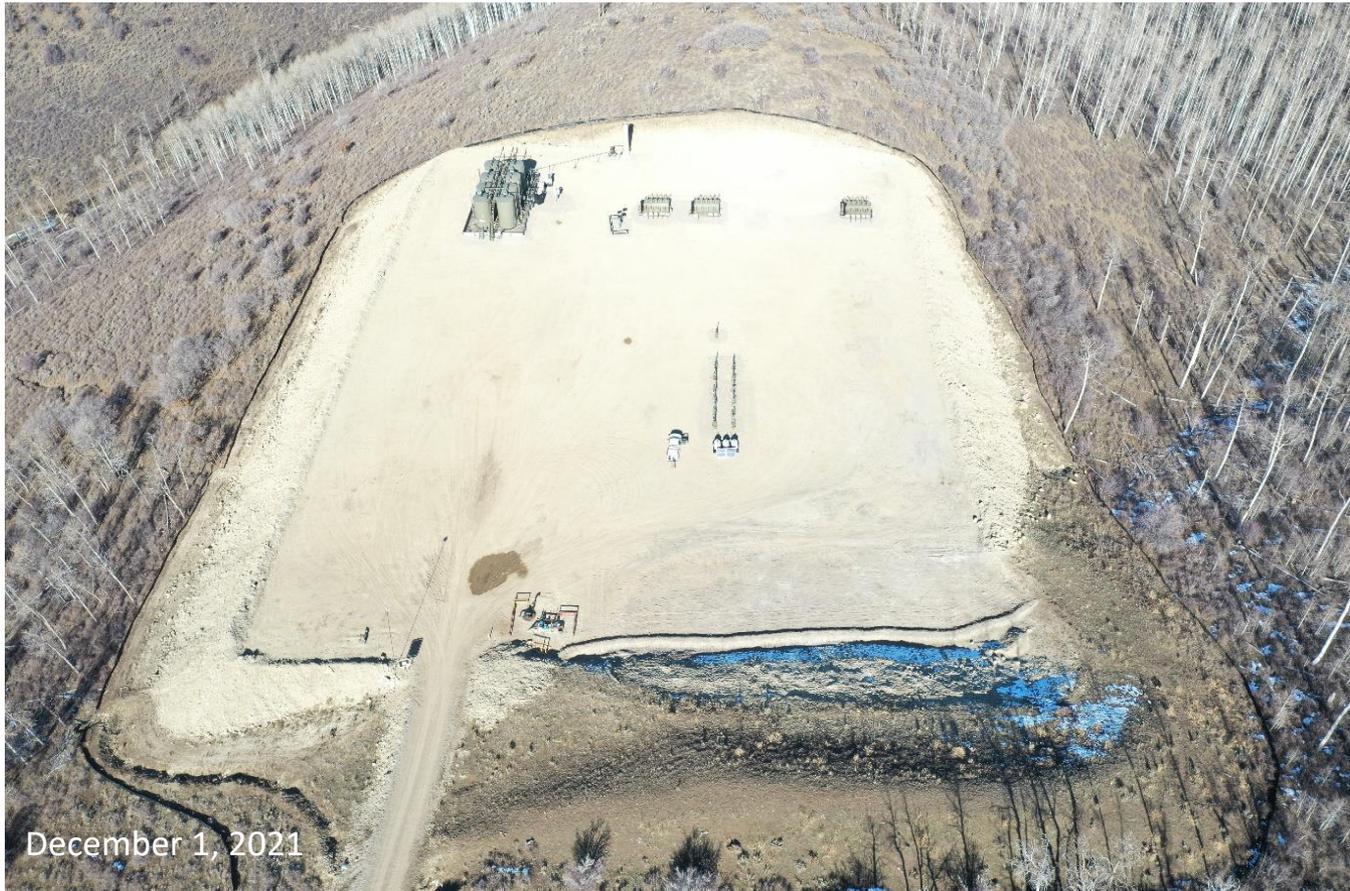
Photo 3: See comments under photo 1.

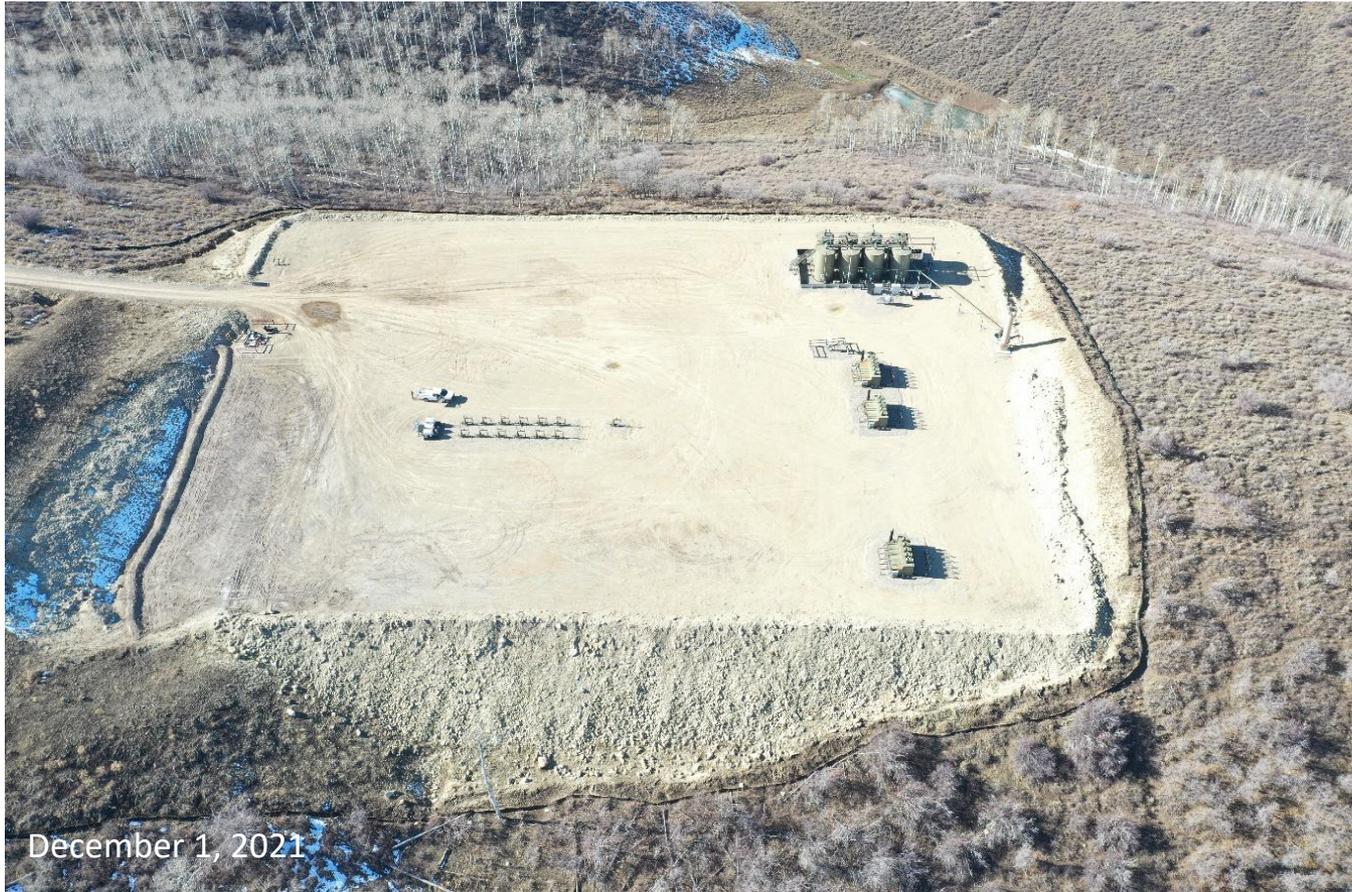
Photo 4: See comments under photo 1.

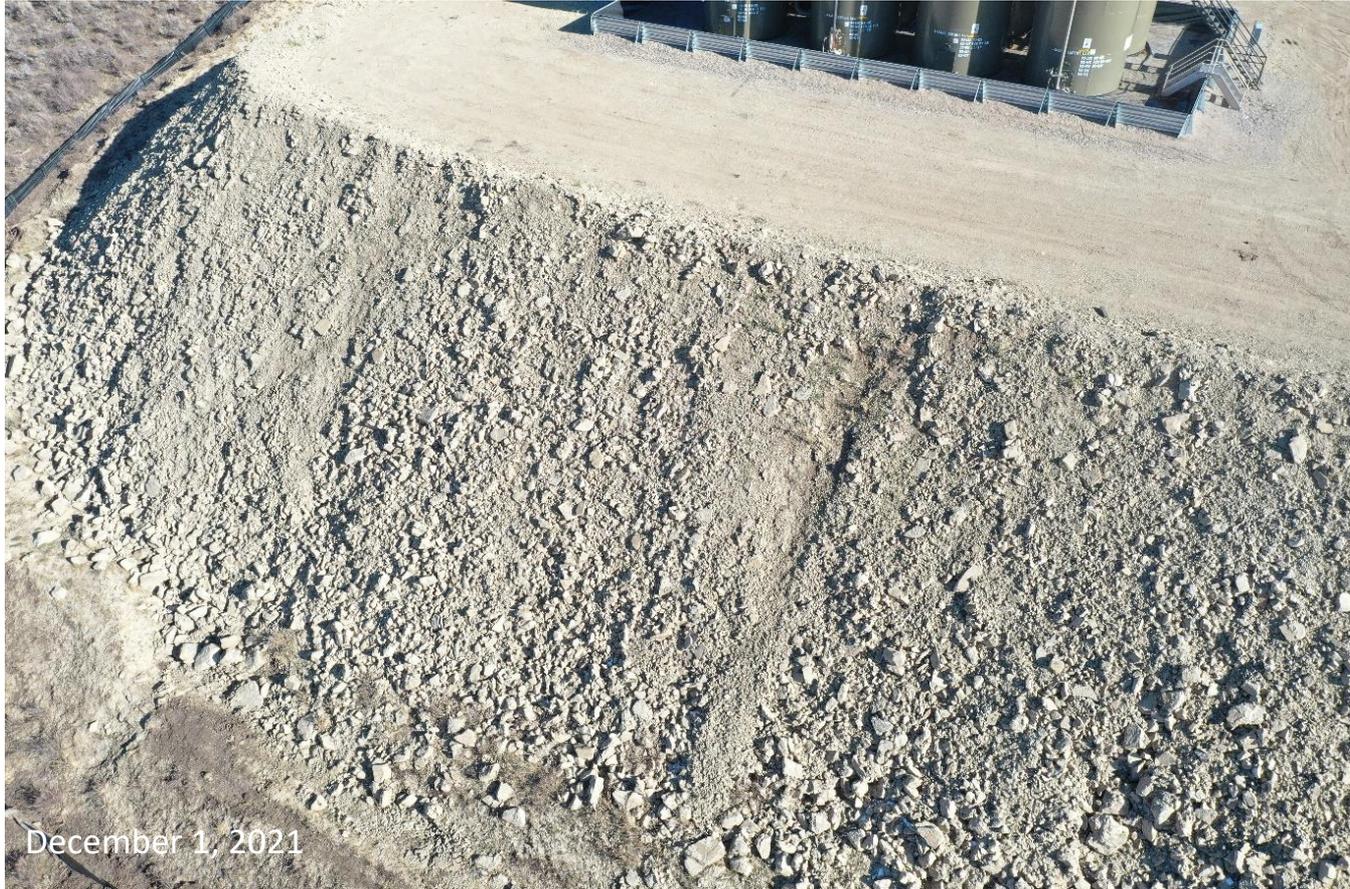
Photo 5: Photo provides example of the fill slopes on the west end of the Location; slopes constructed with a steep grade, with rocky subgrade material. Photo shows control measures to protect/stabilize the slopes of the Location remain missing or insufficient.

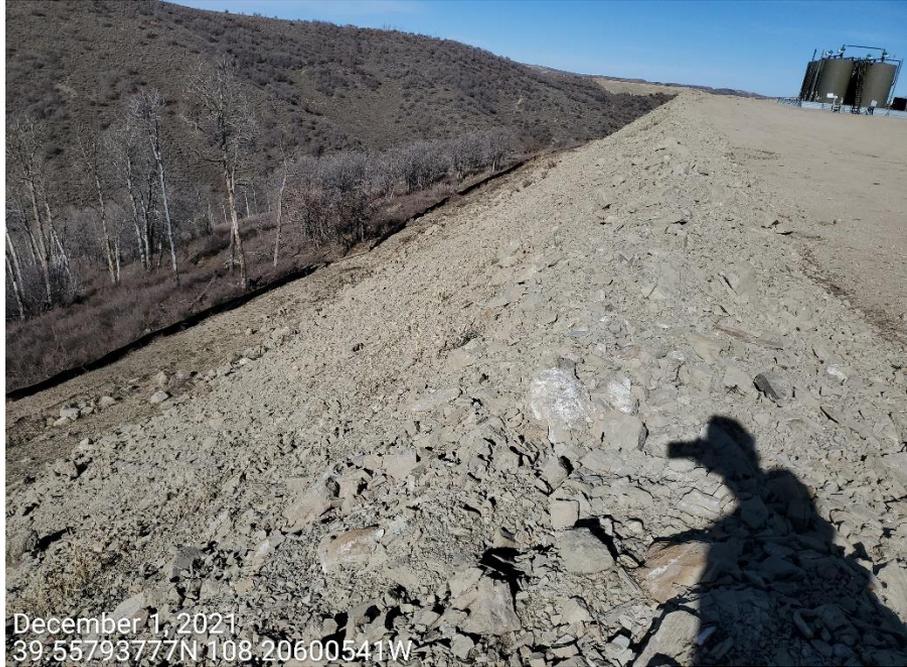
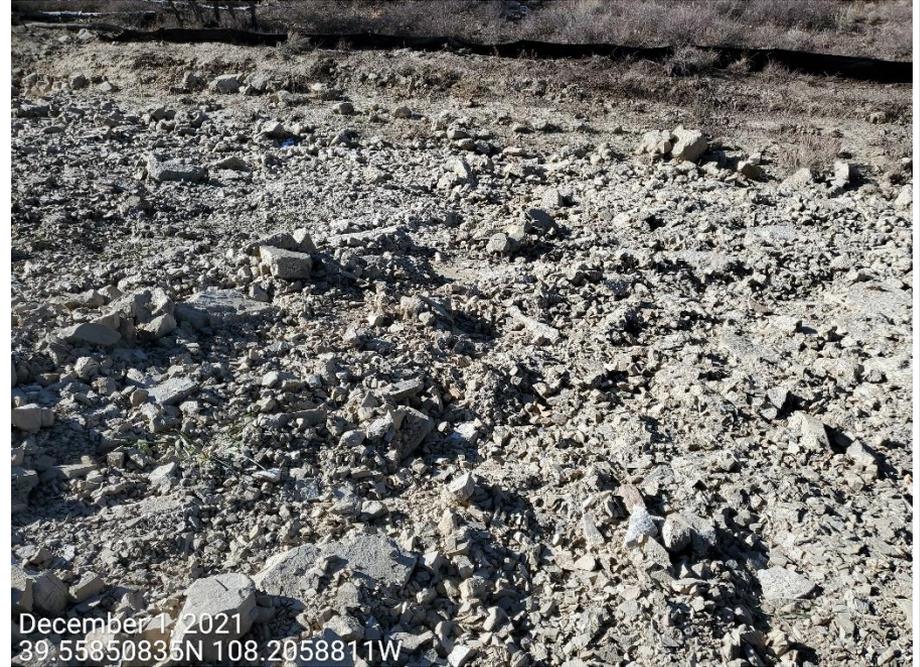
Photo 6: Photo provides example of the fill slopes on the west end of the Location; slopes constructed with a steep grade, with rocky subgrade material. Photo shows control measures to protect/stabilize the slopes of the Location remain missing or insufficient.

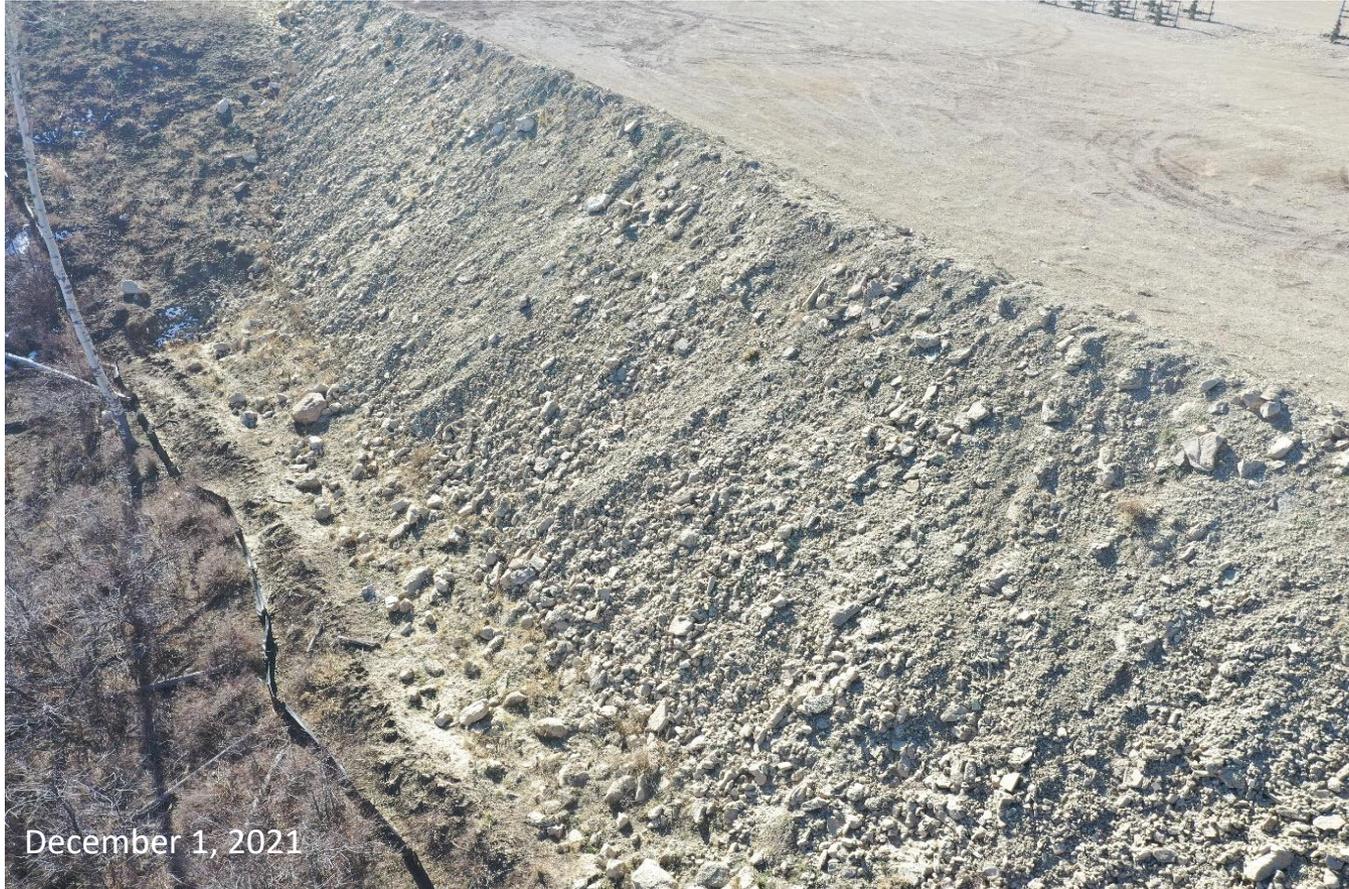
Photo 7: Photo provides example of the fill slopes on the east end of the Location; slopes constructed with a steep grade, with rocky subgrade material. Photo shows control measures to protect/stabilize the slopes of the Location remain missing or insufficient.

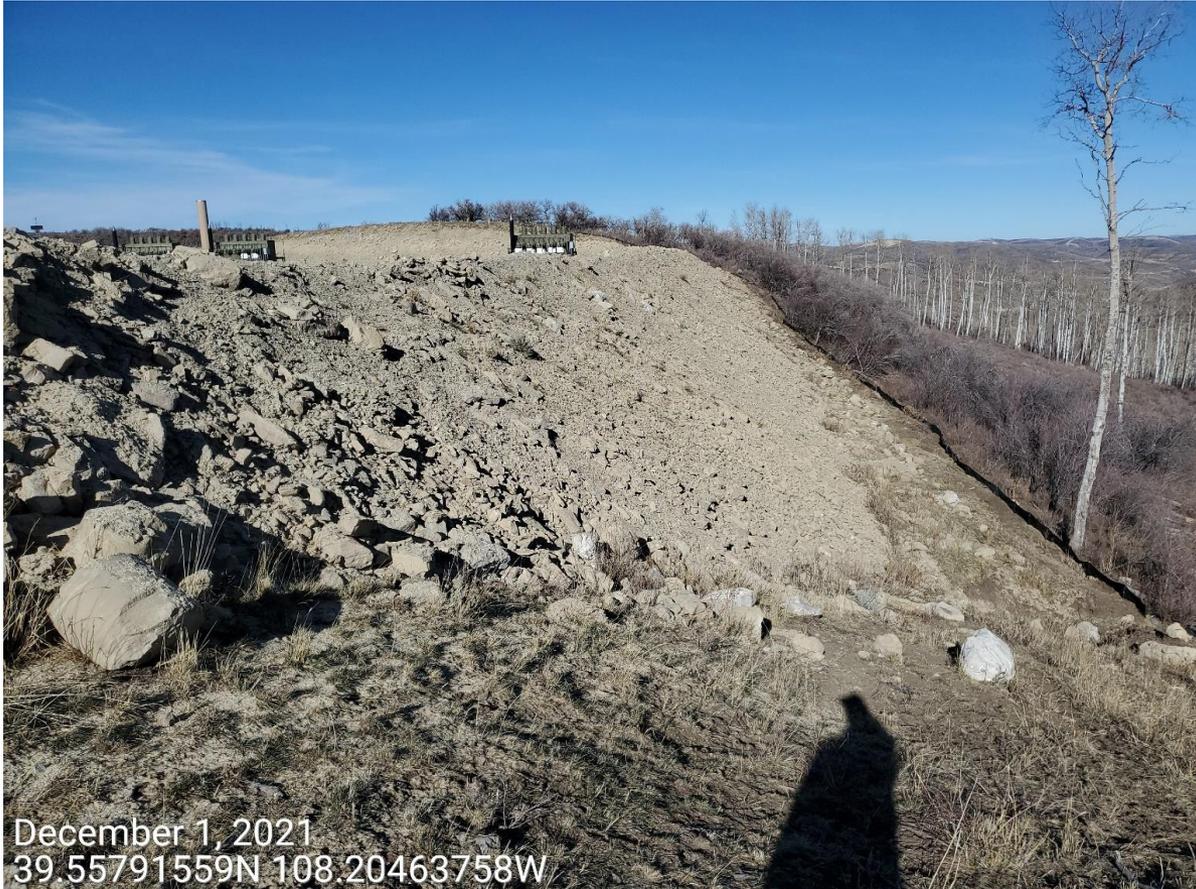
Photo 8: Photo provides example of the fill slopes on the east end of the Location; slopes constructed with a steep grade, with rocky subgrade material. Photo shows control measures to protect/stabilize the slopes of the Location remain missing or insufficient.

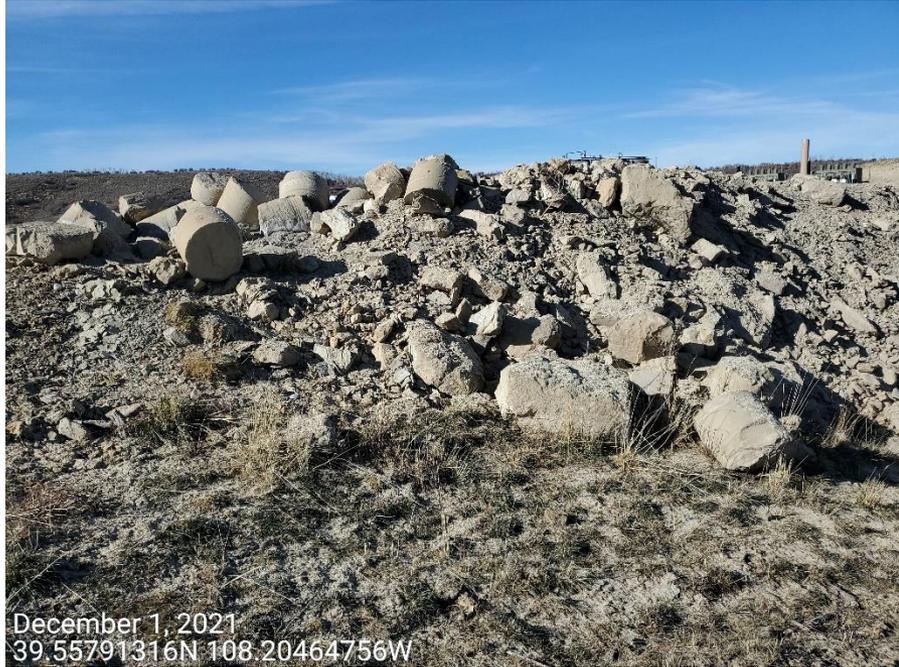
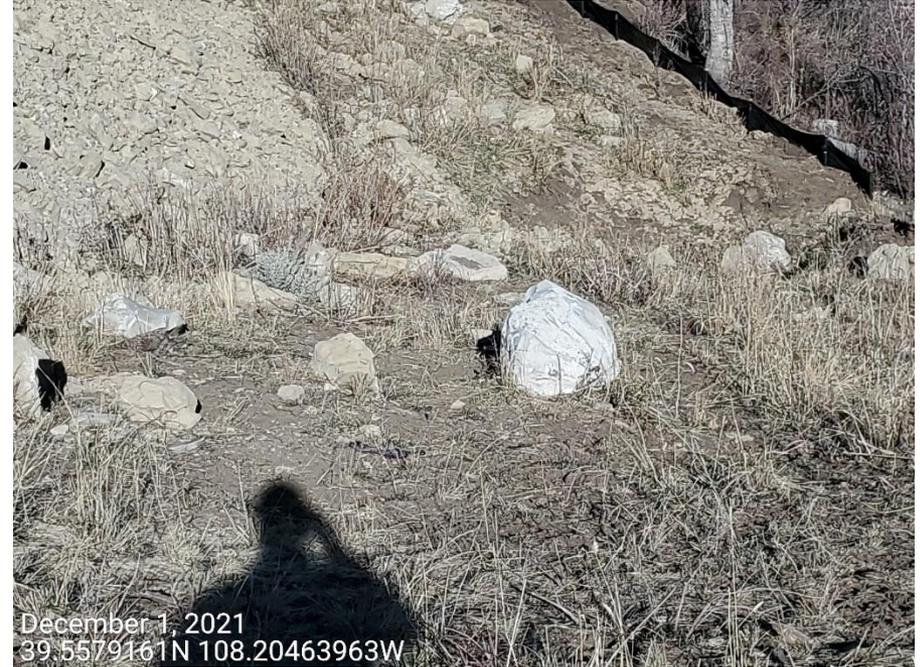
Photo 9: Photos taken from the southeast end of the Location. Photo shows various concrete waste/debris stored and/or partially buried on the southeast end of the Location.

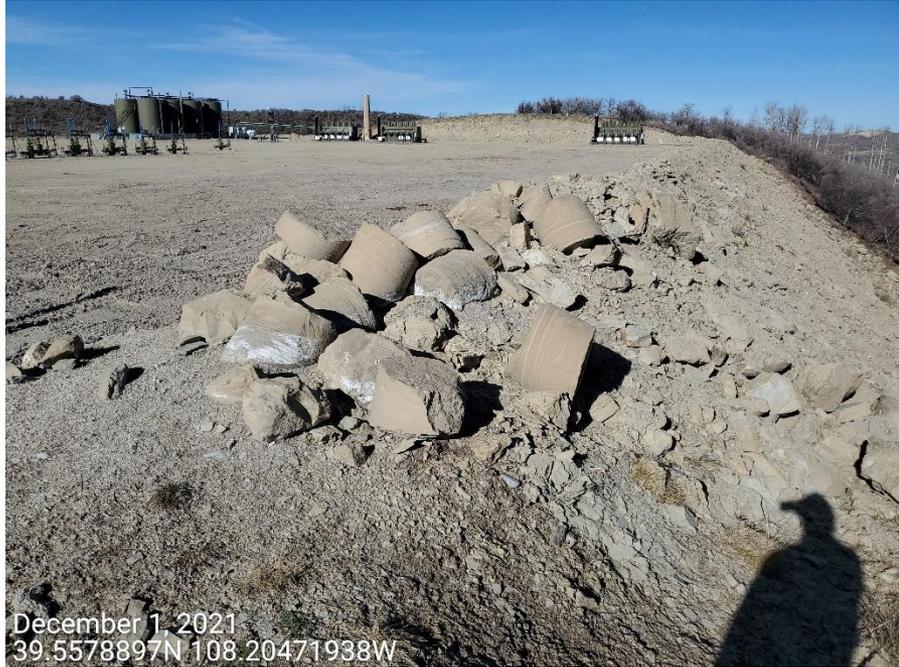
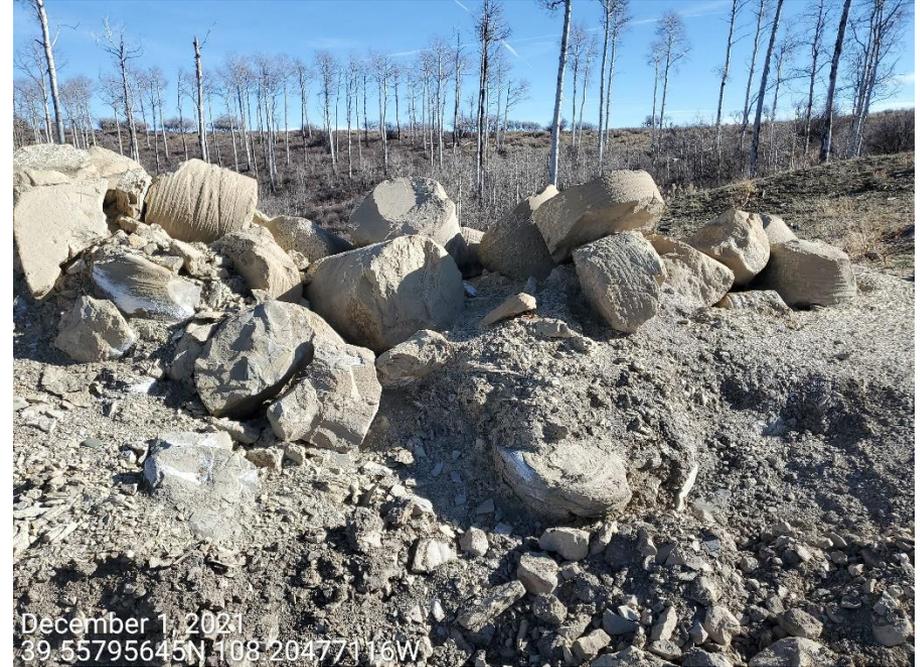
Photo 10: Photos taken from the southeast end of the Location. Photo shows various concrete waste/debris stored and/or partially buried on the southeast end of the Location.

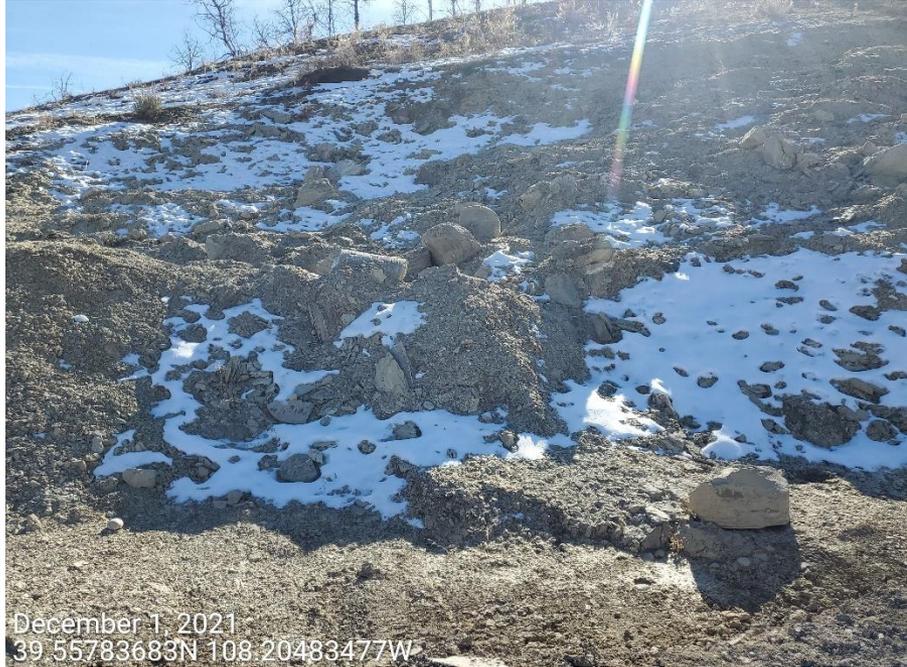
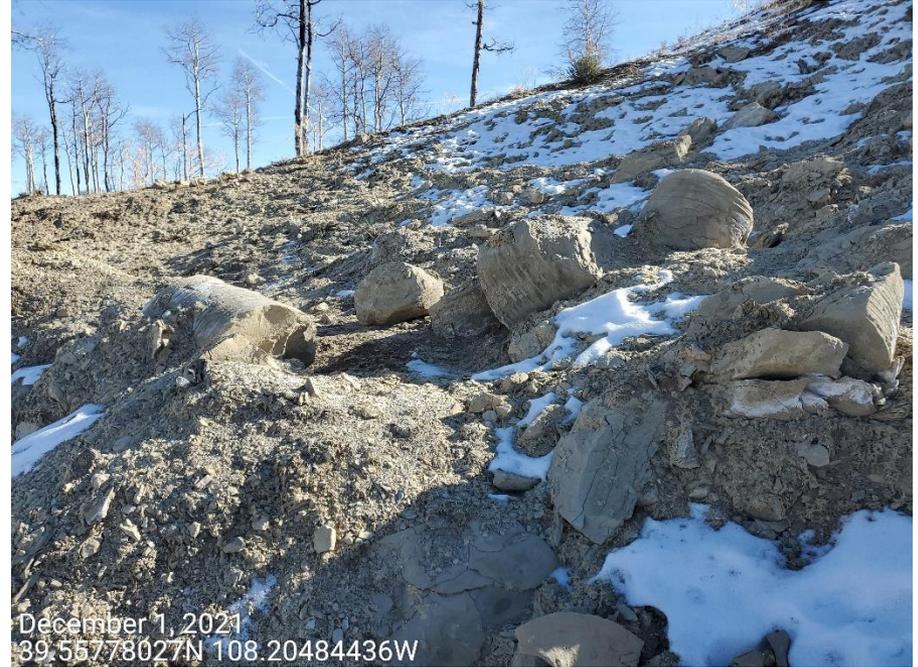
Photo 11: Photos taken from the southeast end of the Location. Photo shows various concrete waste/debris stored and/or partially buried on the cut slope.
