Inspection Photos

API: 009-06441

Operator: INVESTMENT EQUIPMENT LLC

Inspection Date: 11/30/2021

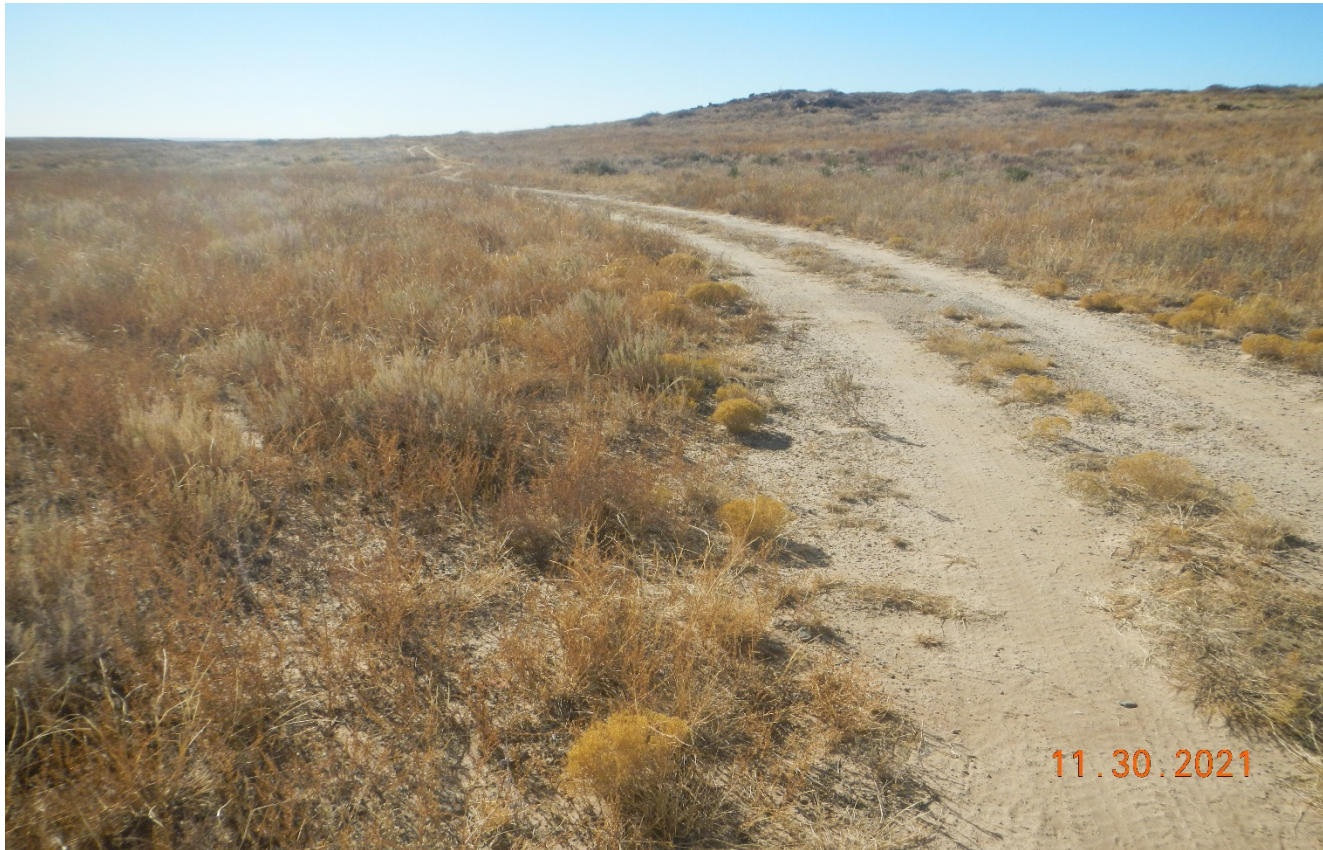
Photo 1. Facing southeast toward the location. The access road continues thru the location.

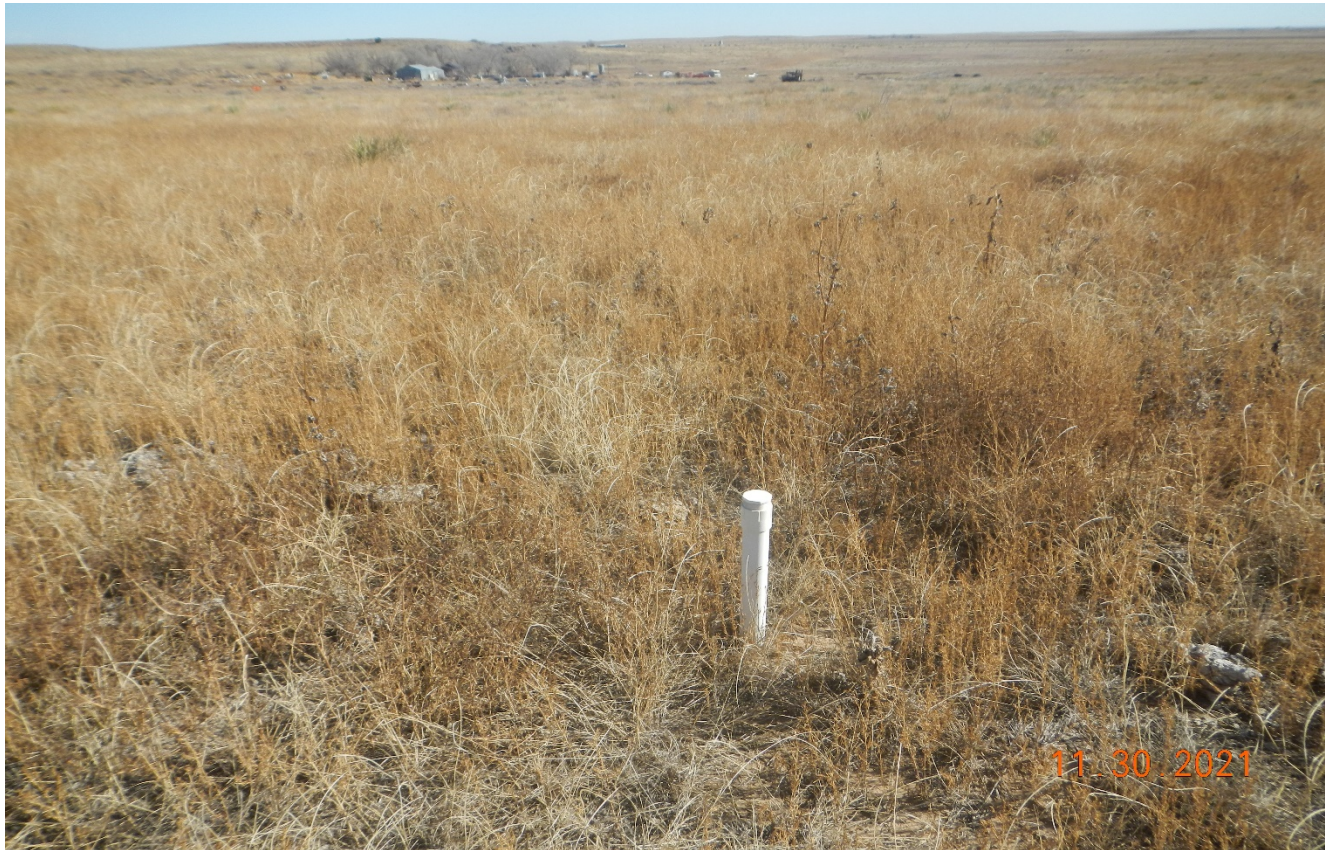
Photo 2. There is a plastic pipe at northeast side of the location. This needs to be removed.

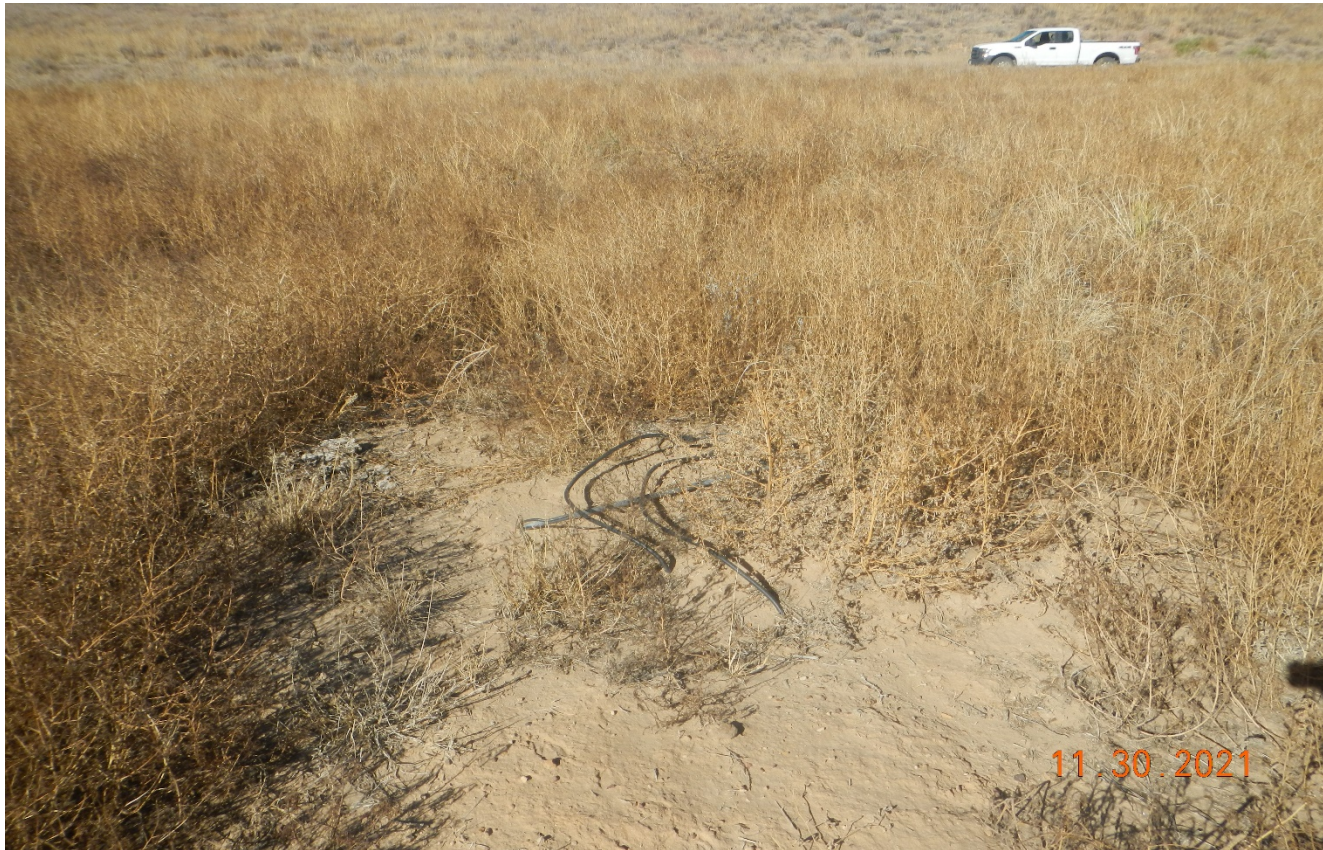
Photo 3. There is electrical wires that remain at the southeast side of the location which needs to be removed.

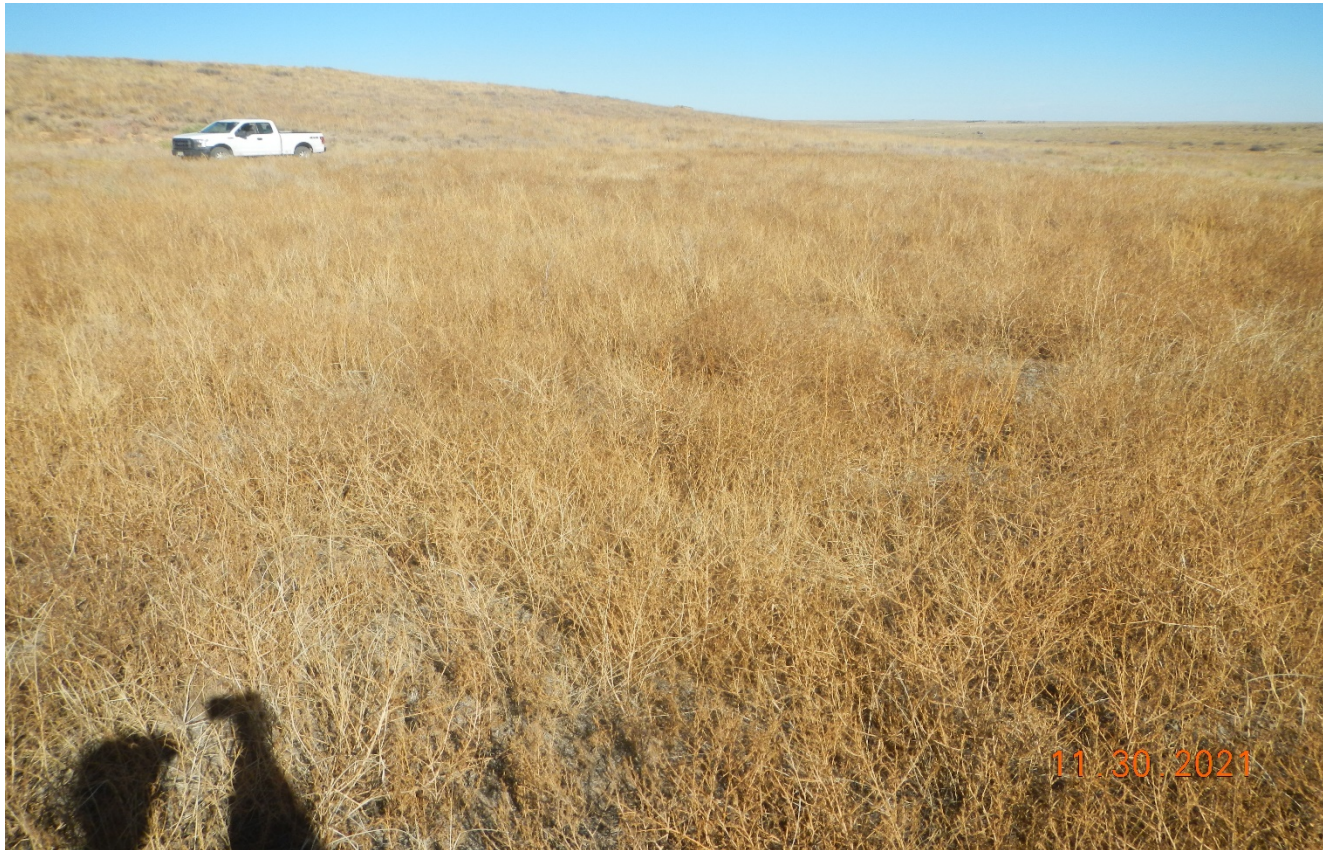
Photo 4. Facing northeast at the south side of the location. This area consists mostly of undesirable weeds (Russian thistle).

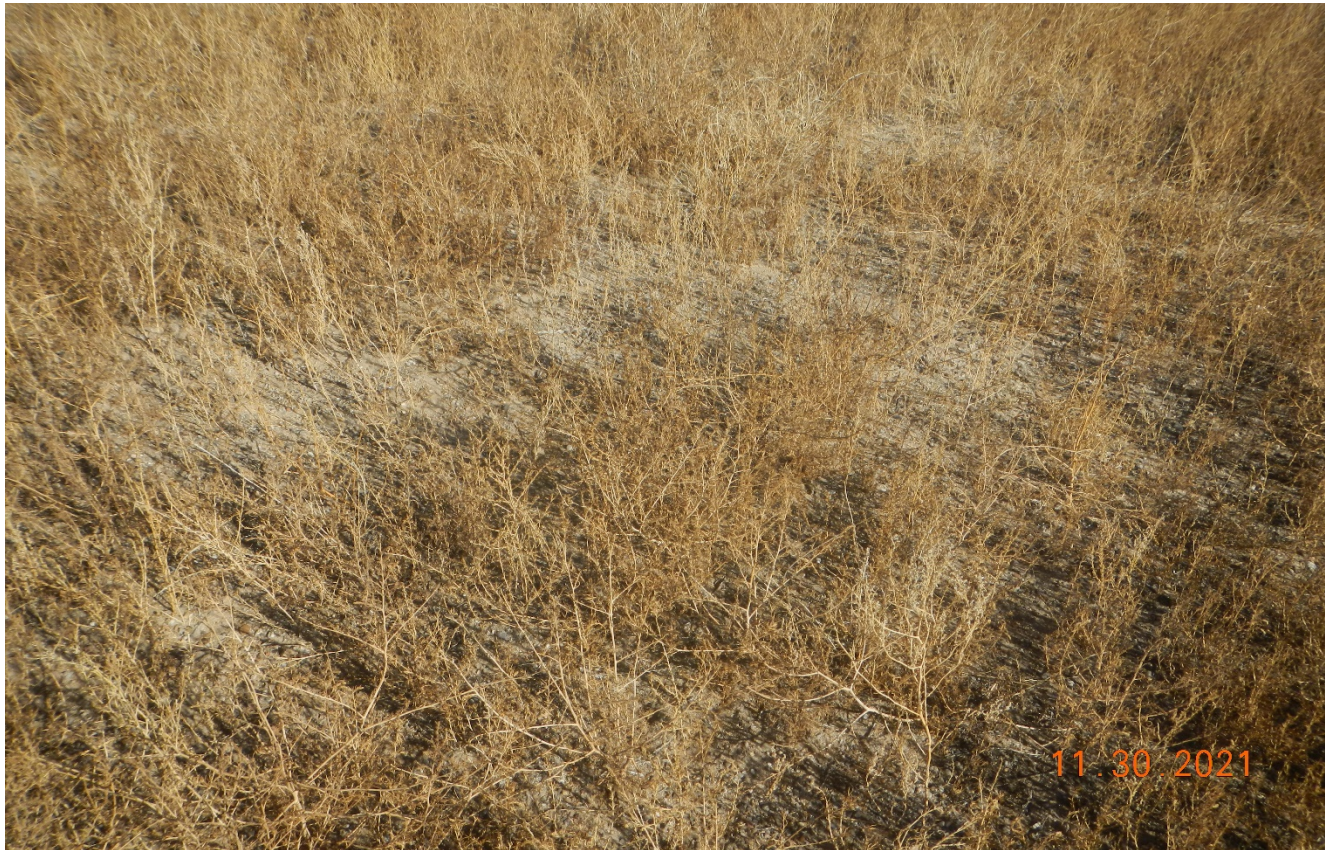
Photo 5. View of undesirable weeds at the south side of the location. The weed debris needs to be removed and the area reseeded.

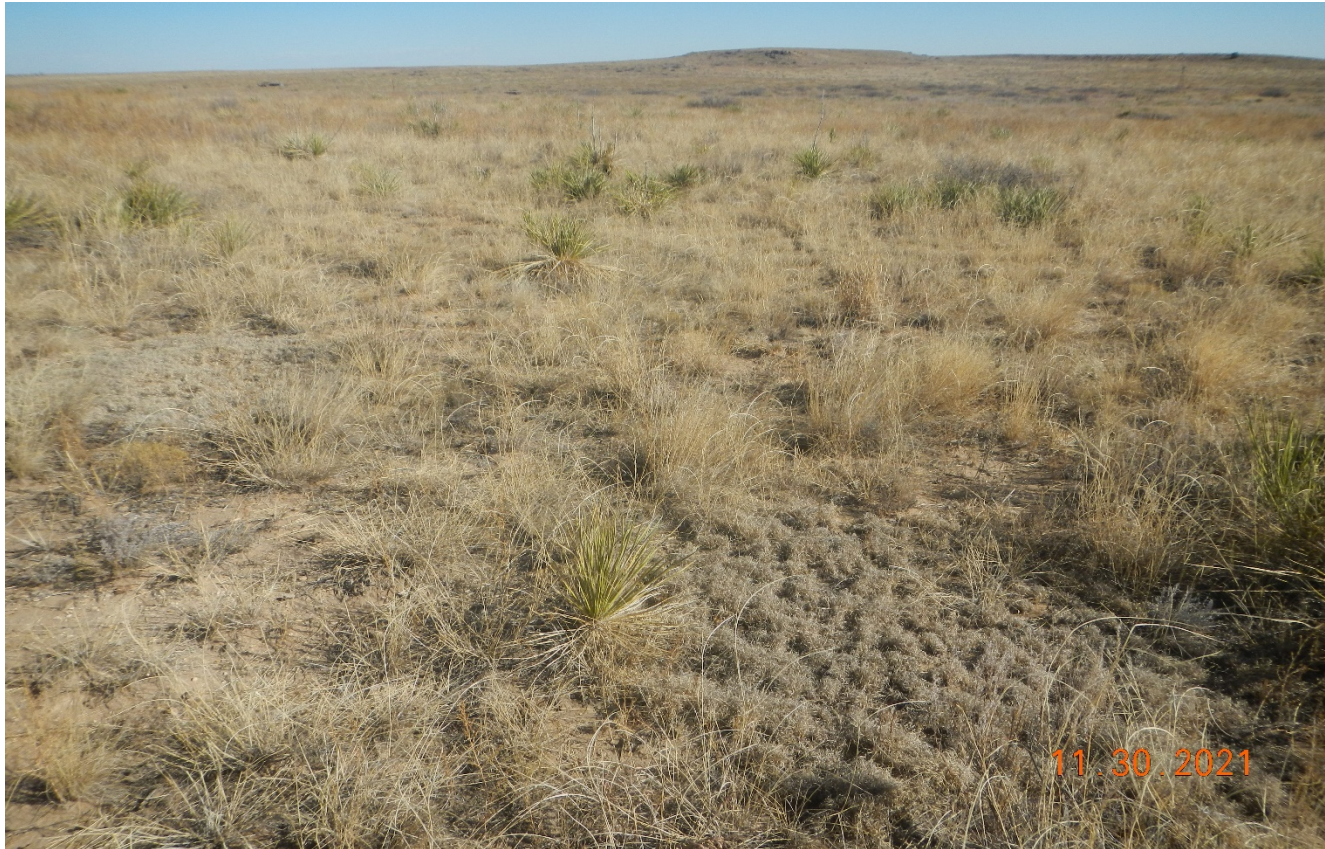
Photo 6. Facing toward the surrounding undisturbed reference area which consists of Blue grama, Sand dropseed, Prairie threeawn, among other native species.
