Inspection Photos
Location Name: Federal 11-90-35 #1
API: 05-051-06059

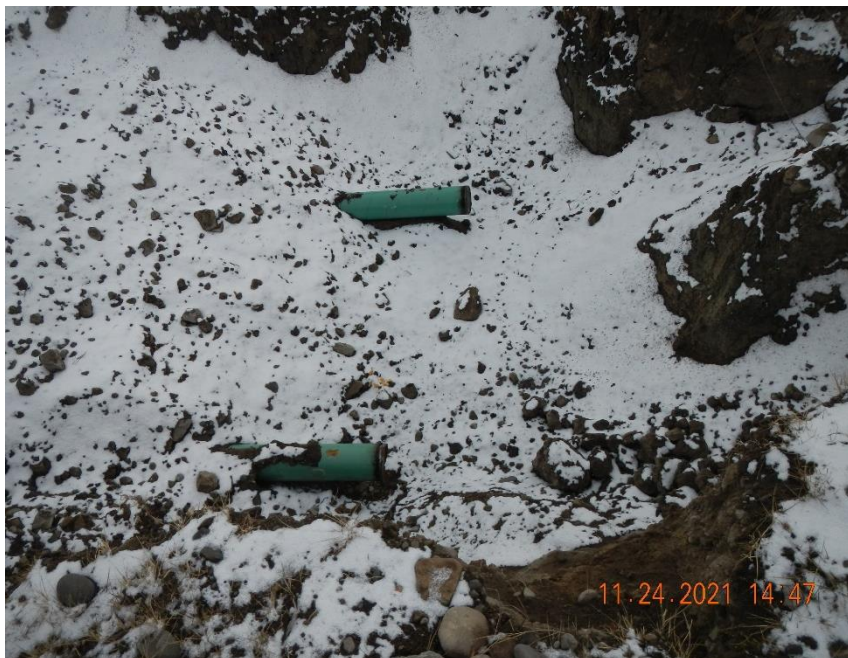
Flow lines with welded on caps near location entrance.

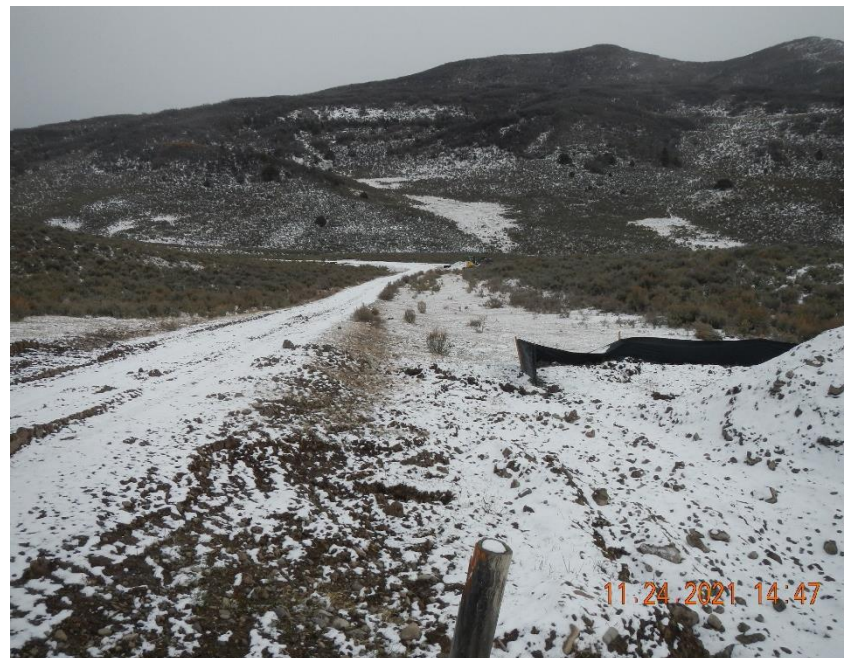
View from location entrance towards main road. Mini ex in background near other end of flow lines.

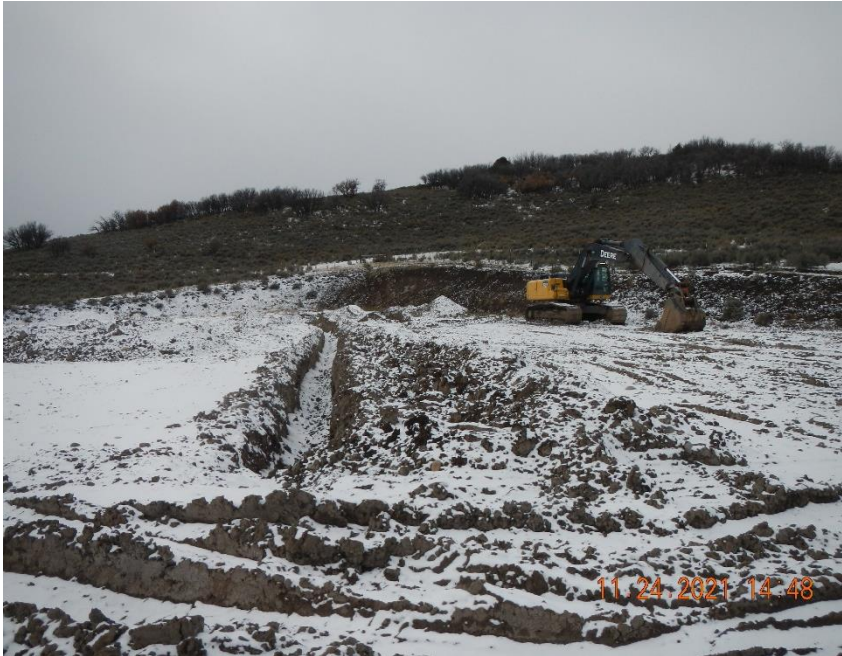
Open excavations on location.

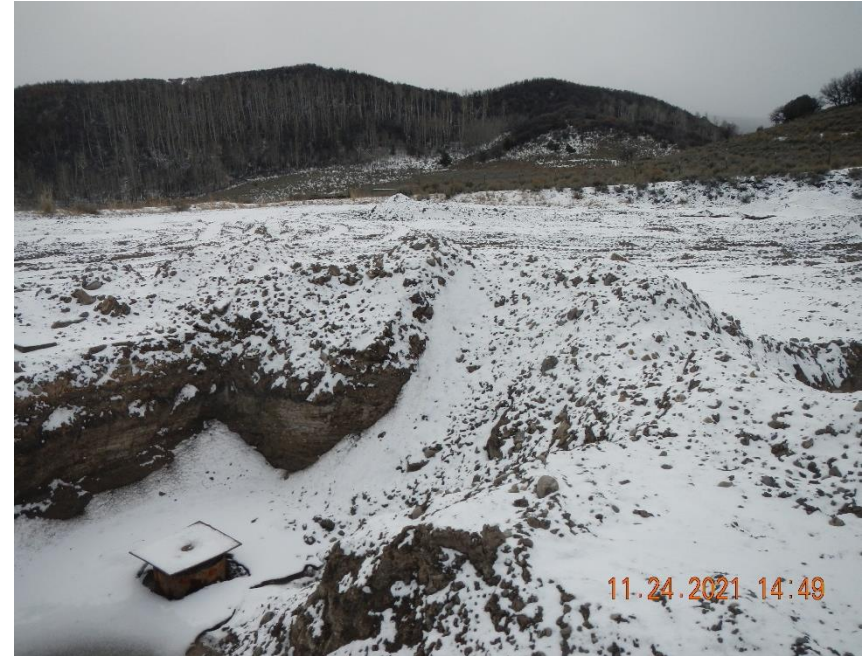
Federal 11-90-35 #1 with steel plate welded on.

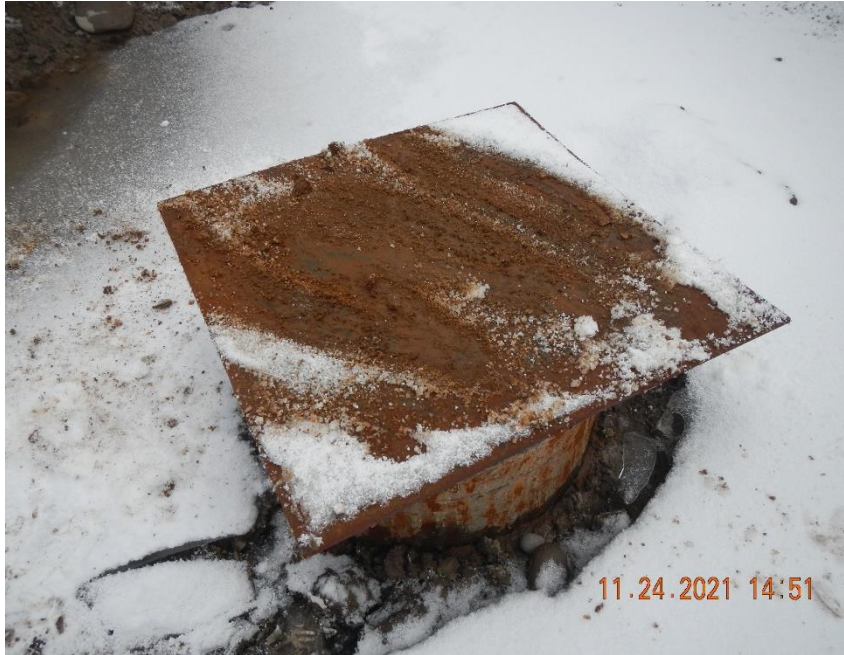
Identifying information is not present on steel plate.

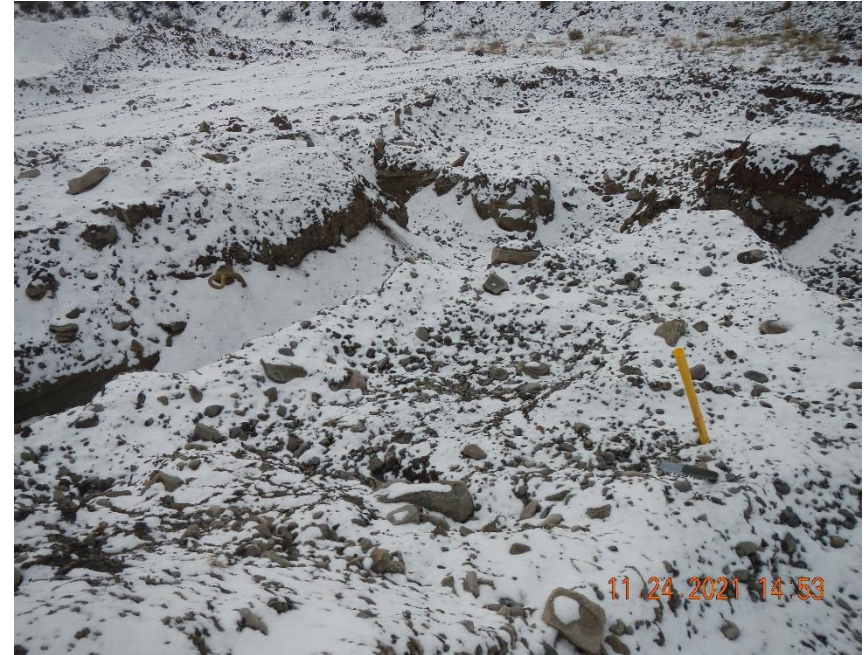
Guy line anchor and marker observed during this inspection.

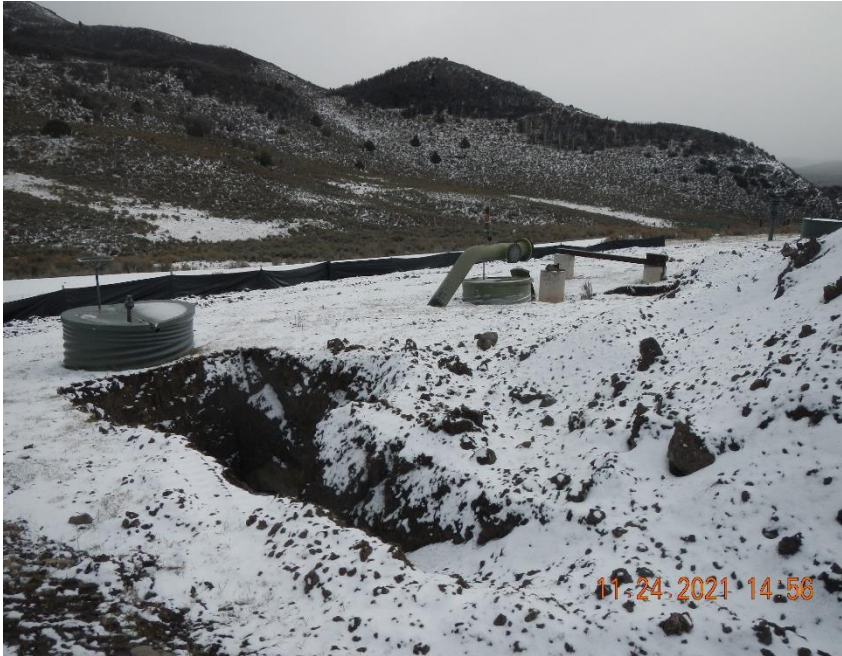
Open excavation near main road.

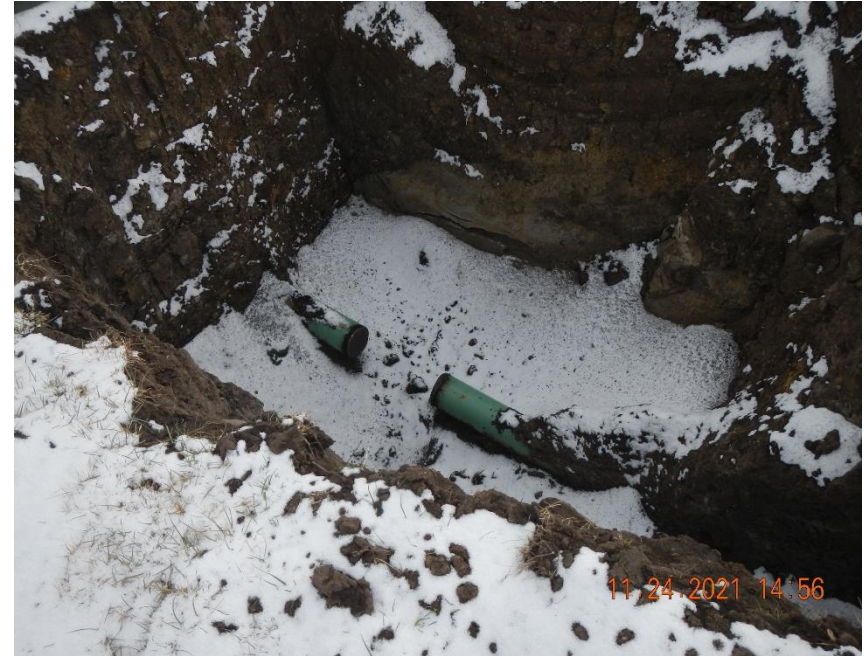
Flow line with caps welded on.

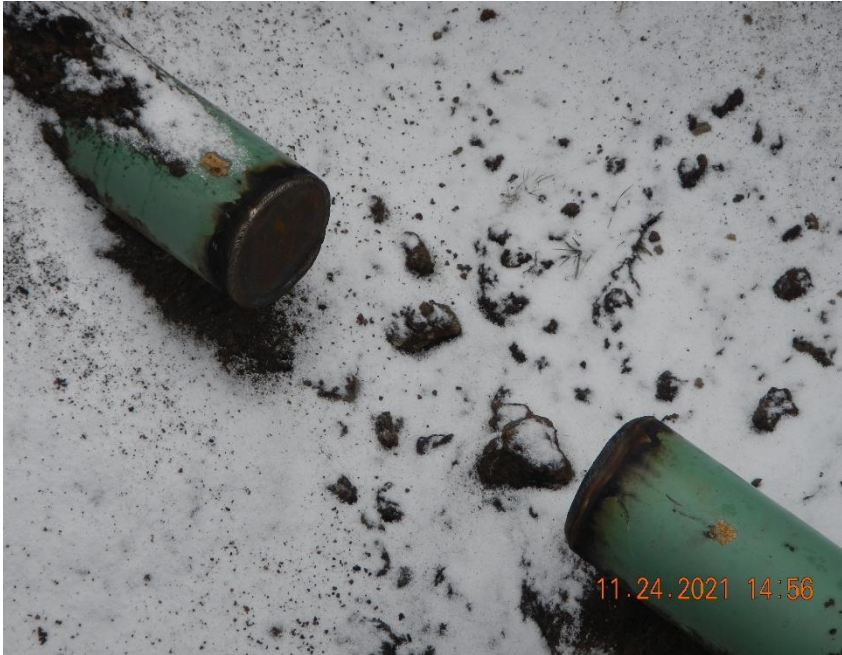
Close up of abandoned flow line.

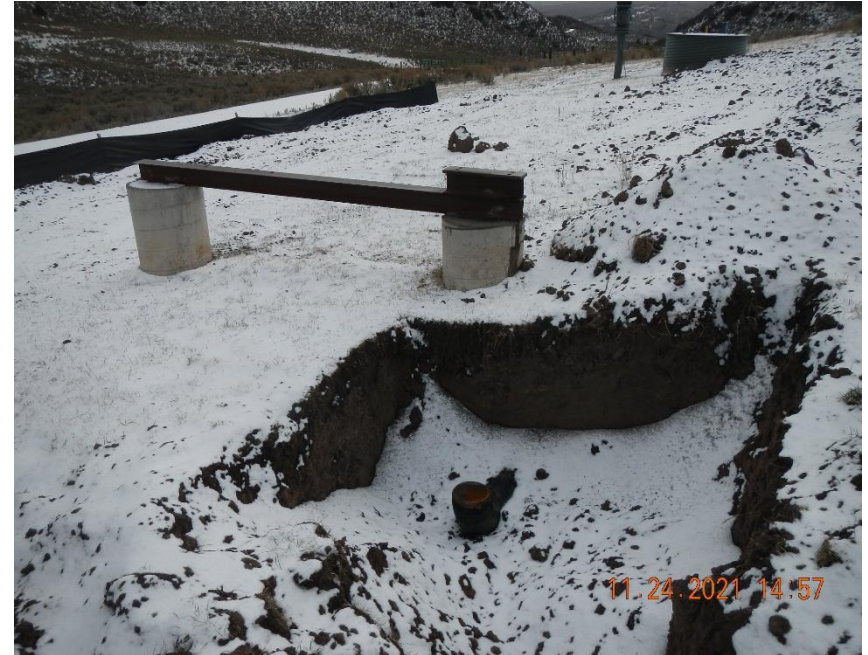
Cap welded onto abandoned flow line.
