Inspection Photos

Location Name: CAERUS PICEANCE LLC FEDERAL-67S95W /19NESE

Location ID: 335031

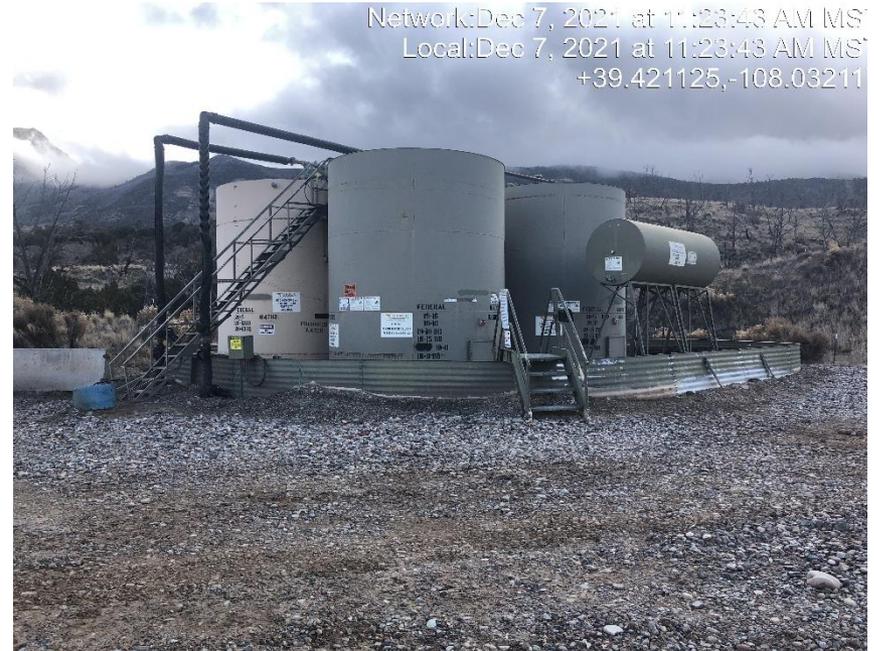
Photo #5329 No battery sign located at the tank battery.

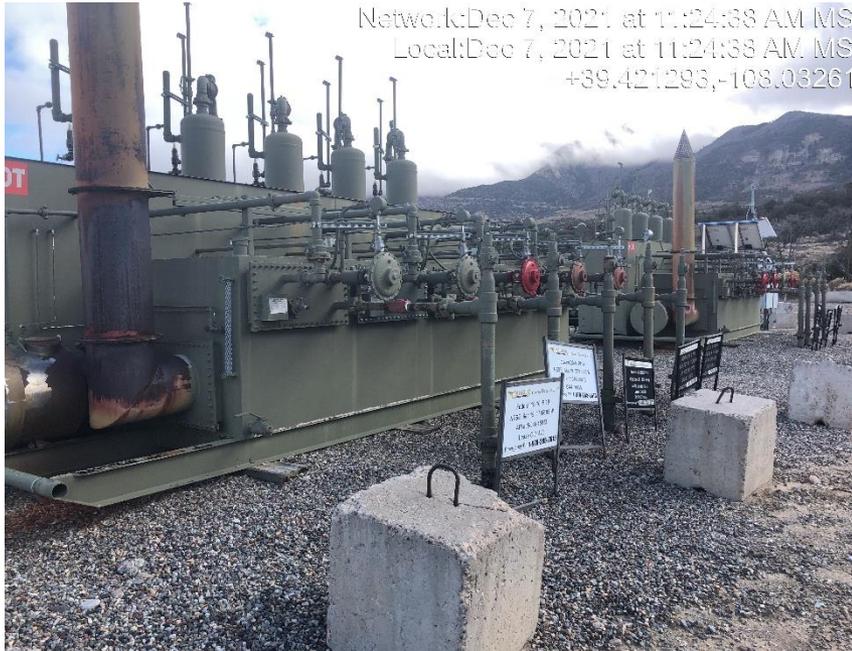
Photo #5332 Multiple unmarked storage tanks.

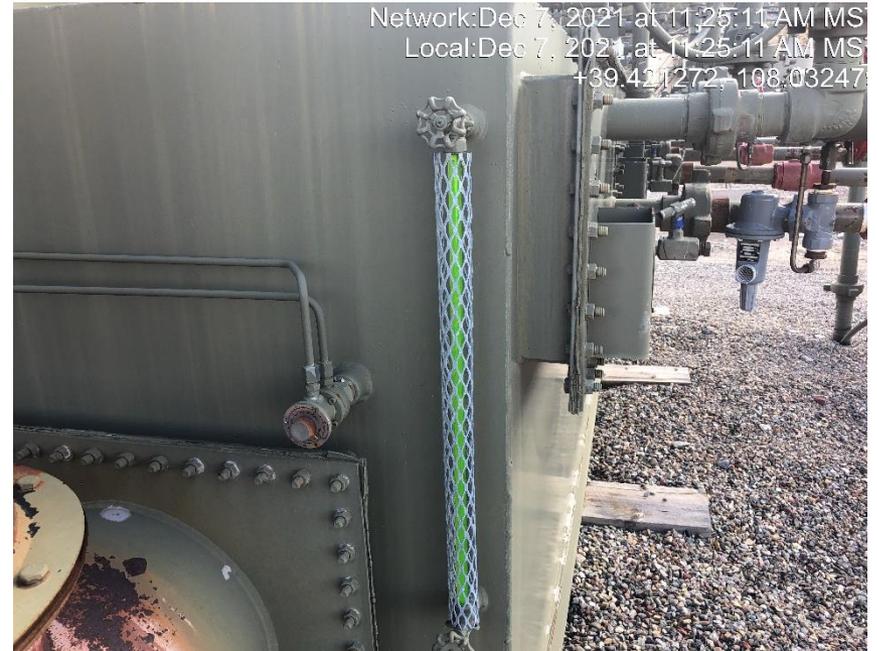
Photo #5333 Sight glass indicates the storage is tank is full of an unknown fluid.

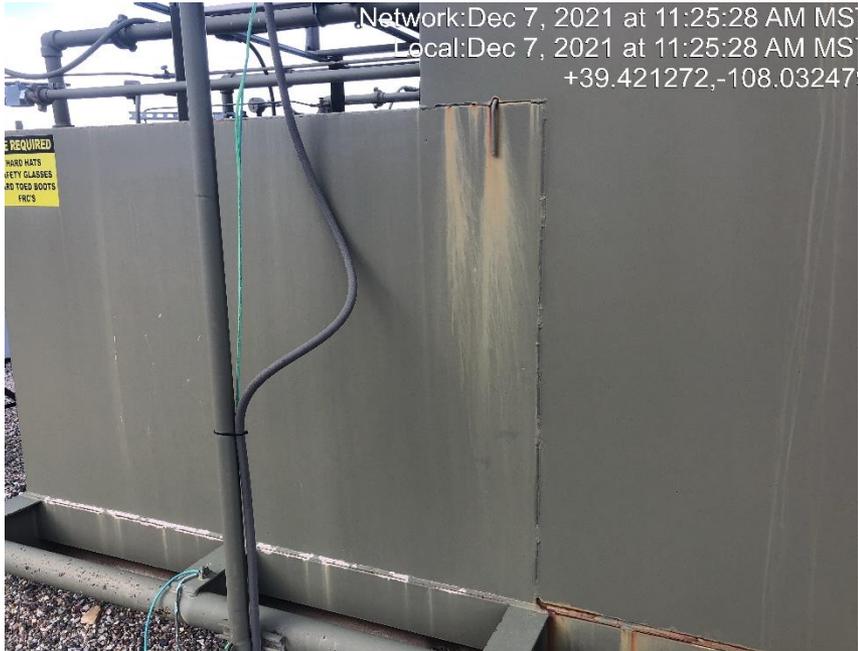
Photo #5334 Storage tank begins at the weld.

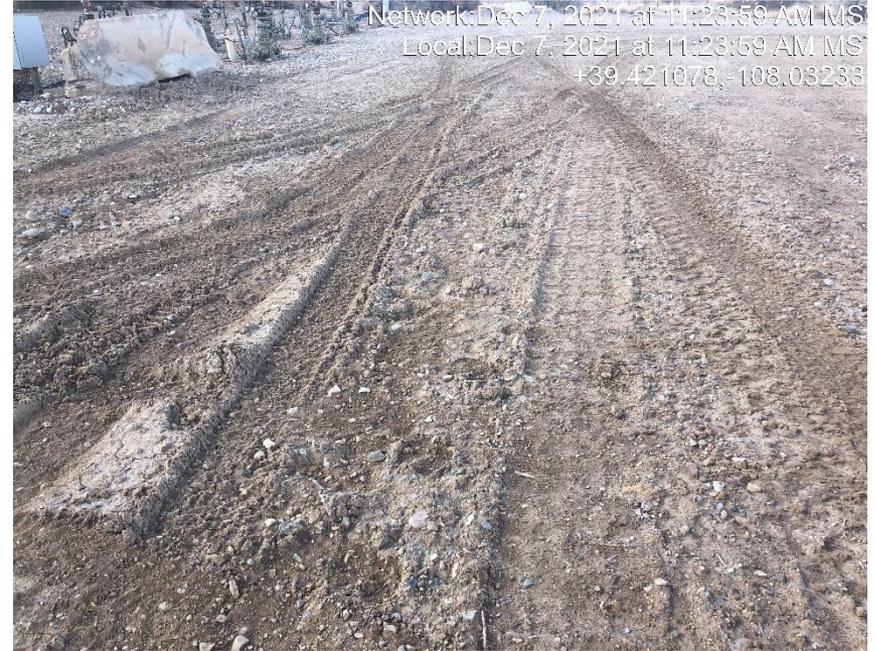
Photo #5330 Location lacks stabilization.

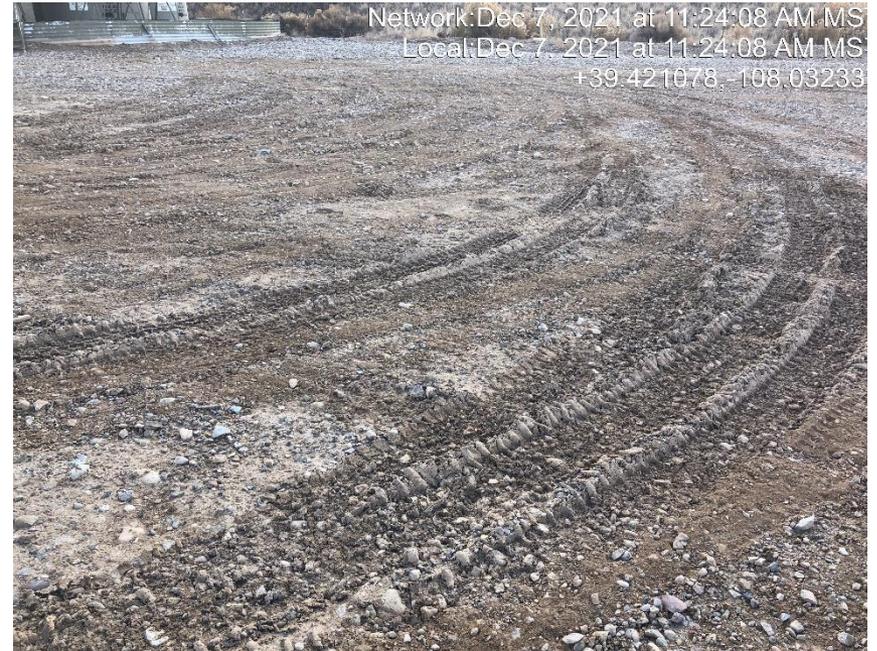
Photo #5331 Location lacks stabilization.
