Inspection Photos
Operator: Logos Operating
API: 067-05474
Date: 12/7/2021

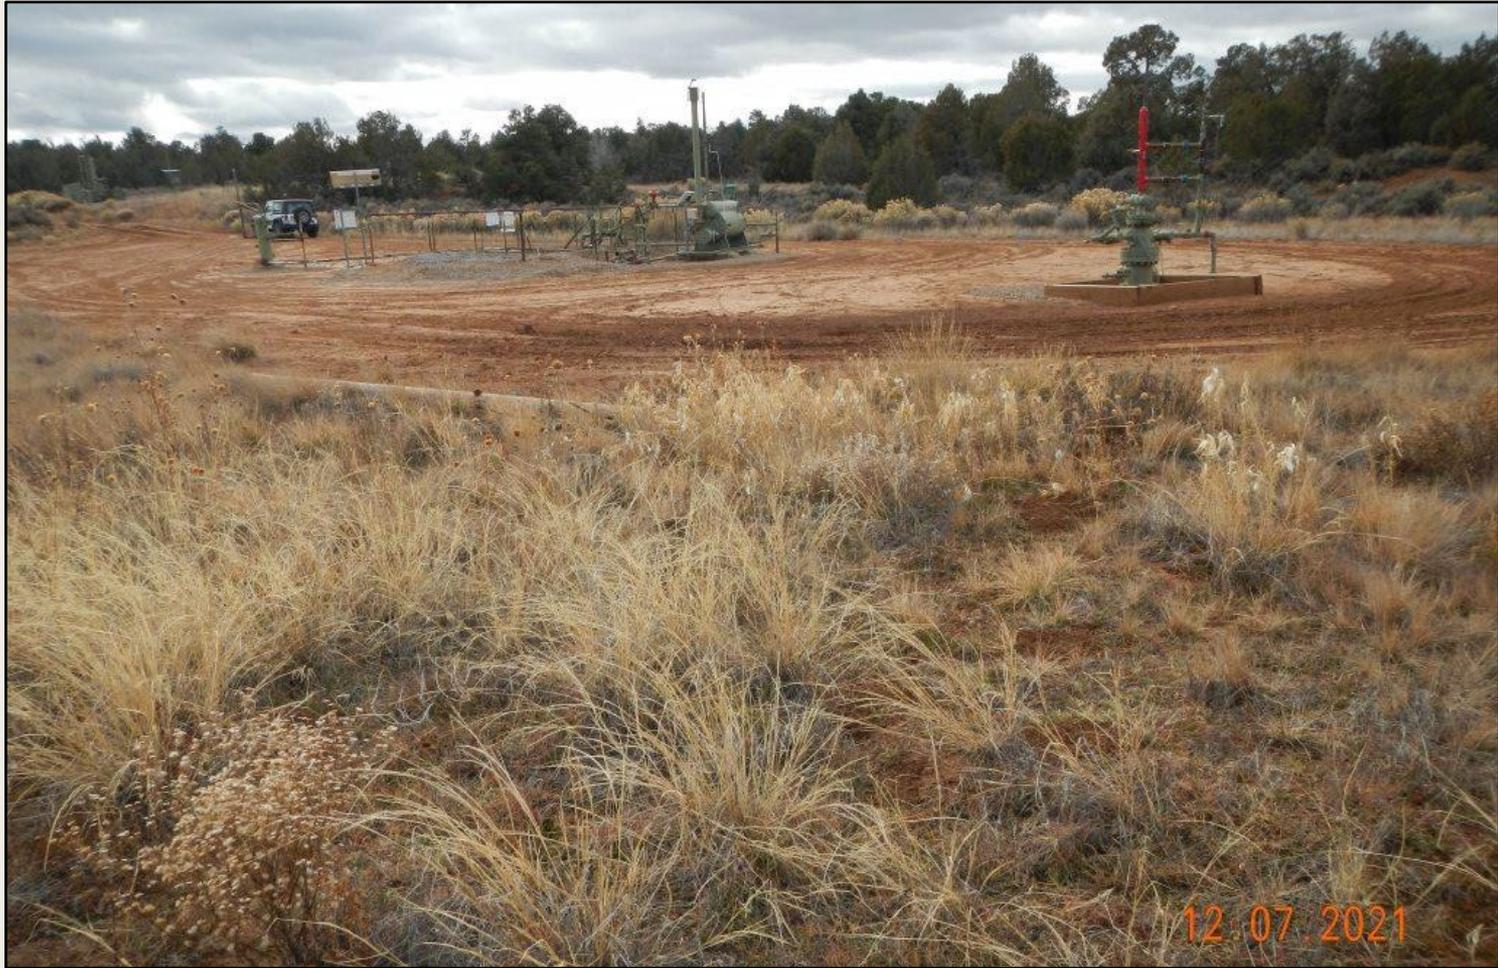
Photo 1. View of the project area from the northeastern corner facing center.

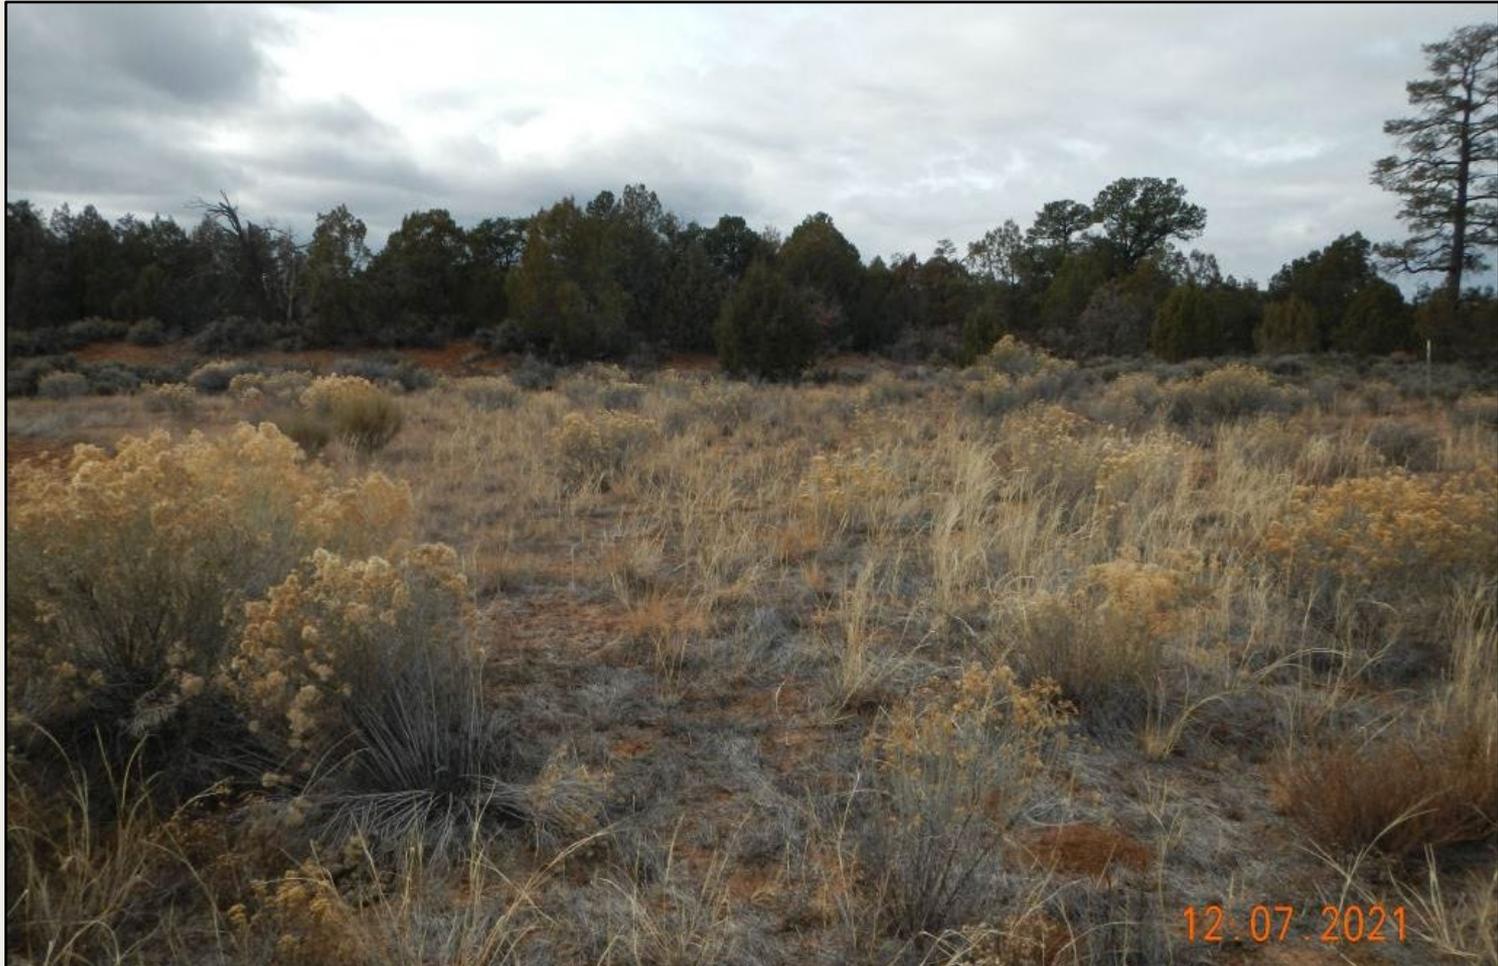
Photo 2. View of the northern project area from the northeastern corner facing westward. Revegetation is progressing here with western wheatgrass, sand dropseed, and rubber rabbitbrush.

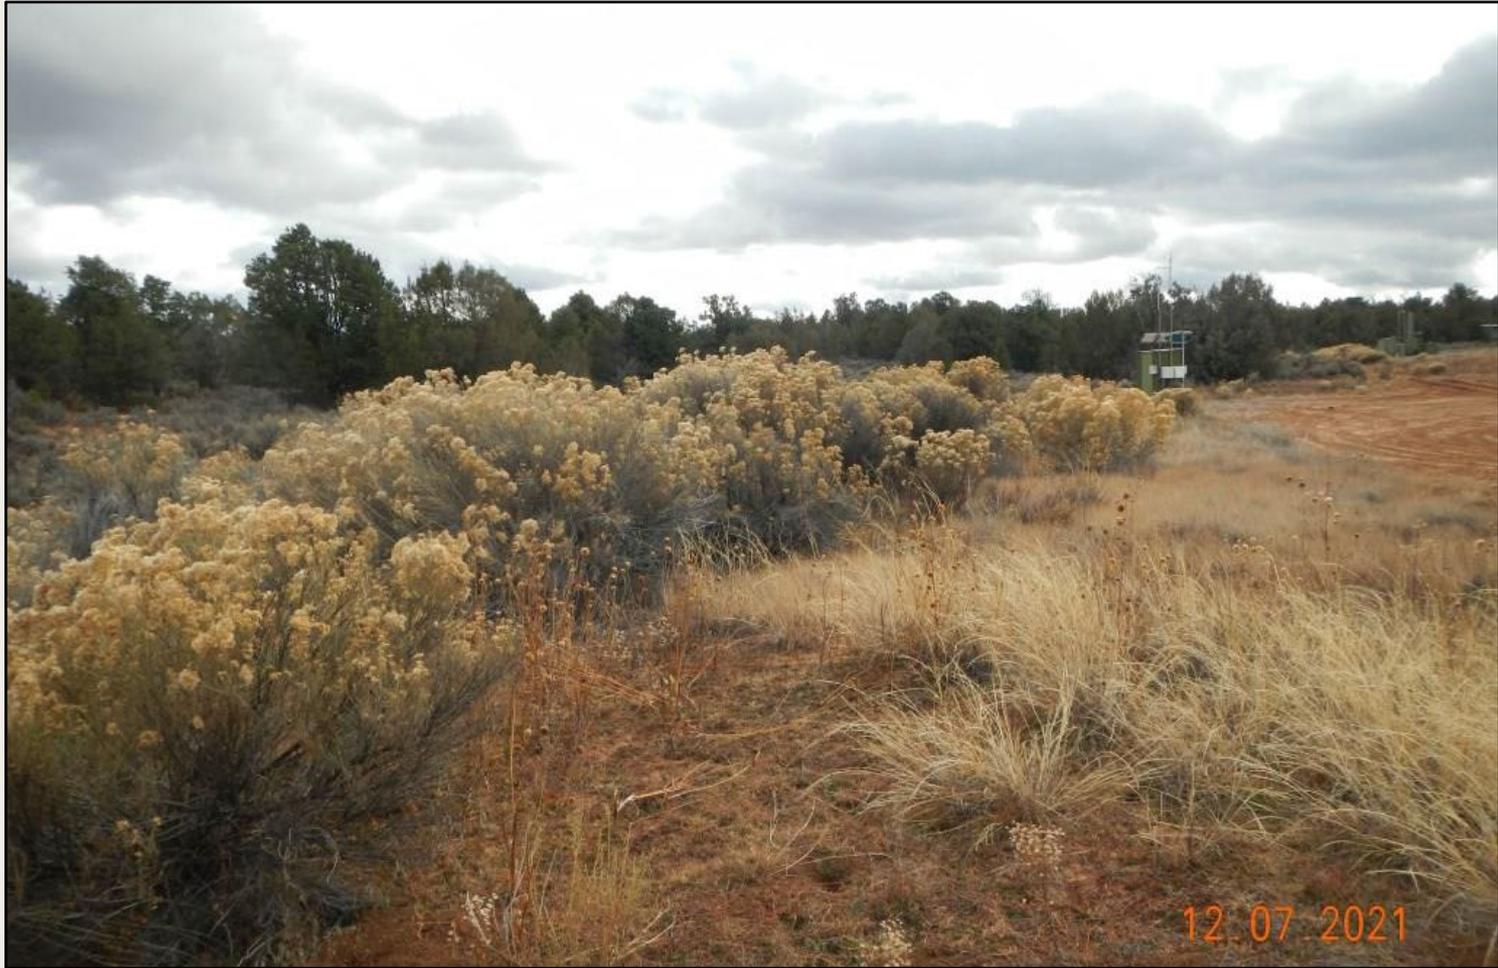
Photo 3. View of eastern project area from the northeastern corner facing southward.

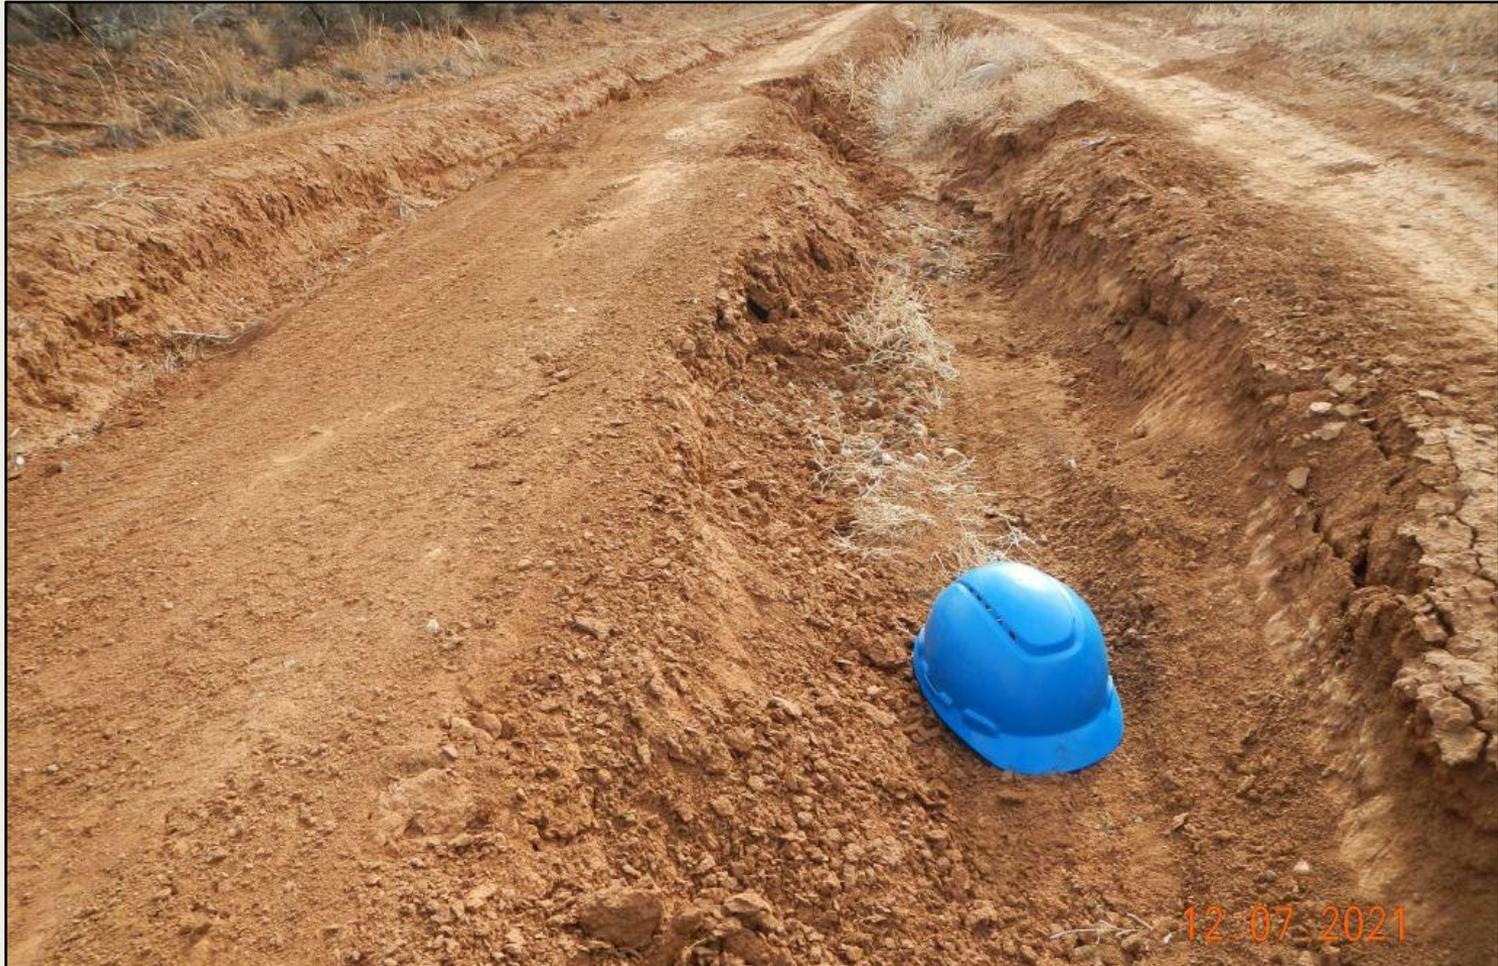
Photo 4. View of erosional channeling occurring on the access road, approximately 1.5-2ft wide and deep. Road needs long-term stabilization. Hard had in place for scale.

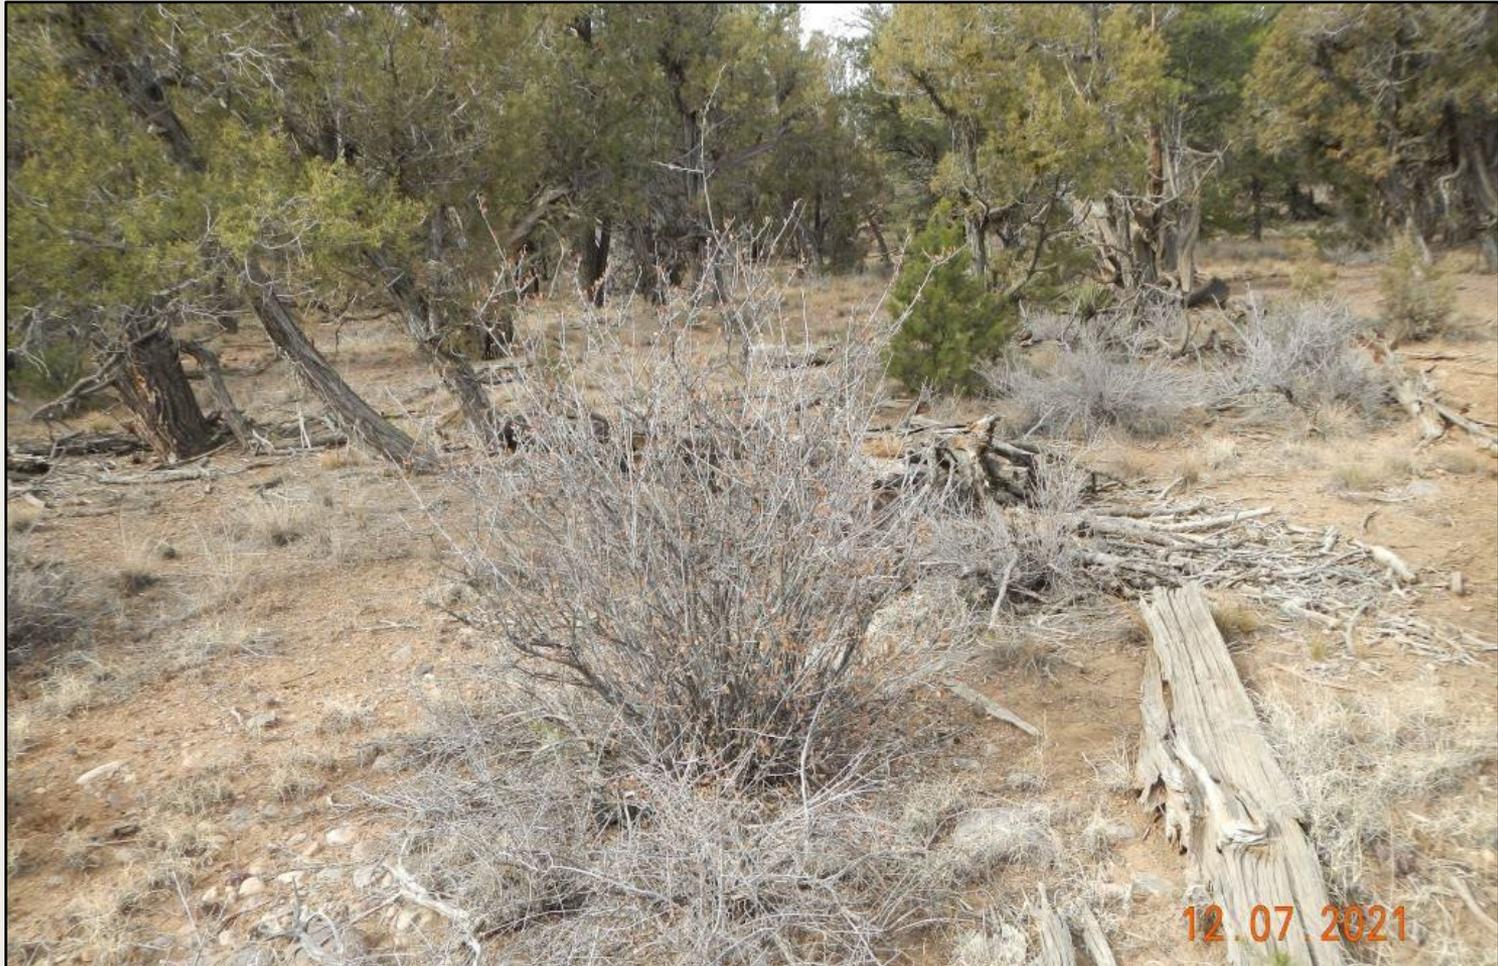
Photo 5. View of reference area comprised of pinyon and juniper woodland with gambel oak, mountain mahogany, Indian ricegrass, and threadleaf sunflower.
