Inspection Photos
Operator: Simcoe
API: 067-07610
Date: 12/7/2021

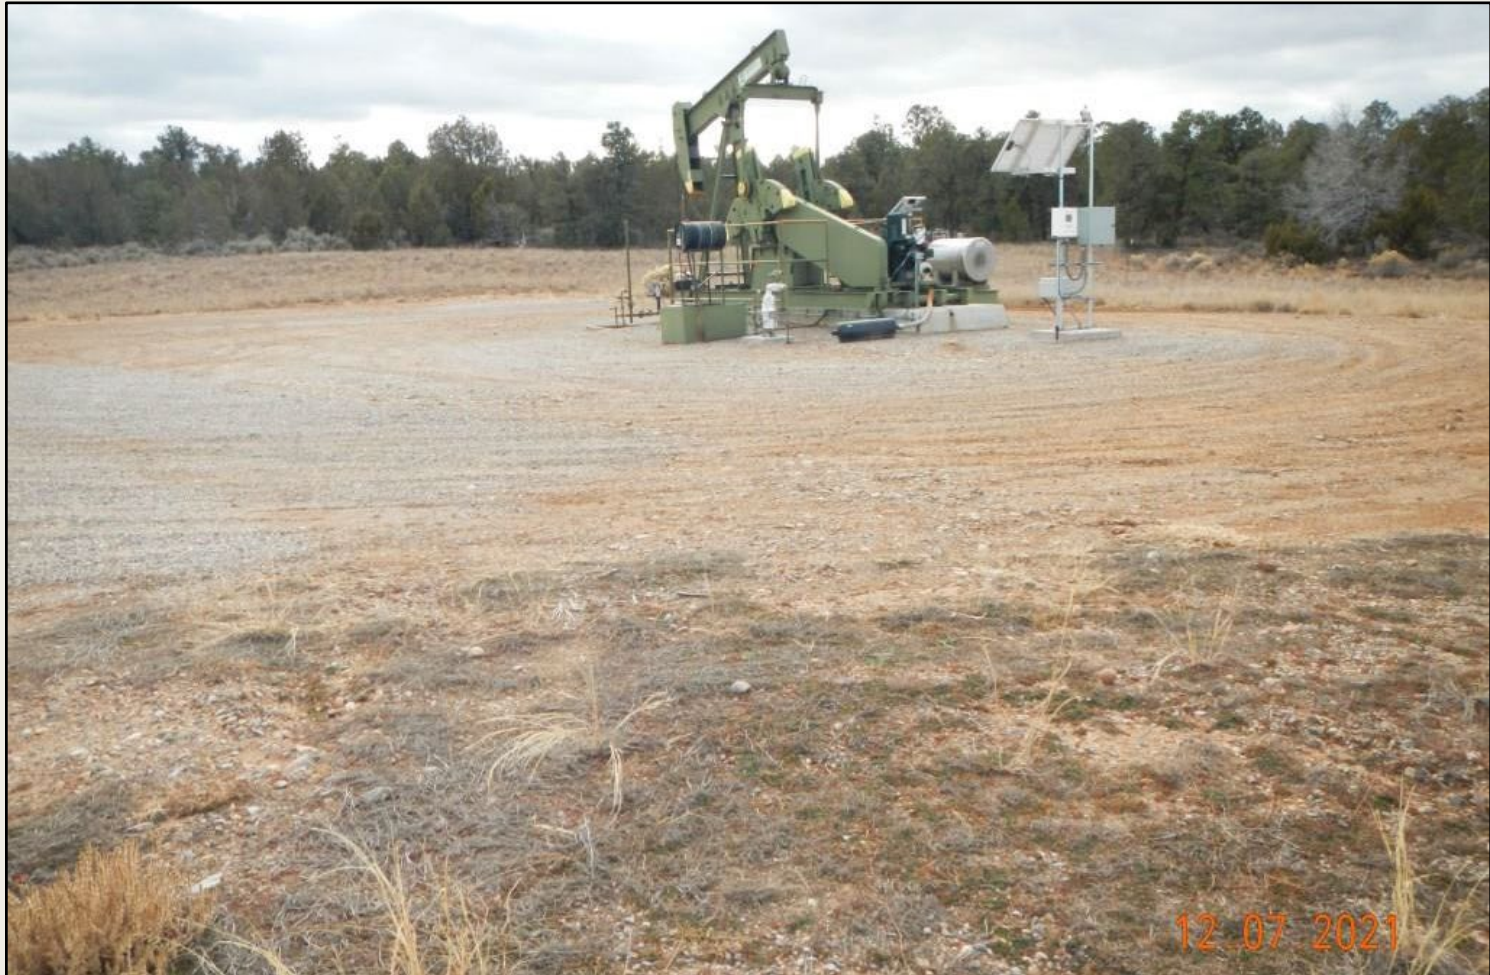
Photo 1. View of the project area from the northeastern corner facing center.

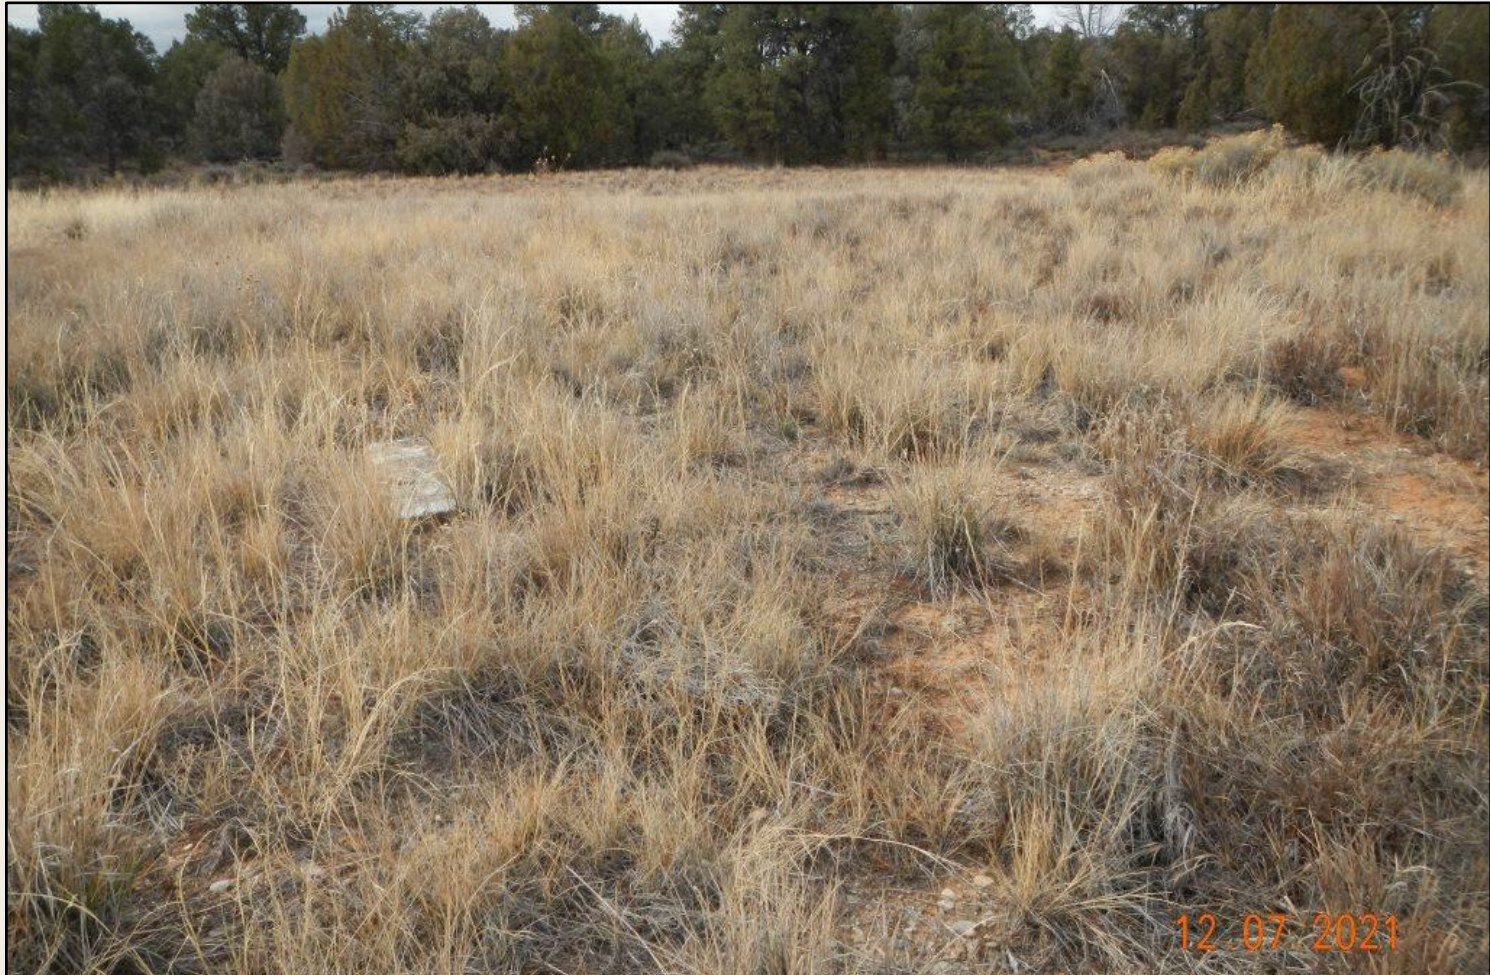
Photo 2. View of the northern project area from the northeastern corner facing westward. Revegetation is progressing here with western wheatgrass, sand dropseed, and crested wheatgrass.

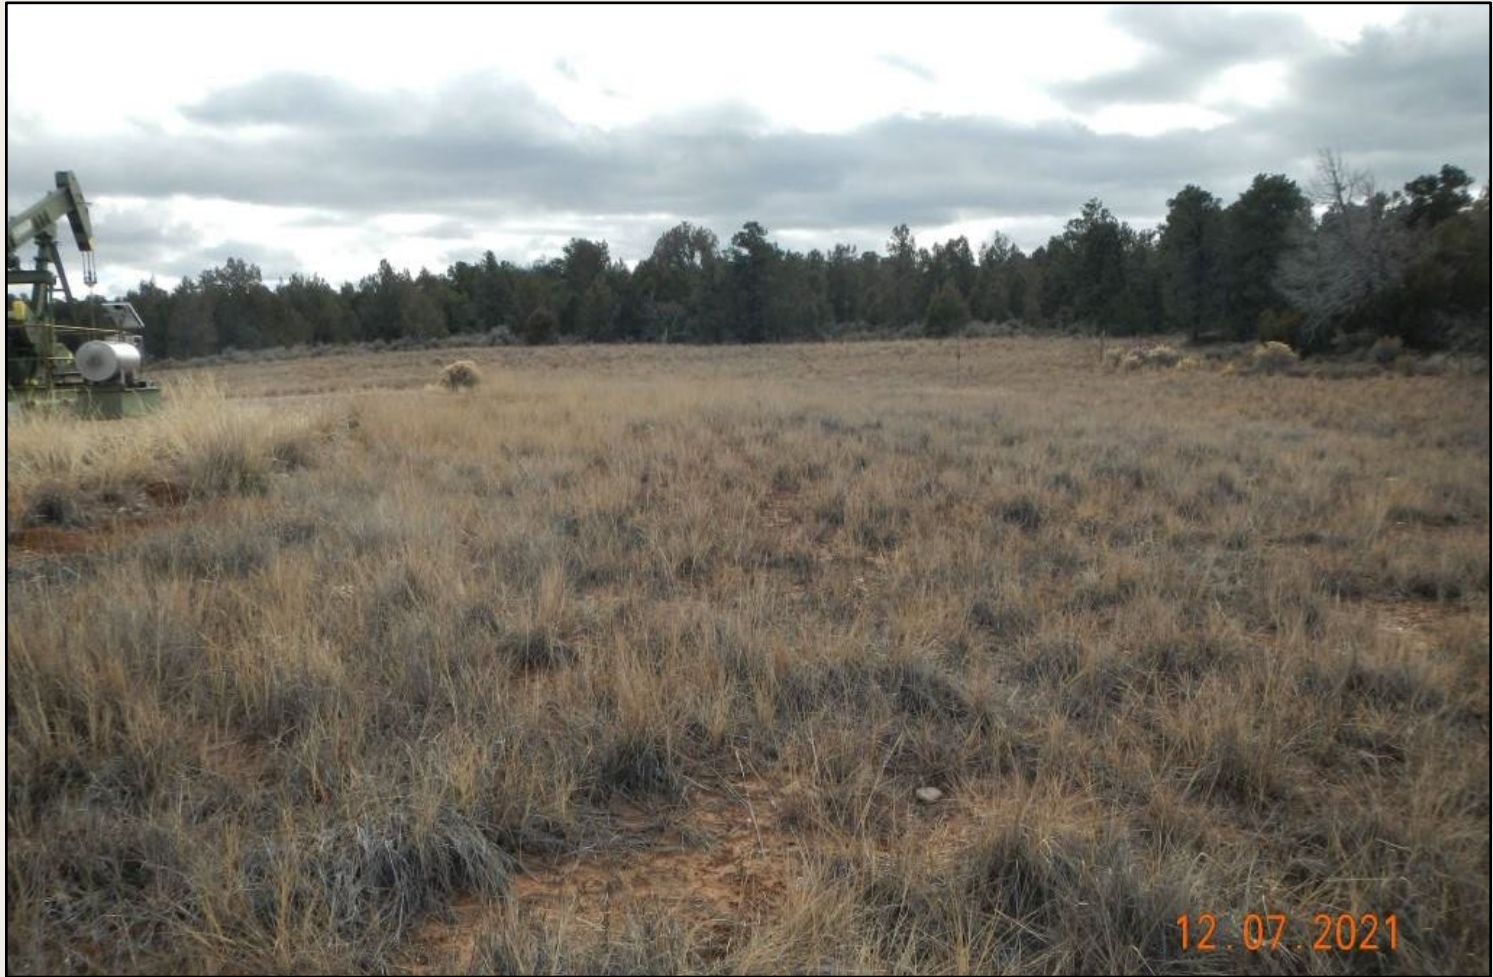
Photo 3. View of western project area from the northwestern corner facing southward.

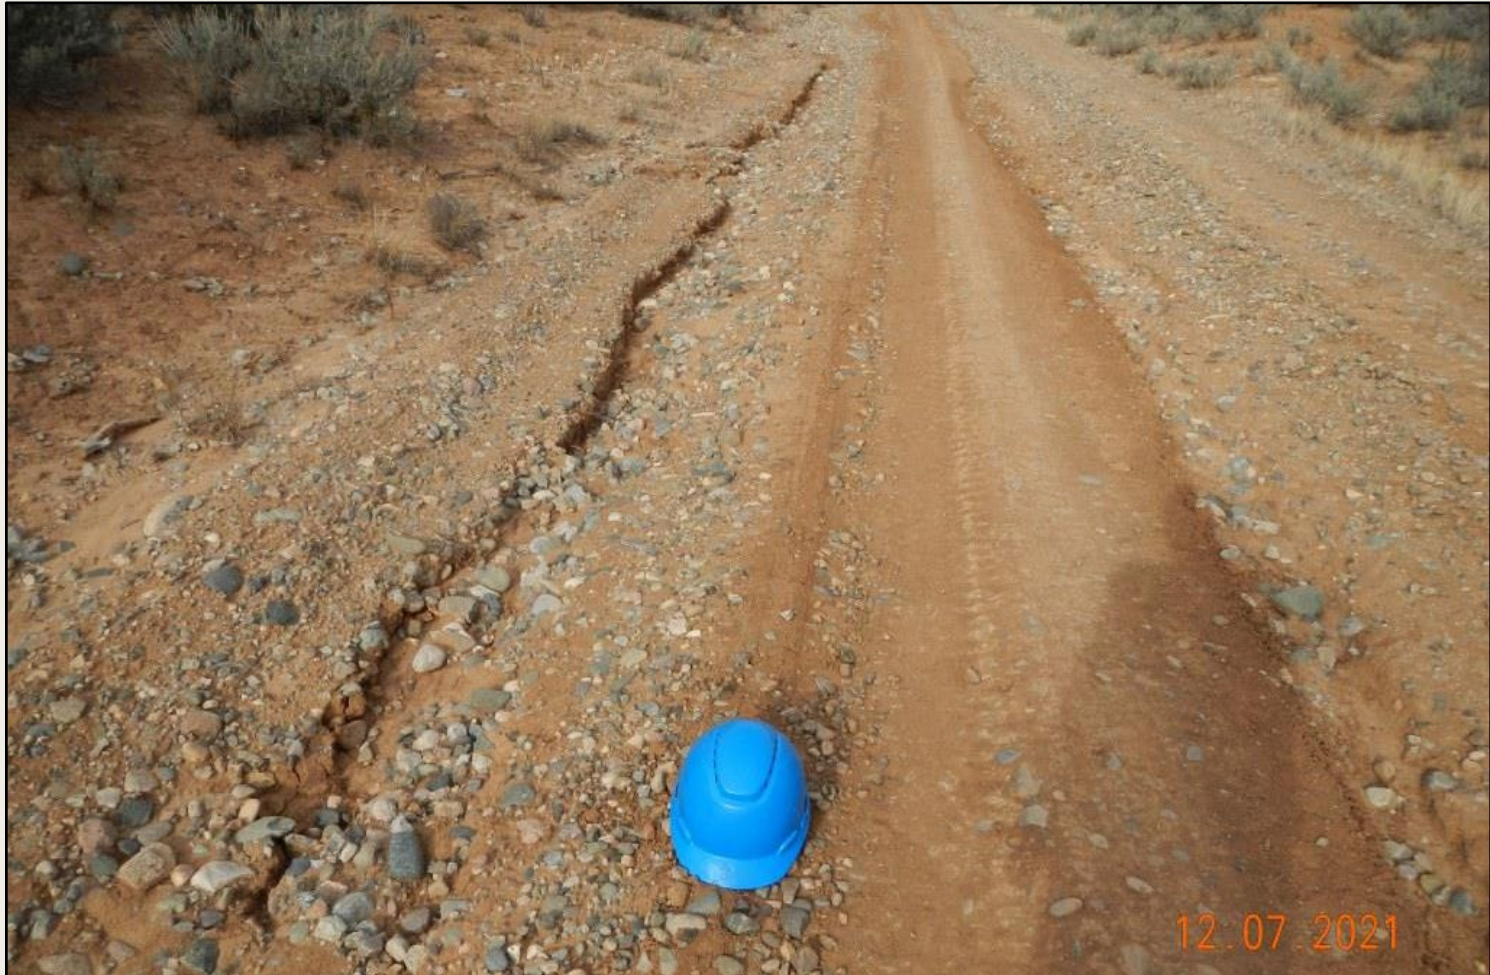
Photo 4. View of erosional channeling occurring on the access road, approximately 6-12 inches wide and deep. Road needs long-term stabilization. Hard hat in place for scale.

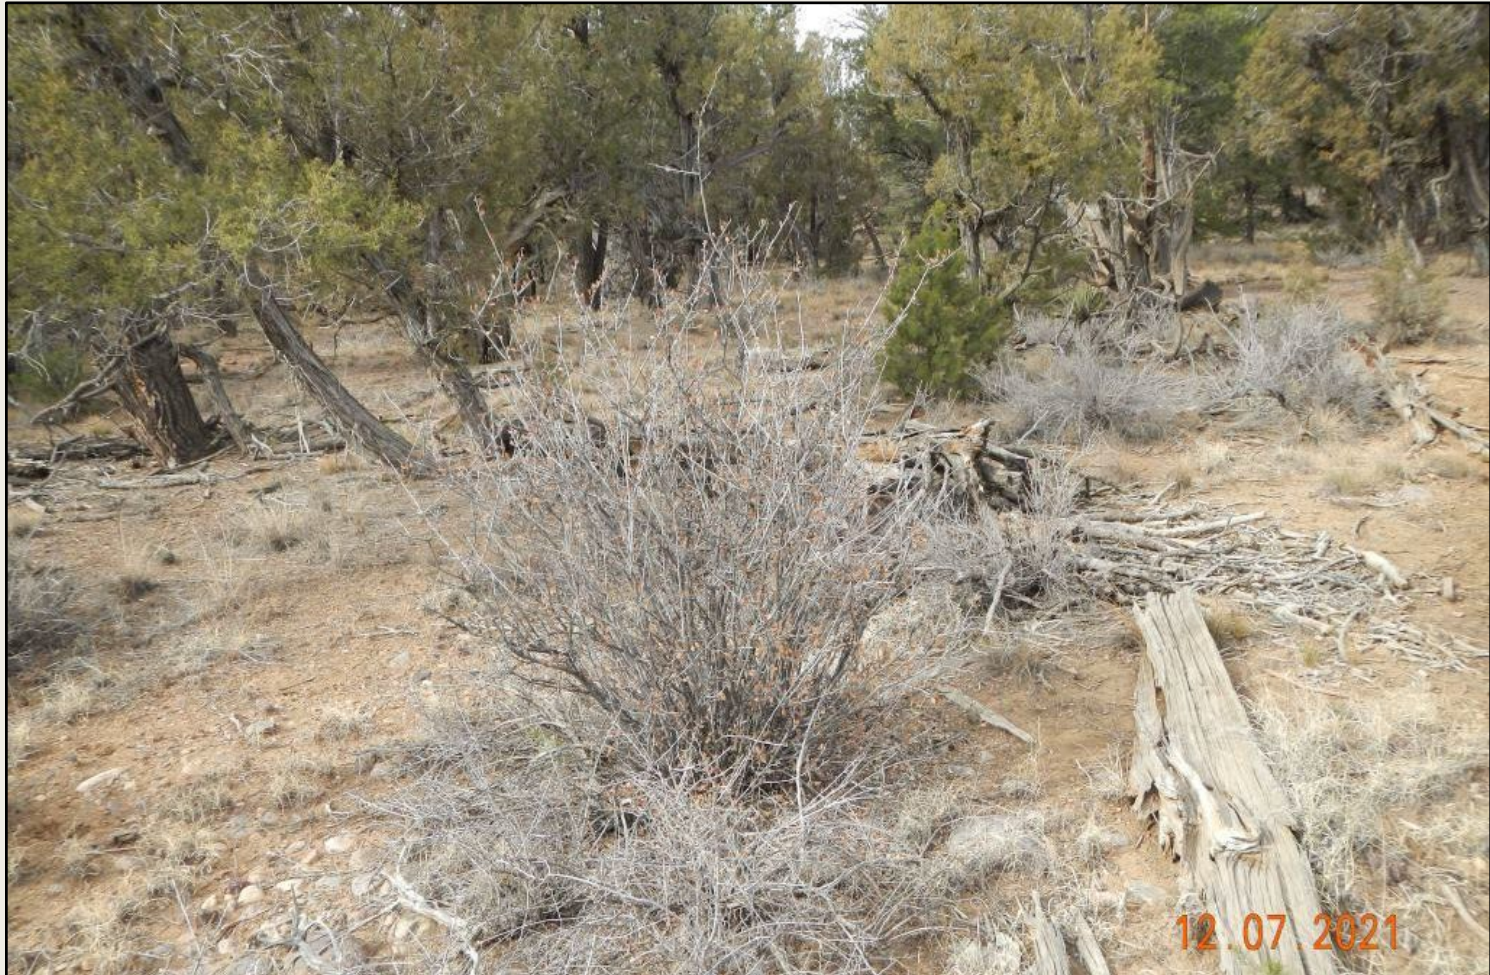
Photo 5. View of reference area comprised of pinyon and juniper woodland with gambel oak, mountain mahogany, Indian ricegrass, and threadleaf sunflower.
