Inspection Photos

12/07/2021

Operator: TEP ROCKY MOUNTAIN LLC #96850

Location ID: 452566

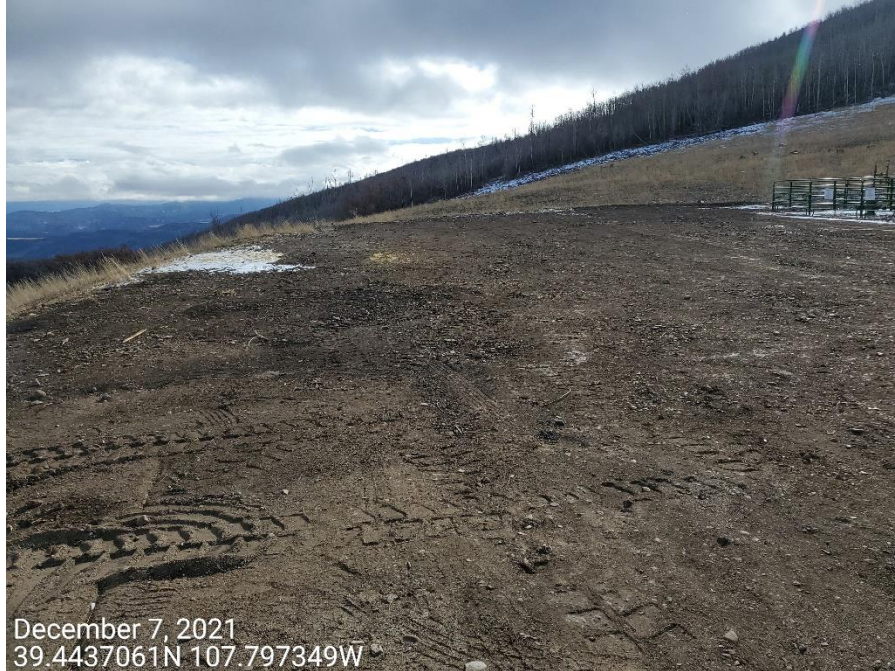
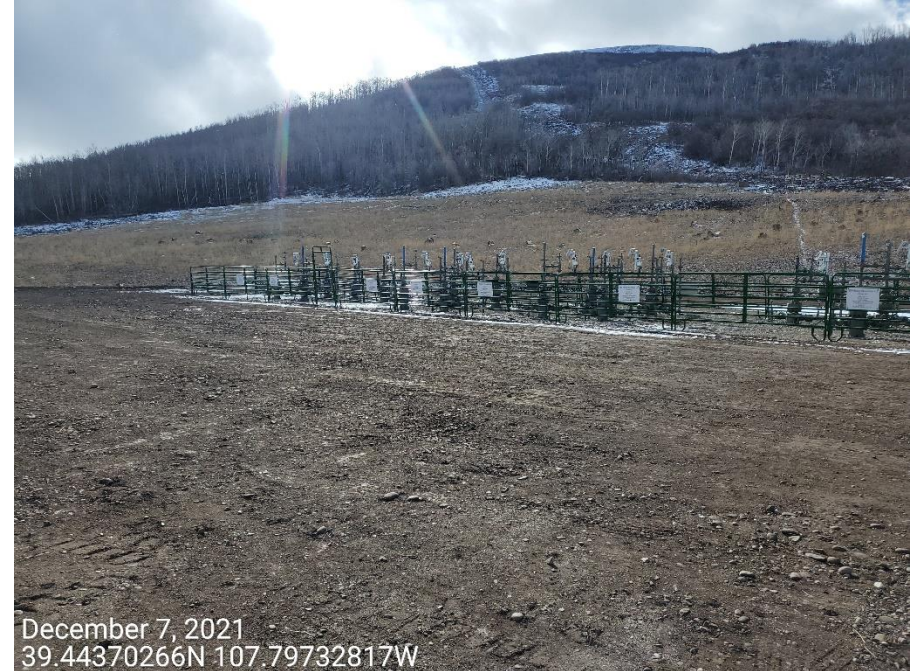
Photo 1: Photos 1-2 provide an overview of the Location from east, southeast, southwest to west.

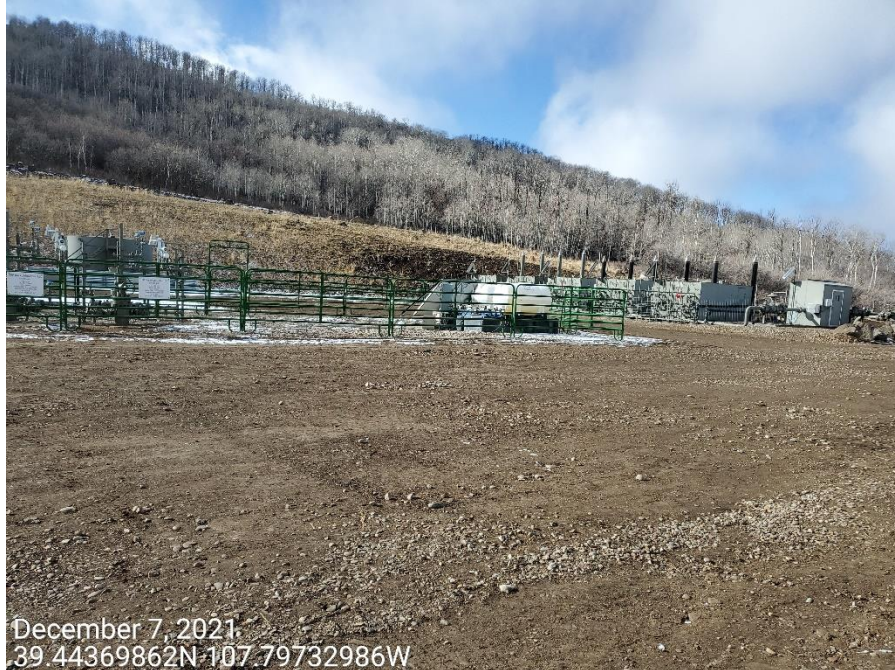
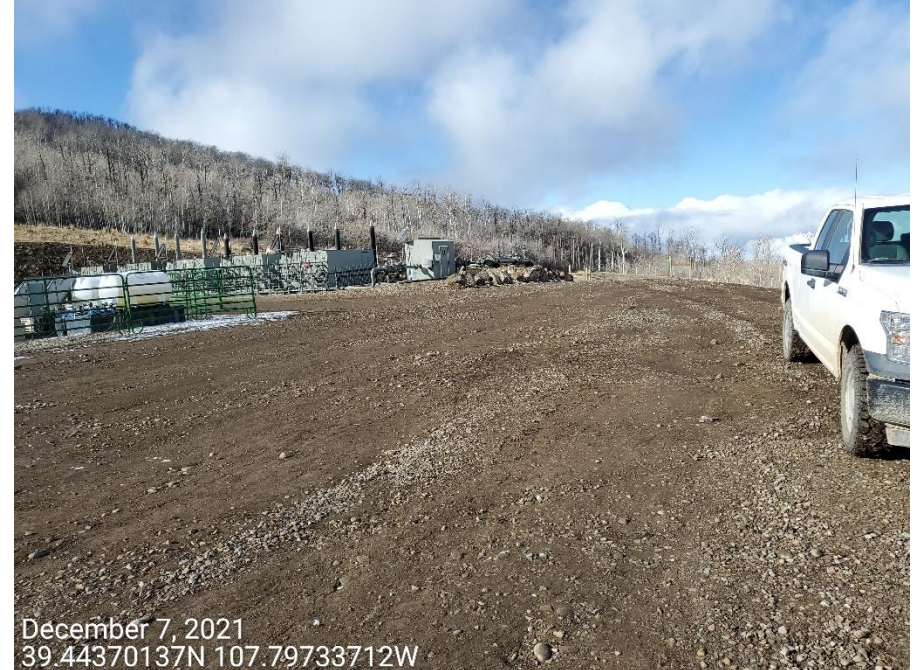
Photo 2: Photos 1-2 provide an overview of the Location from east, southeast, southwest to west.

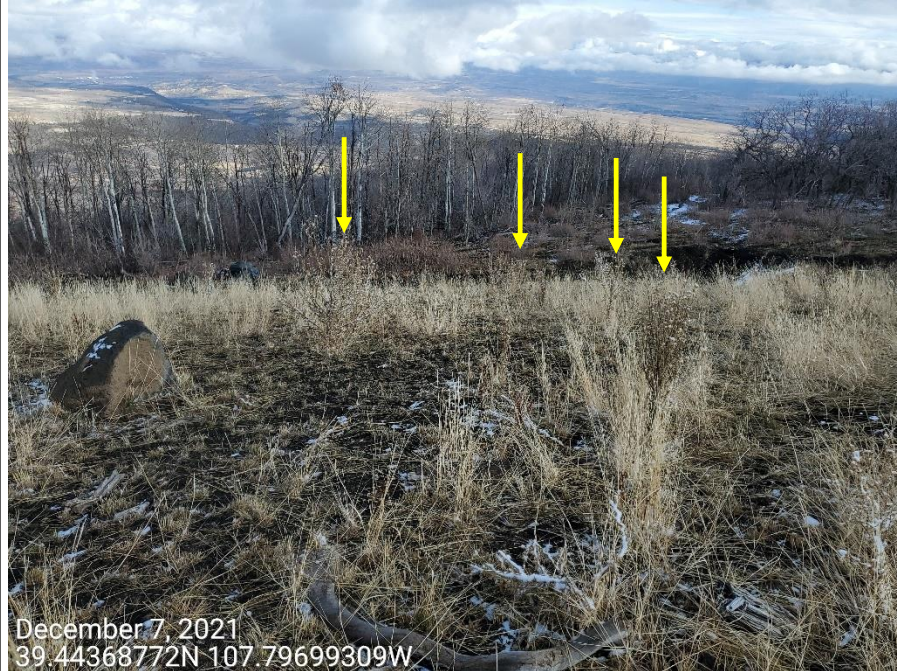
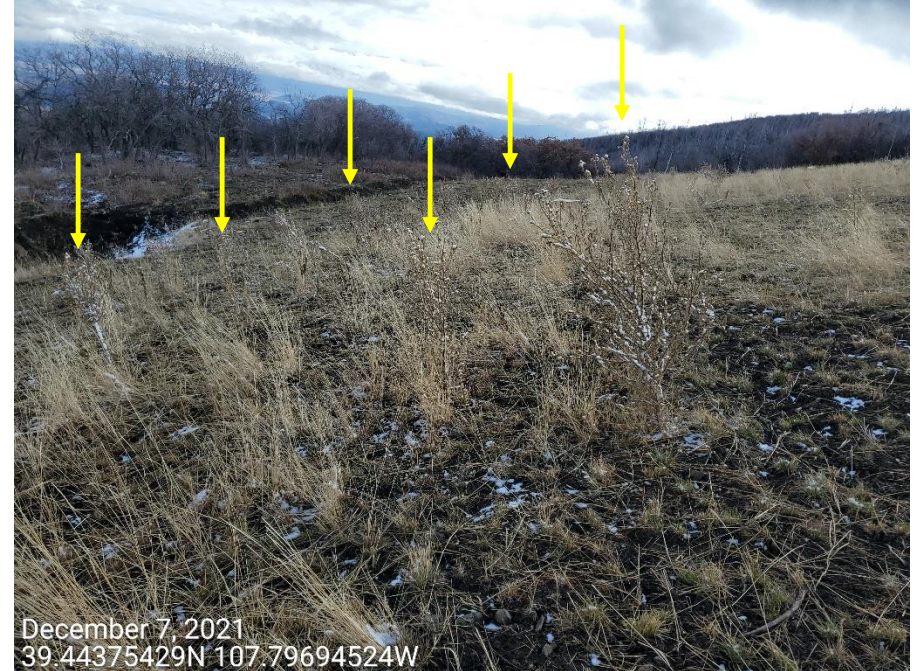
Photo 3: Photo provides example of noxious weeds (plumeless thistle) observed established on the interim areas of the Location.

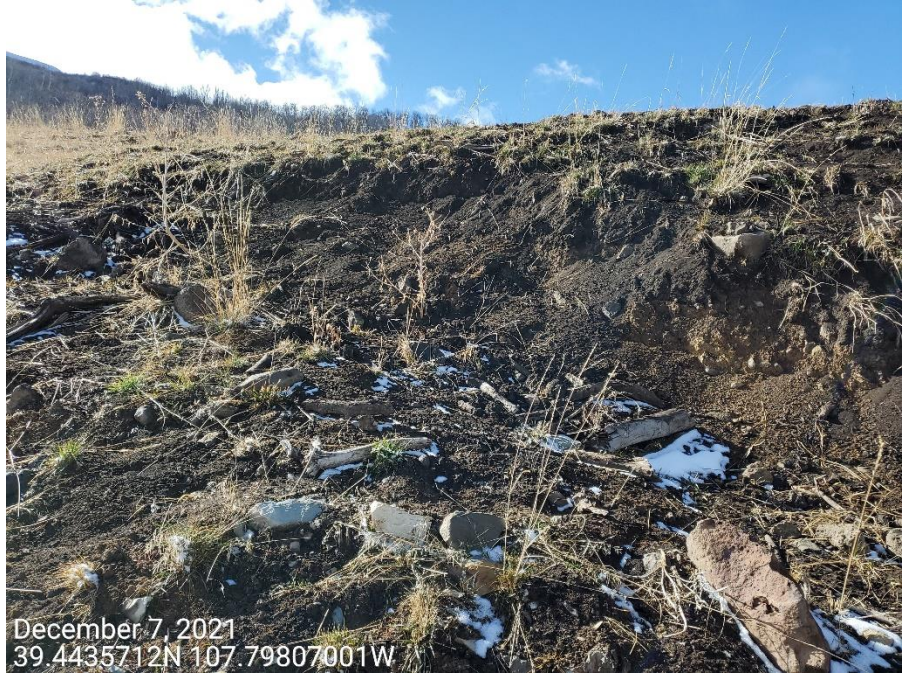
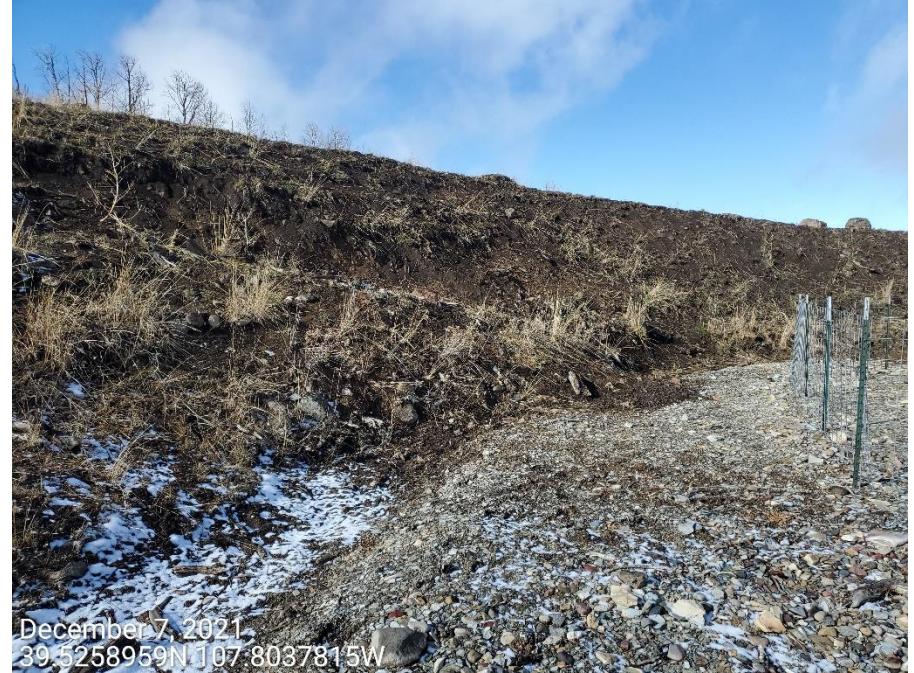
Photo 4: Photos examples showing control measures to protect and stabilize the cut slopes of the Location are missing or insufficient; erosion degradation evident.

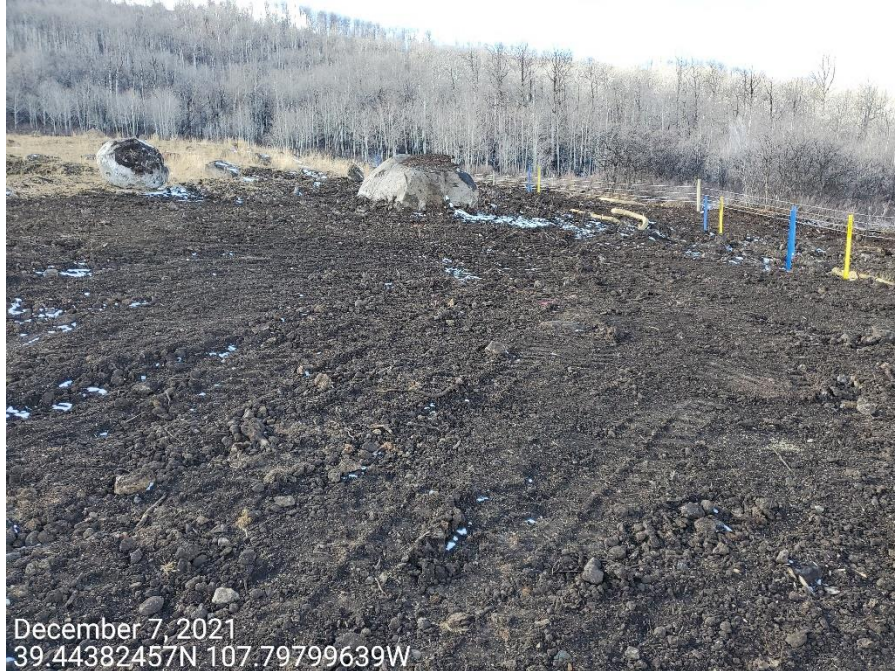
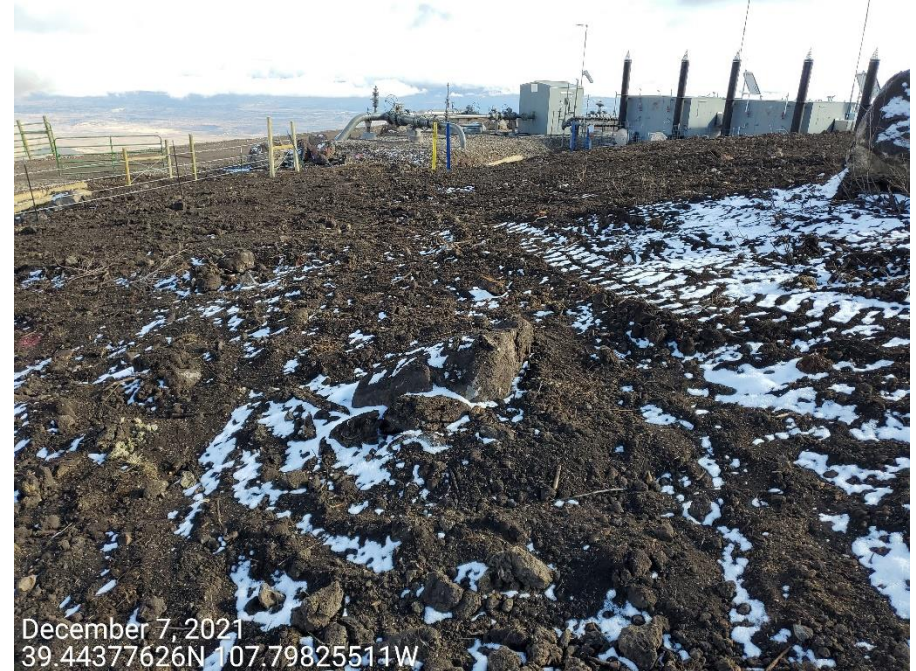
Photo 5: Photos examples showing the recently disturbed areas along the west end of the Location; re-seeding evident. Photos show stormwater and erosion control measures to stabilize soils are missing or insufficient.

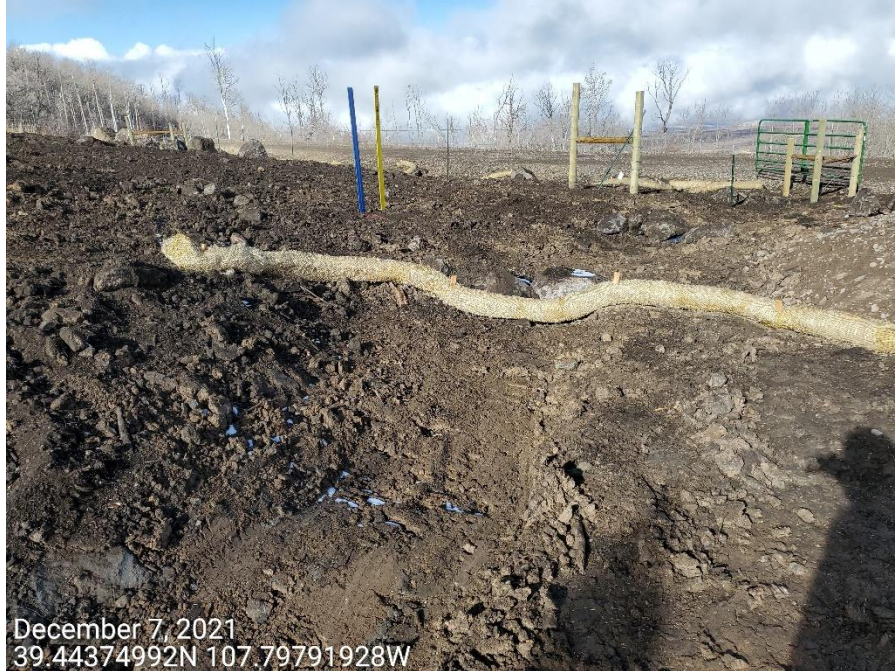
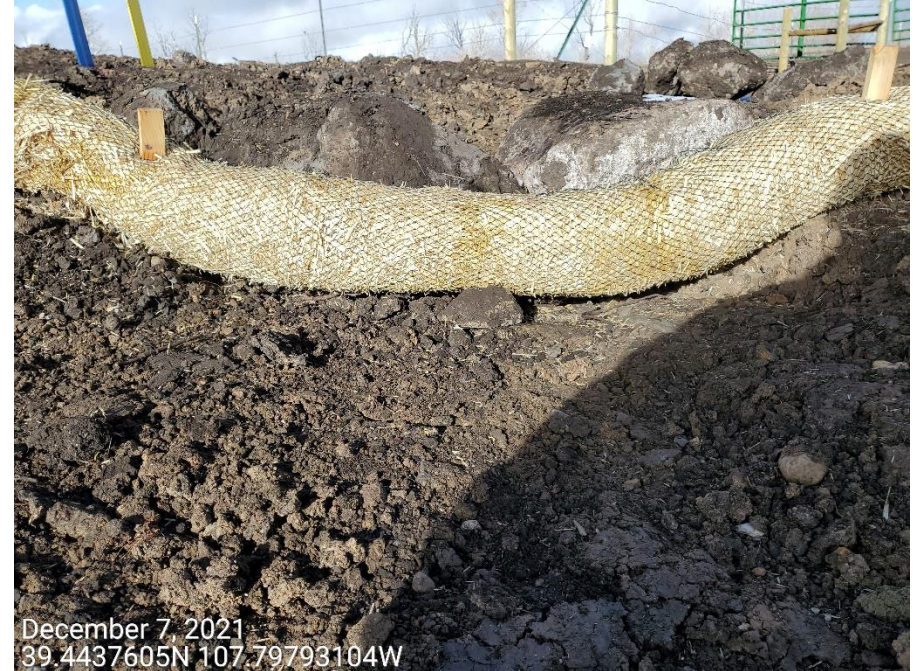
Photo 6: Photos provide example of straw wattles observed implemented on the west end of the Location. Photos show wattles have not been installed per good engineering practices; wattles have been placed/staked upon the surface, and have not been trenched and backfilled.

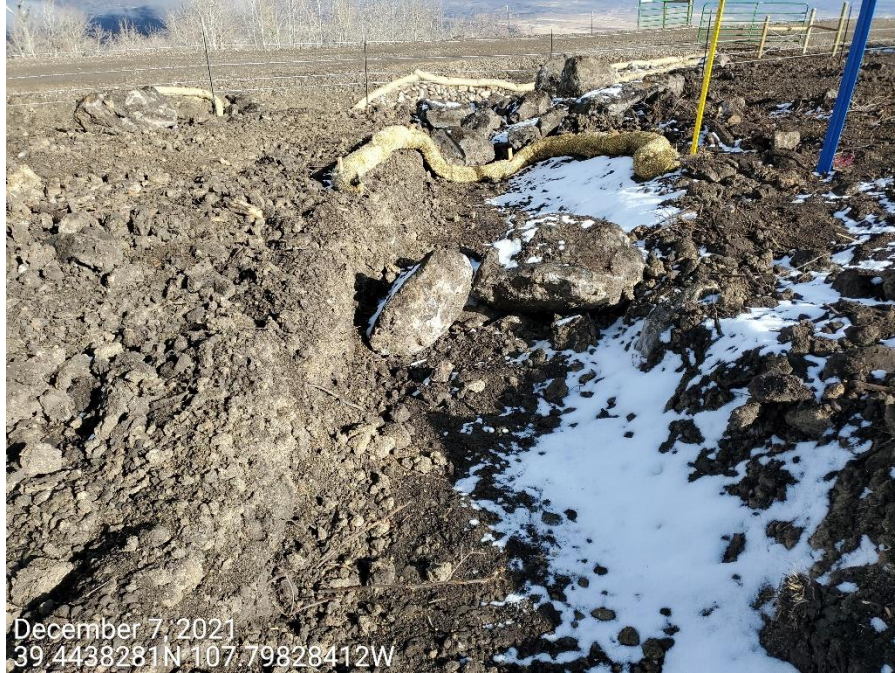
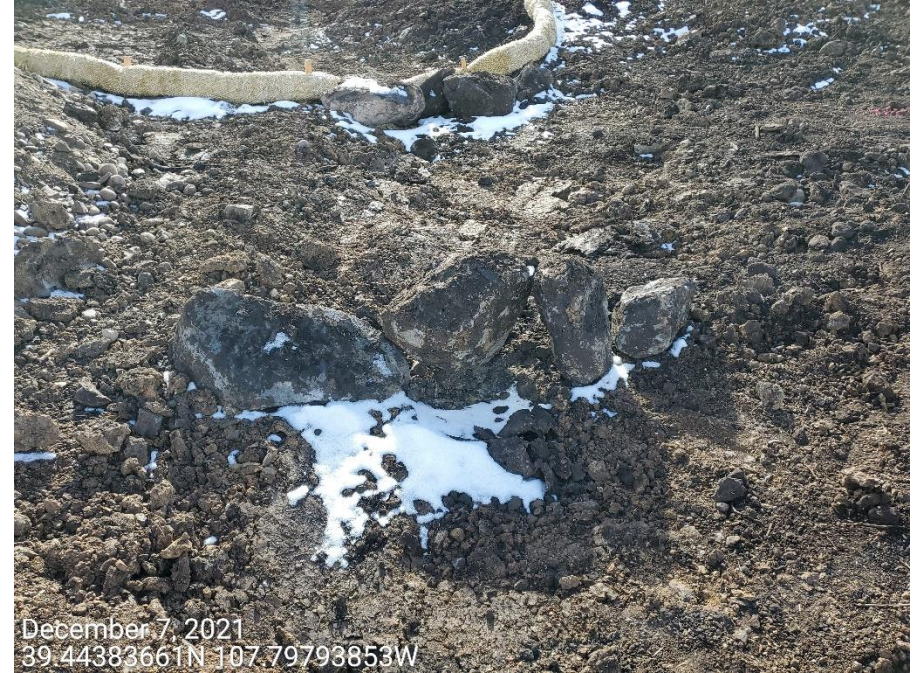
Photo 7: Photos provide example of rock checks / velocity checks observed implemented within the ditch and other areas on the west end of the Location. Rock checks have been constructed with inappropriately sized material, and in such a manner that will facilitate stormwater erosion degradation.

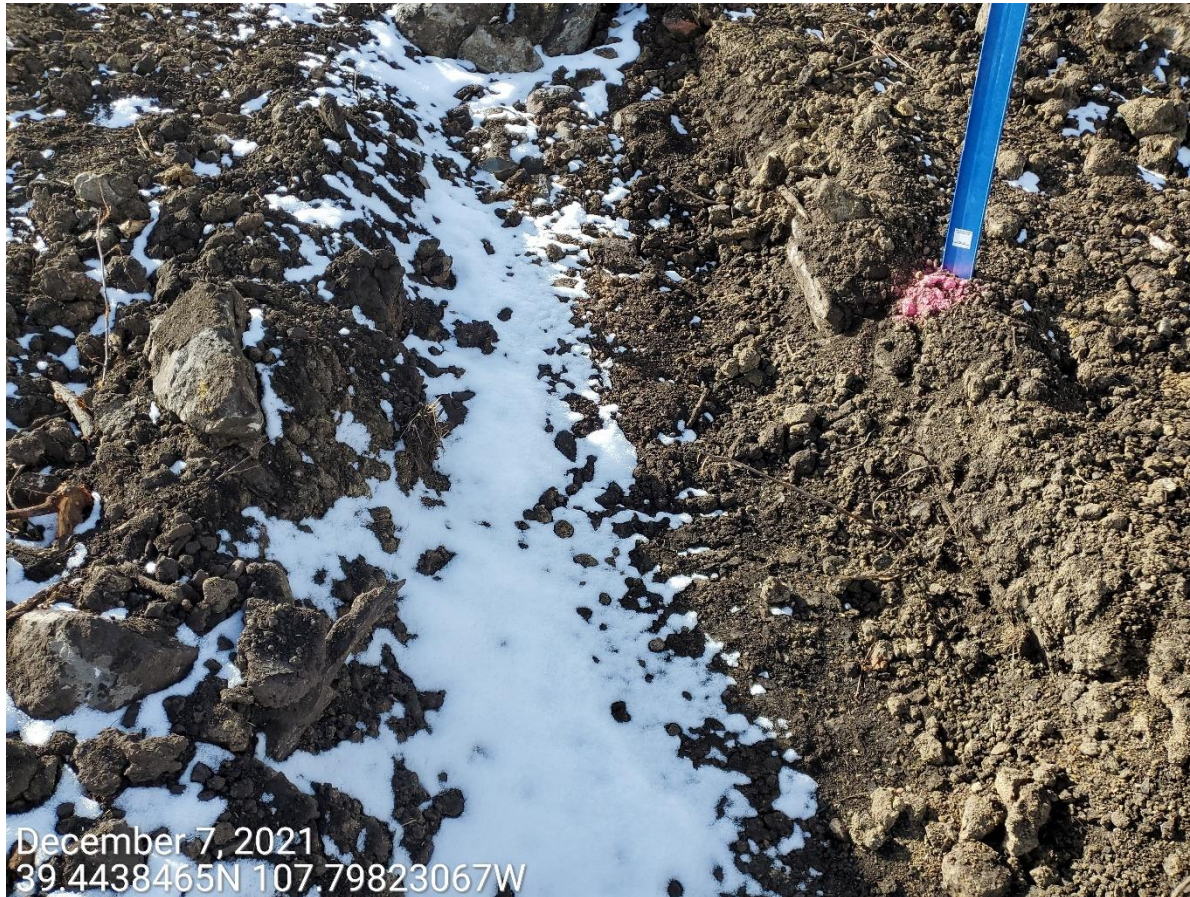
Photo 8: Photo taken from the stormwater diversion ditch on the west end of the Location. Photo shows soils within ditch have not been consolidated in accordance with good engineering practice; soils within ditch are loose, and are considered a pollutant source.

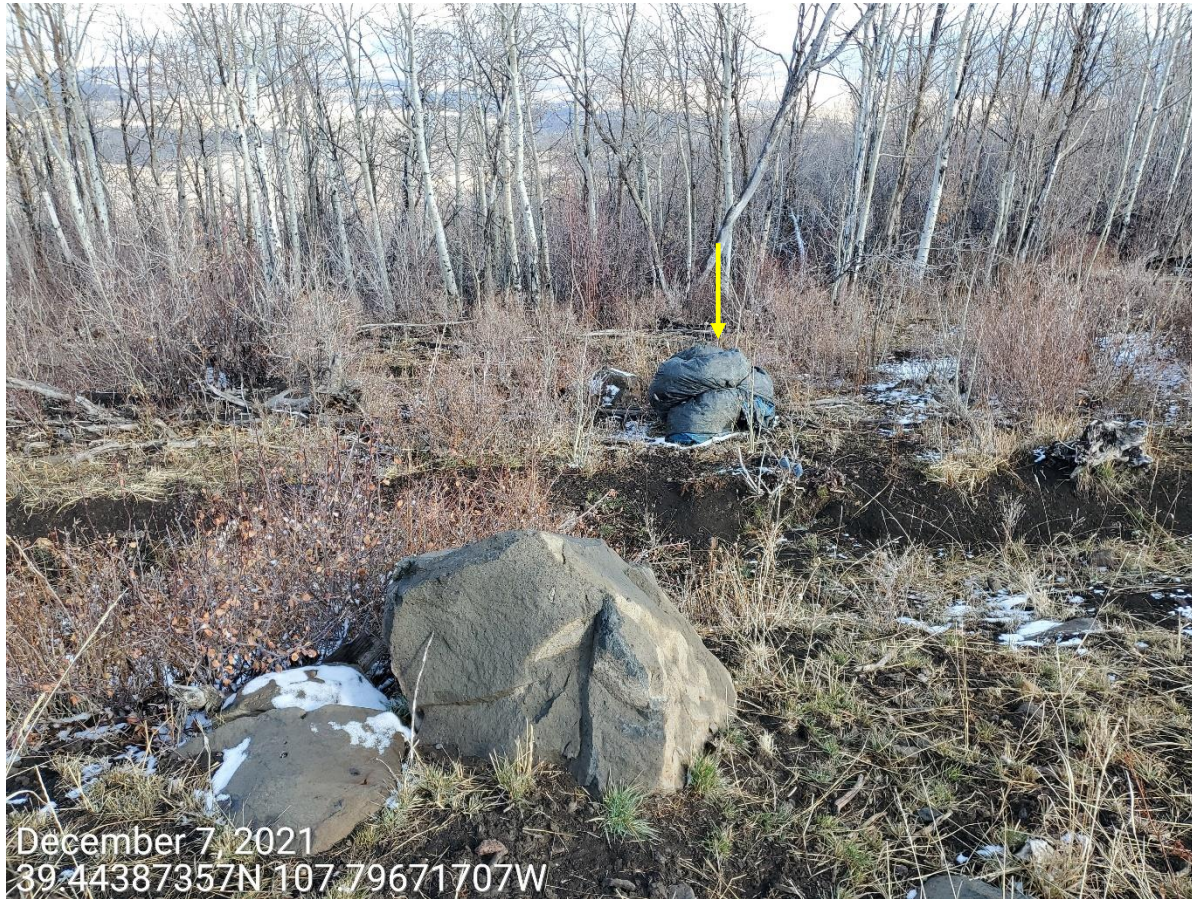
Photo 9: Photo shows what appears to be a bundle of tarp material stored on the northern interim areas of the Location.

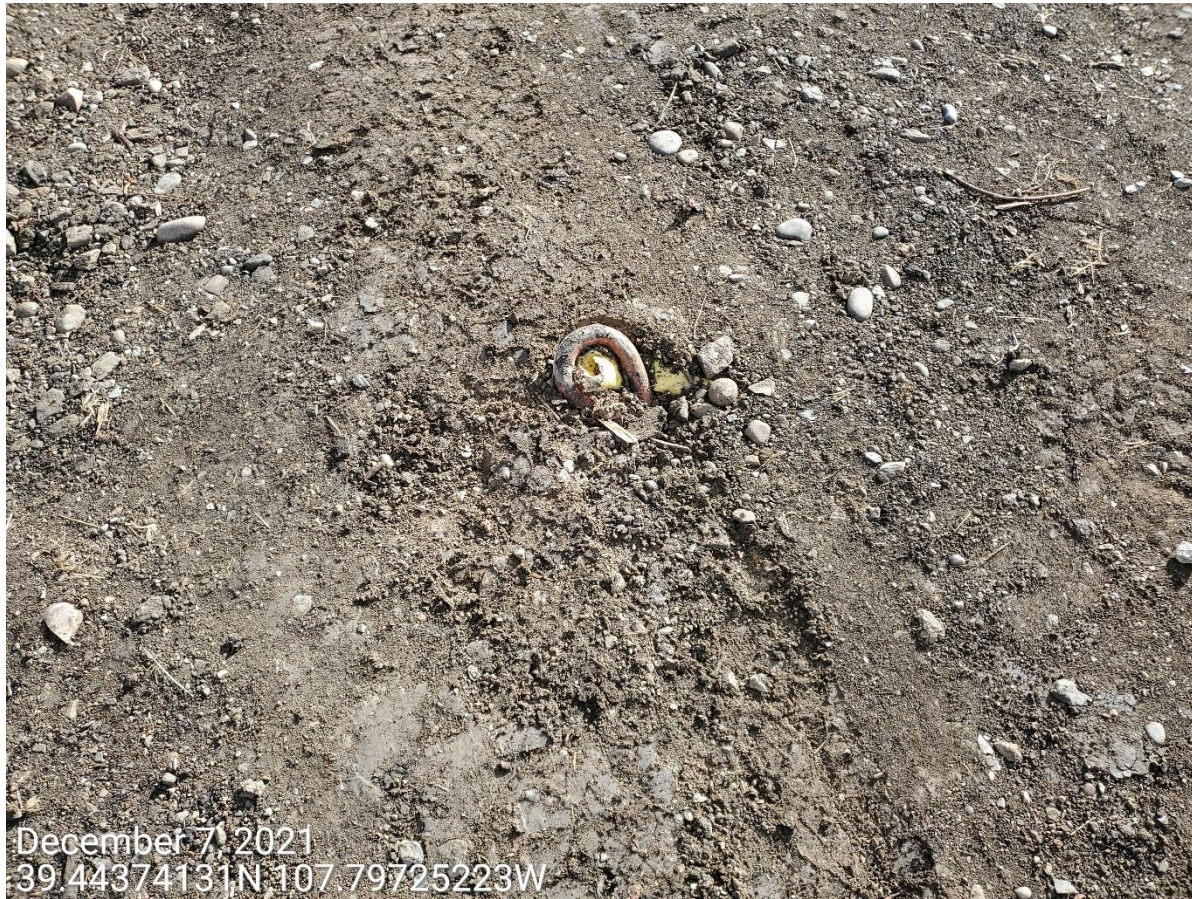
Photo 10: Photo example of anchor observed on the Location without proper marking.
