**Inspection Photos**  
**Location Name: Herring Draw 1-9**  
**Location ID: 392134**

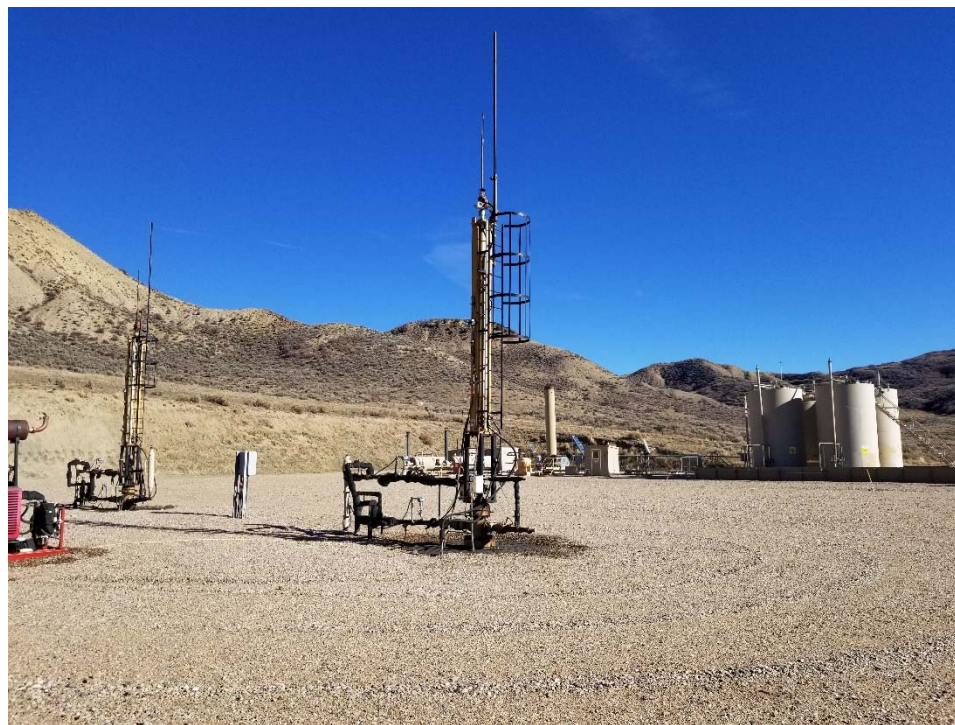
**Photo 1. Overview of location taken facing northeast.  
Stained soil at wellhead.**
