Inspection Photos
Location Name: Kuipers 1
Location ID: 324629

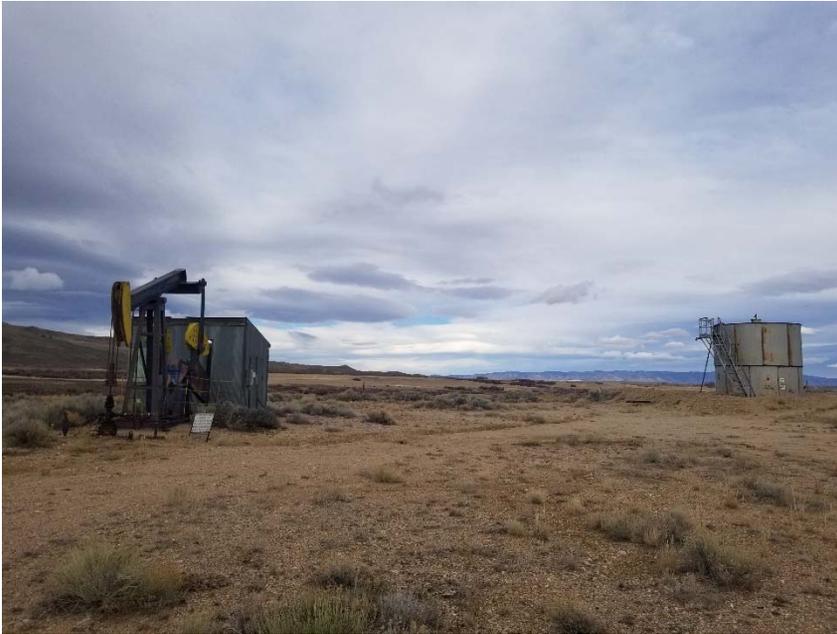
Photo 1. Overview of location taken facing northeast.

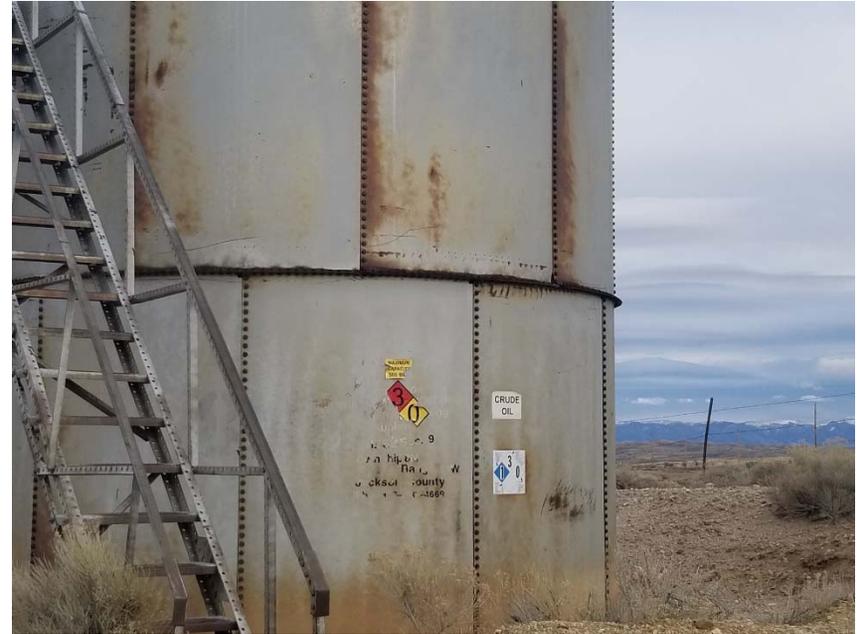
Photo 2. Tank labels faded and peeling.

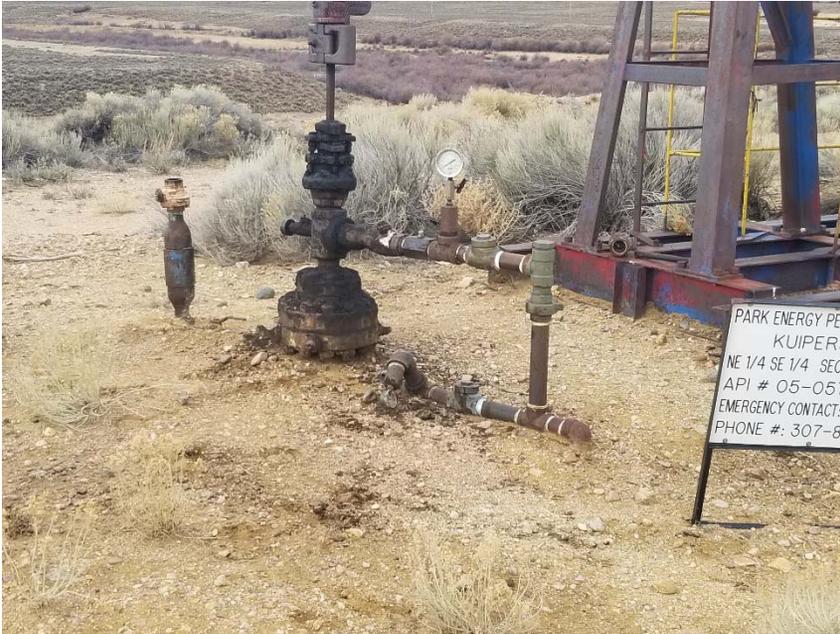
Photo 3. Stained soil at wellhead.

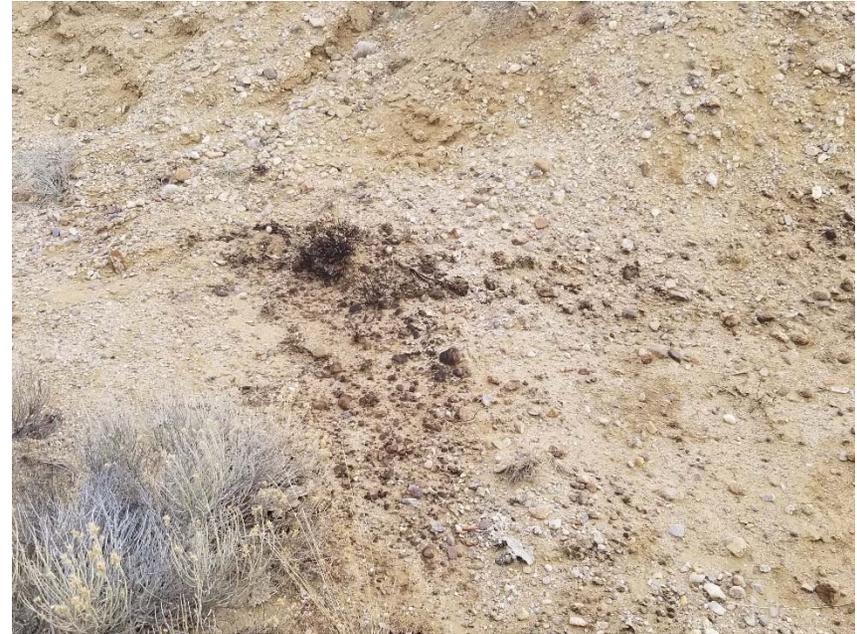
Photo 4. Stained soil on location.

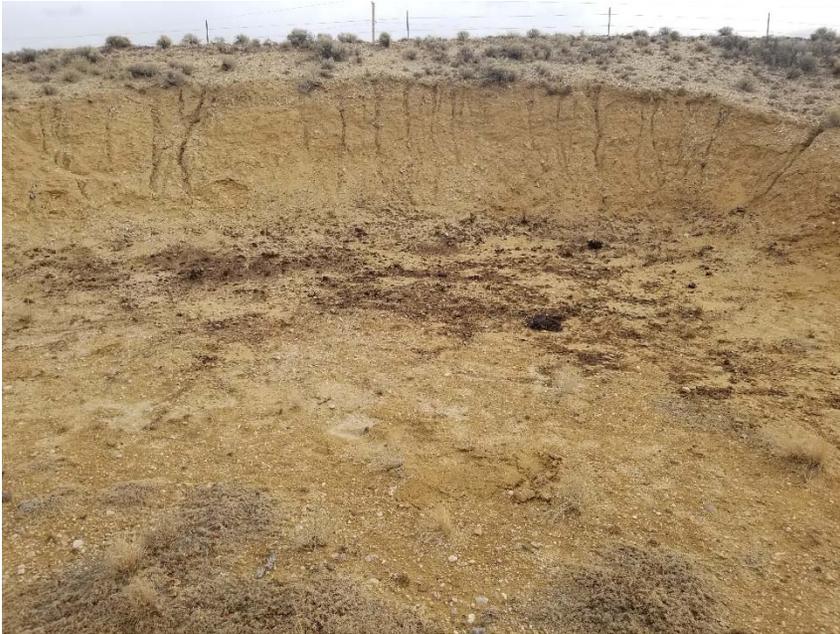
Photo 5. Stained soil on location.

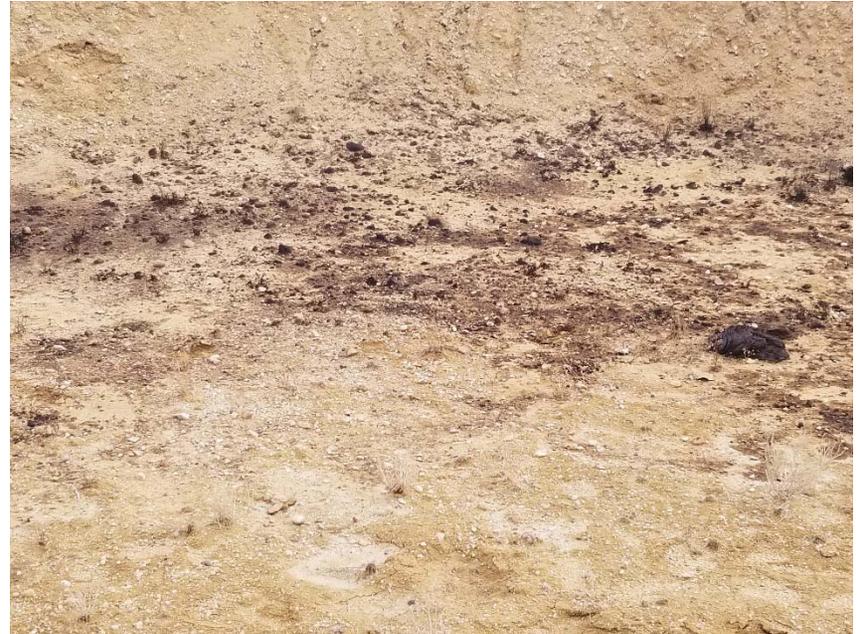
Photo 6. Stained soil on location. Close up of photo 5.
