# Inspection Photos

API: 071-08723

Operator: EVERGREEN NATURAL RESOURCES

Inspection Date: 12/9/2021

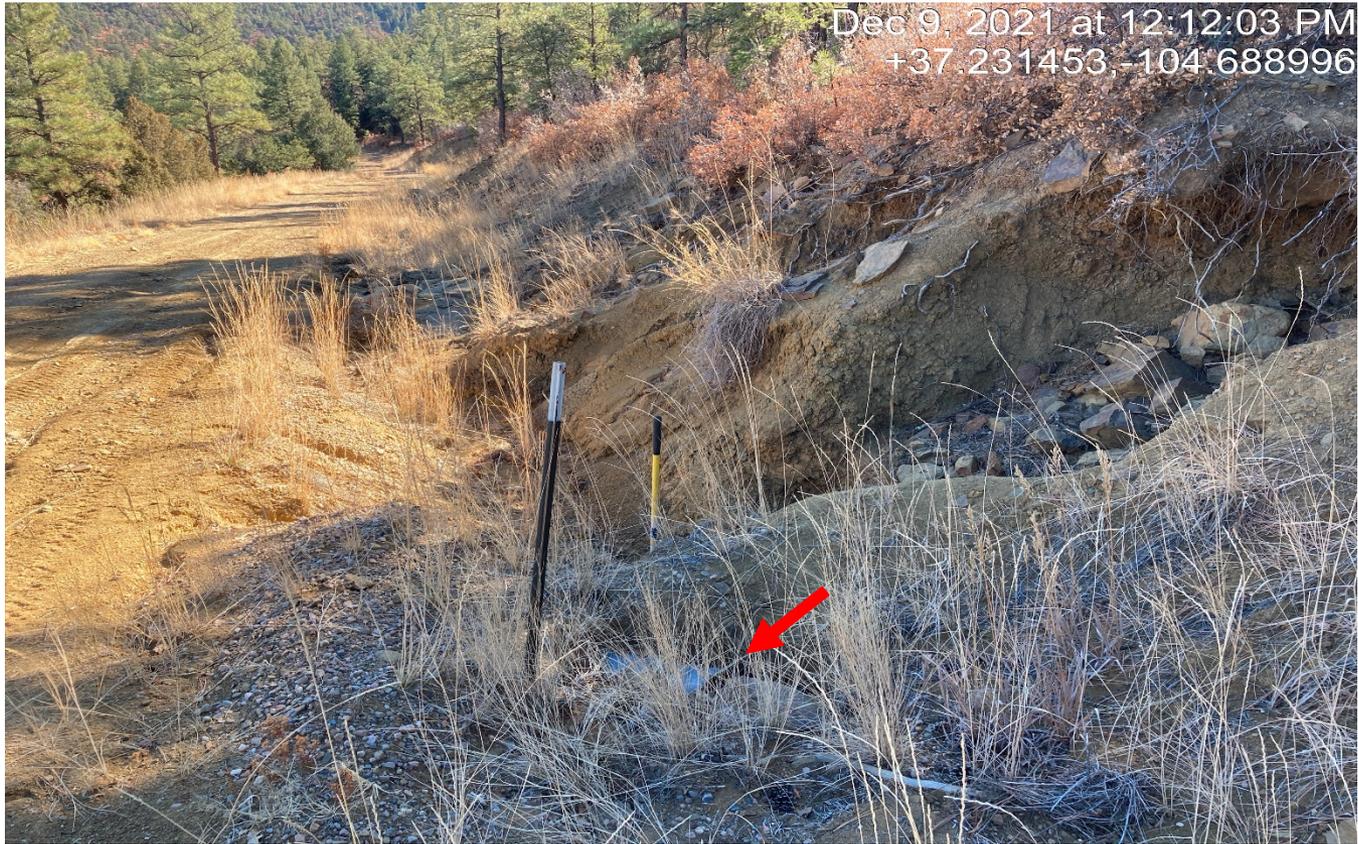
**Photo 1.** Facing southeast along the access road. There is an erosion gully along the road side. The culvert at red arrow is filled in with sediment and the erosion gully was measured to be 4.5 ft. deep. Previous corrective action was not performed.

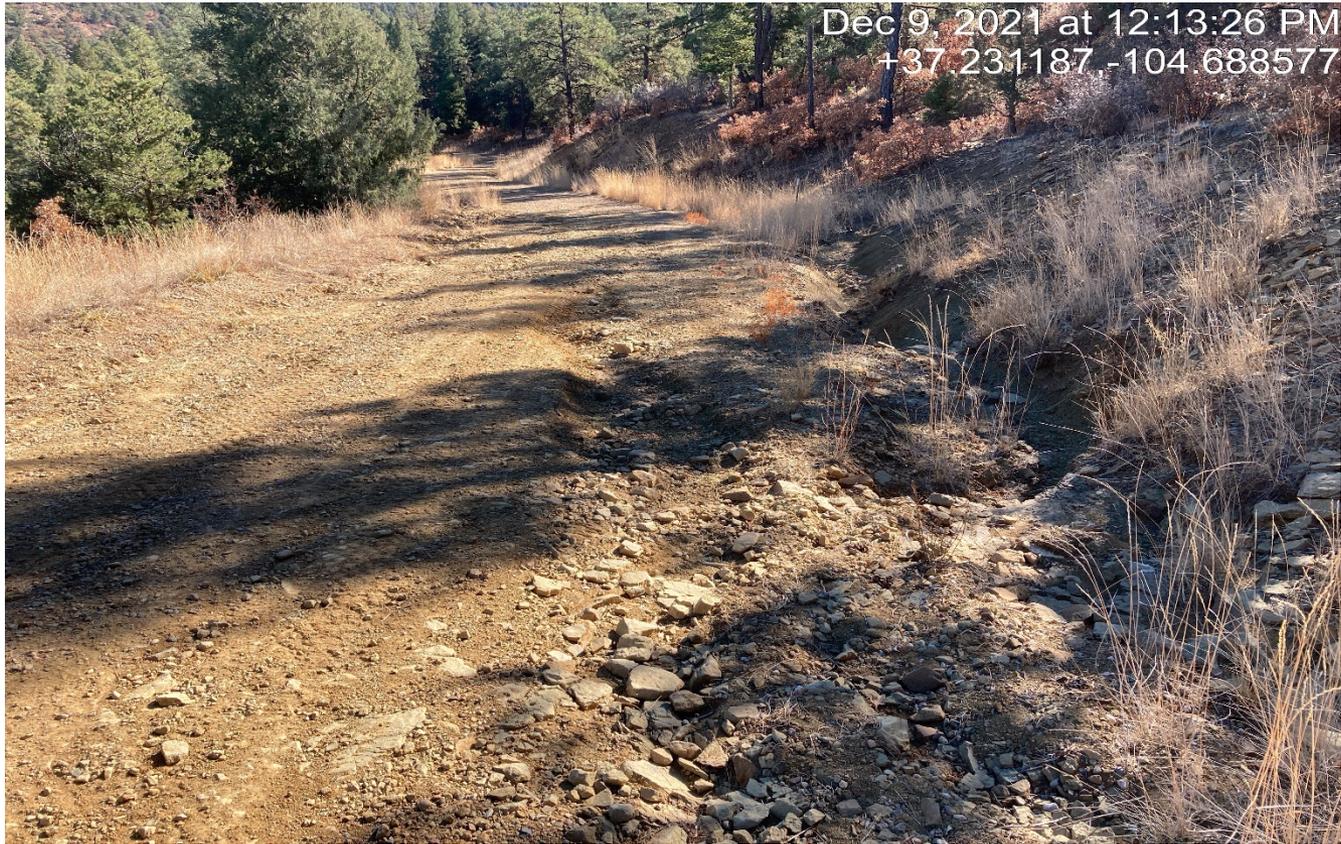
**Photo 2.** Facing southeast further down the road. There is erosion along the road that needs to be repaired and stabilized.

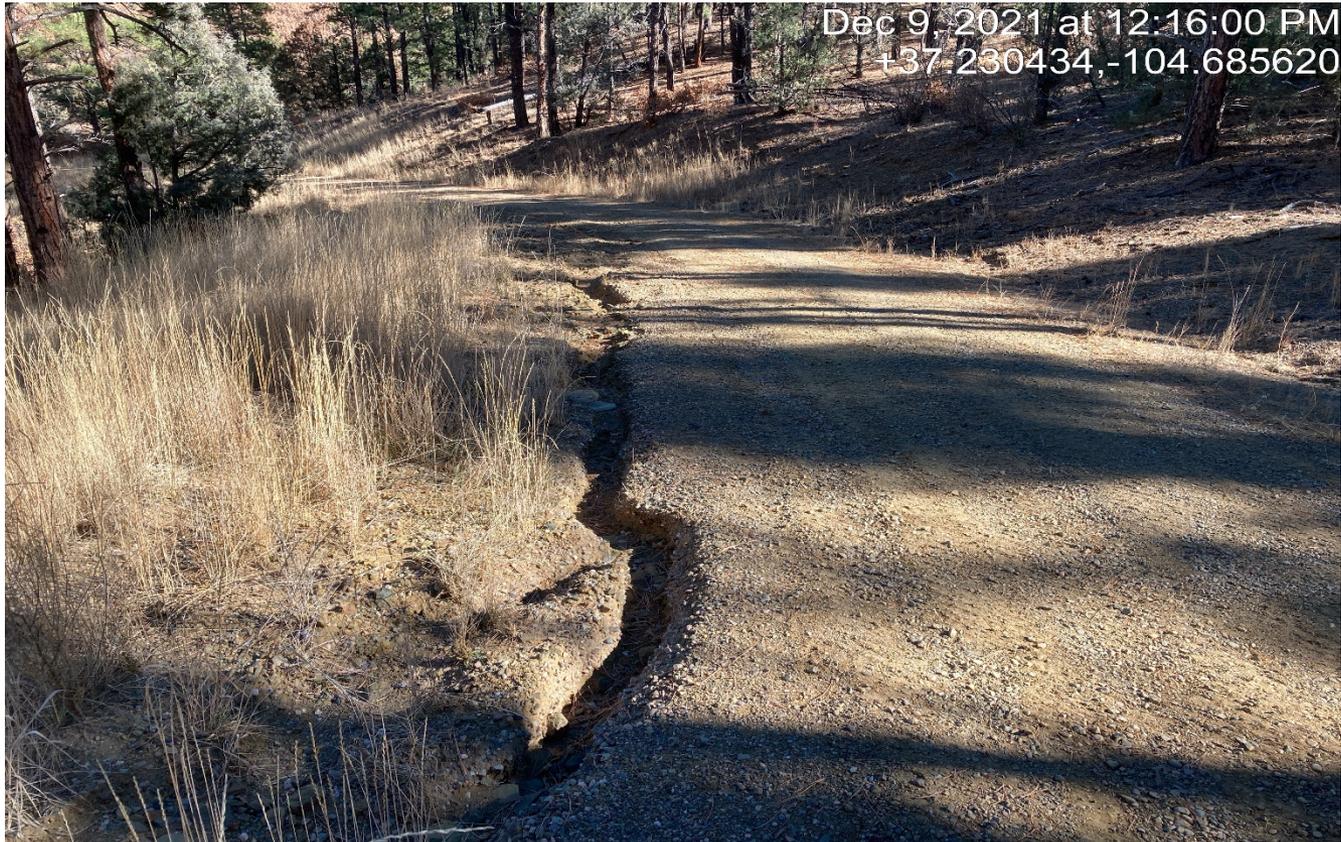
**Photo 3.** Stormwater is not properly diverted causing erosion of the road.

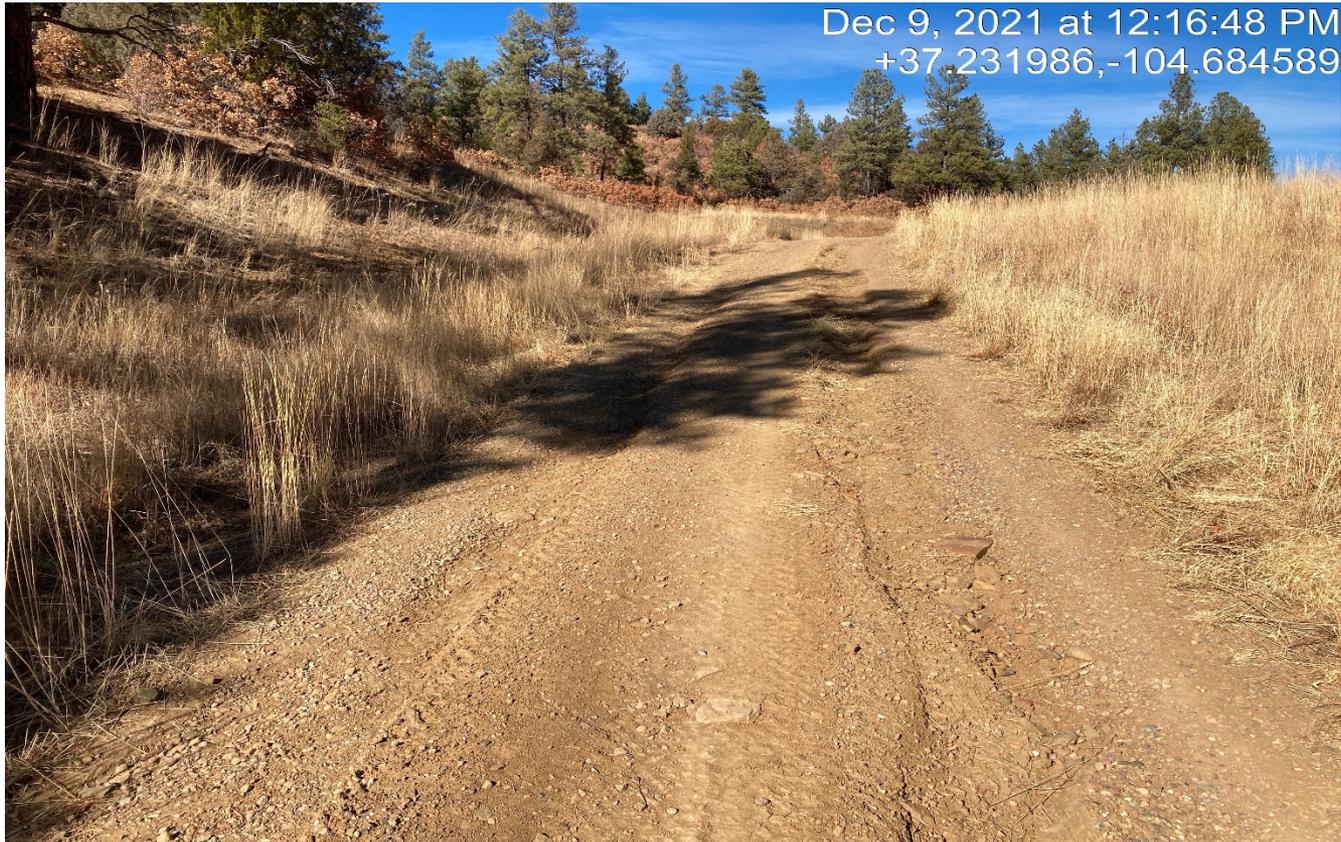
**Photo 4.** Facing north near the location. There is erosion along the road coming from the location.
