Inspection Photos

Loc ID: 334233

Operator: EVERGREEN NATURAL RESOURCES

Inspection Date: 12/9/2021

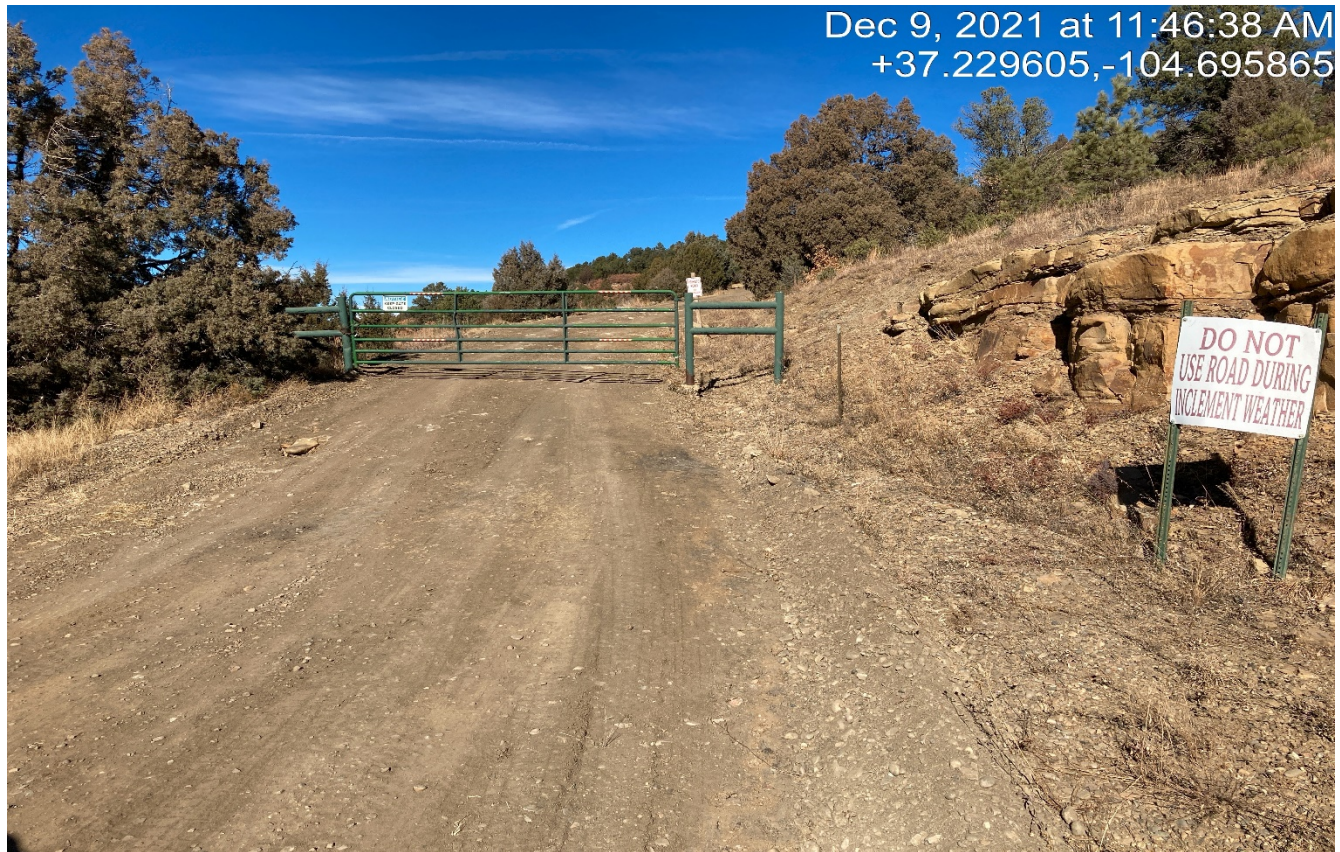
Photo 1. Facing northeast at the beginning of the access road.

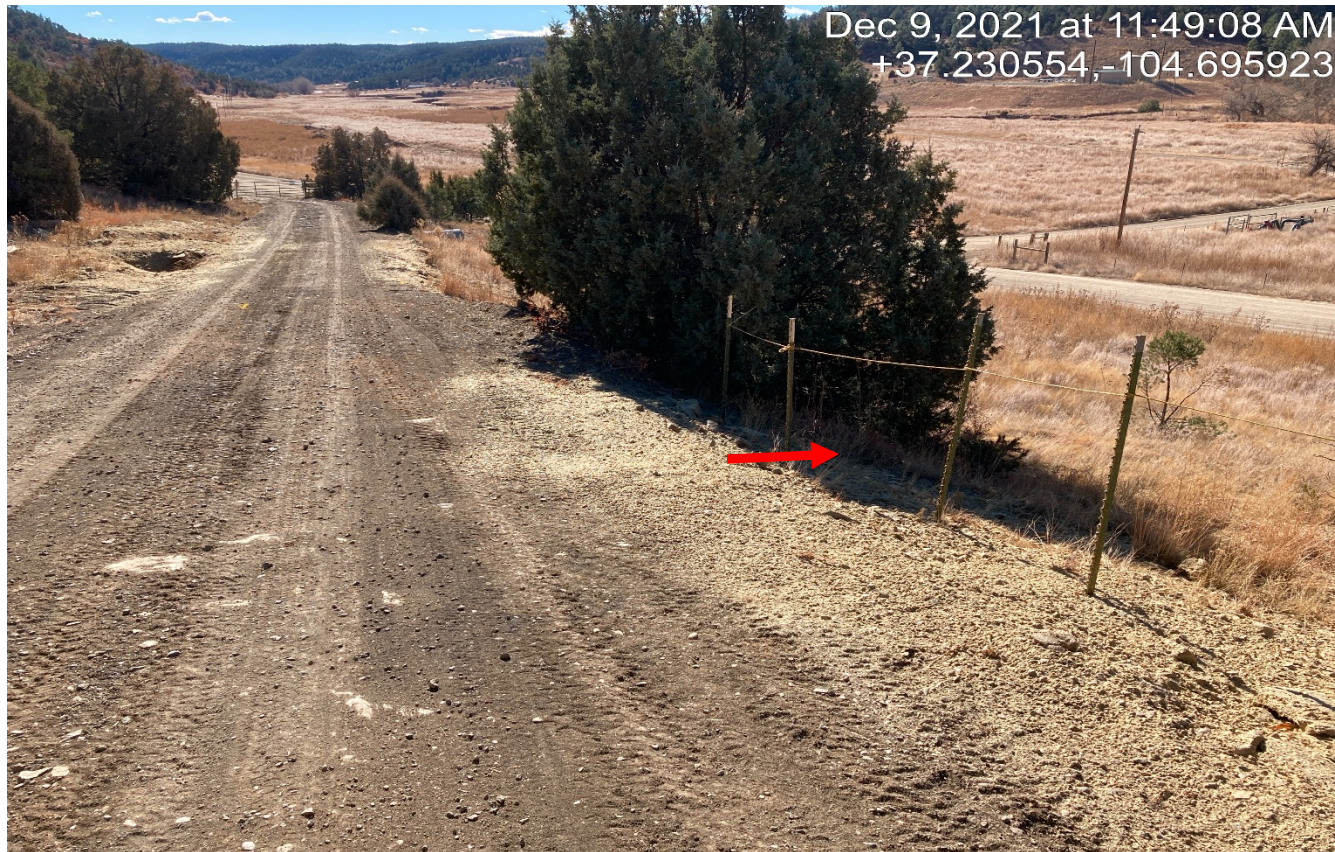
Photo 2. Facing south down the access road near county road 51. Red arrow points to where vehicle had driven off the designated road. This area down to the gate has not been restricted to prevent access by fence installation.

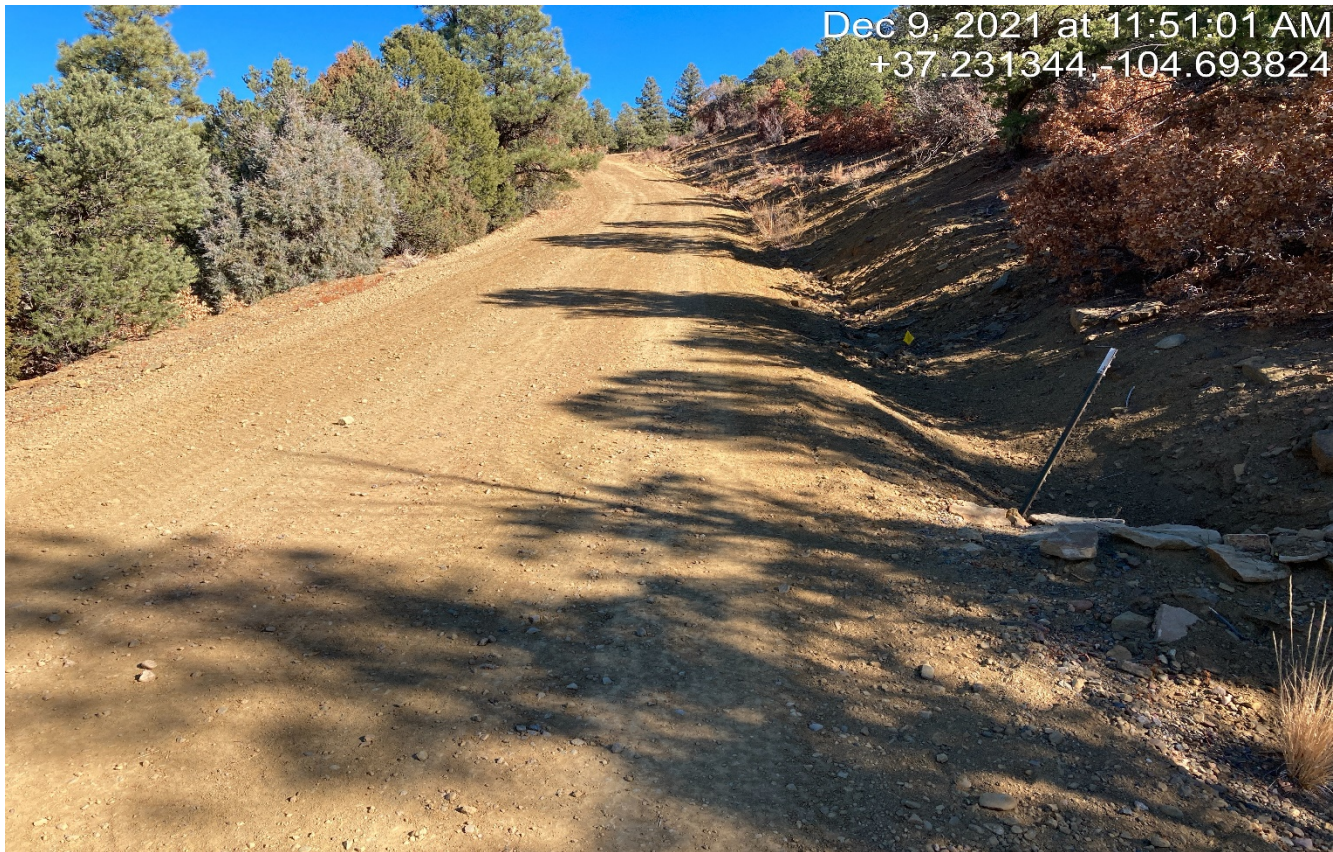
Photo 3. Facing northeast along the steep road. The road was graded however loose soils are susceptible to erosion.

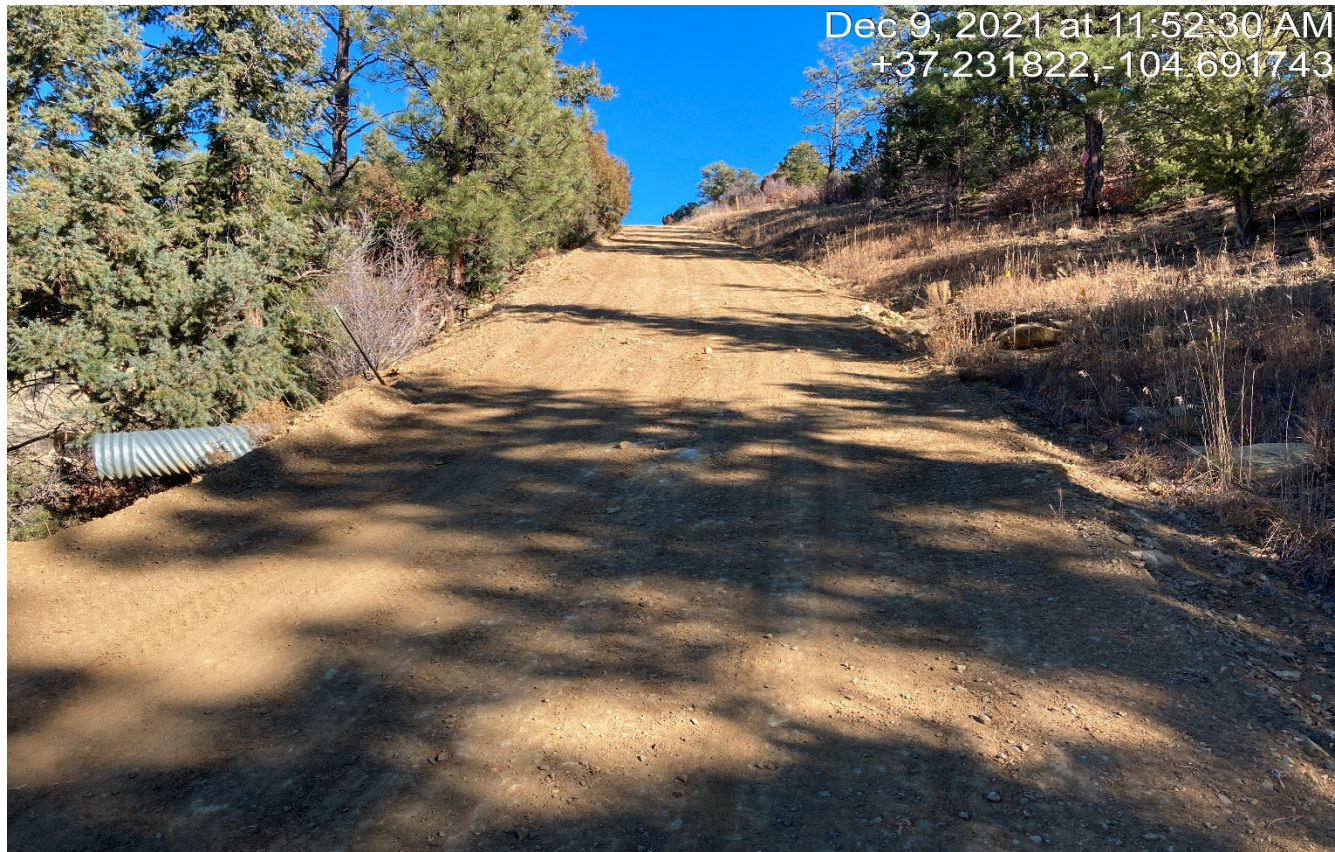
Photo 4. Facing northeast along the steep road. The road was graded however loose soils are susceptible to erosion.

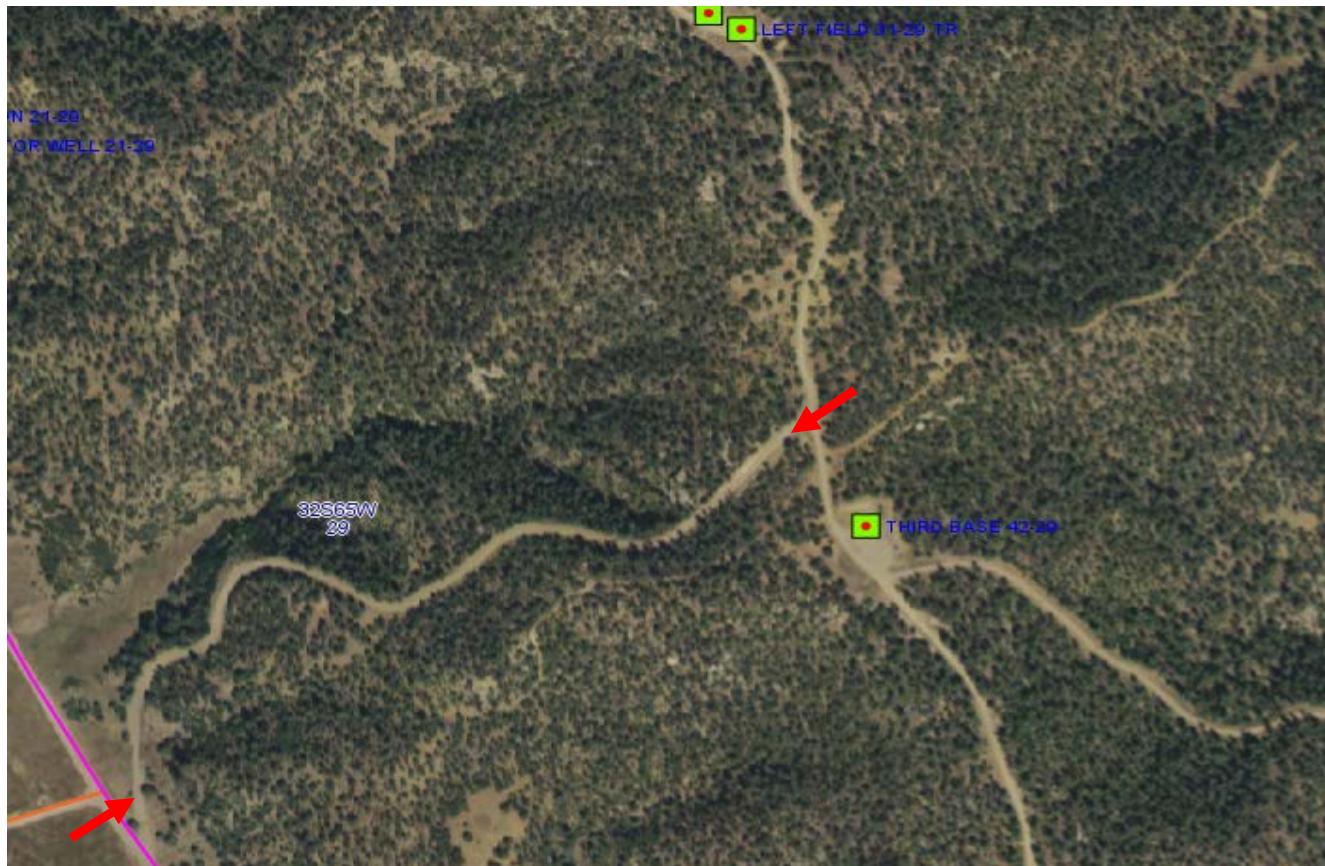
Photo 5. View of the aerial map between the two red arrows is the road shown in photos 1 thru 4. This road is steep and not stabilized as shown in the photos. This section of the road is not necessary for production of the well and needs to be recontoured and reclaimed.

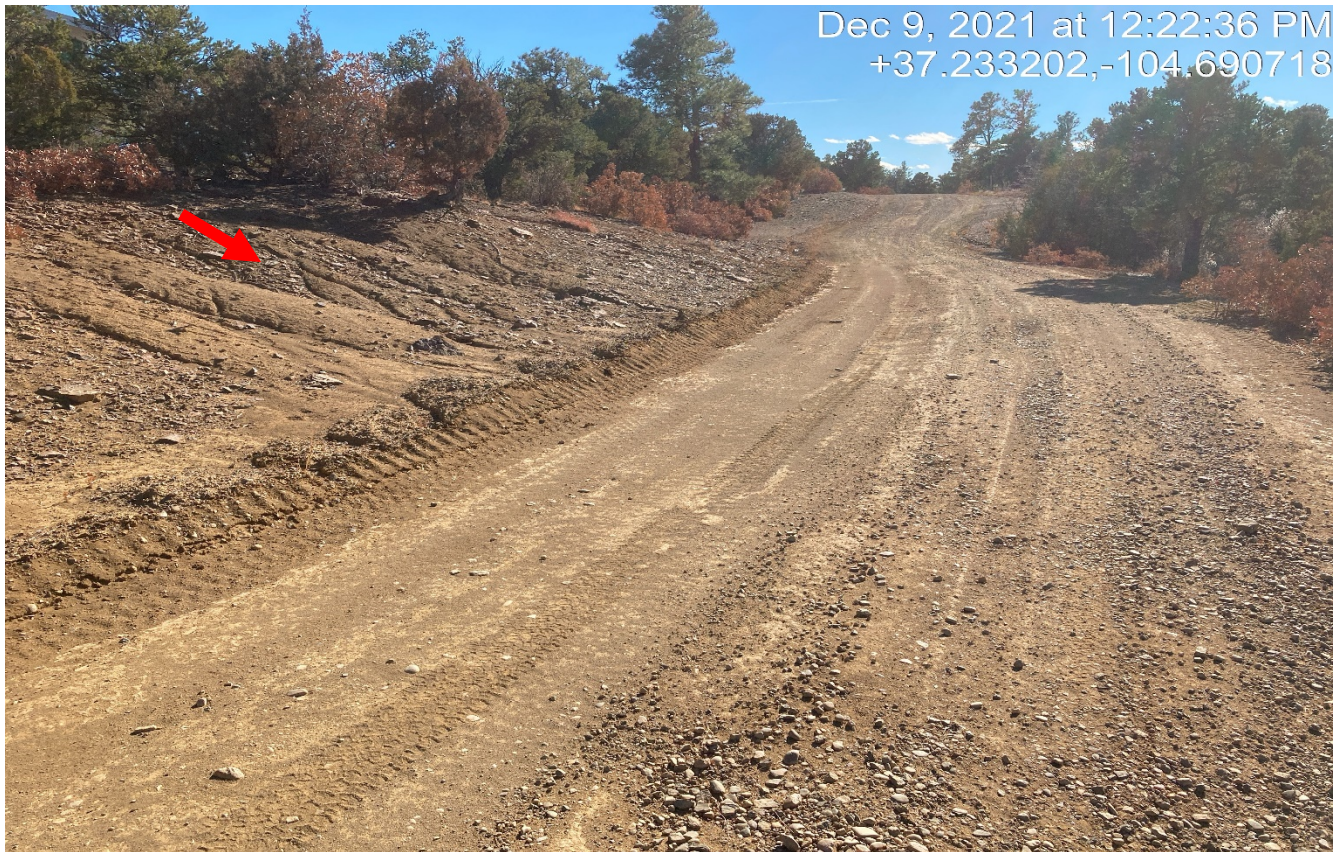
Photo 6. Facing south along the access road. The red arrow shows where erosion is directing sediment onto the road. The side of the road needs to be seeded and stabilized. The road needs to be crowned and stabilized in this area.

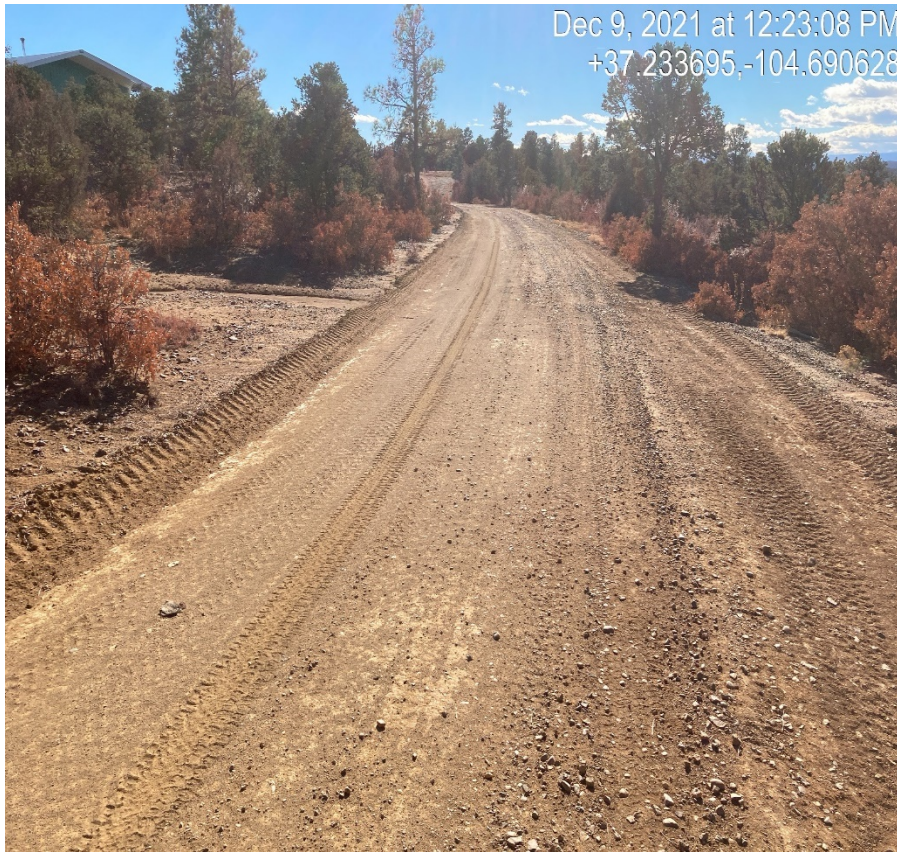
Photo 7. Facing south along the access road. The road was graded however there is insufficient stabilization.

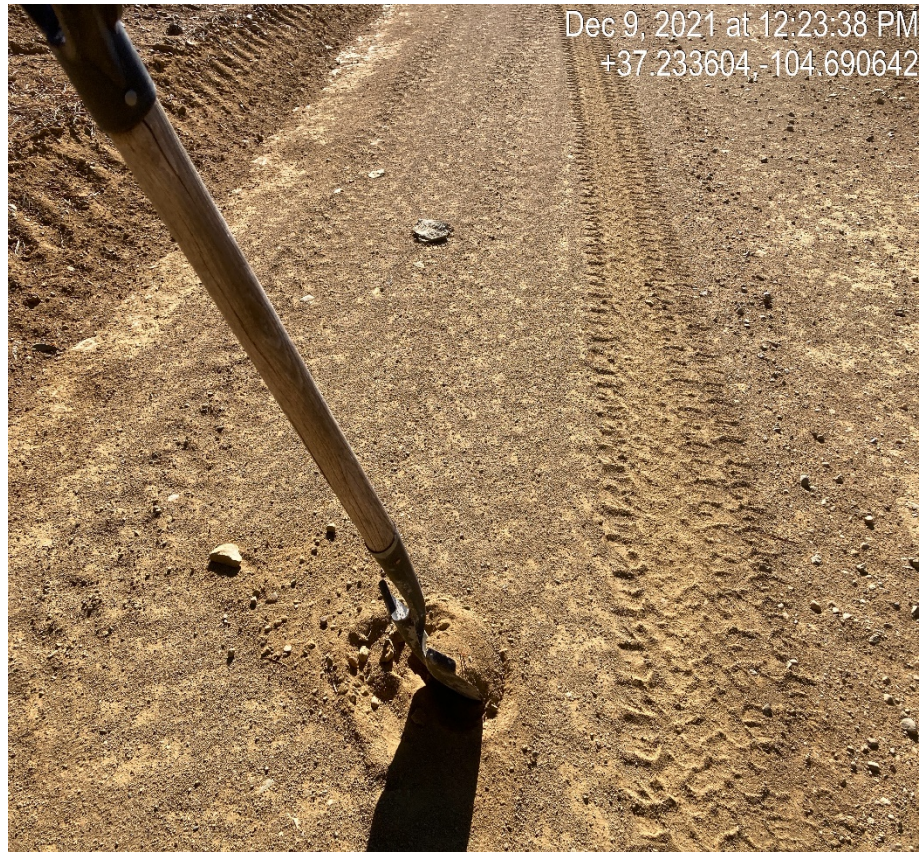
Photo 8. The shovel placed in the road surface shows loose soils and lack of stabilization.

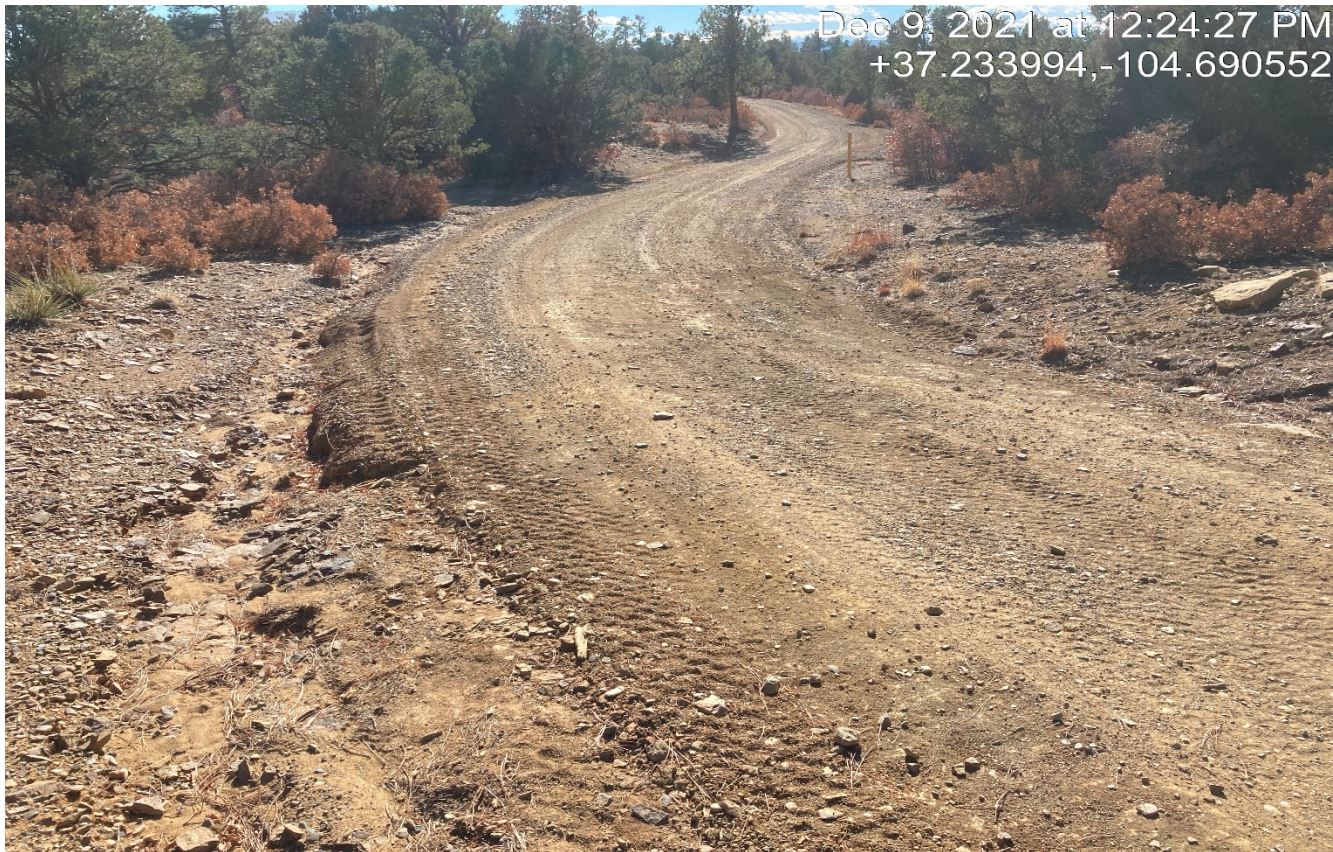
Photo 9. Facing south along the access road. The road was graded however there is insufficient stabilization.

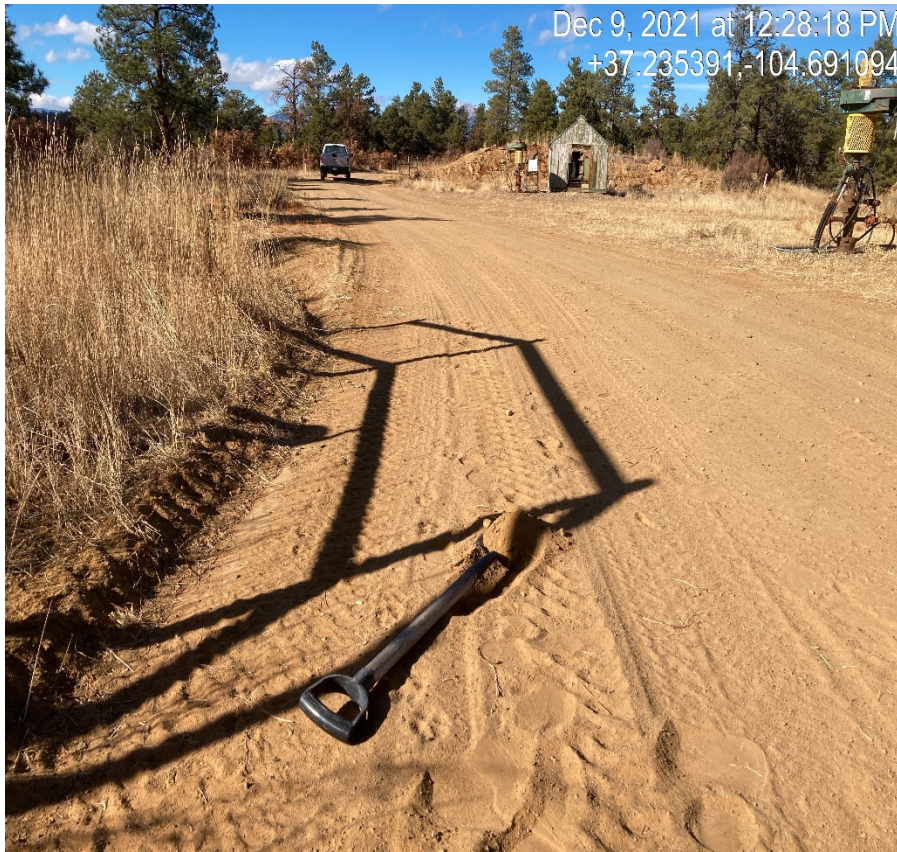
Photo 10. Facing north along the access road at the well site. The shovel placed in the road surface shows loose soils and lack of stabilization

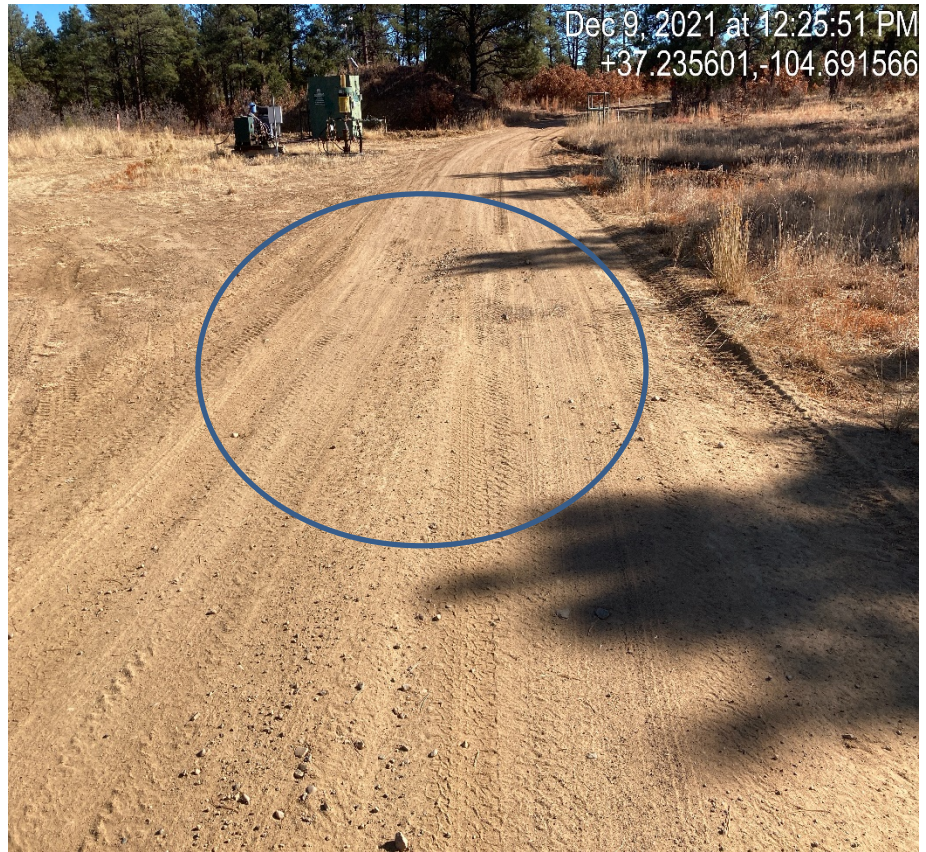
Photo 11. The access road was bladed however the area of water pooling circled has not been stabilized and repaired. This area of the road should be crowned to divert water from the road.

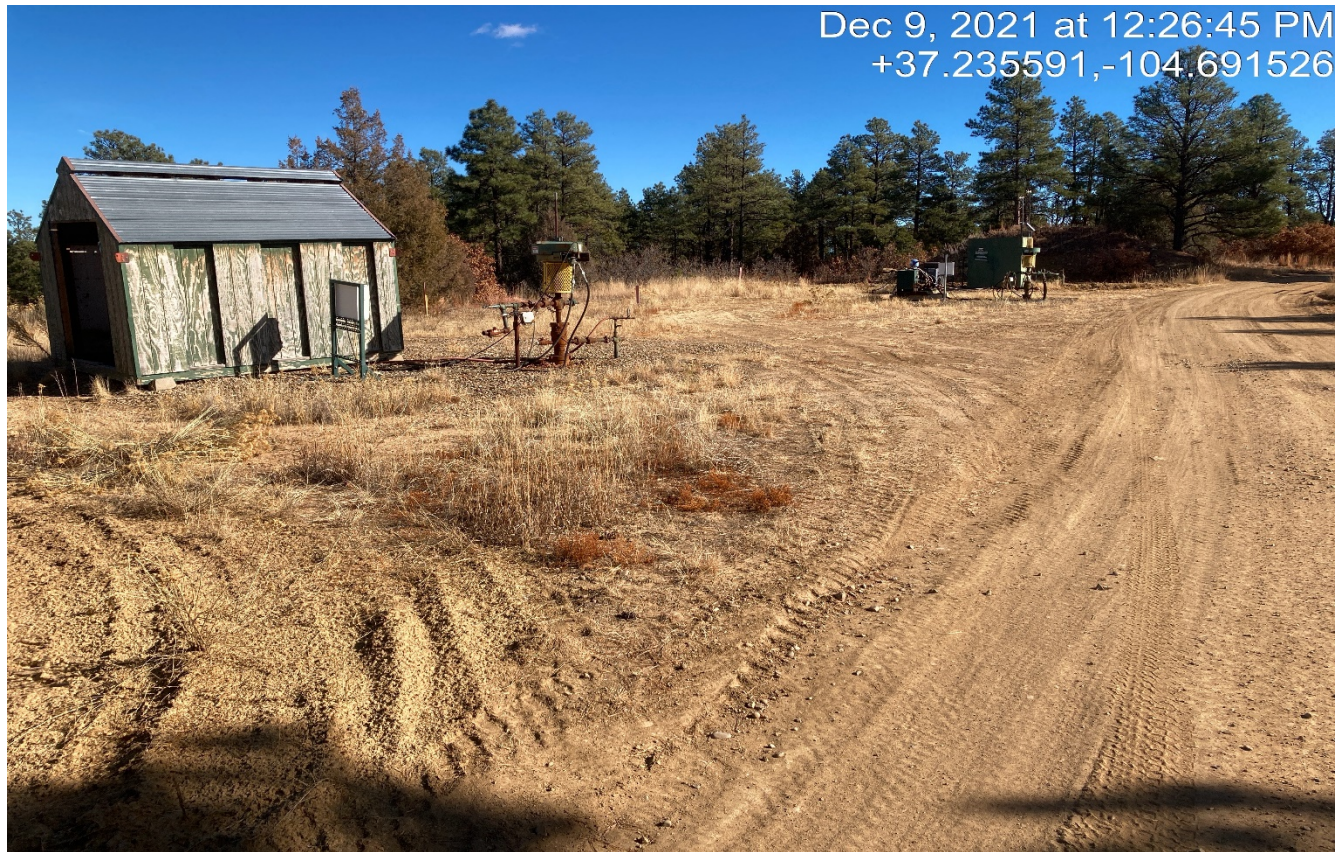
Photo 12. Facing southeast toward the LEFT FIELD #31-29 well site.
