Inspection Photos
Location Name: Morgan A#1
Spill ID: 481051

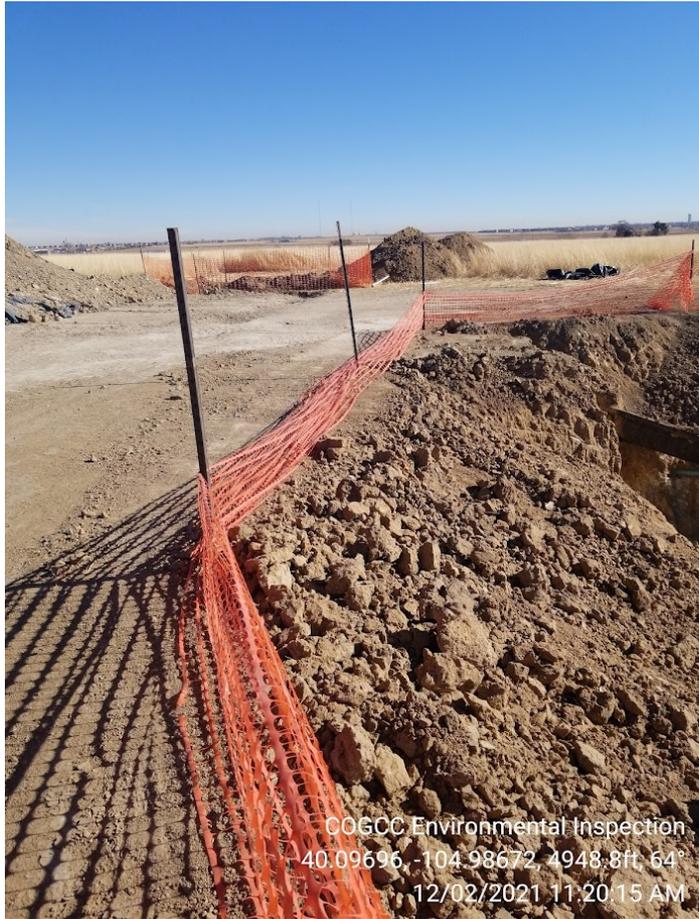
Photo 1 – Downed fencing on 12/2/2021

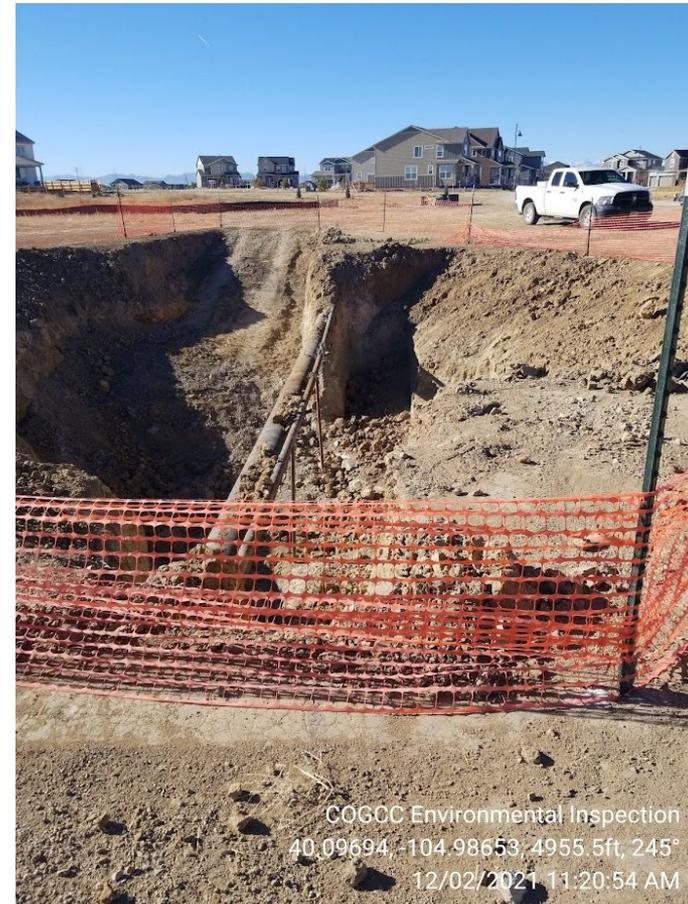
Photo 2 – Remedial excavation on 12/2/2021

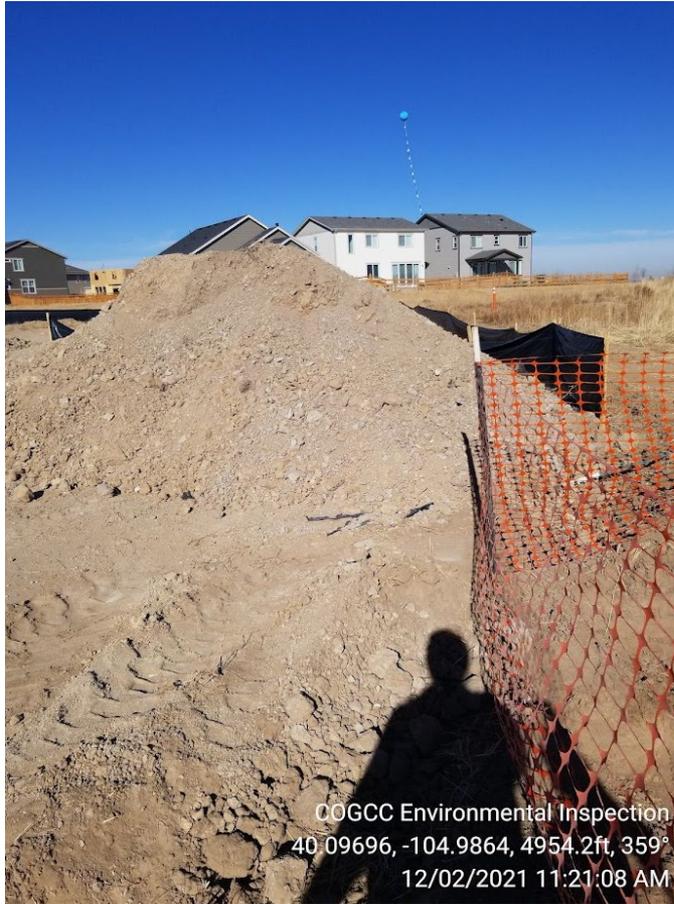
Photo 3 – Stockpiled soils next to repair excavation on 12/2/2021.

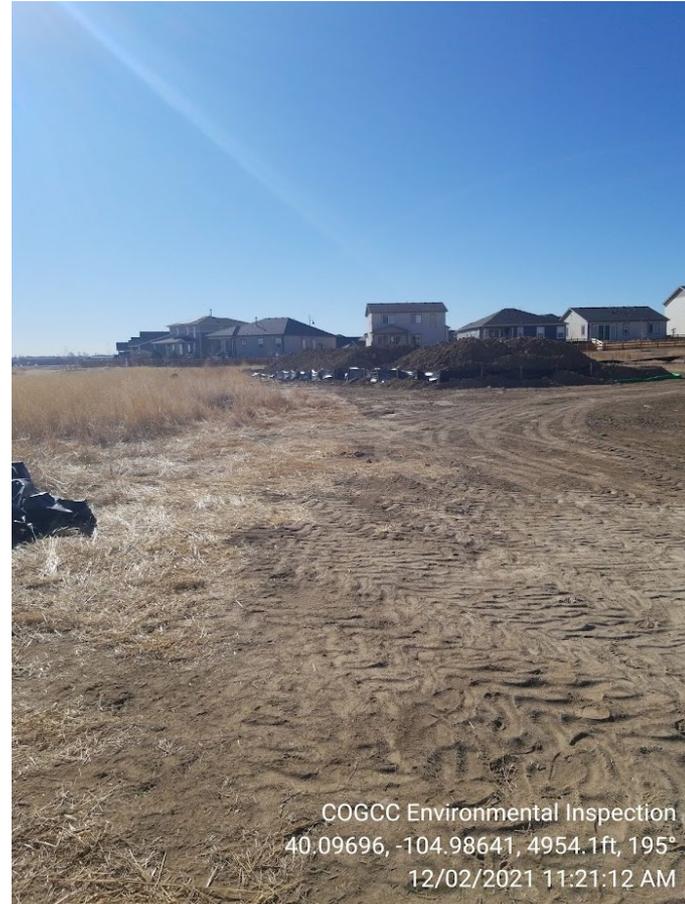
Photo 4 – Large stockpile SE of remedial excavation on 12/2/2021

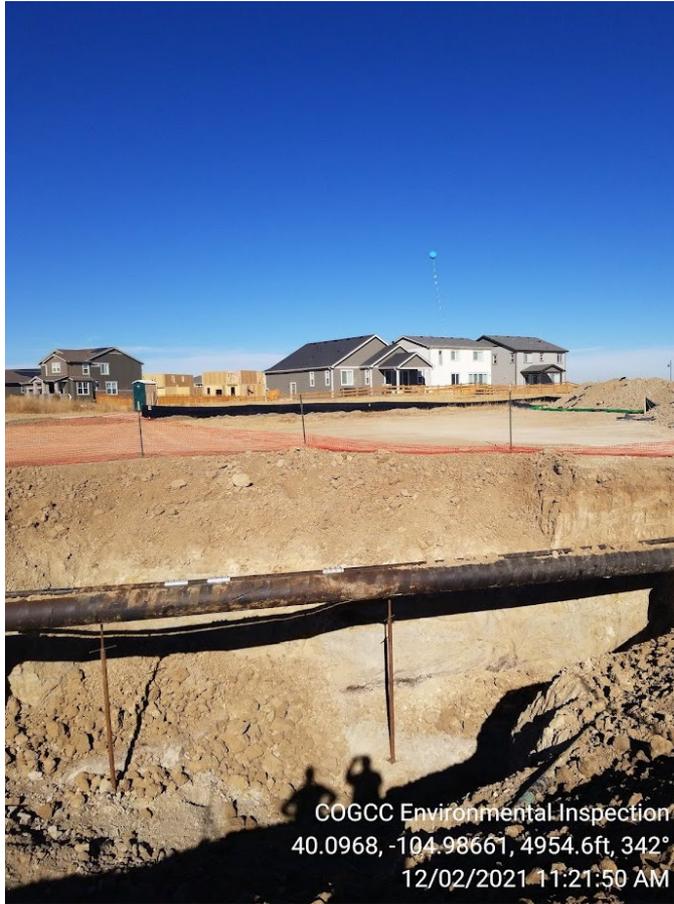
Photo 5 – 12/2/2021: Foreground: Remedial excavation and downed fencing. Background: Additional soils stockpiles.

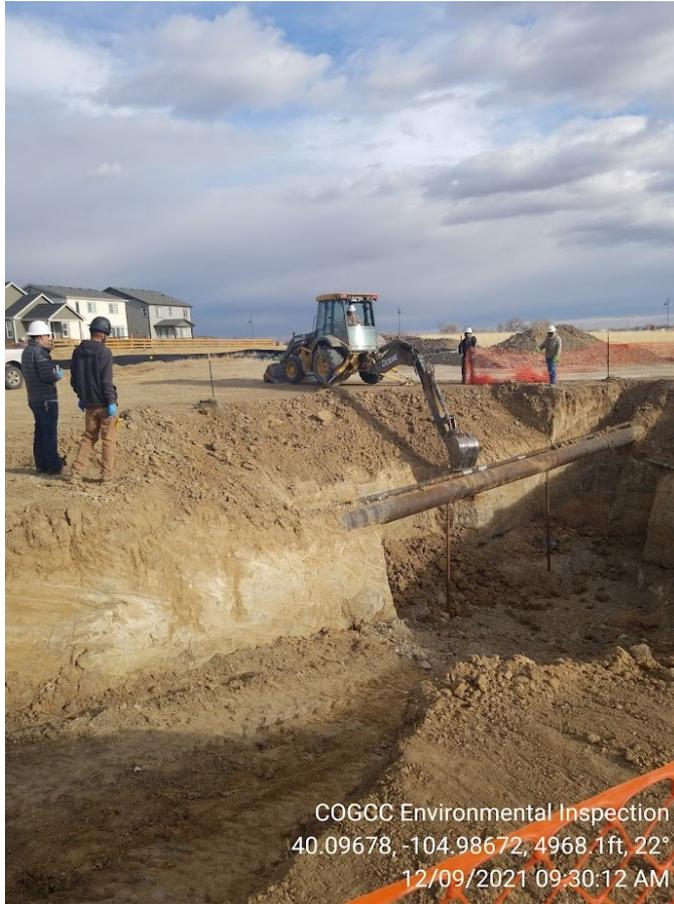
Photo 7 – Sampling event 12/9/2021.

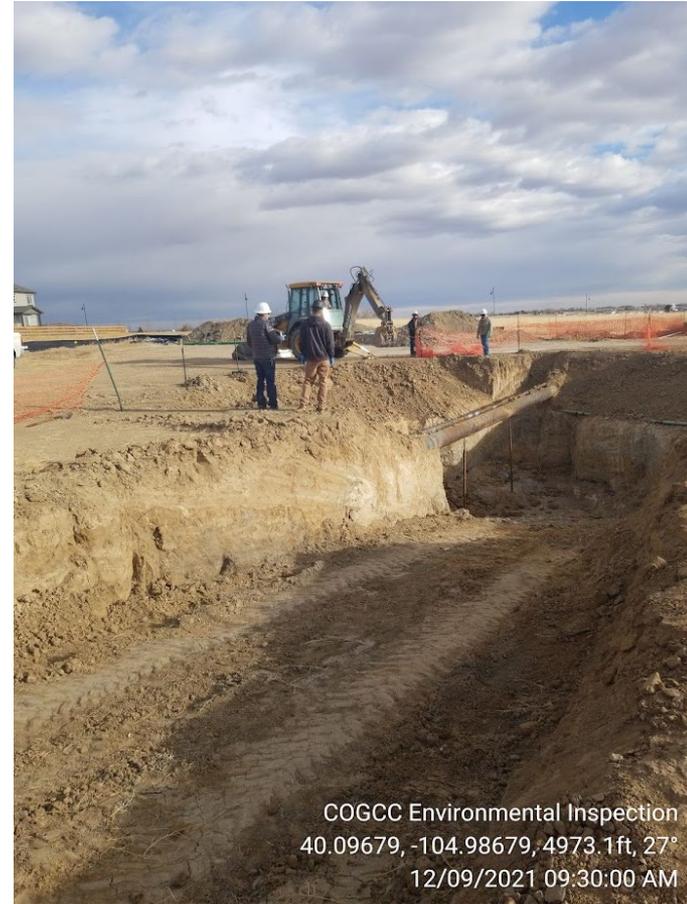
Photo 8 – Sampling event 12/9/2021.
