**Inspection Photos**  
**Location Name: Moser 1A**  
**Spill ID: 481067**

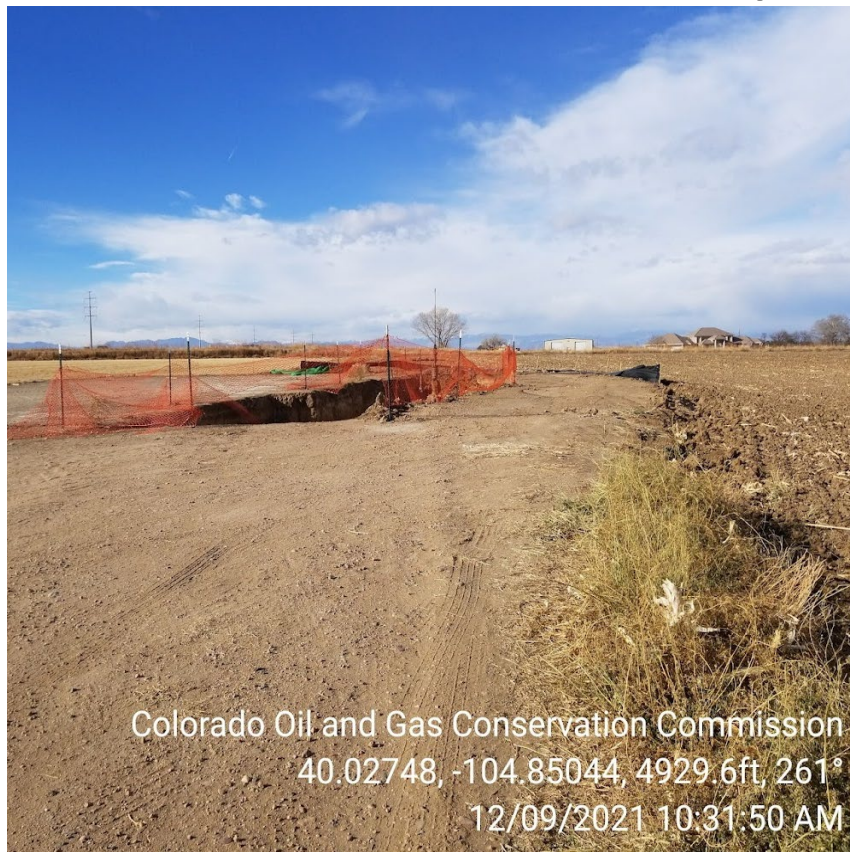
**Photo 1 – Site overview, silt fence damaged by wind, fencing down.**

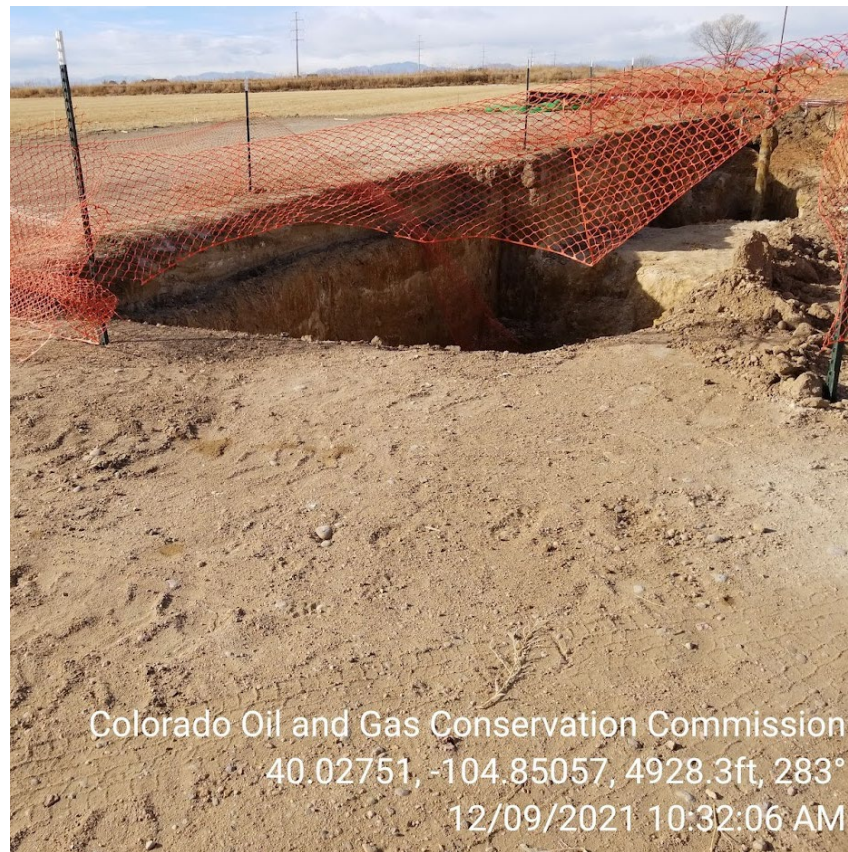
**Photo 2 – Excavation. Fencing down.**

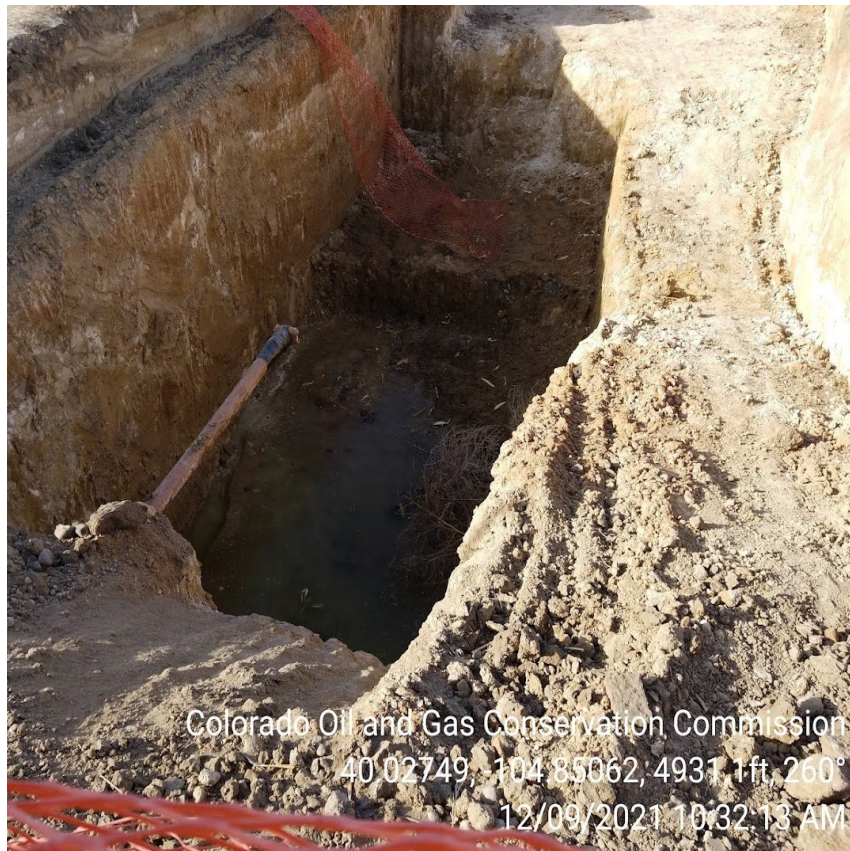
**Photo 3 – Groundwater in excavation**

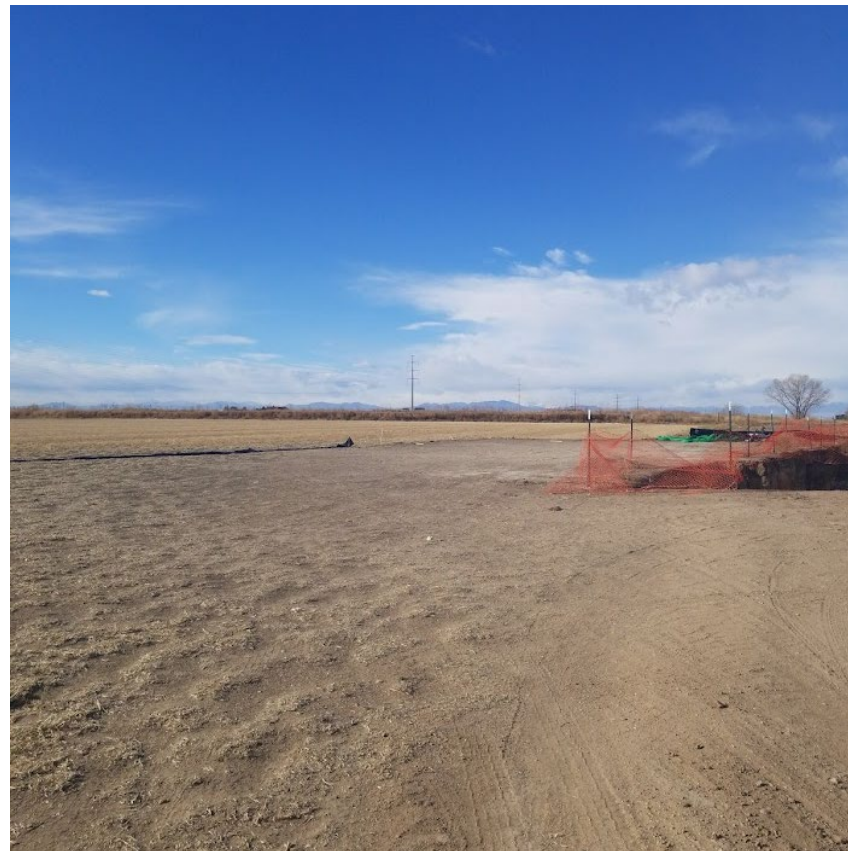
**Photo 4 – Site overview; silt fence damaged by wind.**

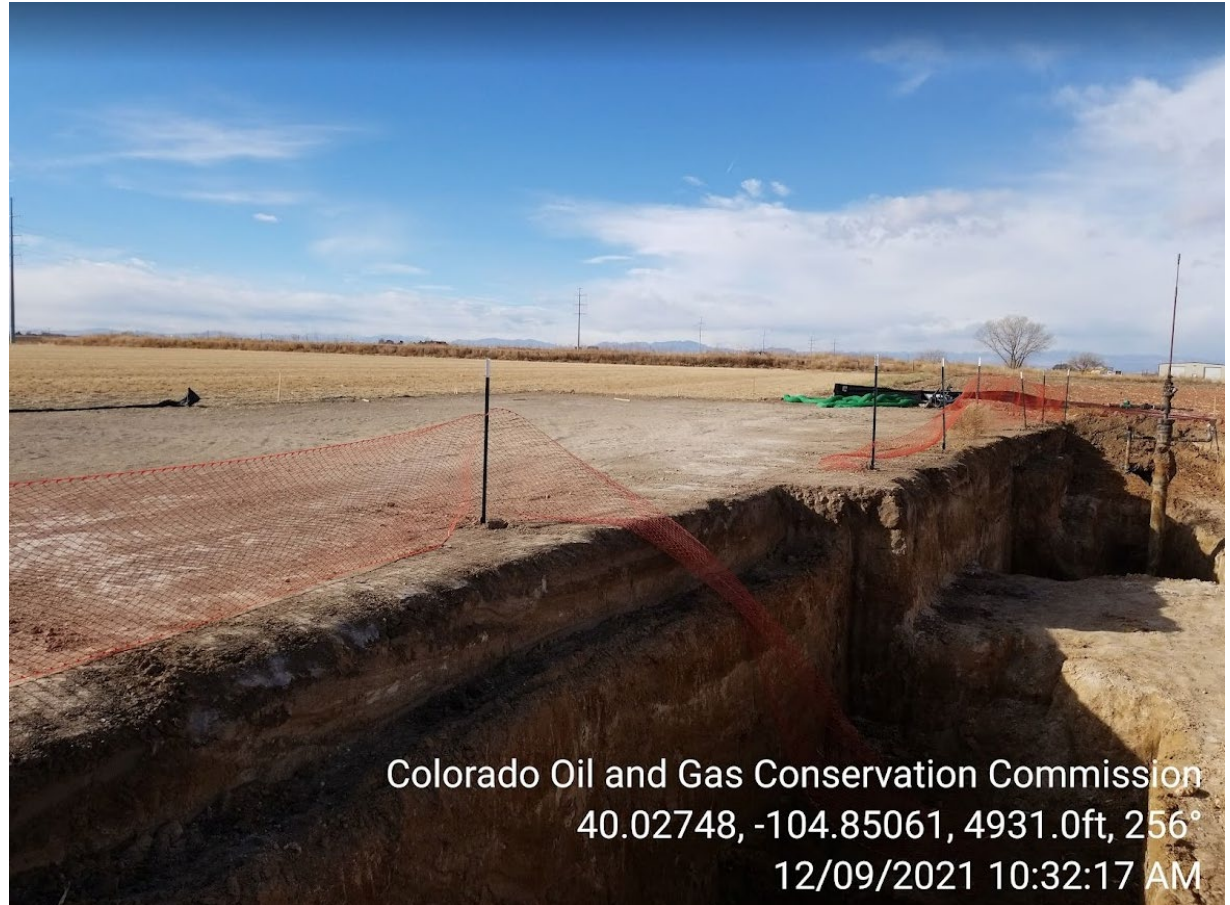
**Photo 5 –**  
**Foreground: Fencing**  
**down around**  
**excavation,**  
**Background: Silt**  
**fence damaged by**  
**wind.**
