GOLDEN EAGLE 20-05X API# 05-071-08637 – OGRIS OPERATING LLC
OGCC OPERATOR NUMBER 10758 - DATE: DECEMBER 09, 2021
CORRECTIVE ACTIONS COMPLETED REGARDING COGCC FIR DOCUMENT # 690202344

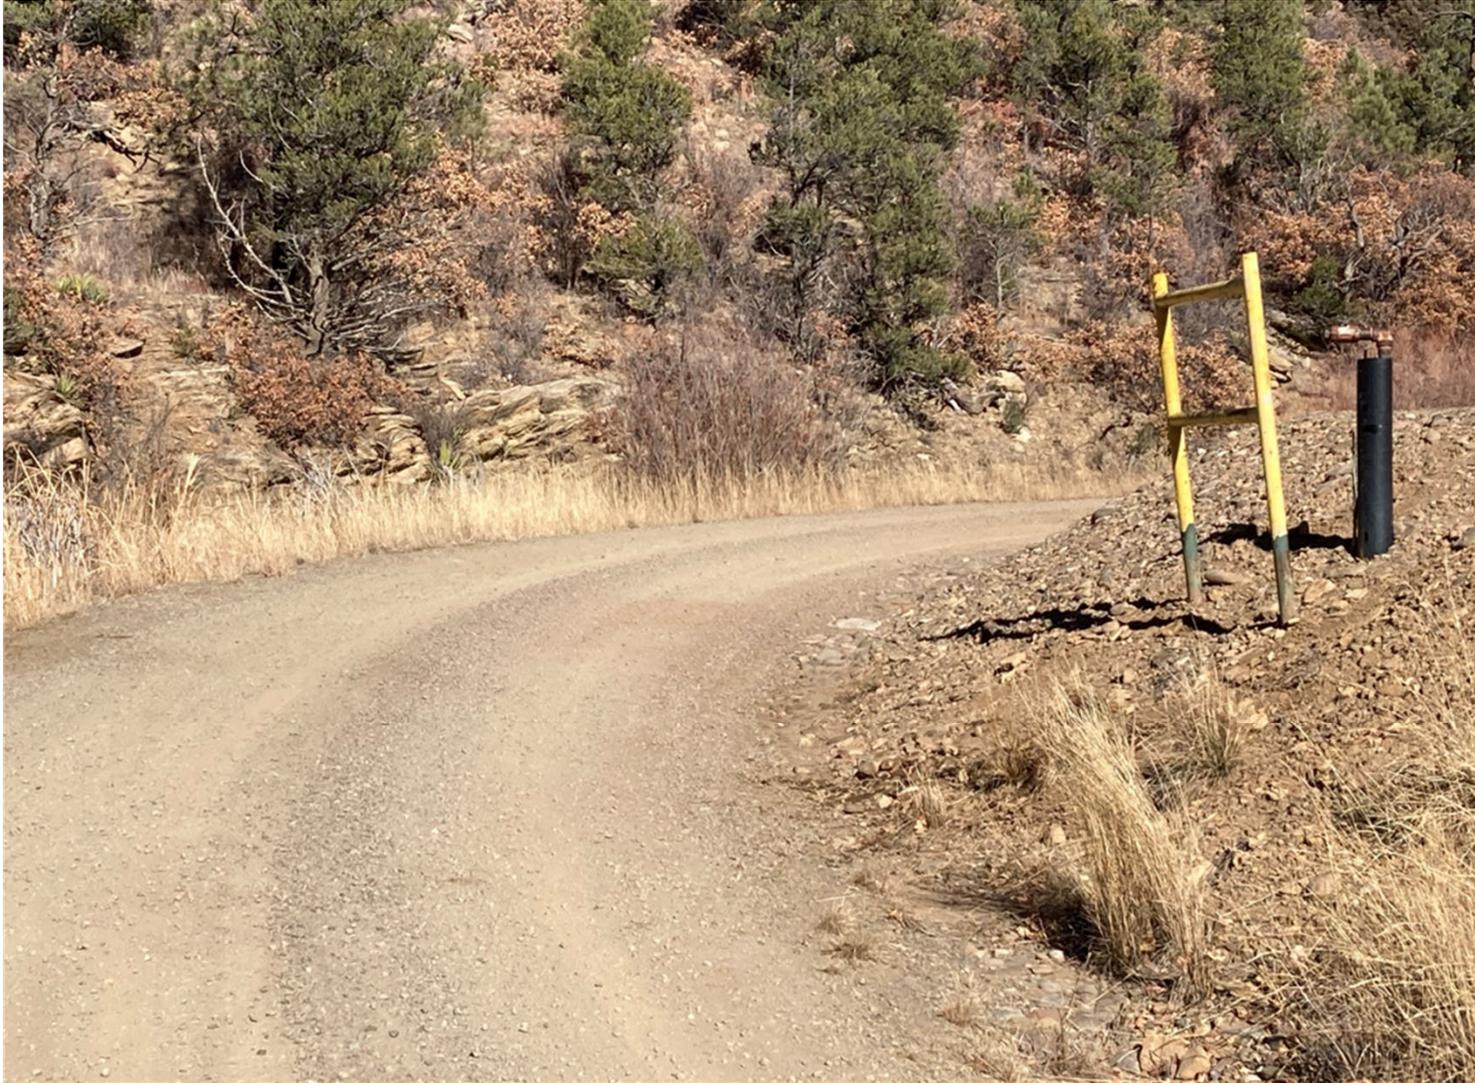
THE IMPACTED SOIL ON THE GROUND NEAR THE DRIP RISER ALONG THE MAIN ROAD WAS CLEANED UP. NO ENVIRONMENTAL IMPACTS WERE DISCOVERED.

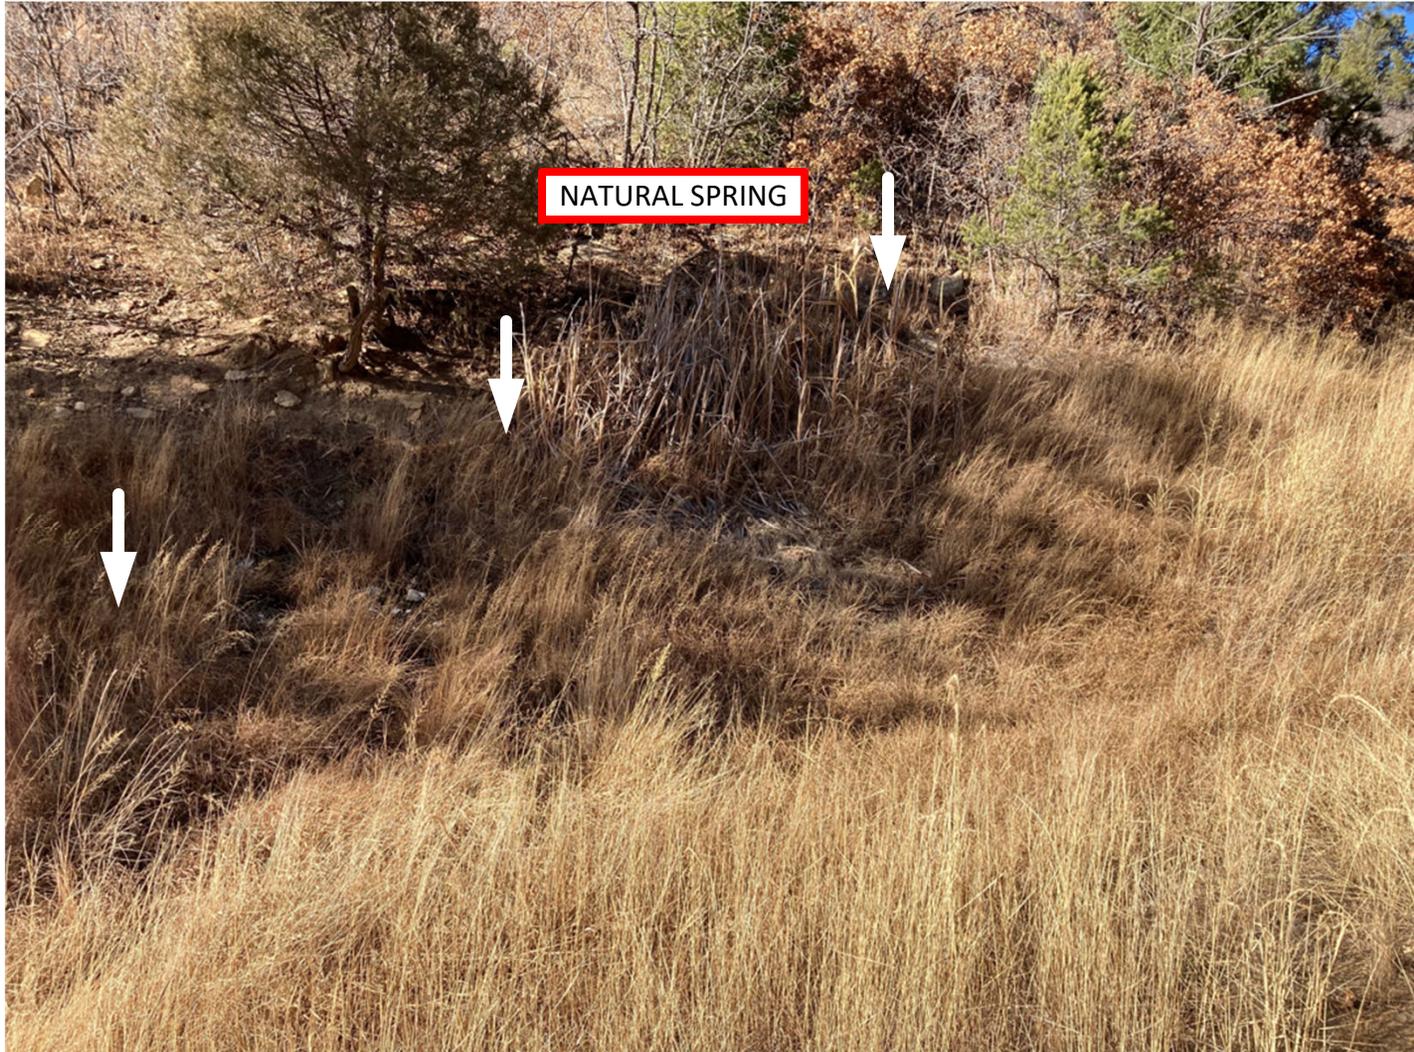
THE SOURCE OF THE WATER THAT WAS FOUND ON THE ROAD SURFACE IS FROM A NATURAL SPRING THAT FLOWS YEAR ROUND ADJACENT TO THE LEASE ROAD.

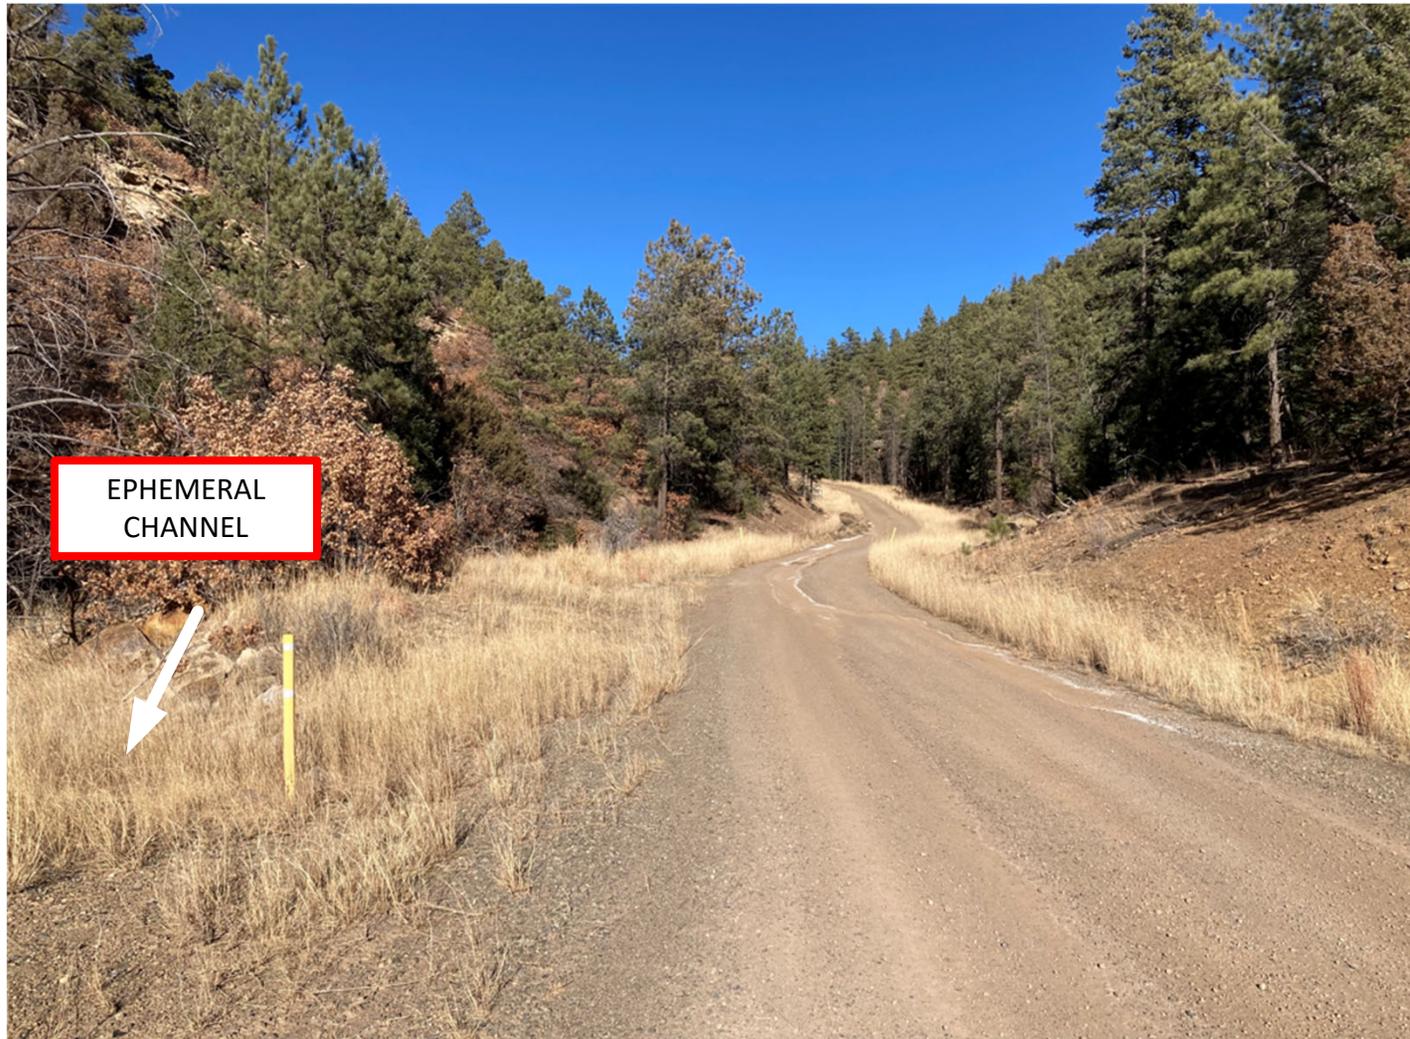
THE VEGETATED BAR DITCH WAS DOMINATED TO RECEIVE WATER FROM THE SPRING. THIS FLOWS DOWN TO THE EPHEMERAL CHANNEL NORTH OF THE GE 20-05X WELL PAD.

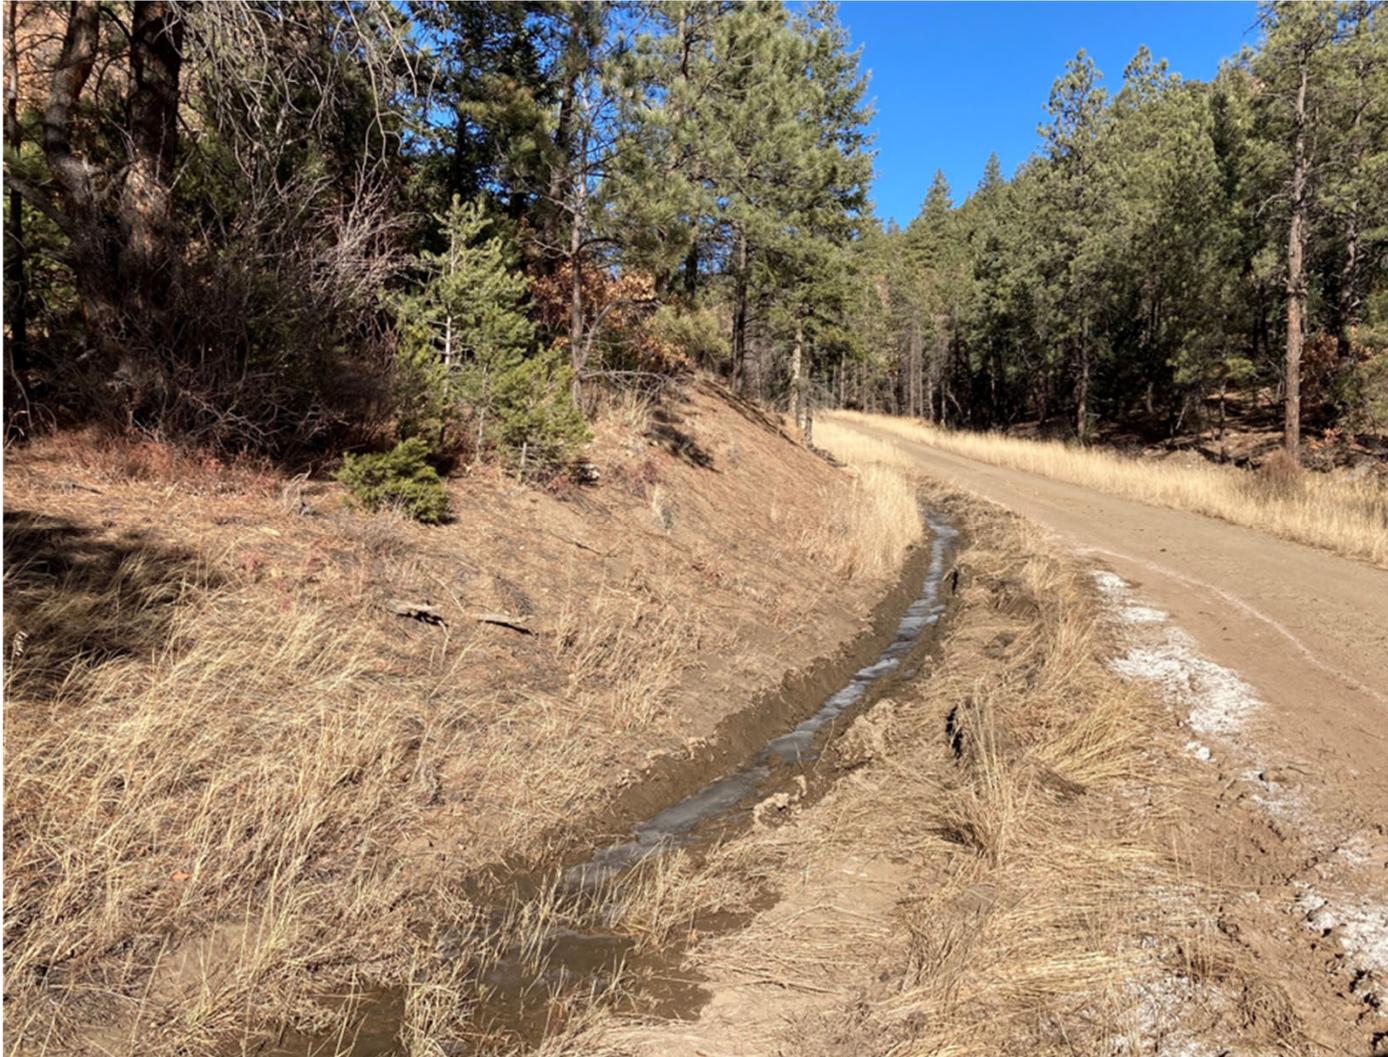
THE VEGETATED BAR DITCH WAS DOMINATED TO RECEIVE WATER FROM THE SPRING WHICH HAS BEEN THE NORMAL COURSE OVER THE YEARS FOR THE SPRING.
