TEP
RWF 333-18
Location # 335133

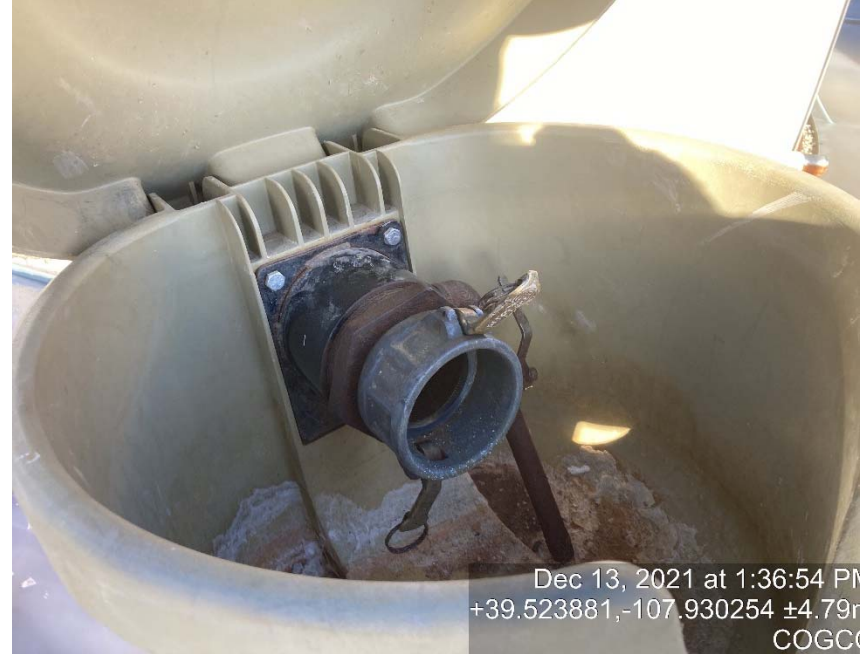
Load lines lacking bull plugs/caps

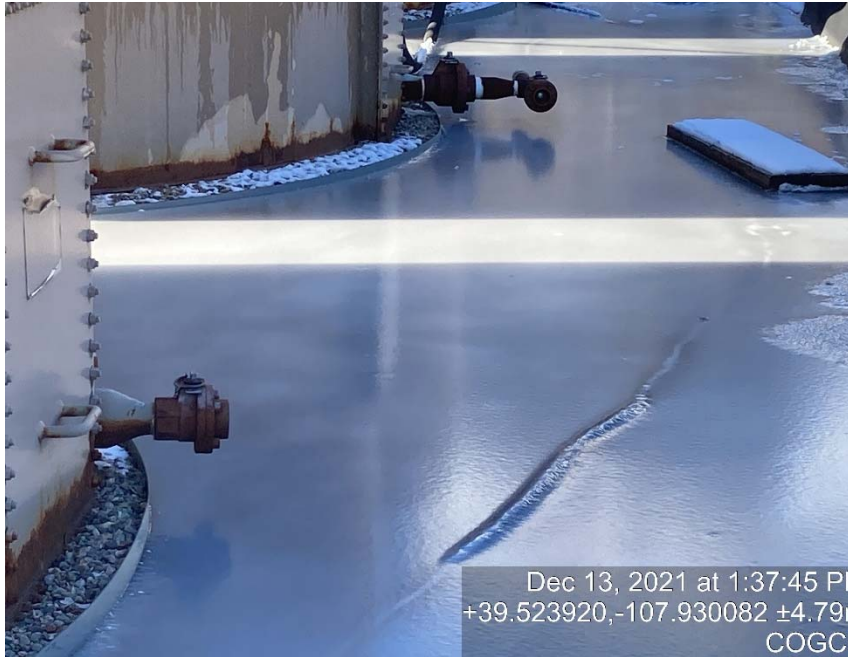
Load lines lacking bull plugs/caps

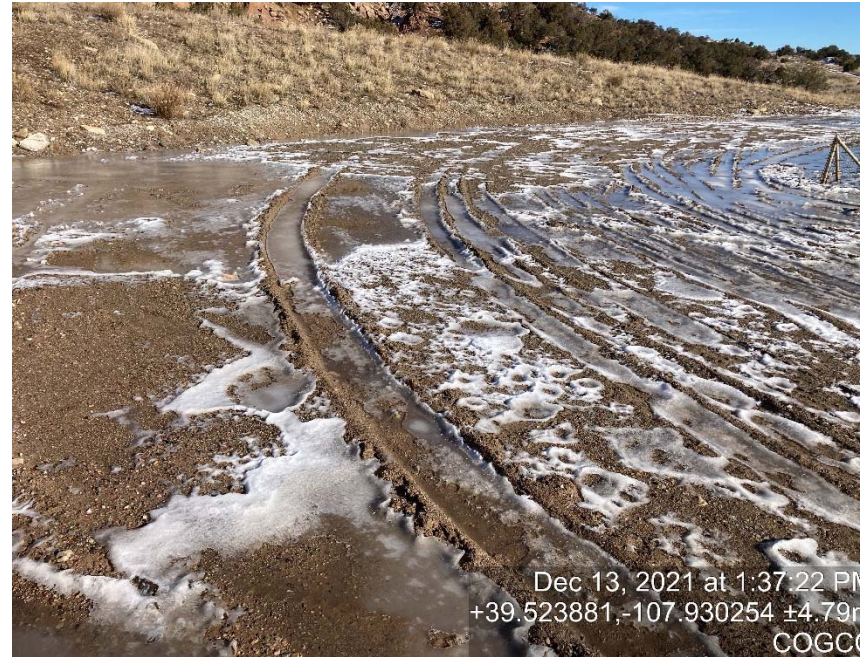
Lack of stabilization/compaction

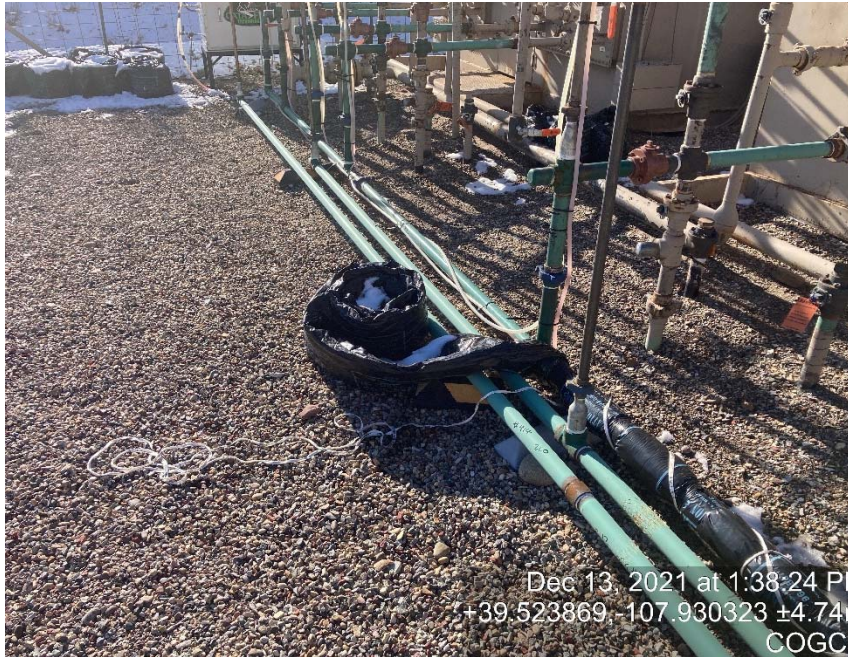
Insulation

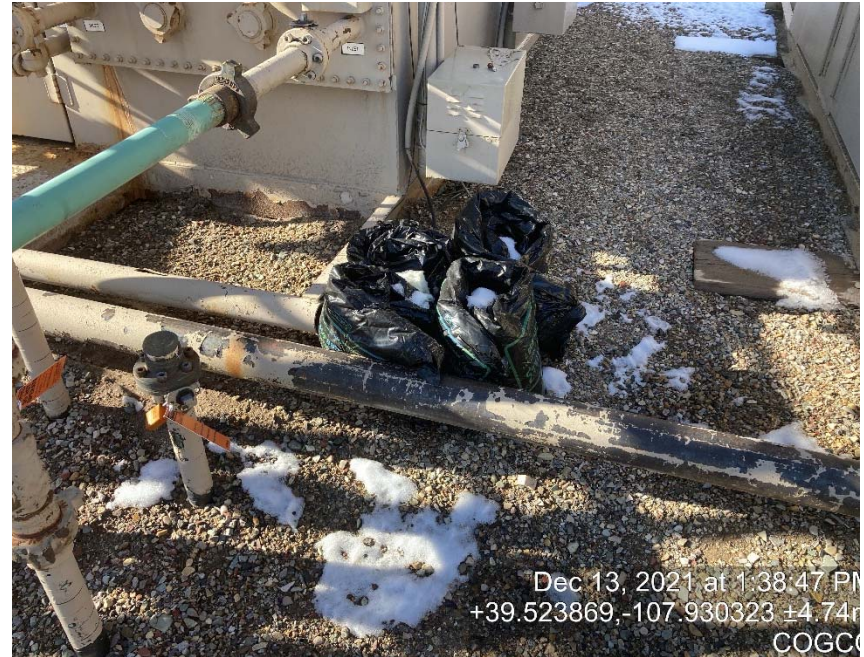
Insulation

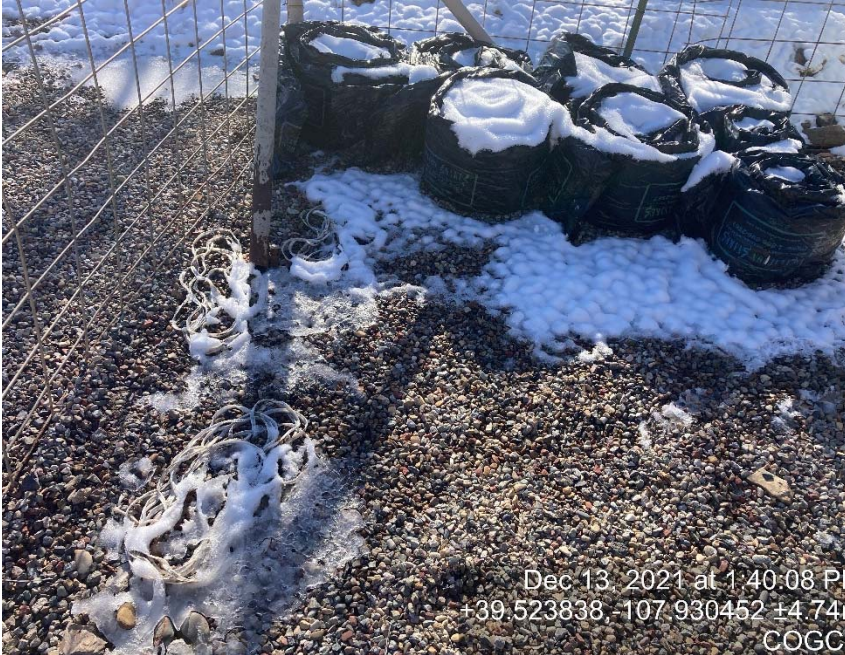
Rope and insulation

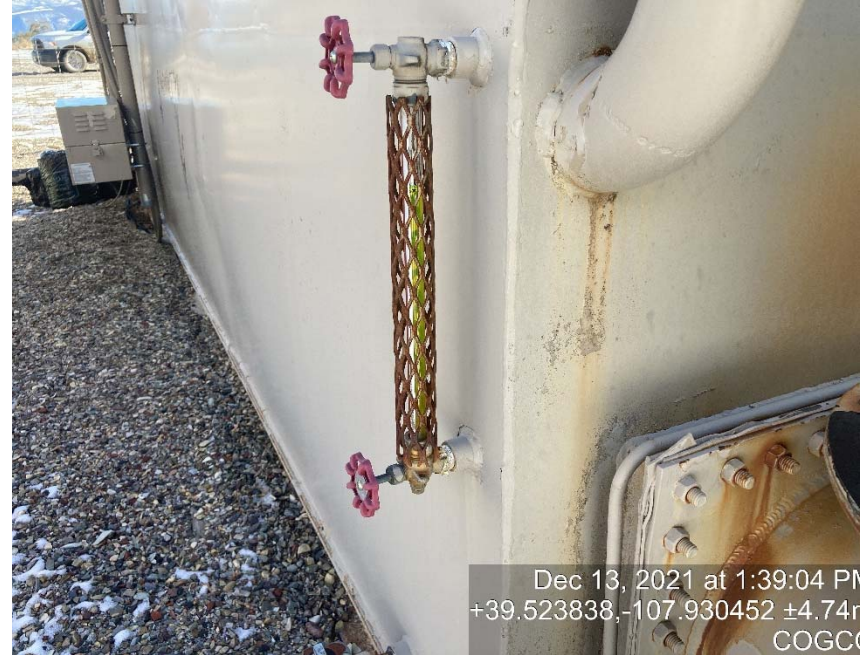
Sight glass shows fluid in storage tank

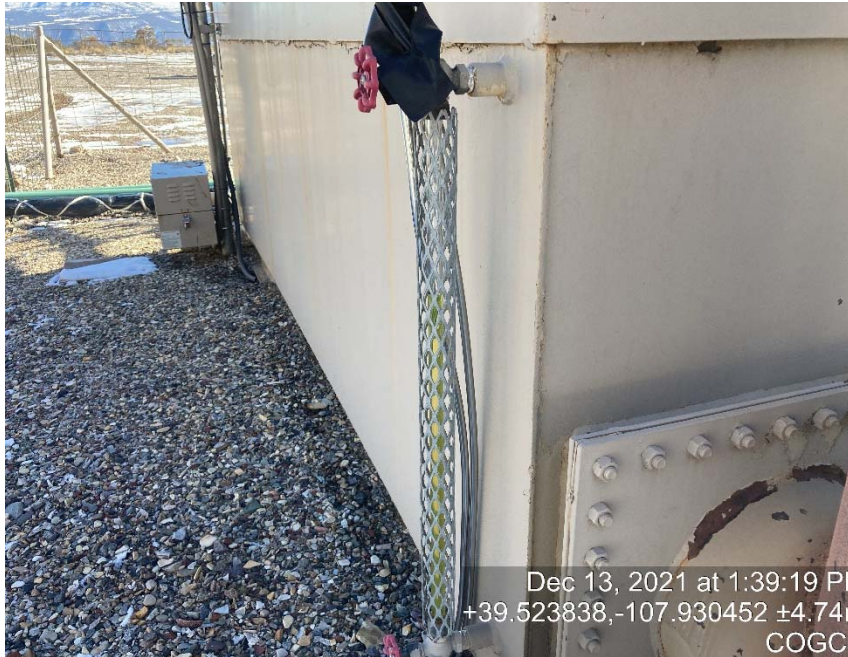
Sight glass shows fluid in storage tank

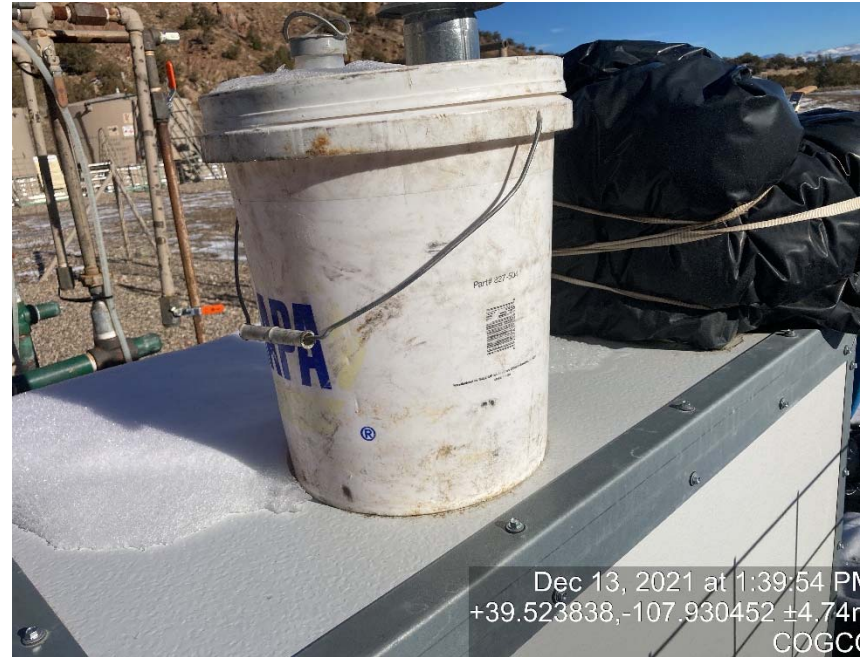
Unknown contents bucket

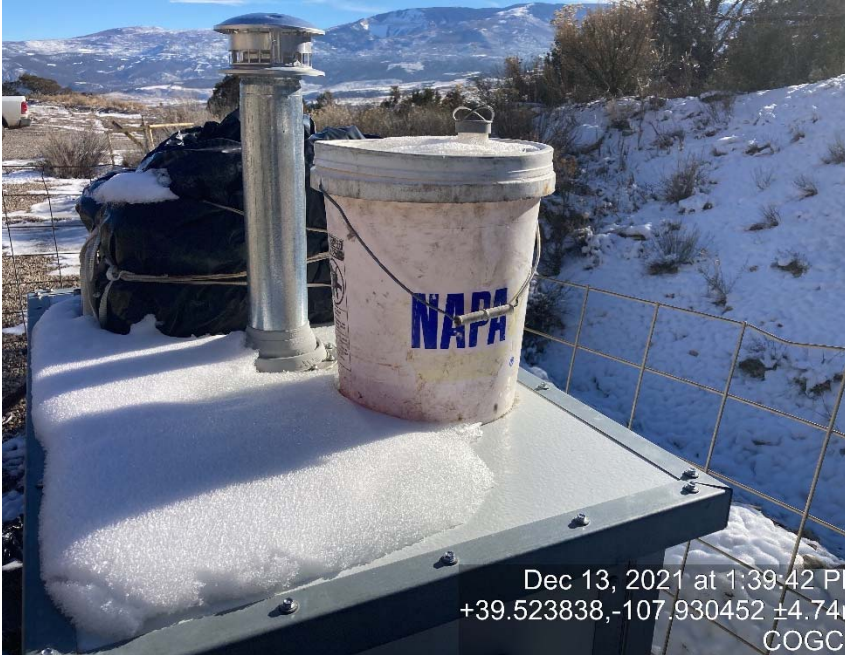
Unknown contents bucket
