Inspection Photos  
Operator: Morningstar  
API: 007-06308  
Date: 12/13/2021

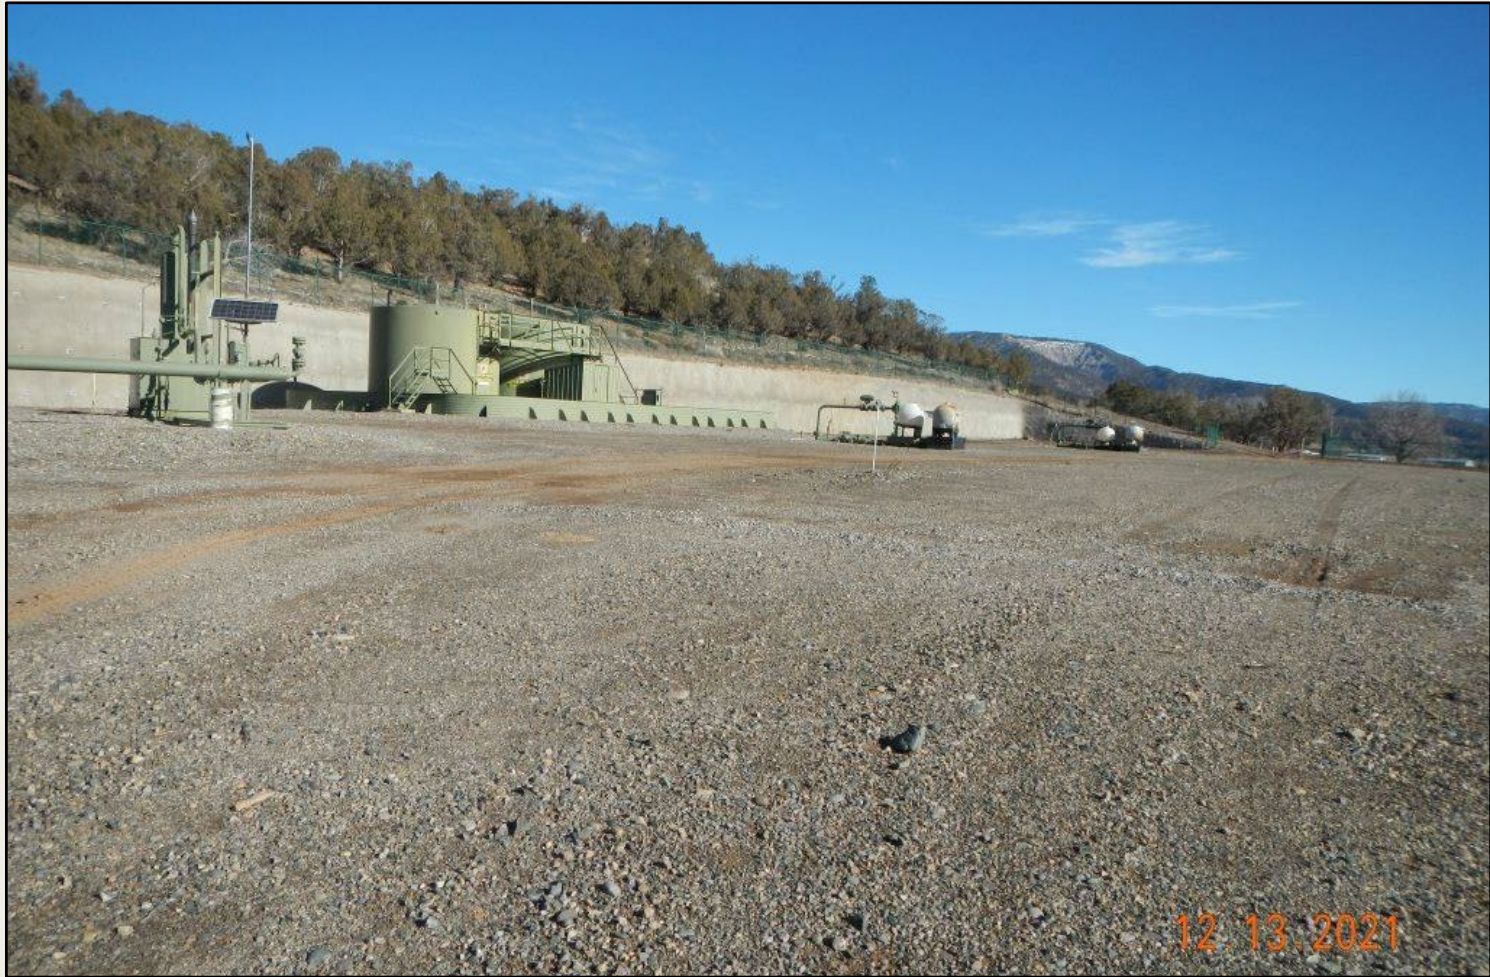
Photo 1. View of the project area from the well pad entrance facing center.

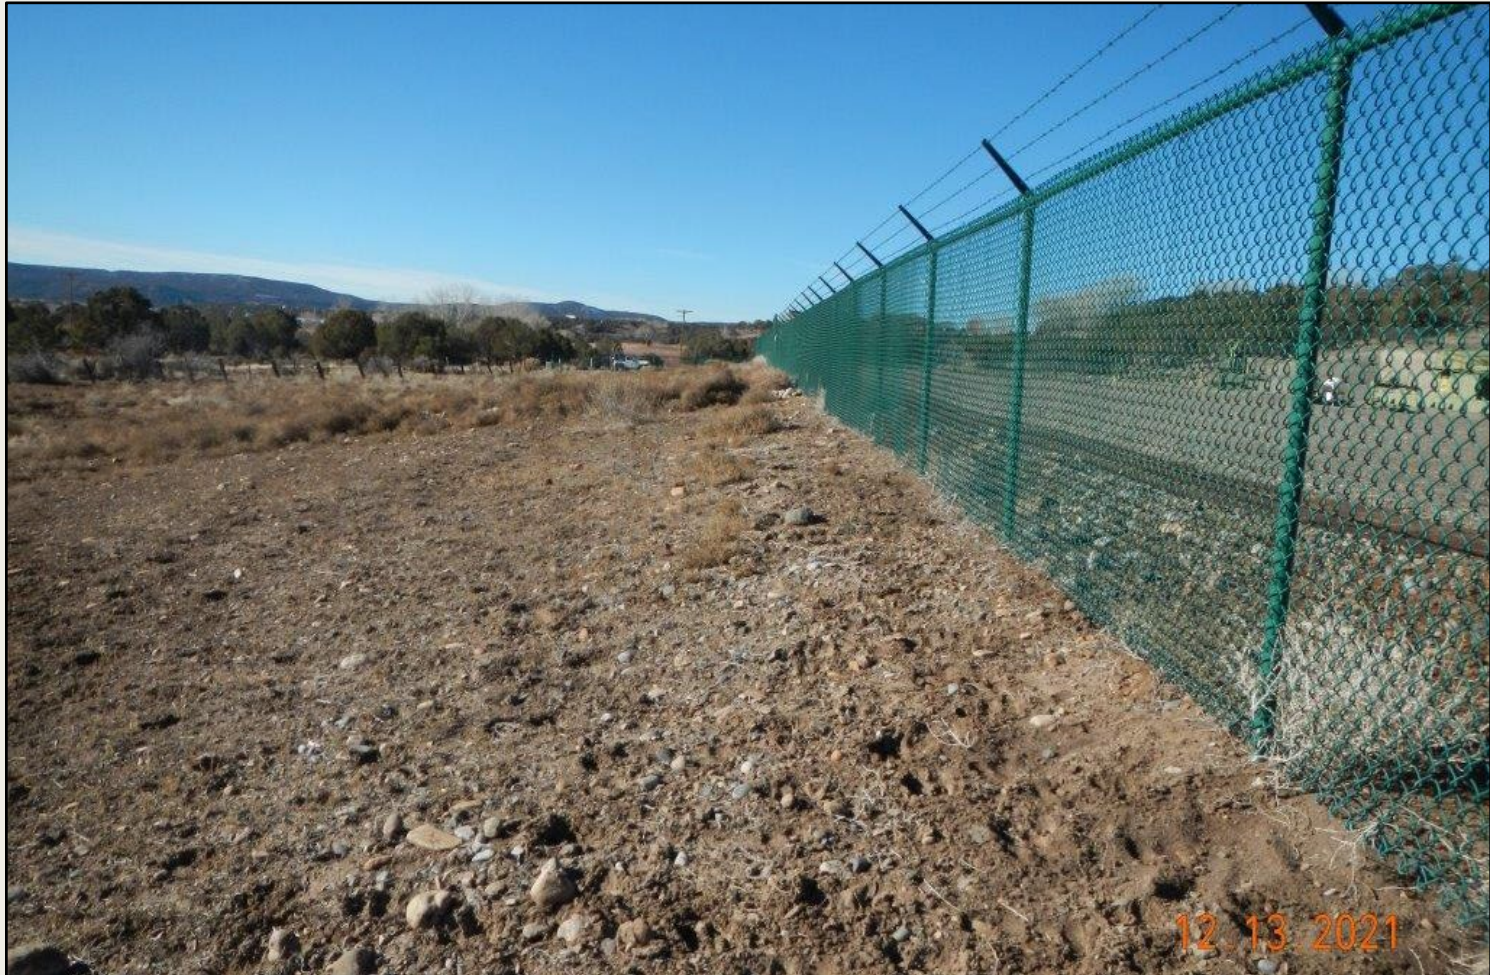
Photo 2. View of the southern project area from the southeastern corner facing westward. Revegetation appears sparse, but progressing in a largely grazed condition. This should be assessed during the active growing season.

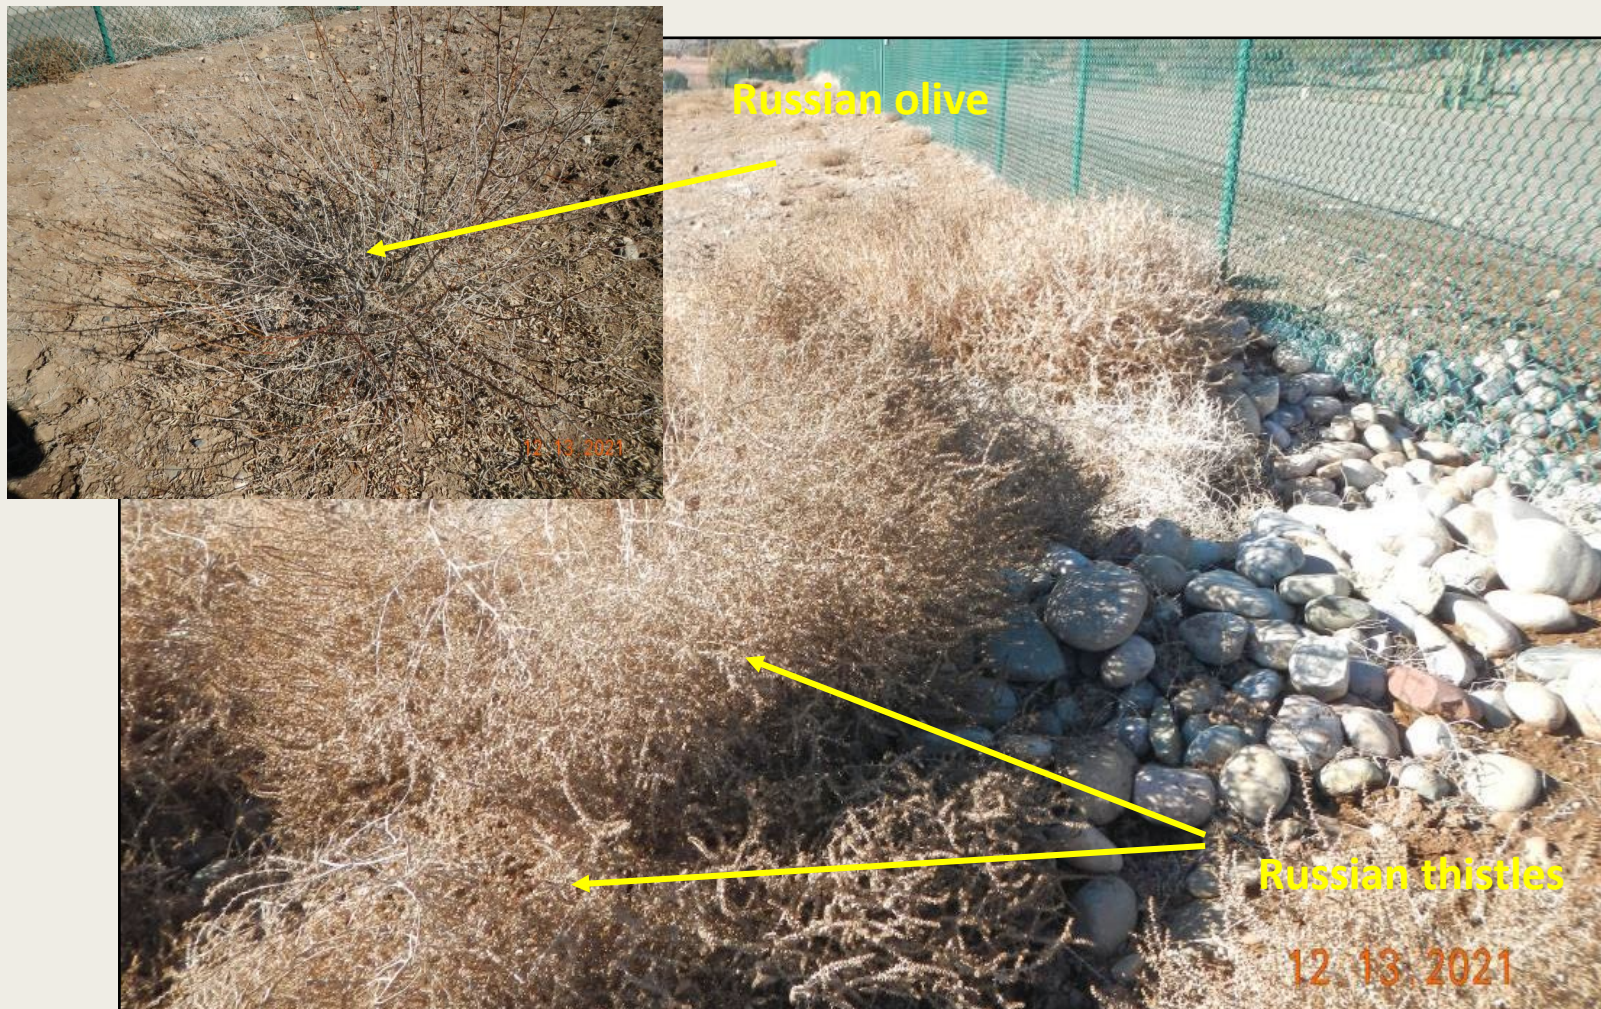
Photo 3. View of dense Russian thistle debris observed within the southern project area. Inset shows a Russian olive tree that needs to be removed.

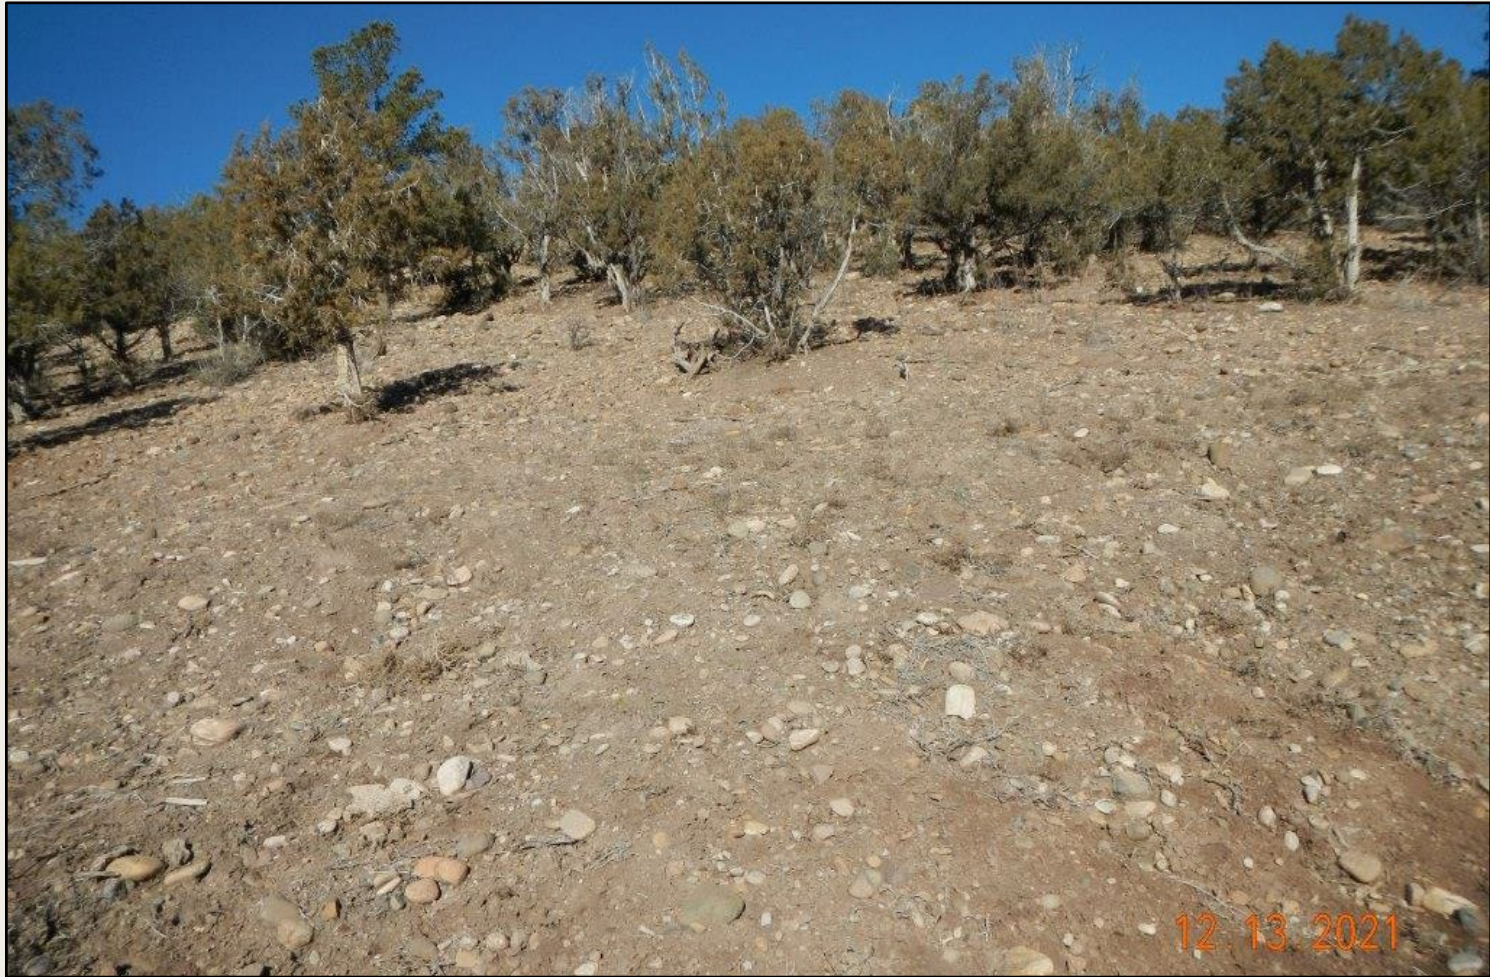
Photo 4. View of reference area comprised of pinyon and juniper woodland with blue grama, cholla, and snakeweed in the understory.
