Inspection Photos  
Operator: Simcoe  
API: 007-06325  
Date: 12/13/2021

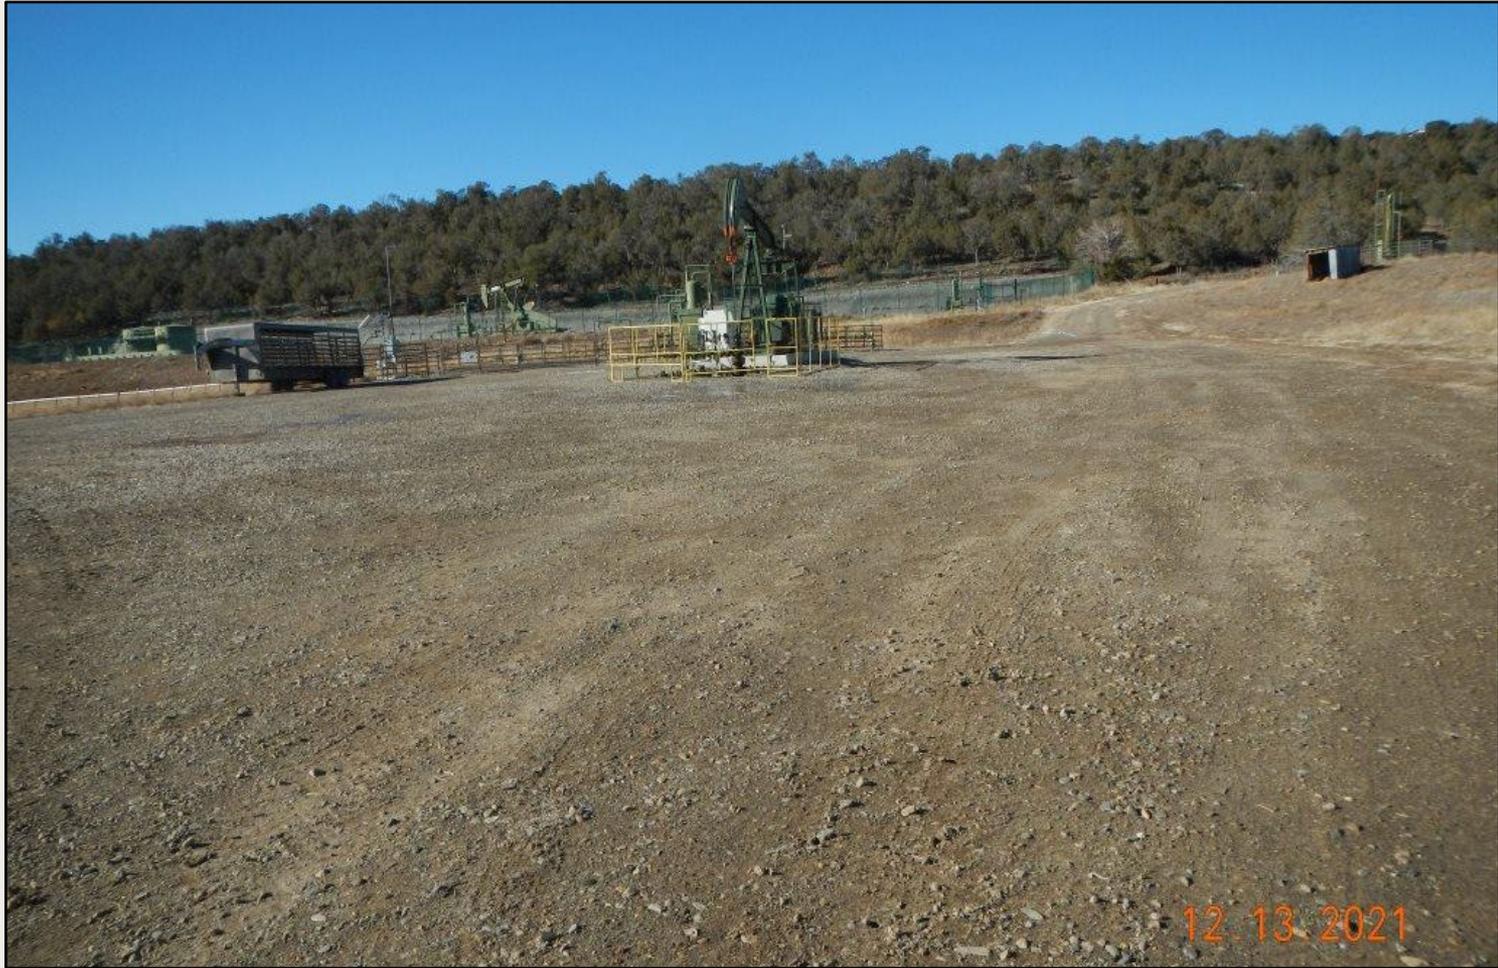
Photo 1. View of the project area from the well pad entrance facing center.

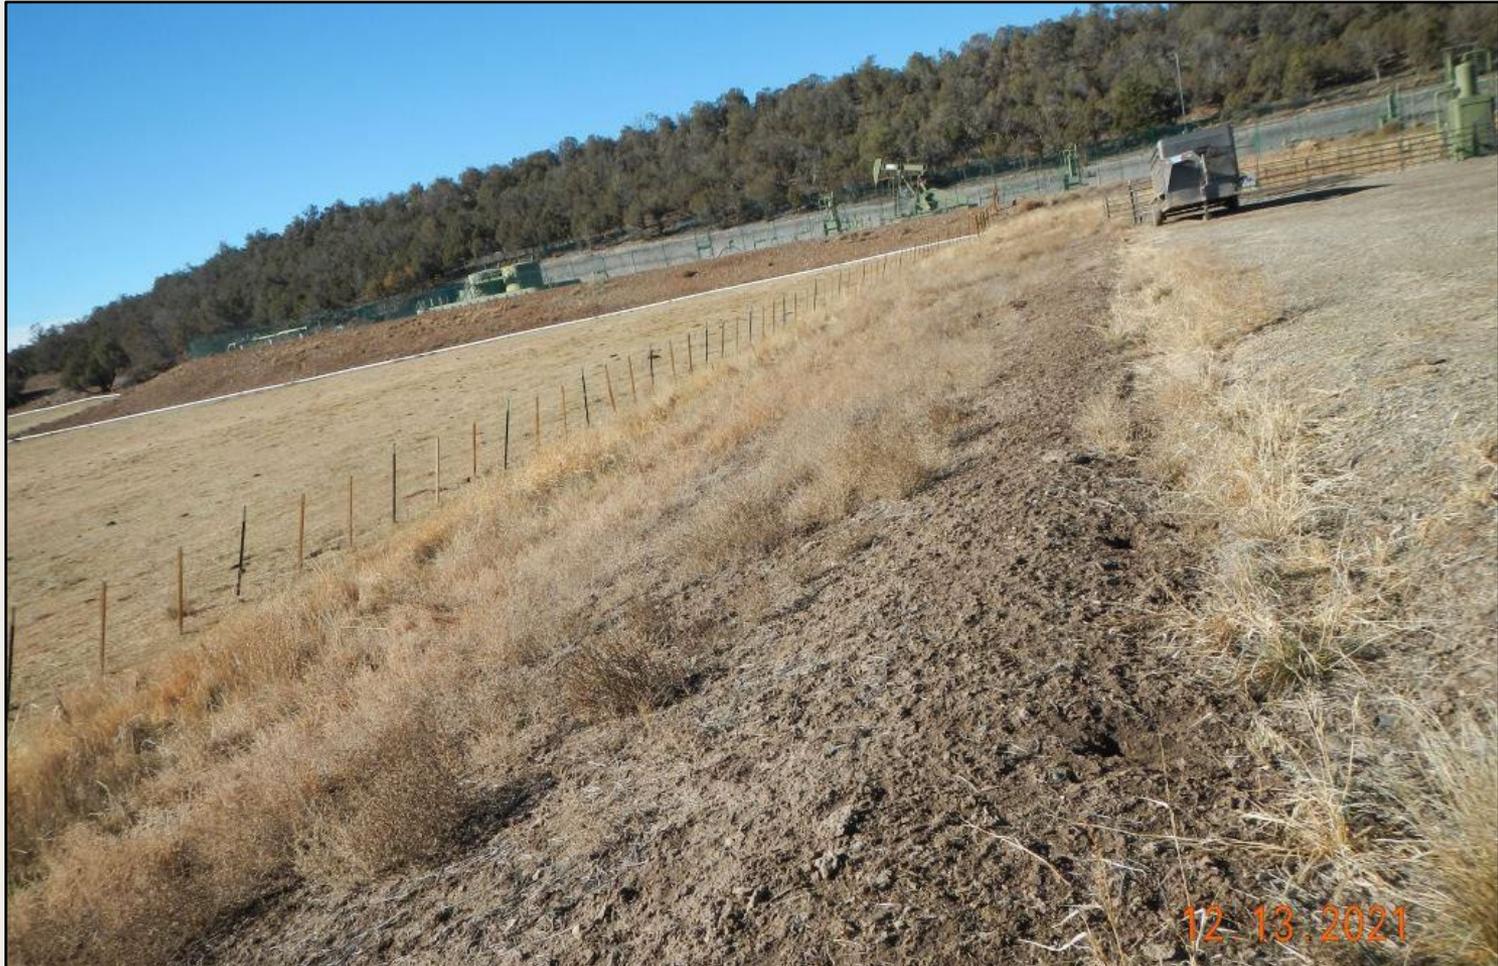
Photo 2. View of the southern project area from the southeastern corner facing westward. Revegetation is progressing with western wheatgrass, crested wheatgrass, and sand dropseed. Portions of the slope remain sparse and need to be monitored.

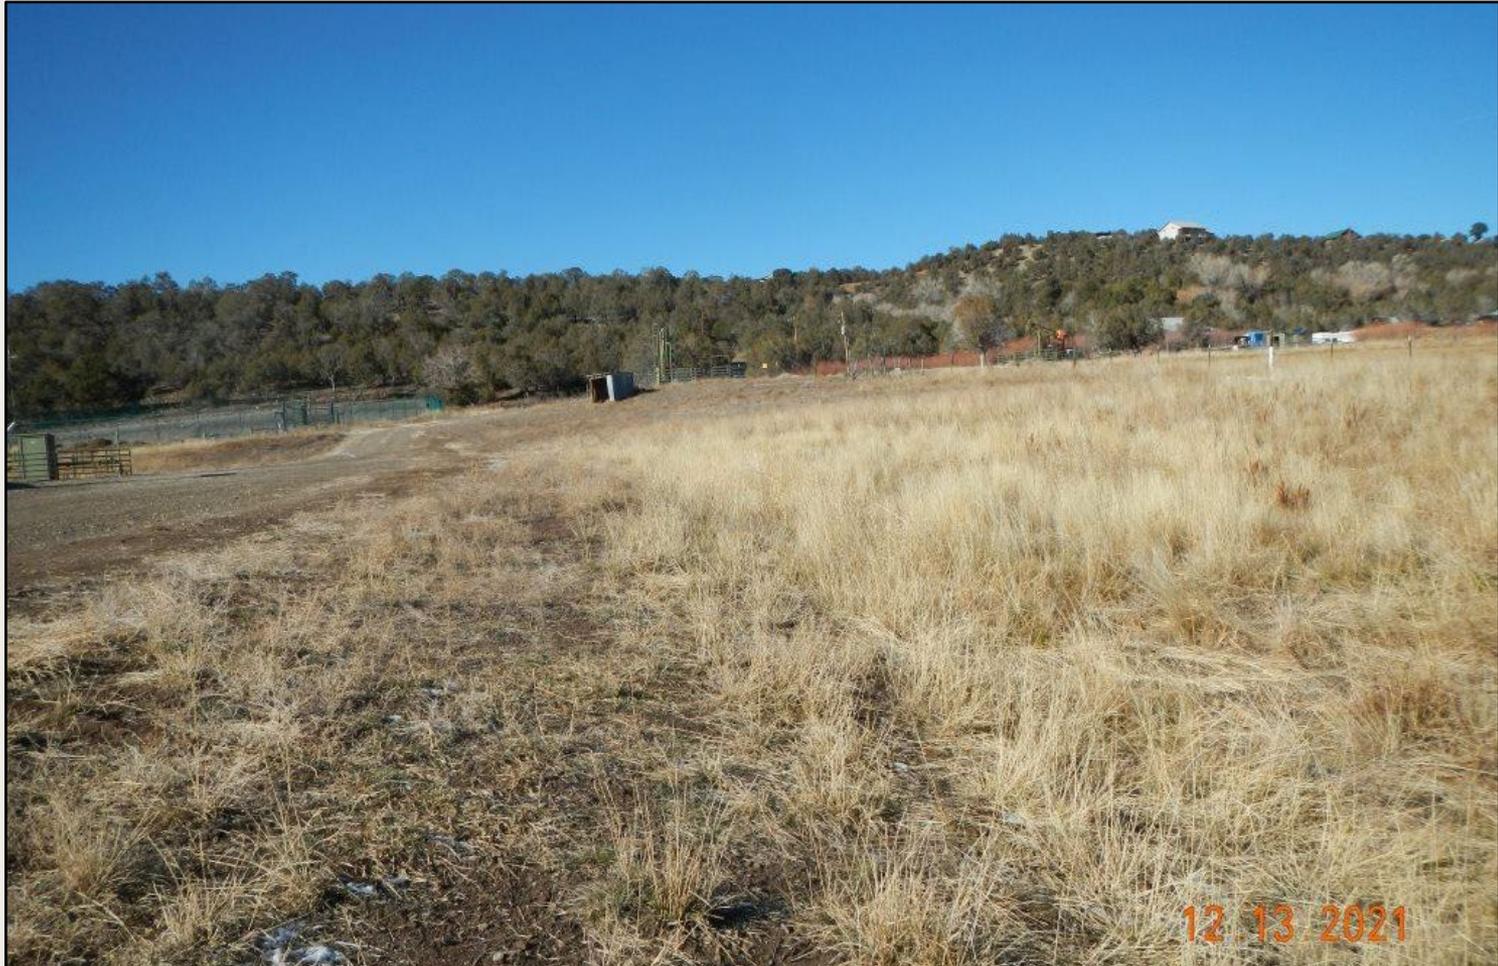
Photo 3. View of the northern project area from the northeastern corner facing westward.

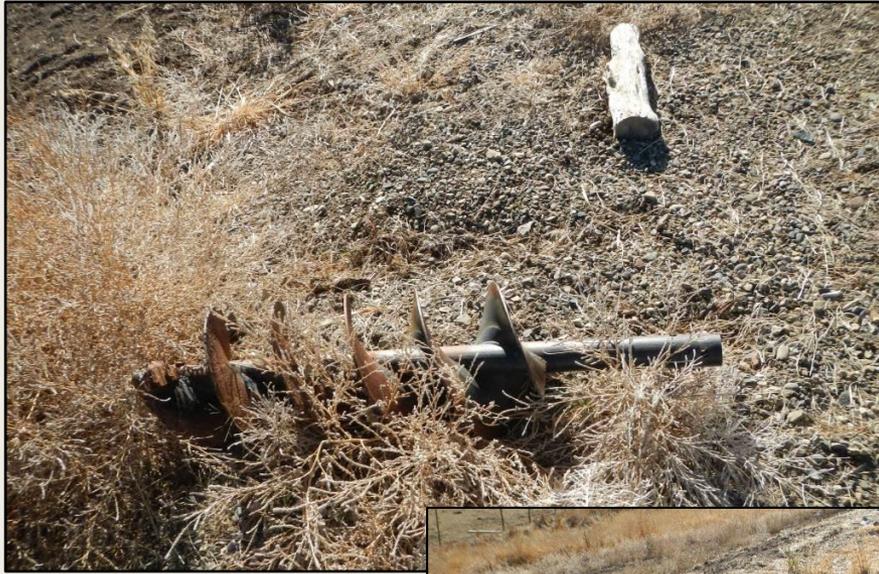
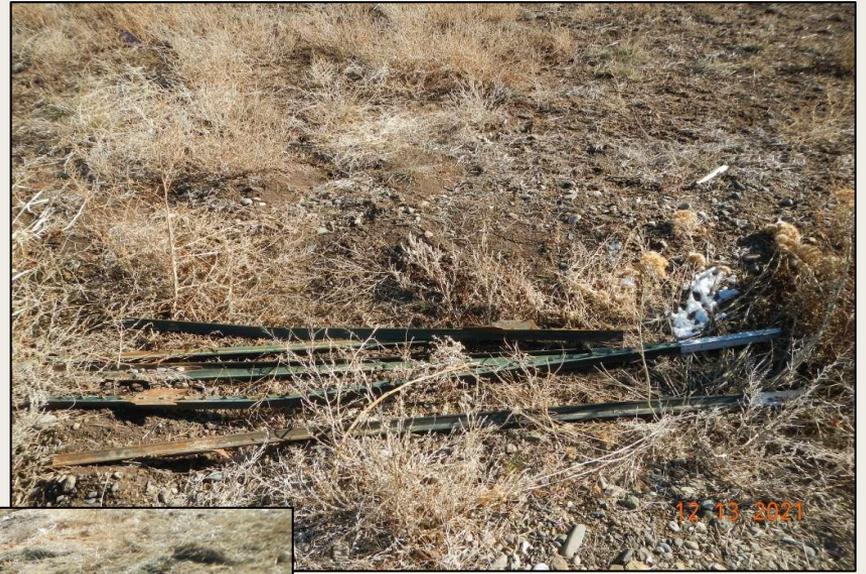
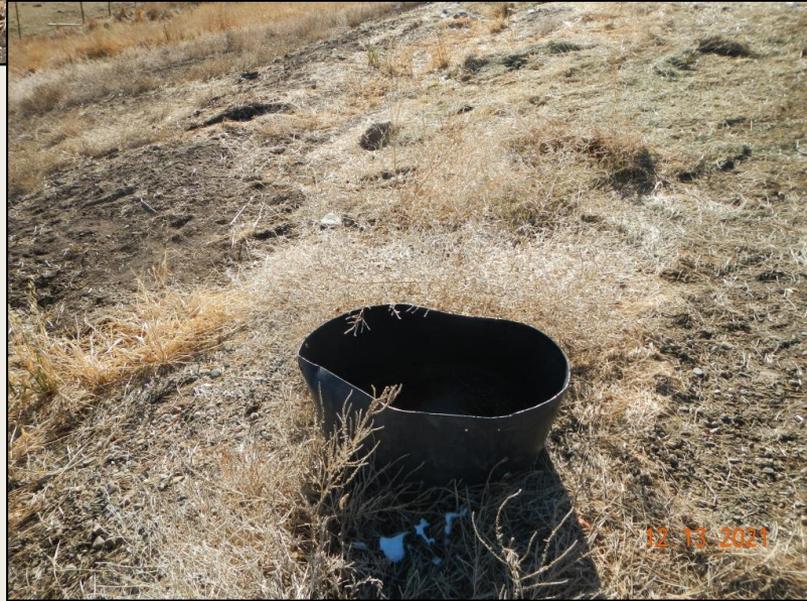
Photo 3. View of materials stored within the interim reclamation areas, need to be removed.

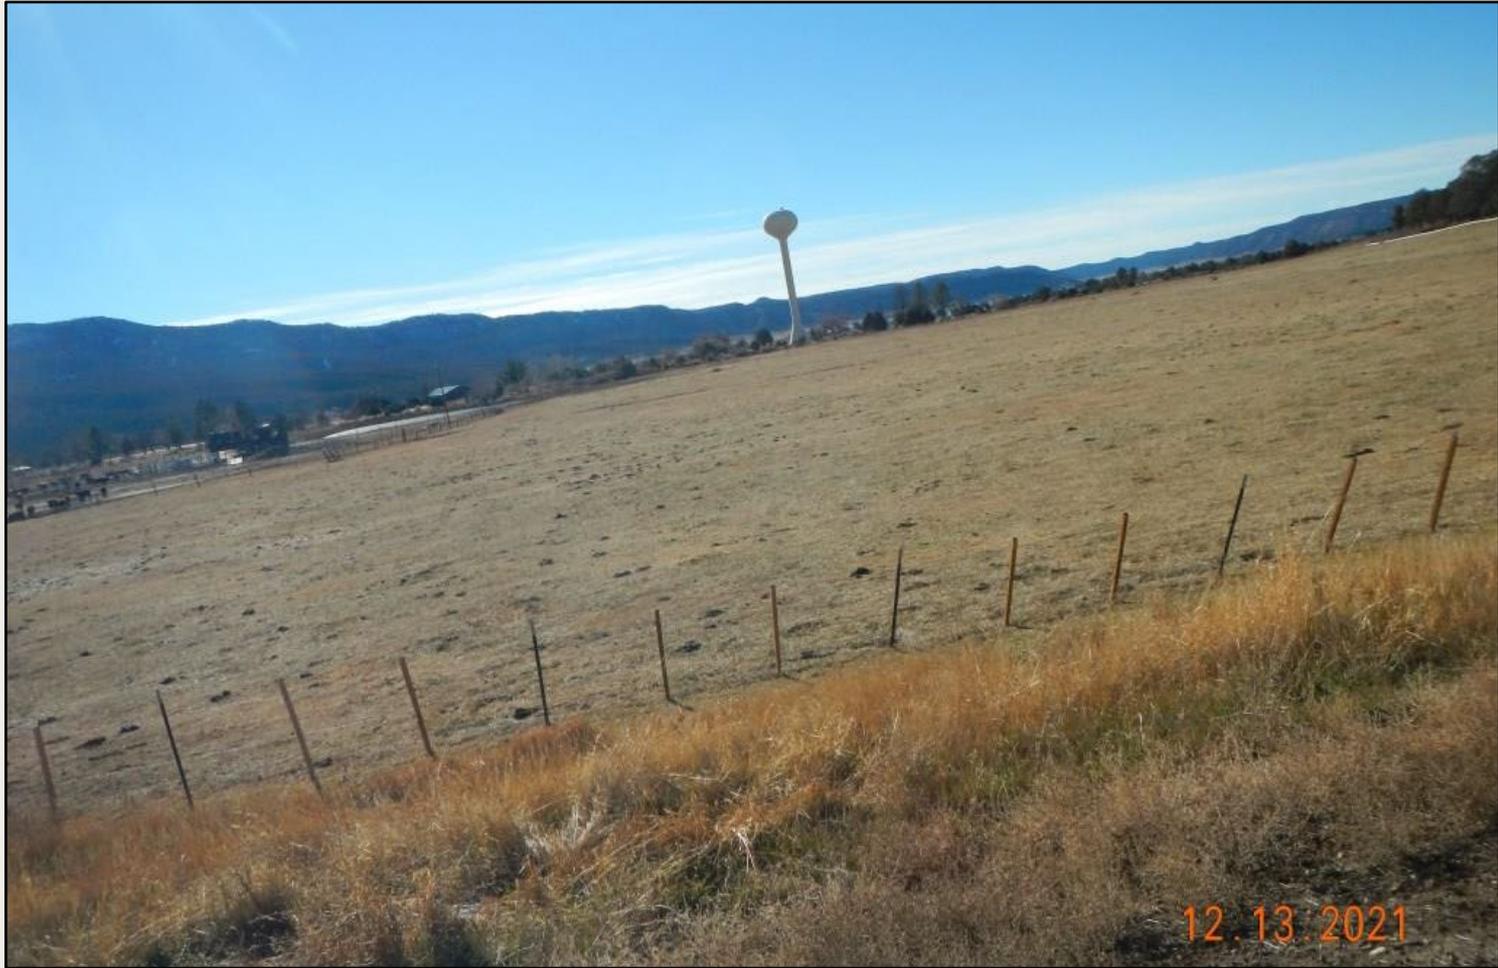
Photo 4. View of reference area (beyond fenceline) comprised irrigated grass field. Vegetation is largely dormant and grazed at this time.
