Inspection Photos
Operator: Simcoe
API: 007-06320
Date: 12/13/2021

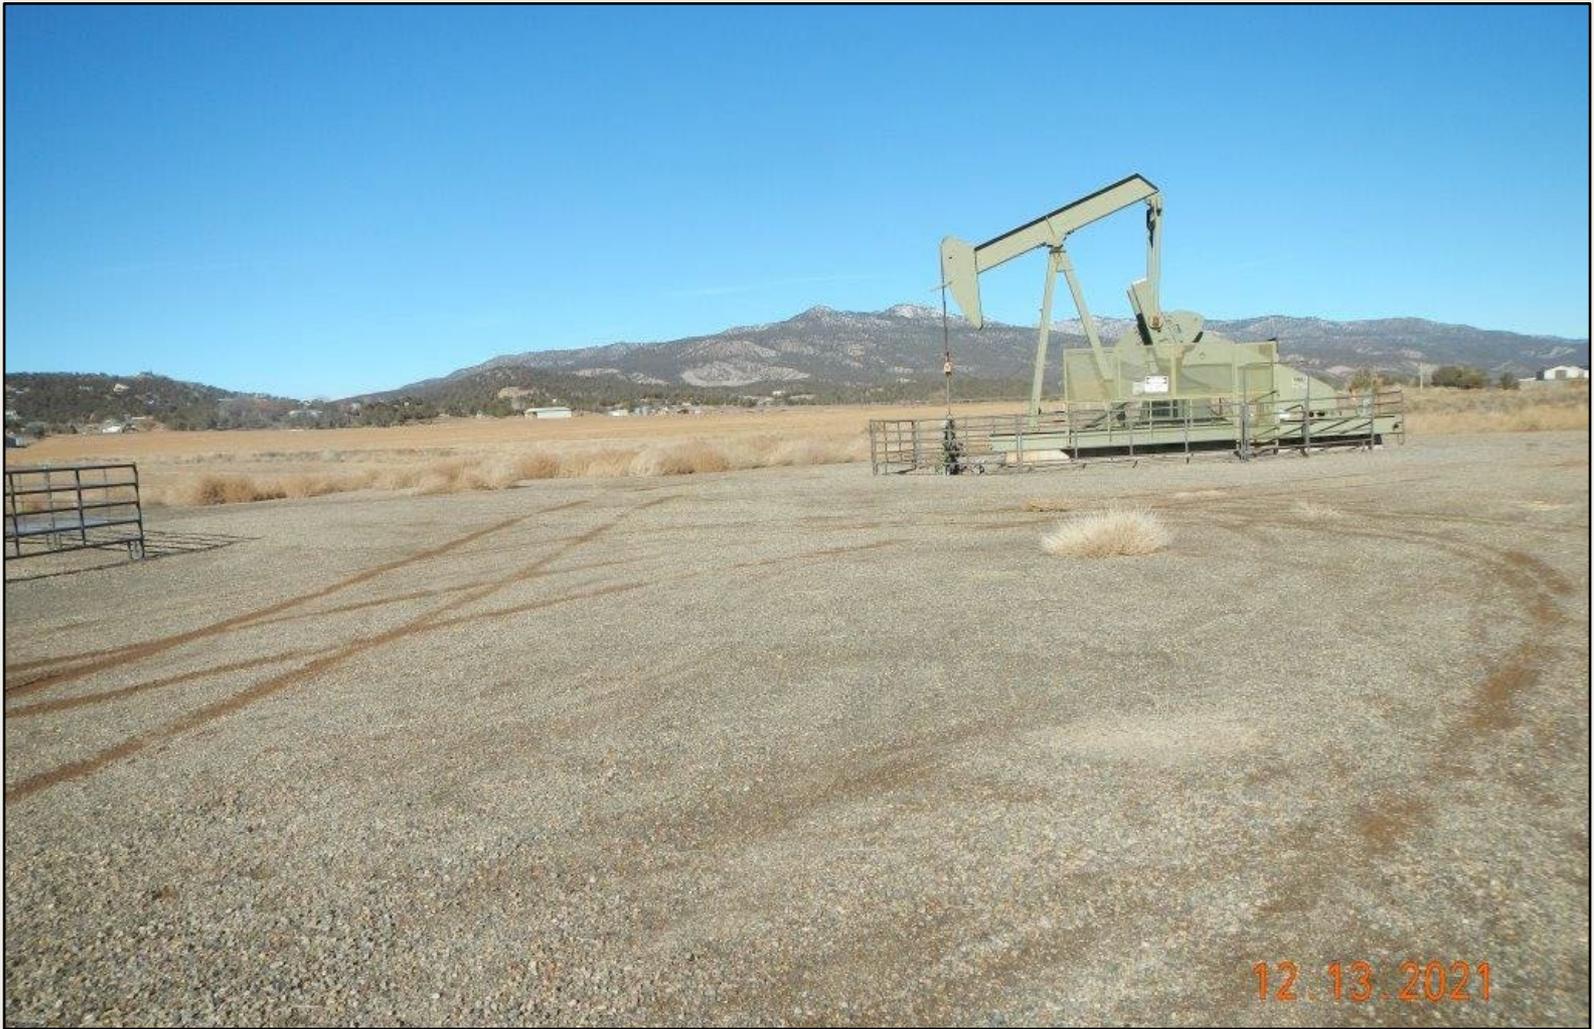
Photo 1. View of the project area from the well pad entrance facing center.

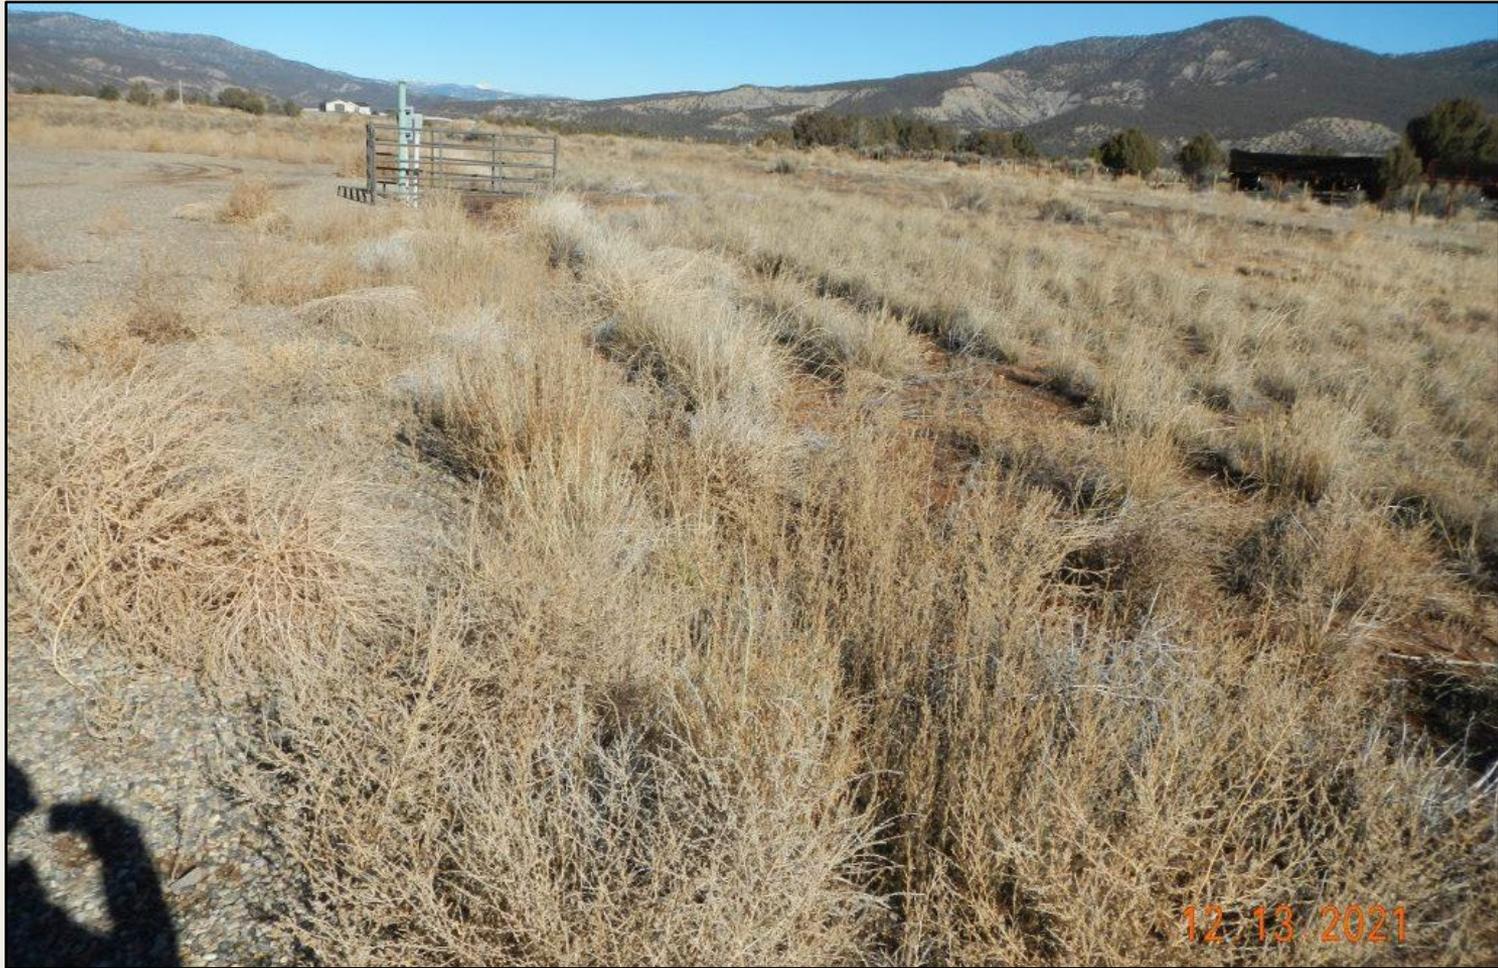
Photo 2. View of the eastern project area from the southeastern corner facing northward. Revegetation is progressing with western wheatgrass, crested wheatgrass, and sand dropseed.

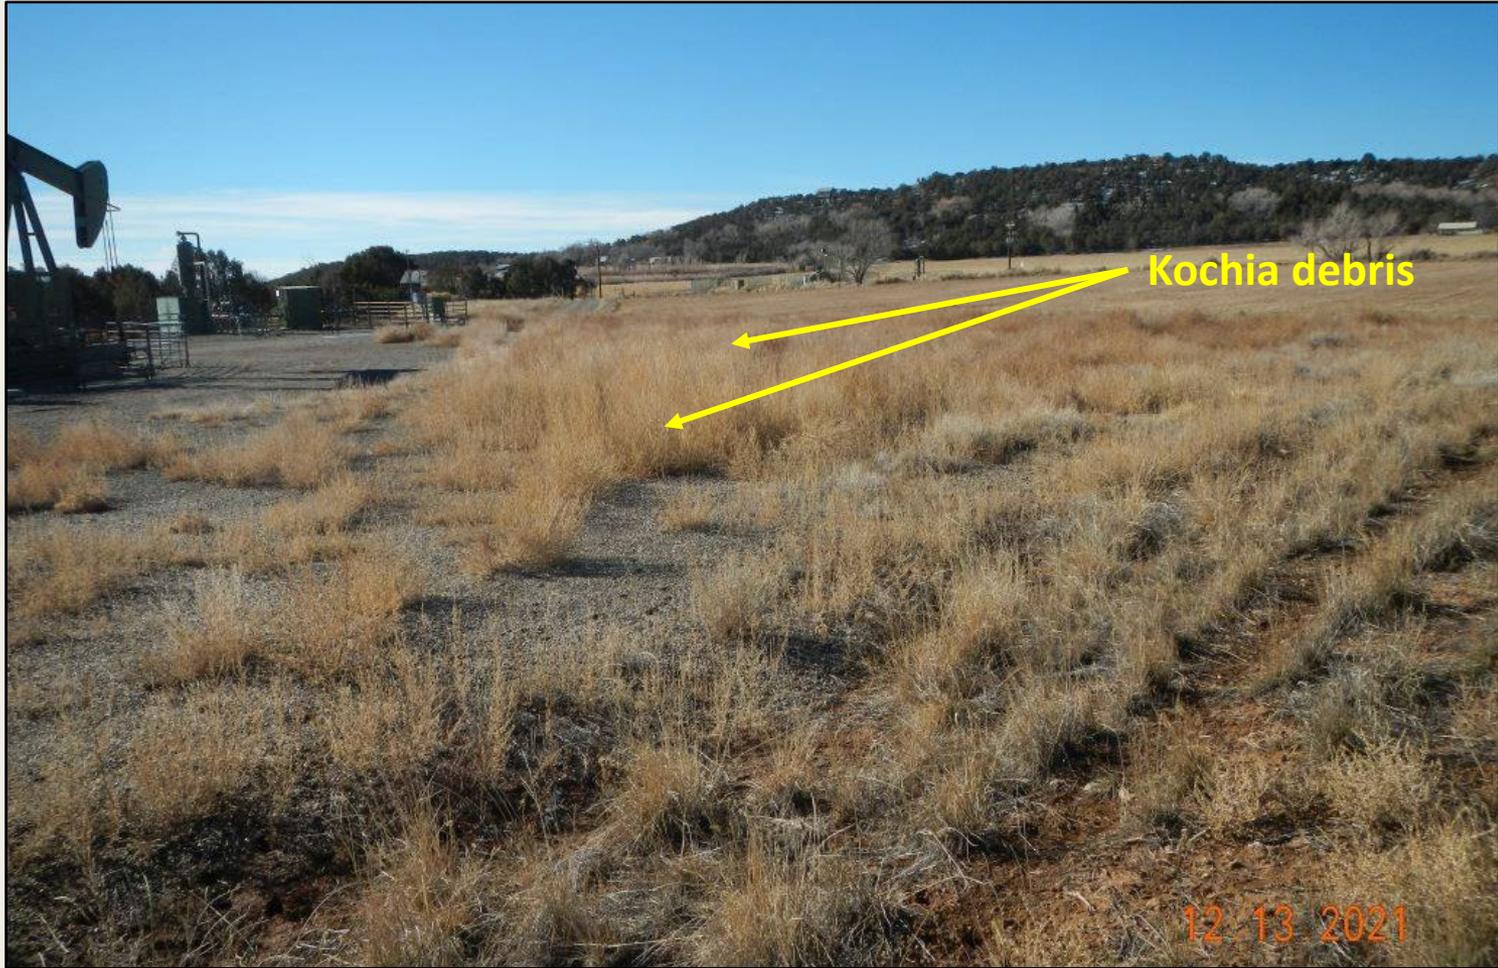
Photo 3. View of dense kochia debris within the northwestern project area.

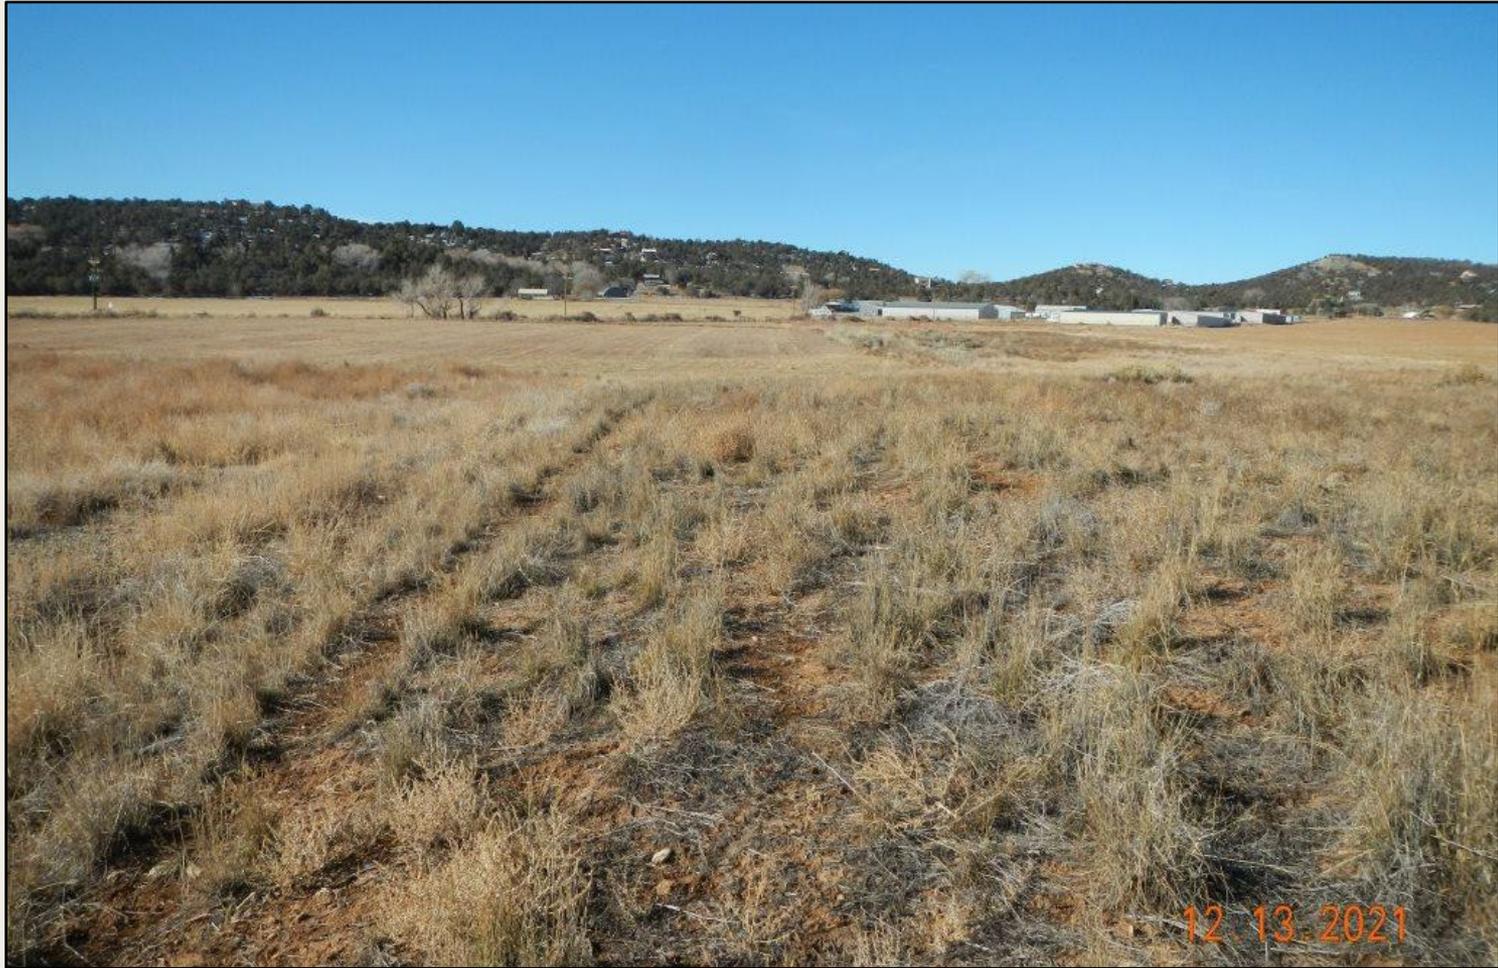
Photo 4. View of reference area comprised irrigated grass field. Vegetation is largely dormant and mowed at this time.
