Inspection Photos
Operator: Morningstar
API: 007-06196
Date: 12/13/2021

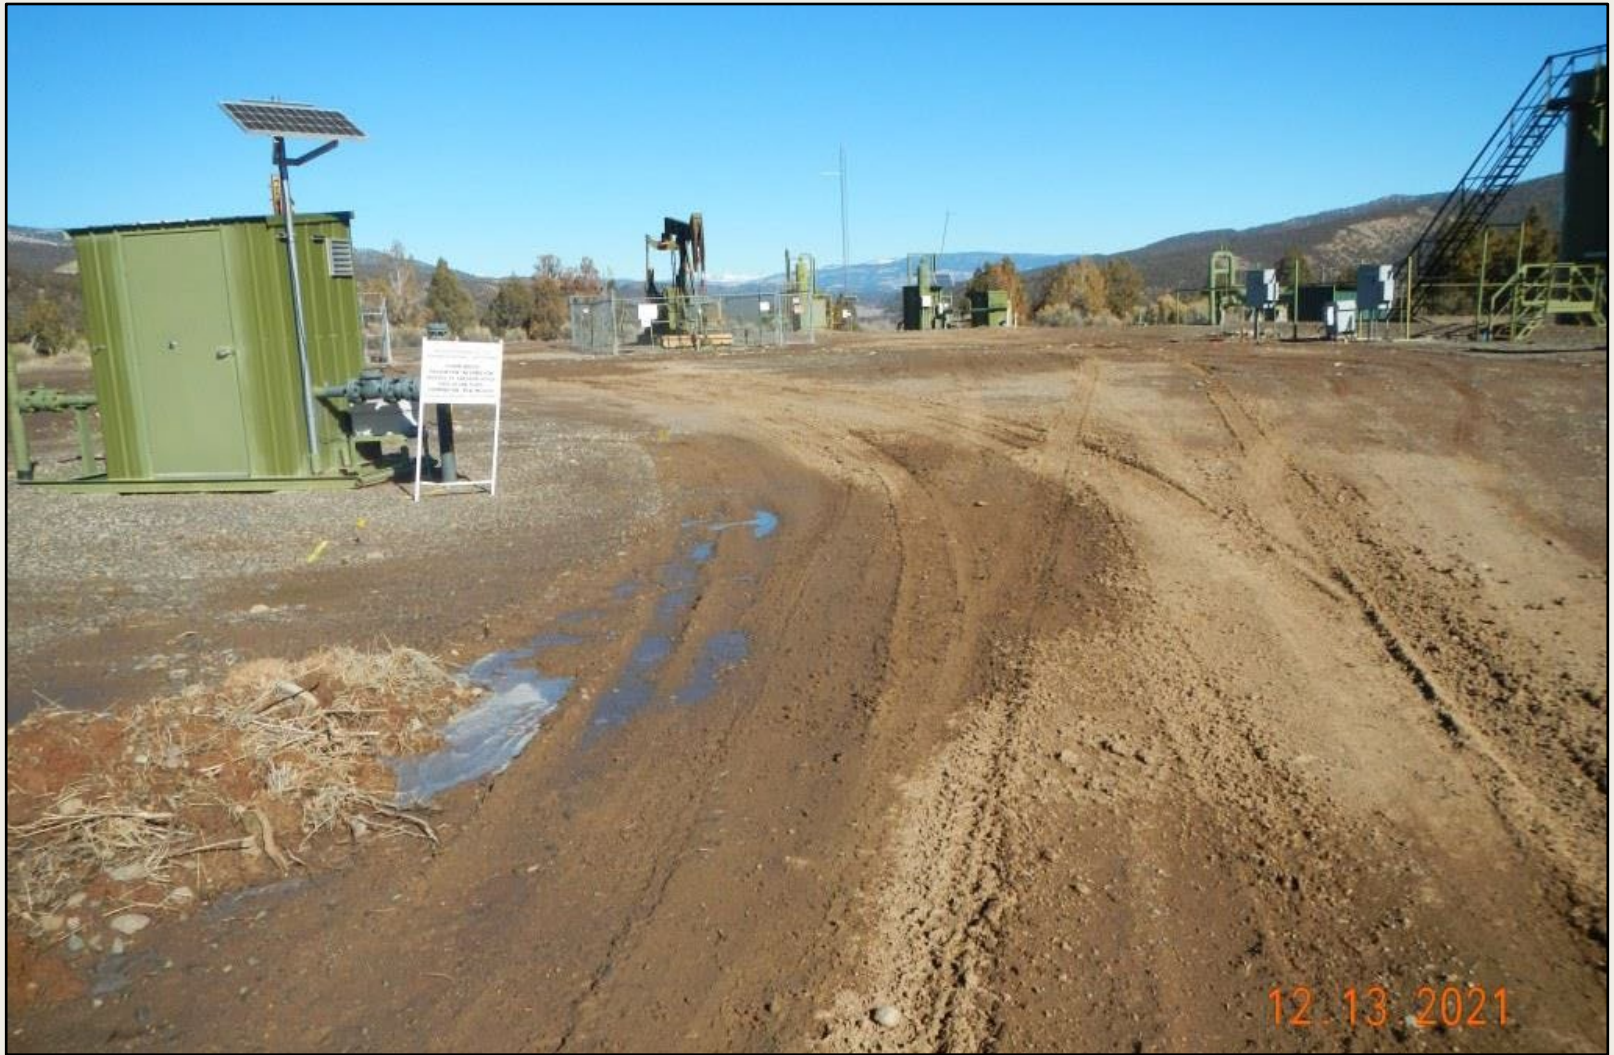
Photo 1. View of the project area from the northwestern corner facing center.

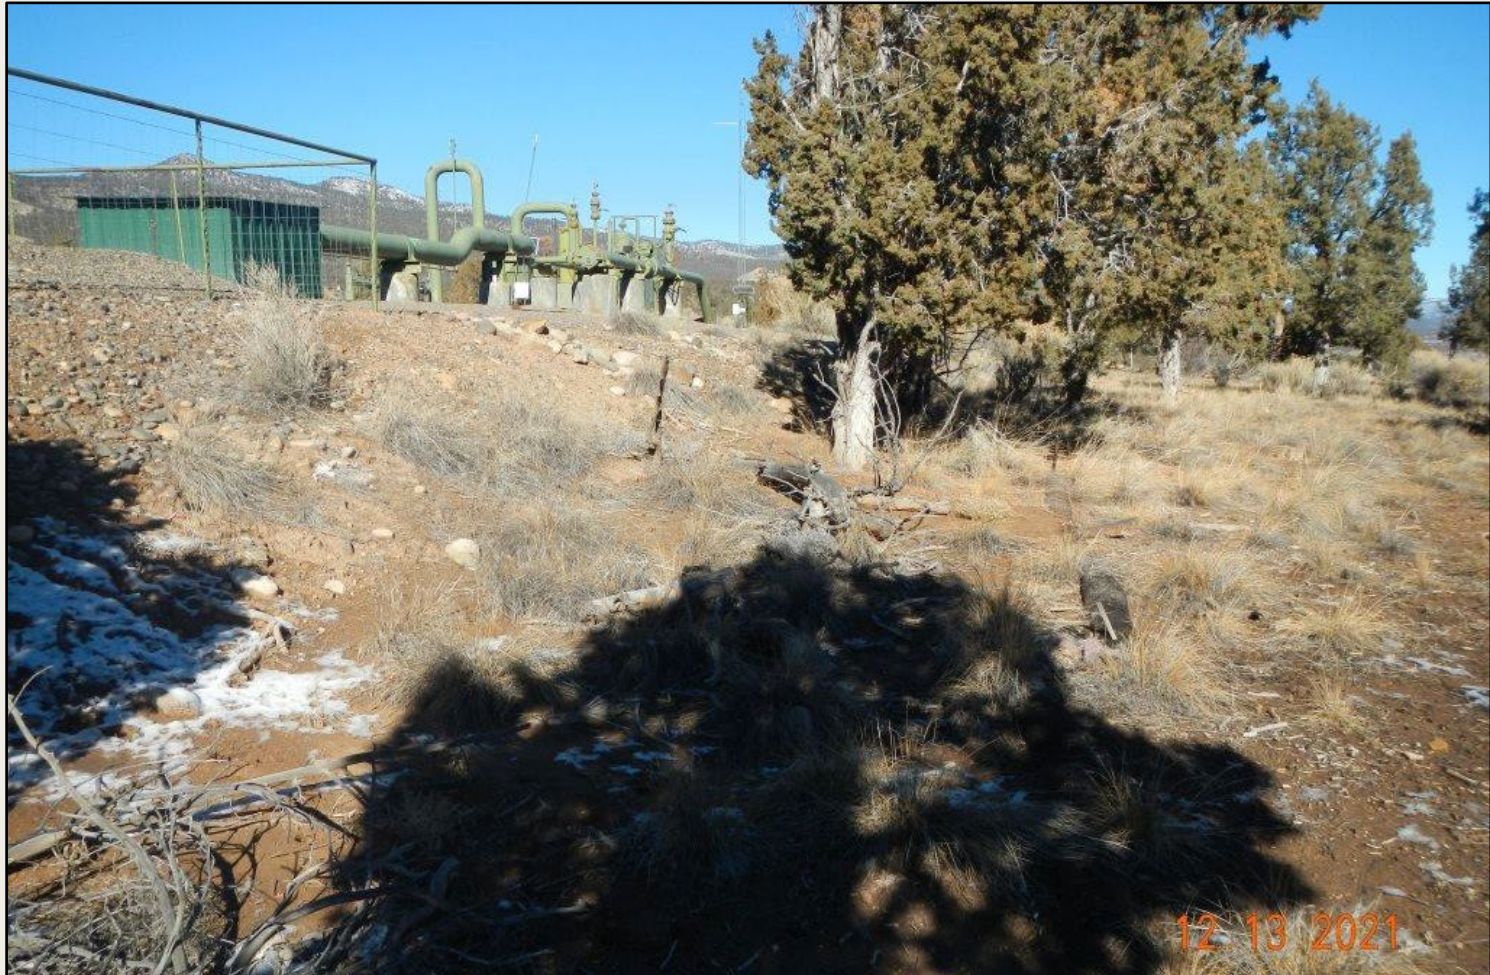
Photo 2. View of the southern project area from the southwestern corner facing eastward. Revegetation is progressing with Indian ricegrass, crested wheatgrass, and rubber rabbitbrush. Pinyon and juniper trees growing along the edges of the project area.

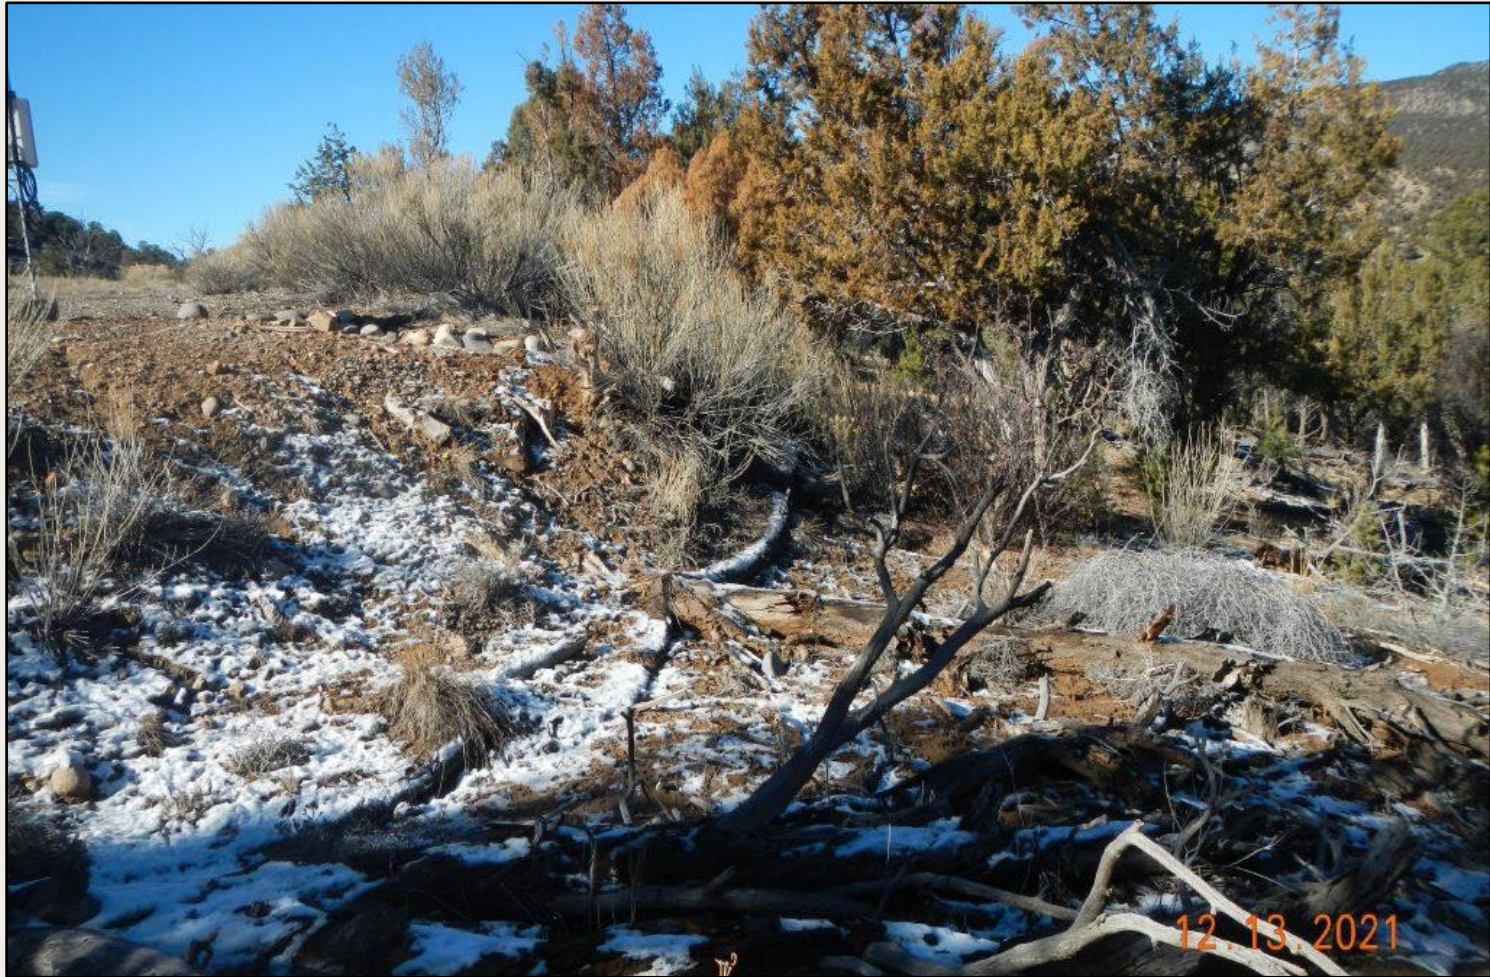
Photo 3. View of the eastern project area from the southeastern corner facing northward.

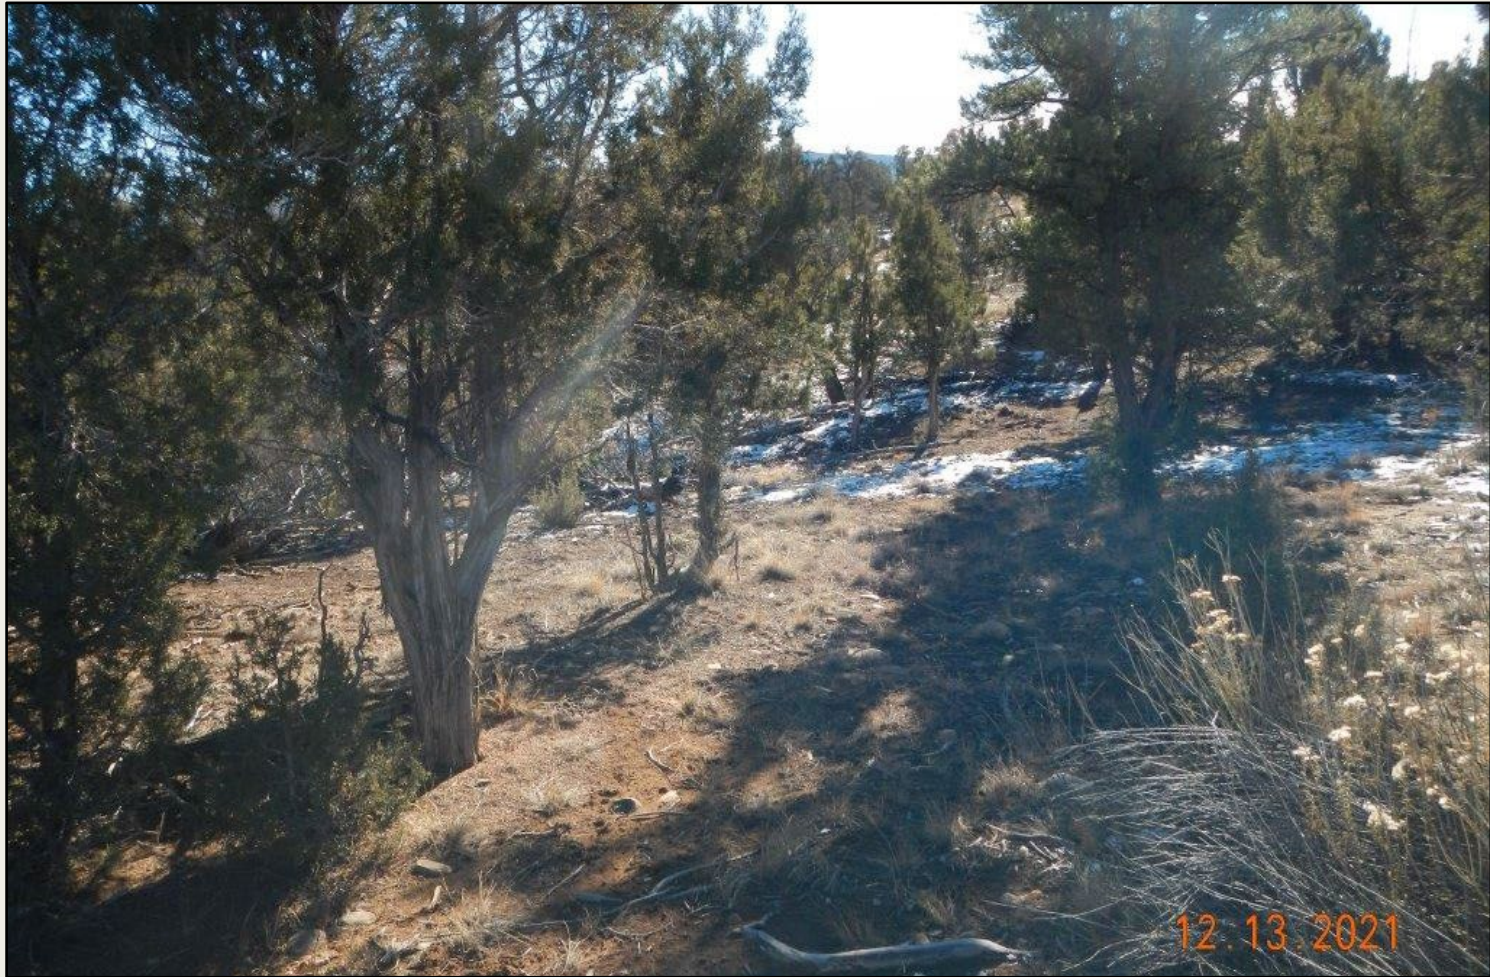
Photo 4. View of reference area comprised of pinyon and juniper woodland with understory of sagebrush, Indian ricegrass, blue grama, James galleta, and cholla.
