Inspection Photos  
Operator: Morningstar  
API: 007-06222  
Date: 12/13/2021

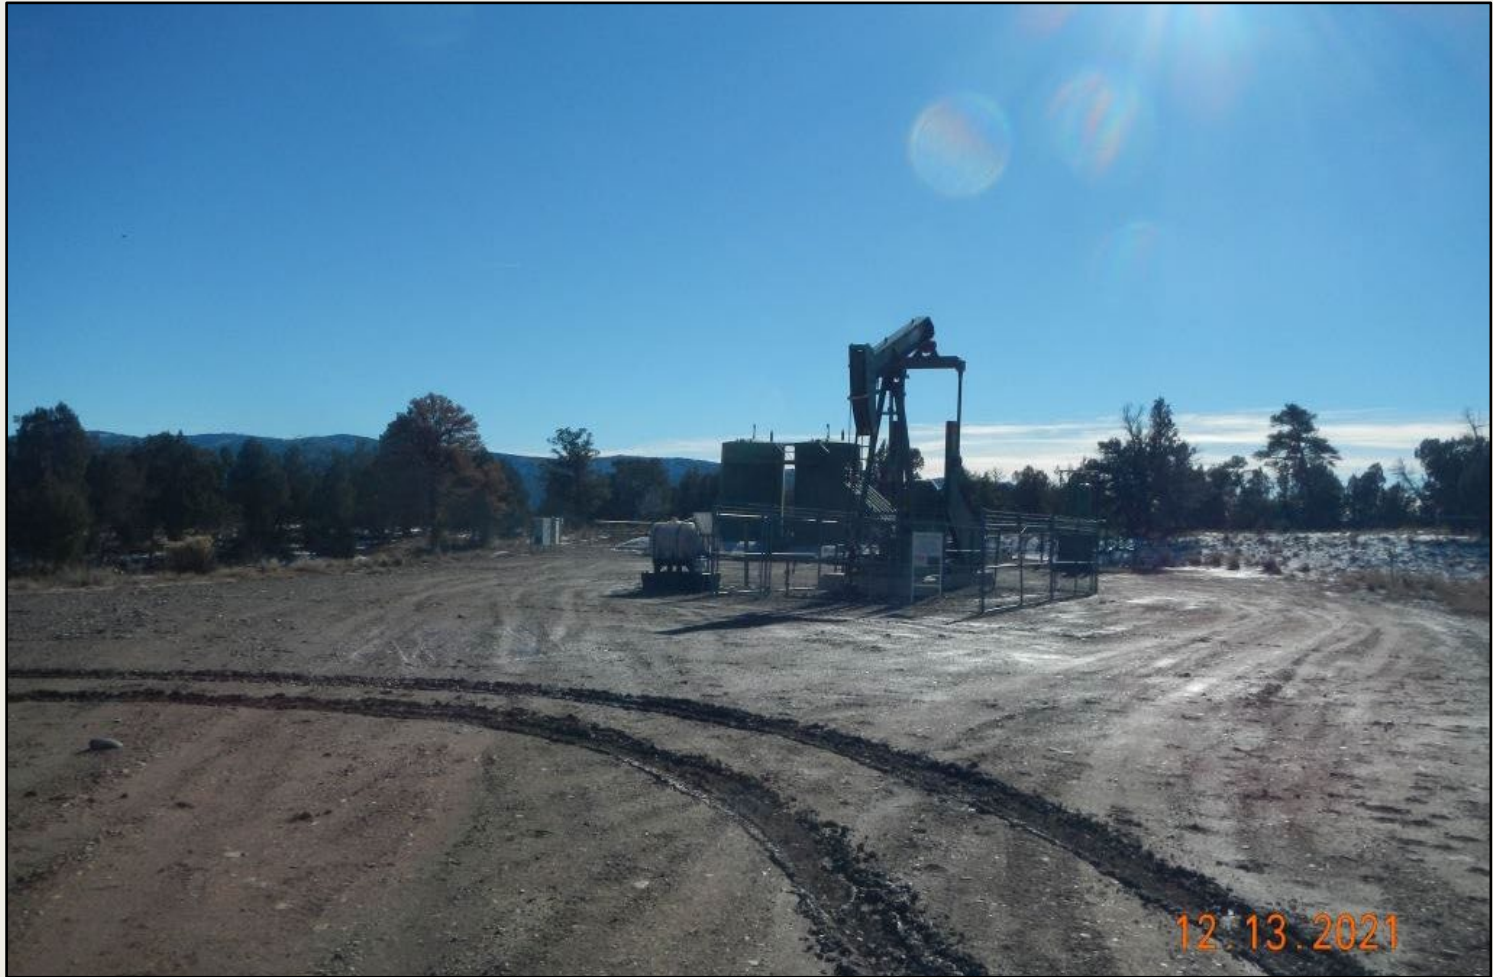
Photo 1. View of the project area from the northwestern corner facing center.

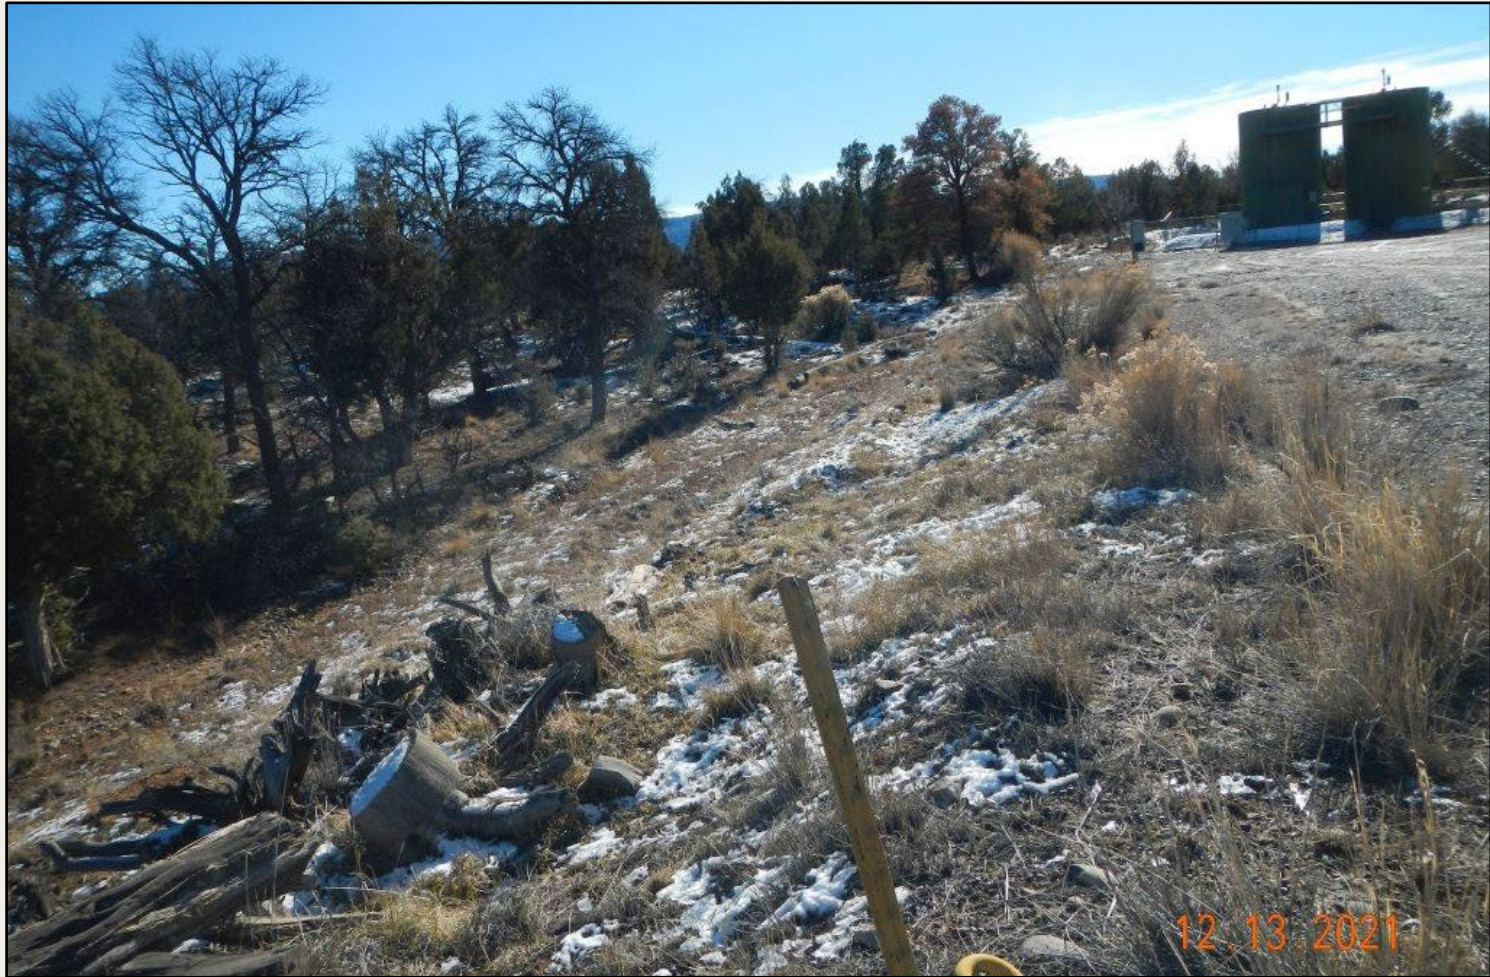
Photo 2. View of the southern project area from the southeastern corner facing westward. Revegetation is progressing with Indian ricegrass, crested wheatgrass, western wheatgrass, and rubber rabbitbrush. Pinyon and juniper trees growing along the edges of the project area.

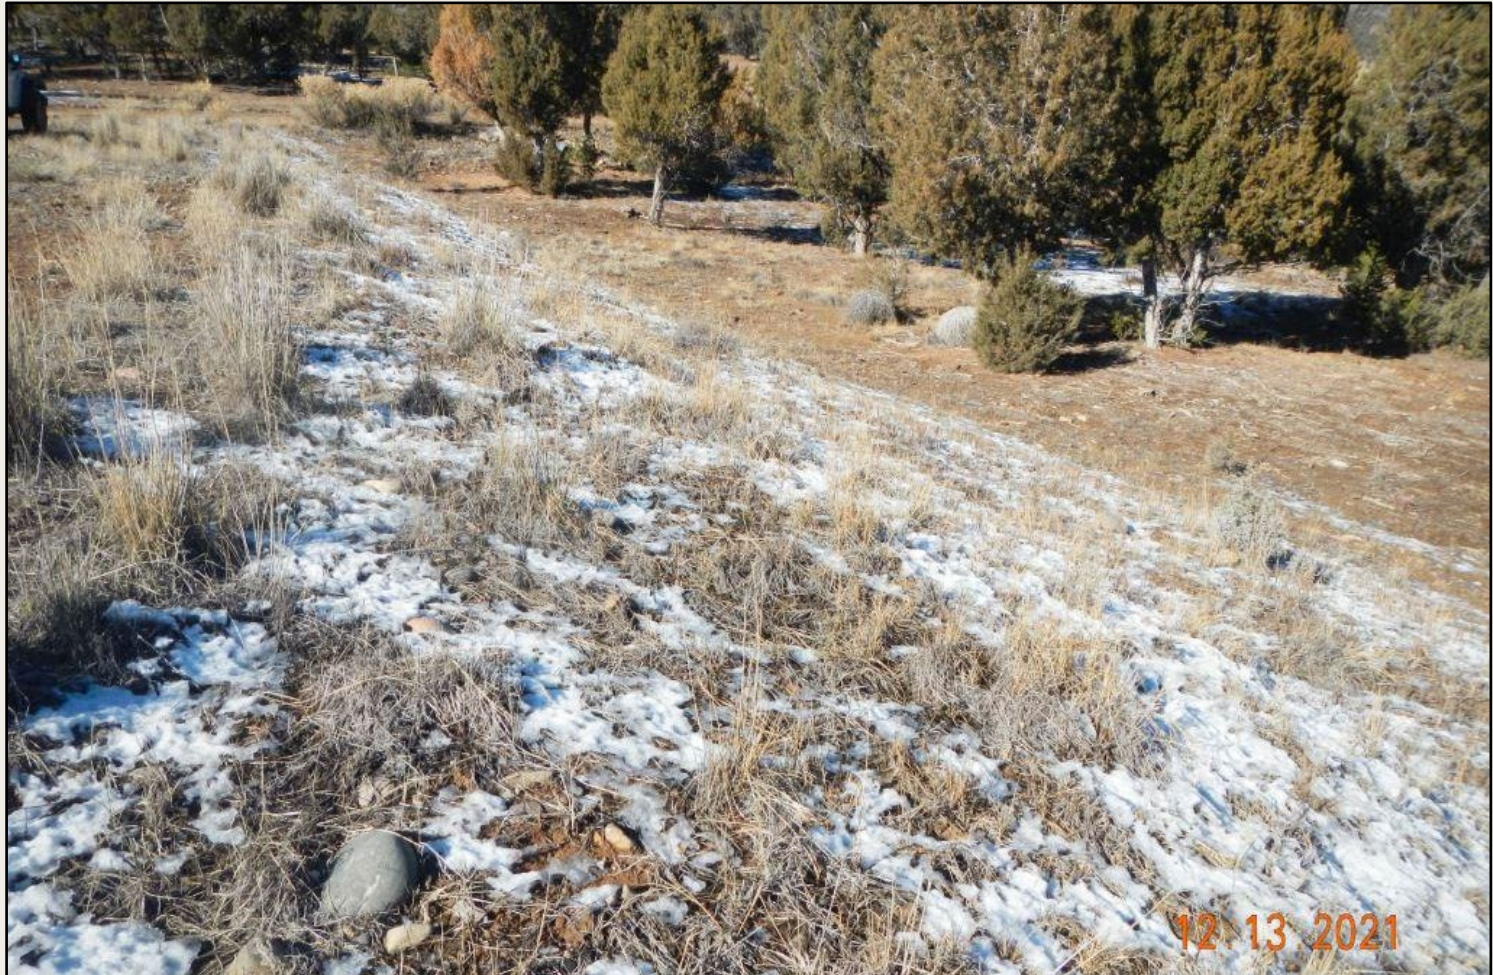
Photo 3. View of the eastern project area from the southeastern corner facing northward.
