Inspection Photos
Operator: Morningstar
API: 007-06268
Date: 12/13/2021

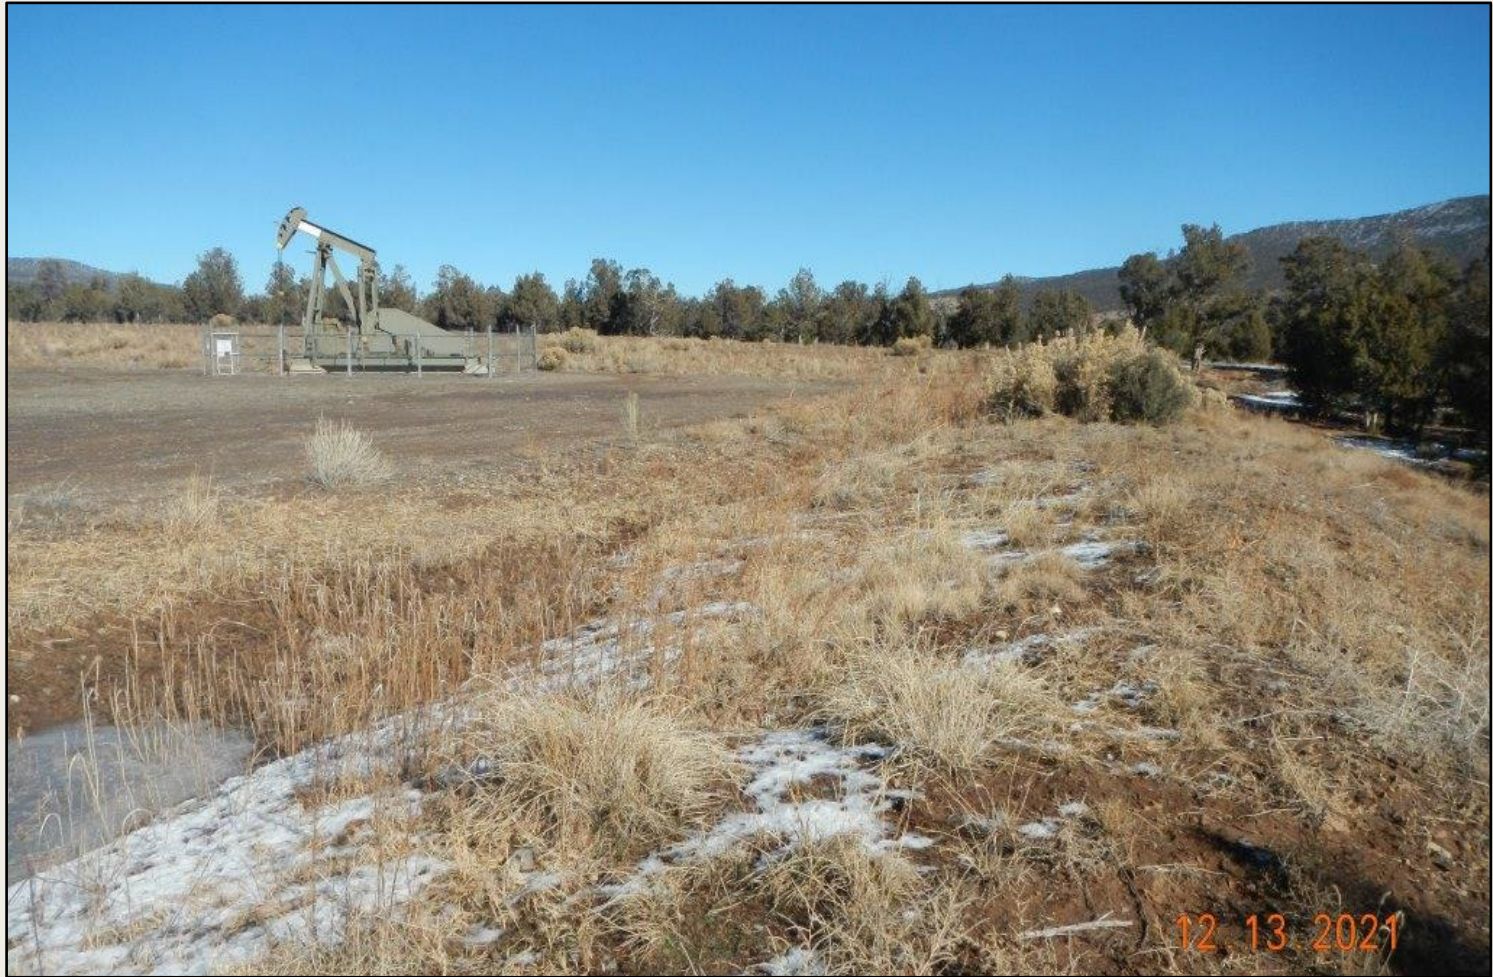
Photo 2. View of the southern project area from the southwestern corner facing eastward. Revegetation is progressing with Indian ricegrass, crested wheatgrass, western wheatgrass, and rubber rabbitbrush. Pinyon and juniper trees growing along the edges of the project area.

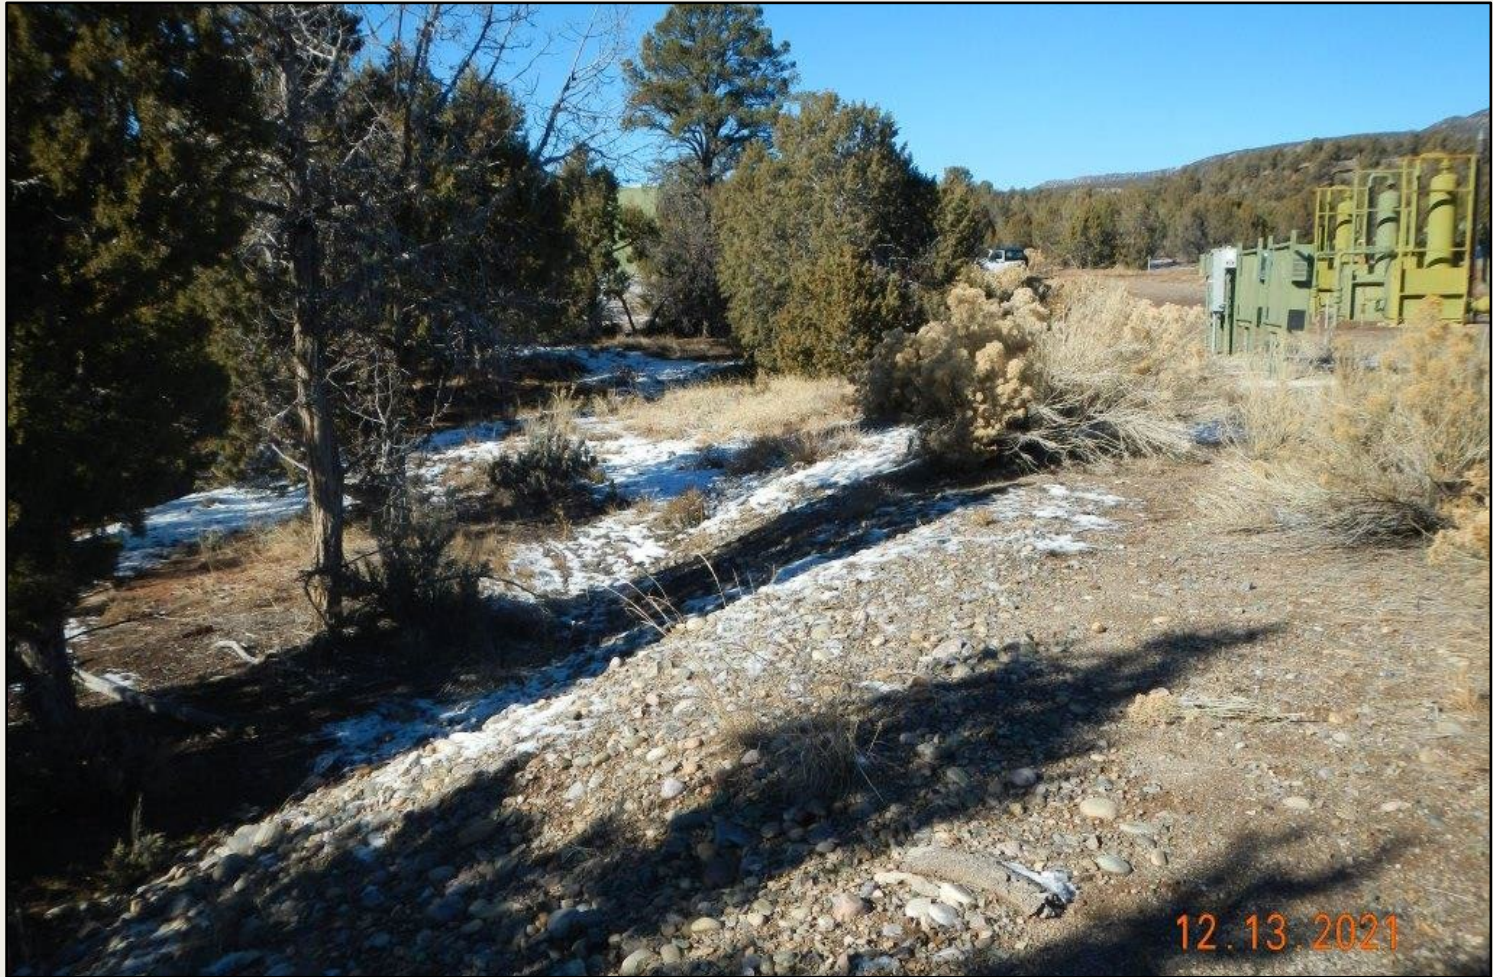
Photo 3. View of the western project area from the southwestern corner facing northward.
