**Inspection Photos**  
**Operator: Morningstar**  
**API: 007-06183**  
**Date: 12/13/2021**

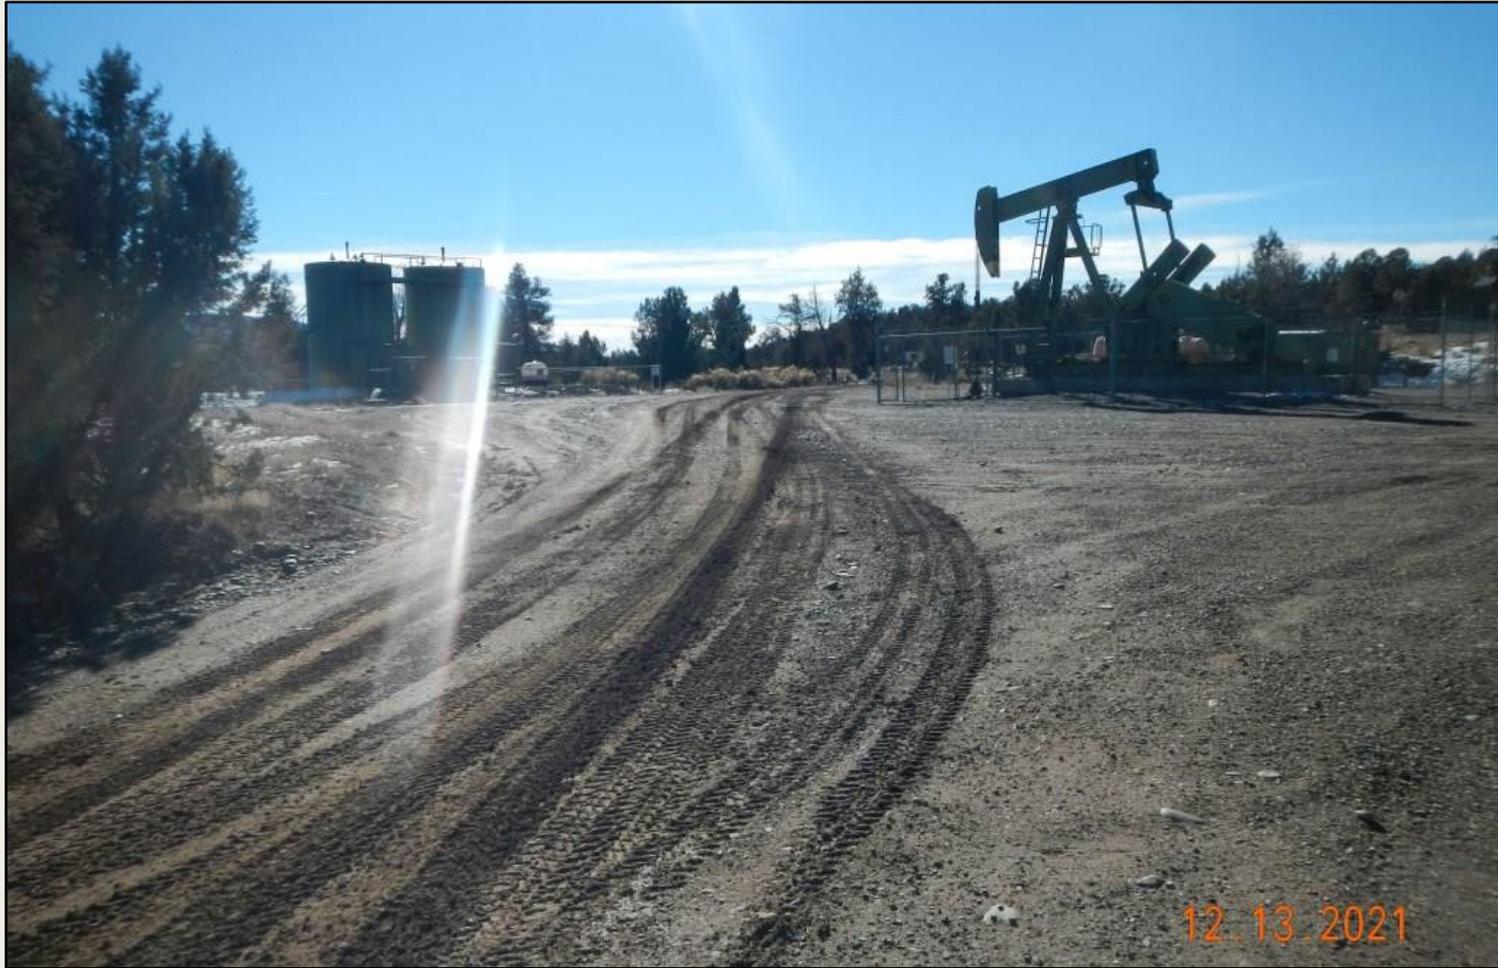
Photo 1. View of the project area from the eastern entrance, facing center.

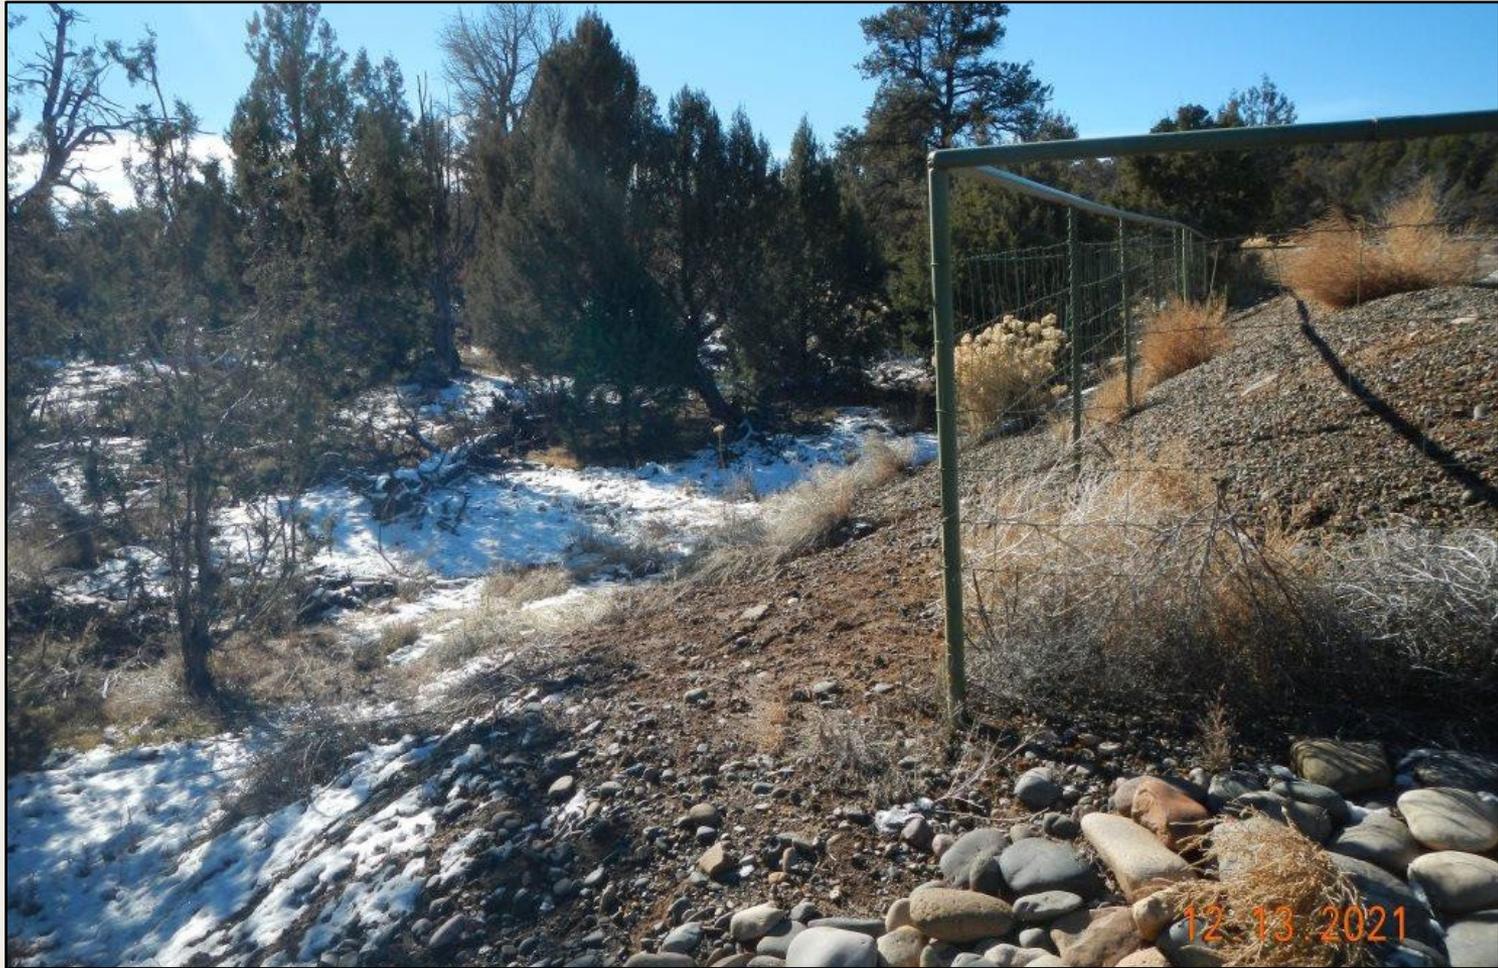
Photo 2. View of the southern project area from the southeastern corner facing westward. Revegetation is progressing with Indian ricegrass, crested wheatgrass, western wheatgrass, and rubber rabbitbrush. Pinyon and juniper trees growing along the edges of the project area.

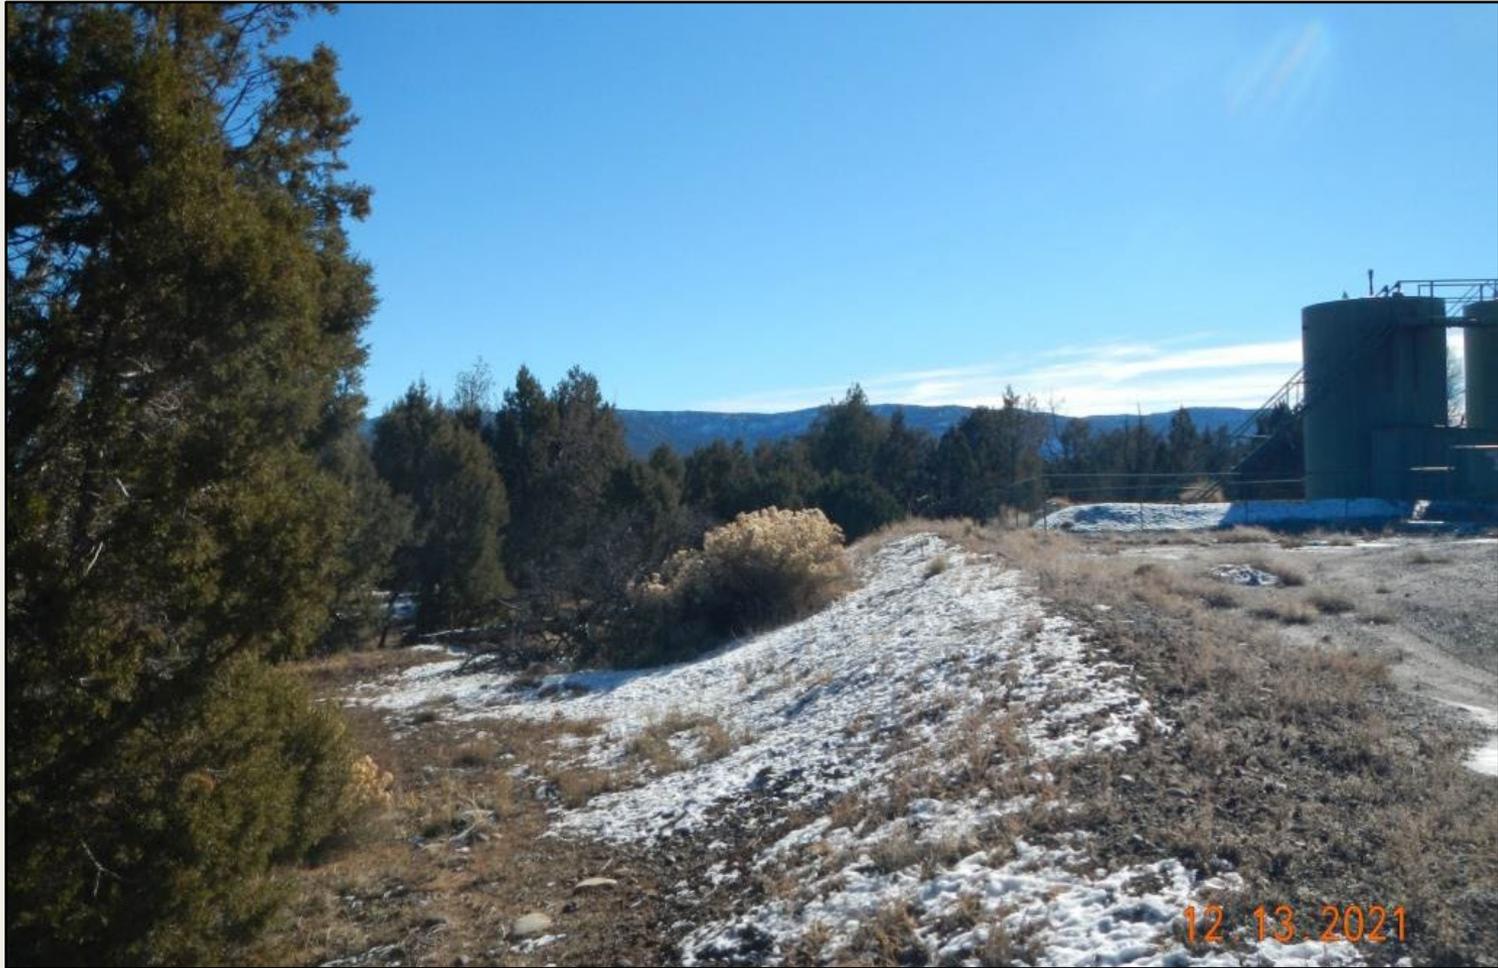
Photo 3. View of the eastern project area from the northeastern corner facing southward.

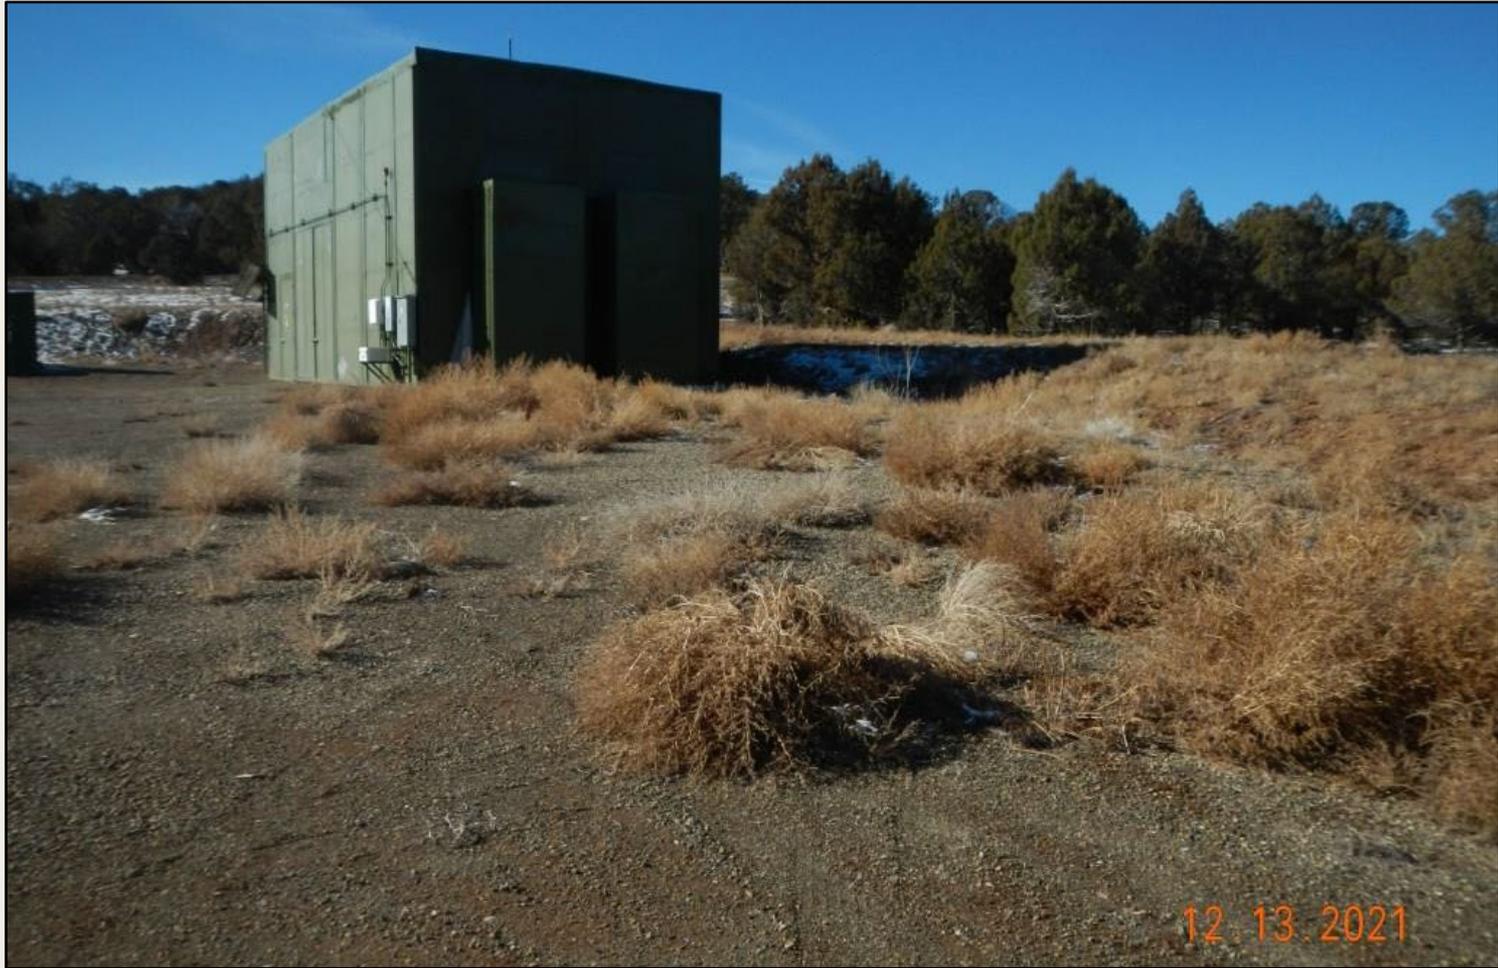
Photo 4. View of Russian thistle debris within the northeastern project area, needs to be removed and properly disposed of.

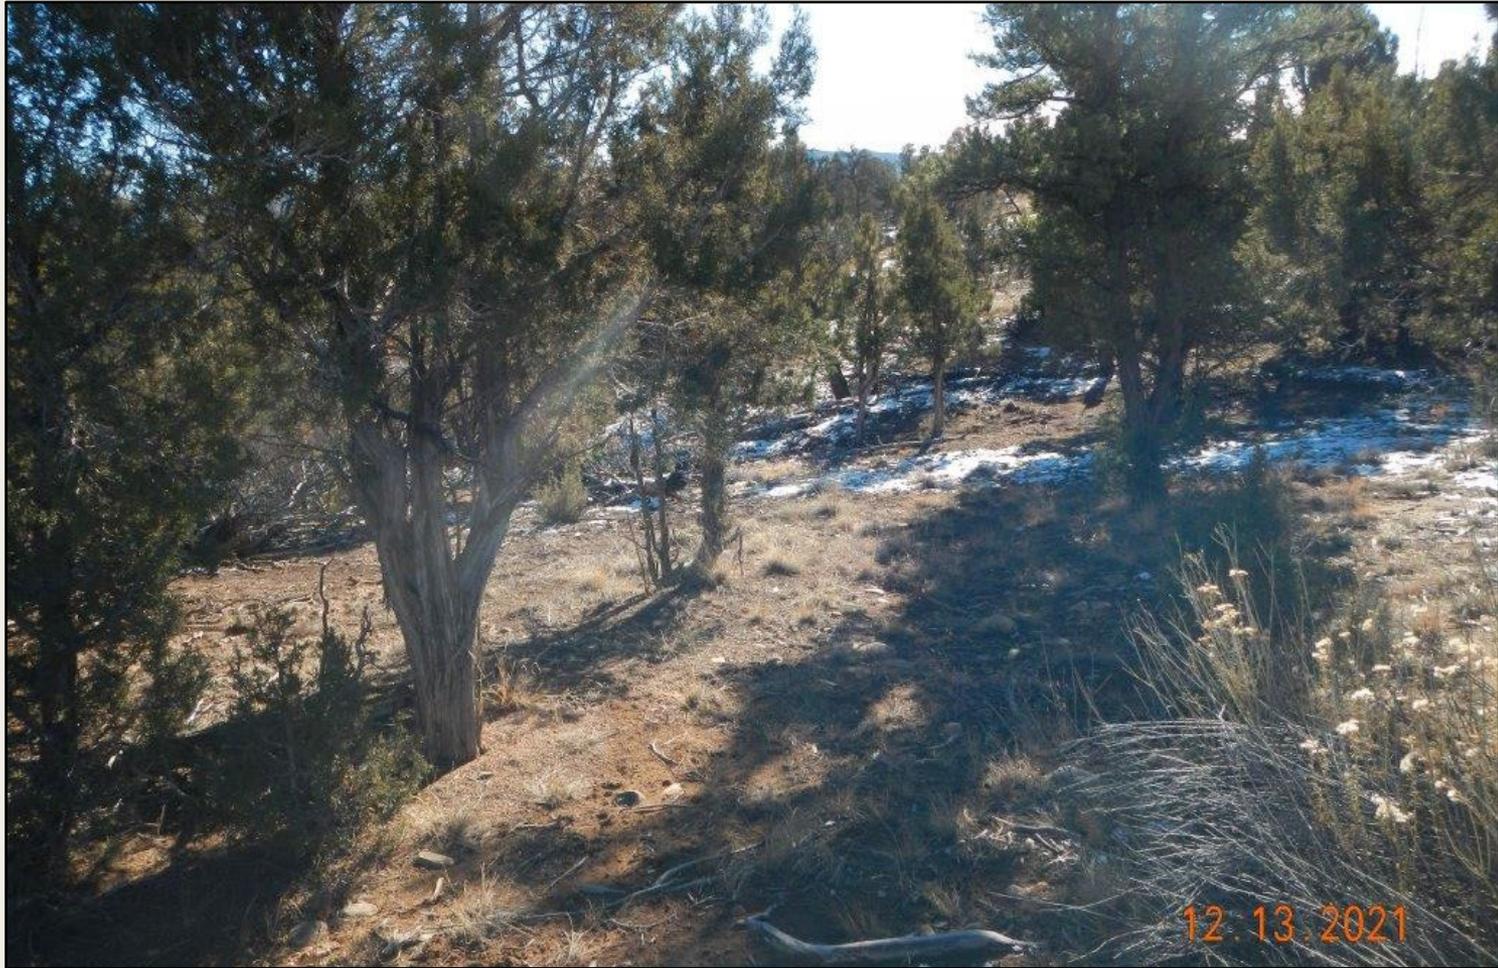
Photo 5. View of reference area comprised of pinyon and juniper woodland with understory of sagebrush, Indian ricegrass, blue grama, James galleta, and cholla.
