Inspection Photos

API: 043-06141

Operator: JAVERNICK OIL

Inspection Date: 12/14/2021

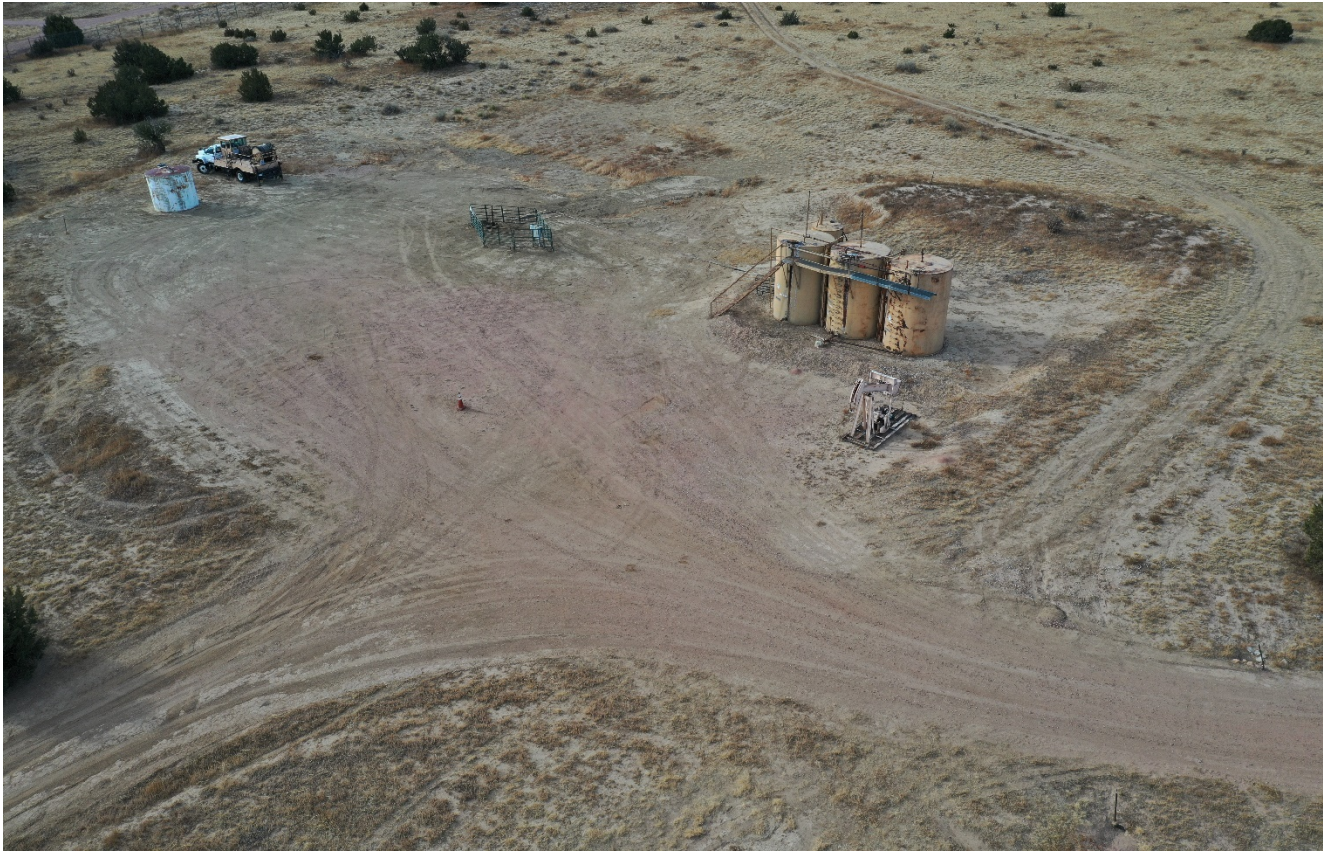
Photo 1. Drone aerial photo facing southwest toward the well site. Most of the unused equipment previously observed has been removed. There is still a pumpjack, tank, and truck that needs to be removed.

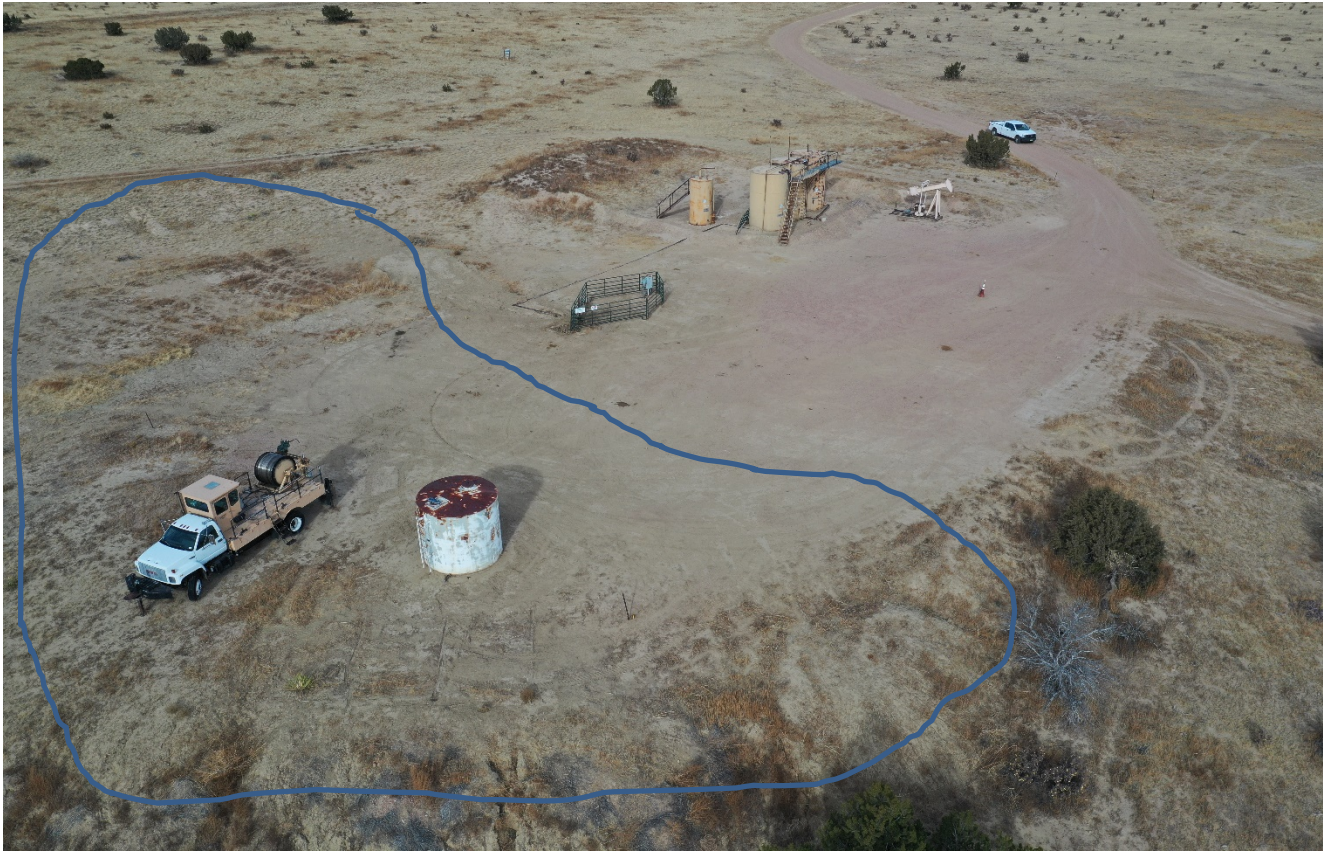
Photo 2. Drone aerial photo facing northwest toward the well site. There is a truck and tank that needs to be removed. Unused areas circled need to be recontoured and reclaimed per 1003 Rules.

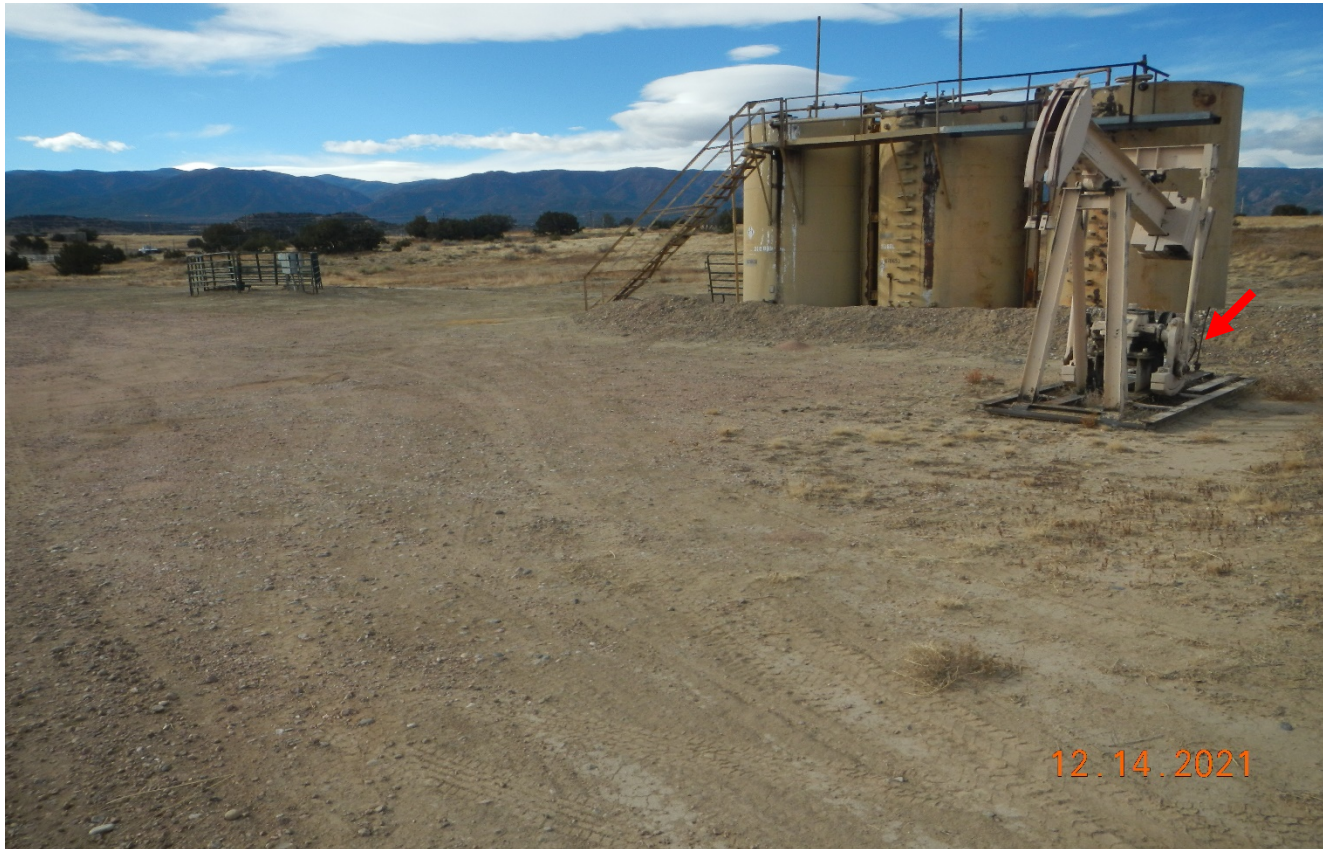
Photo 3. Facing southwest at the well site. The pumpjack has been disconnected from the well and needs to be removed.

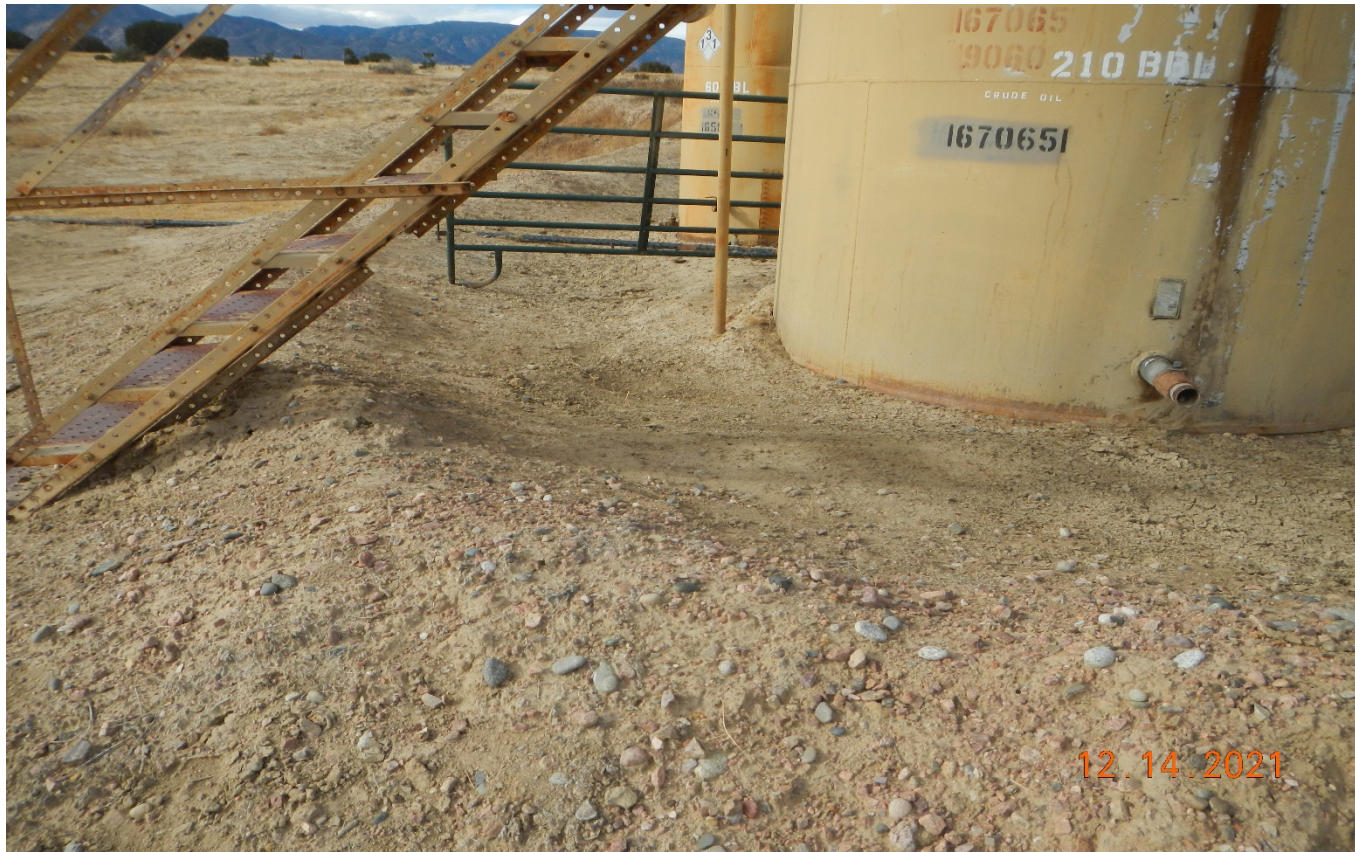
Photo 4. The buckets of oil have been removed and cleaned up.

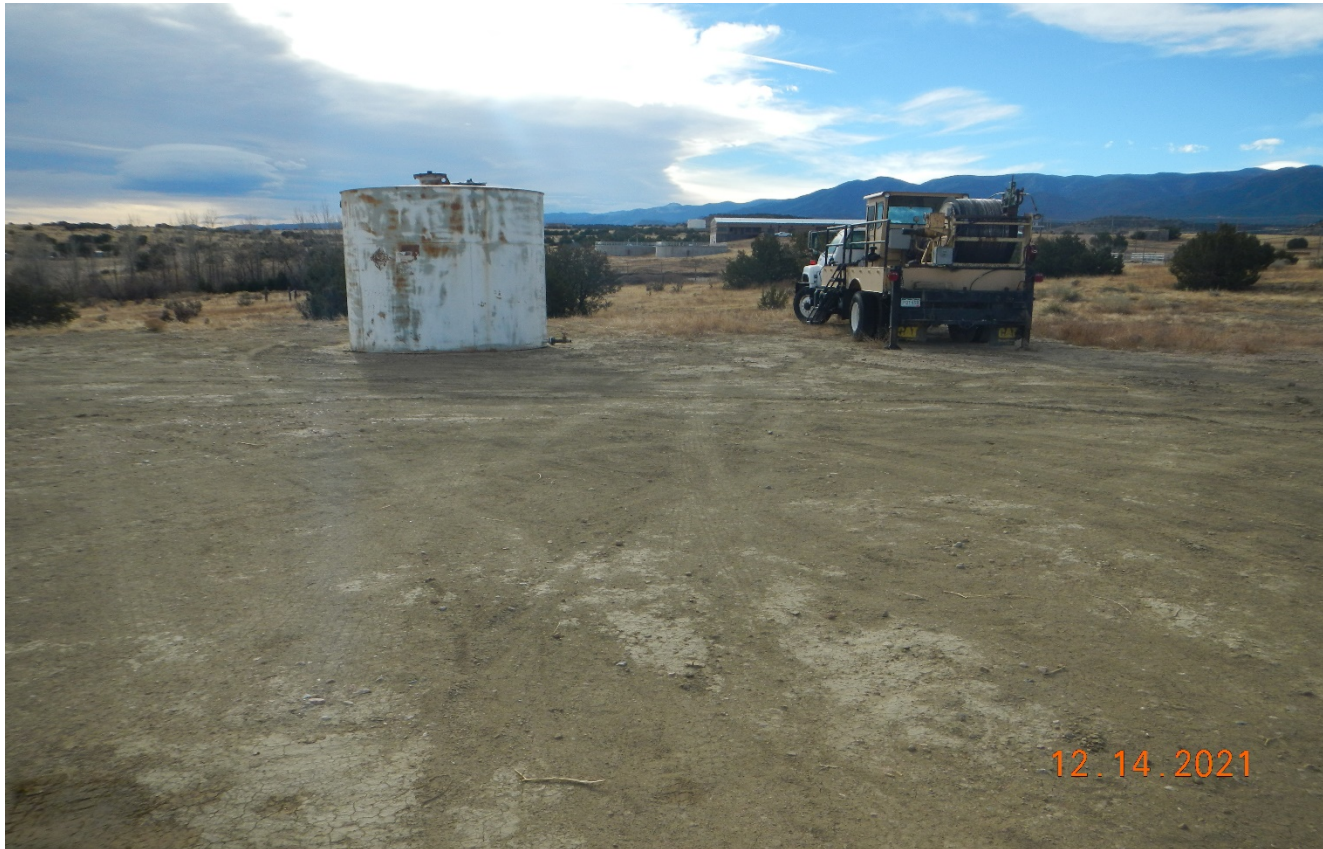
Photo 6. Facing southwest at the south side of the location. There is a tank and truck that needs to be removed.
