Inspection Photos

API: 043-40001

Operator: JAVERNICK OIL

Inspection Date: 12/14/2021

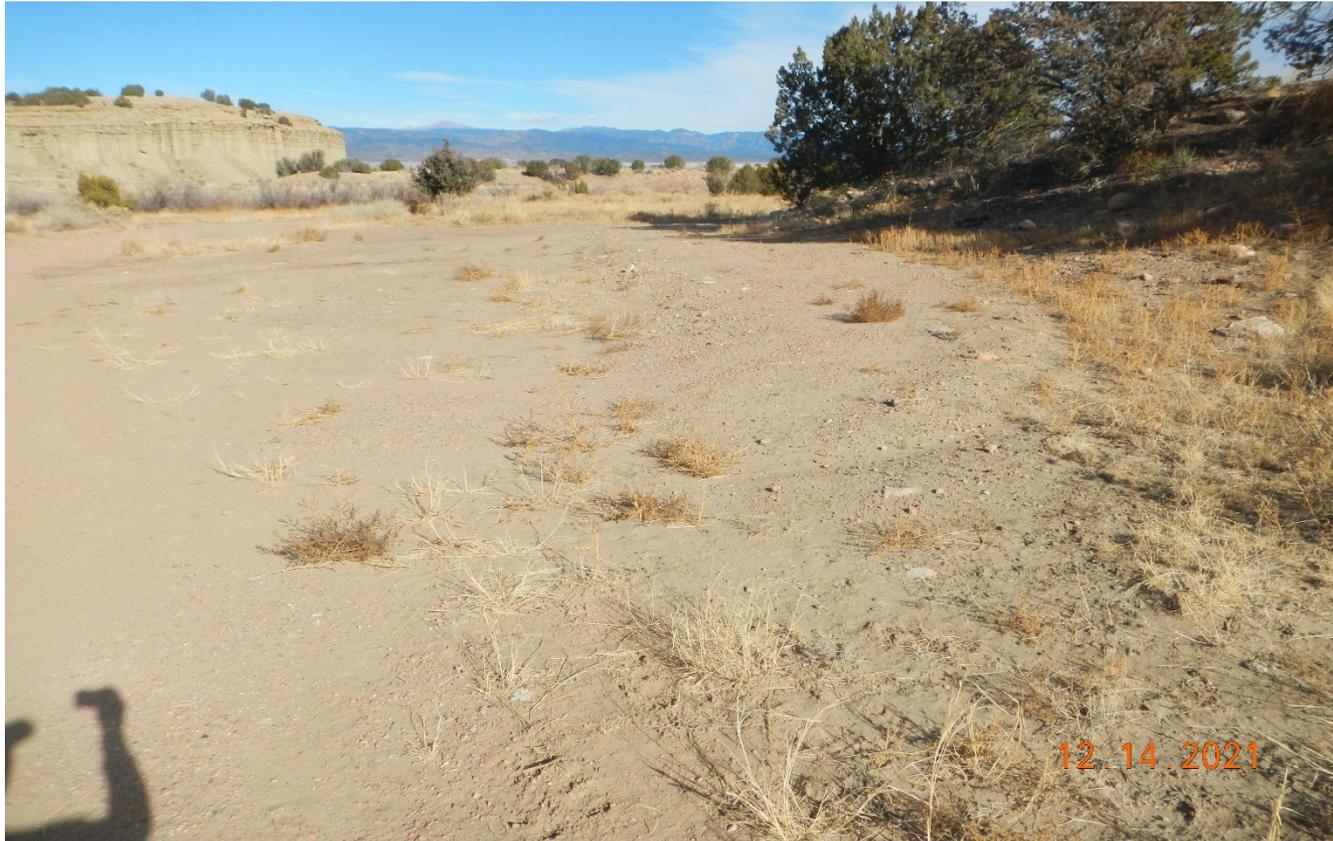
Photo 1. Facing north at the abandoned well site. The location has not been reclaimed and soils are bare of vegetation.

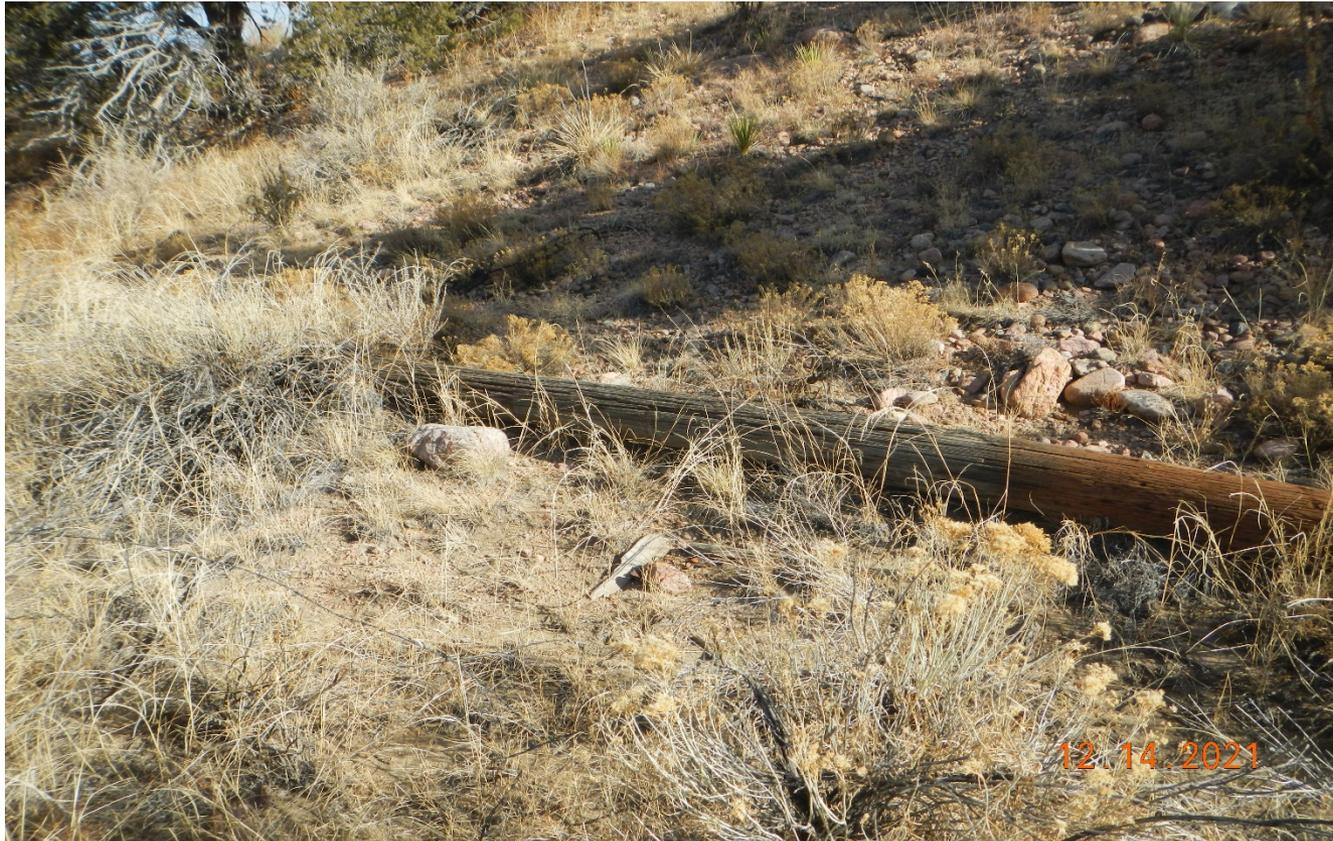
Photo 2. There is an abandoned powerpole that remains which needs to be removed.

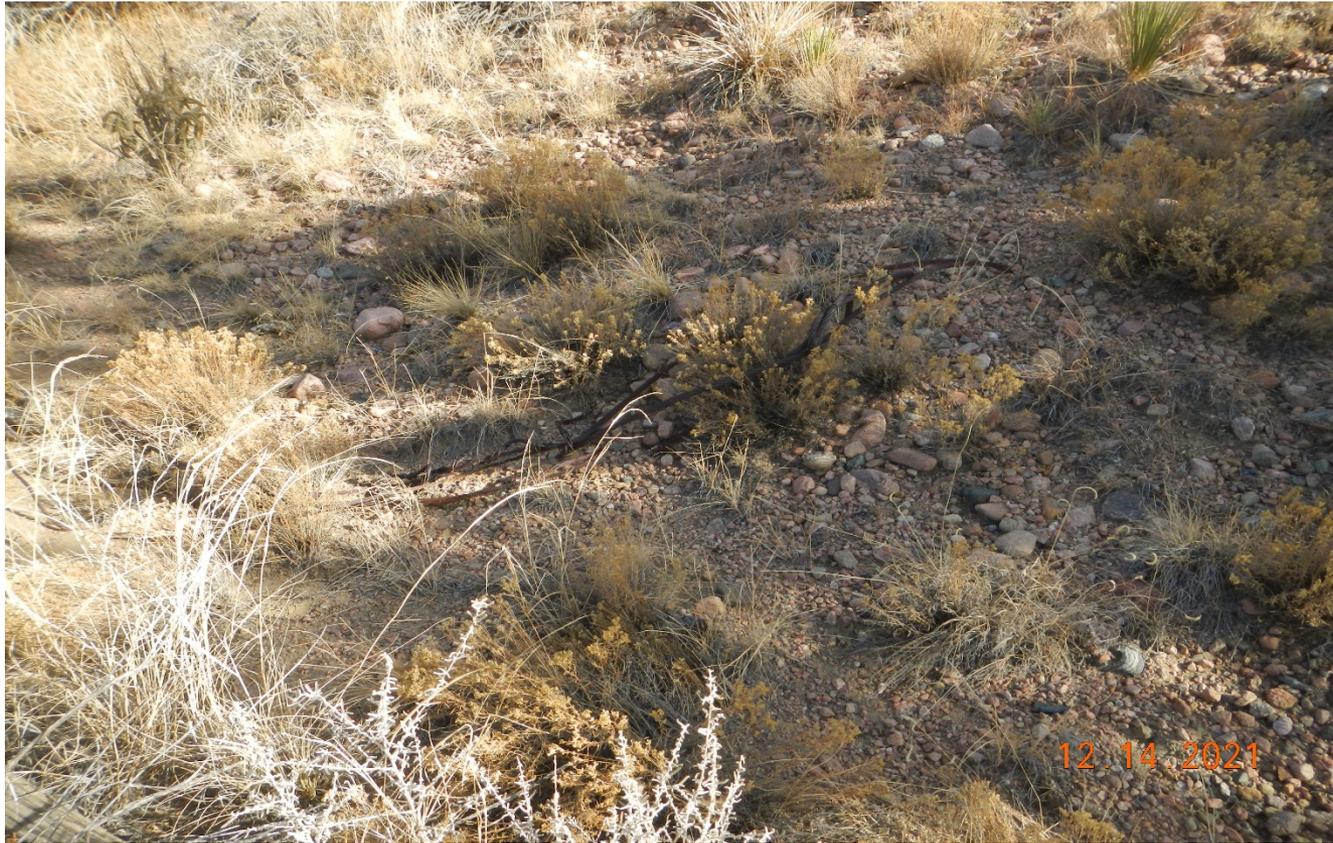
Photo 3. There is guyline anchor cable that remains at the southeast side of the location.

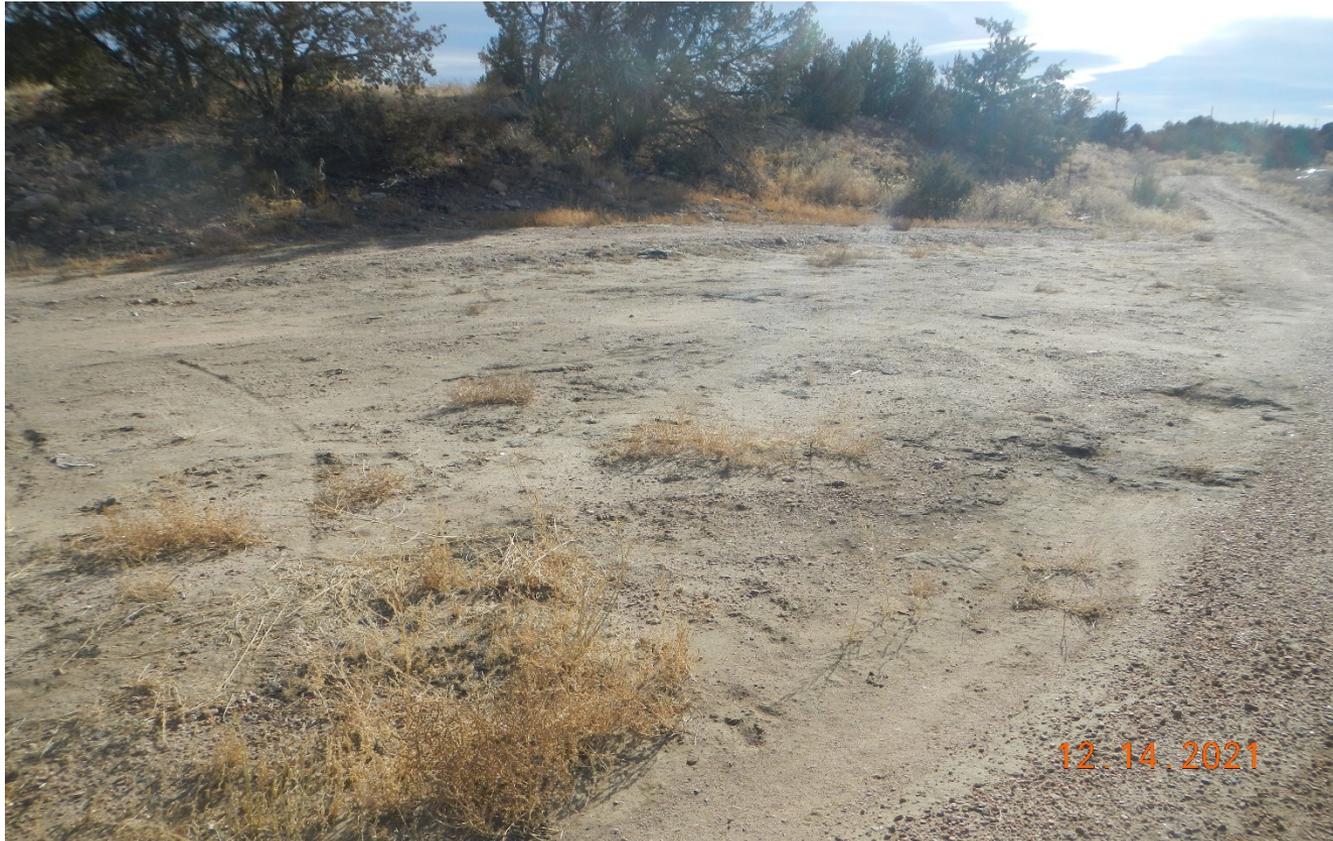
Photo 4. Facing southeast at the abandoned well site. The location has not been reclaimed and soils are bare of vegetation.

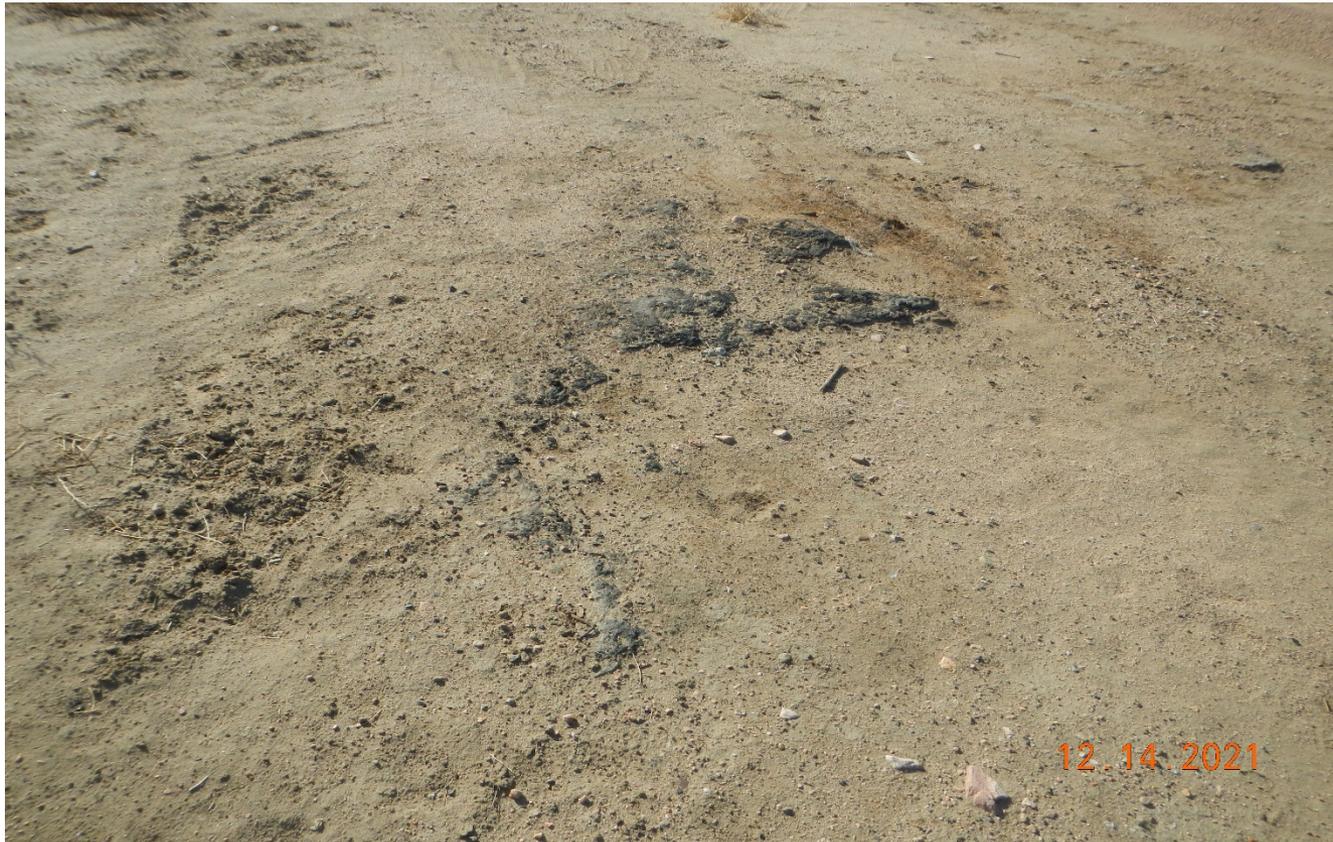
Photo 5. There is oil stained soils at center of location that needs to be cleaned up.

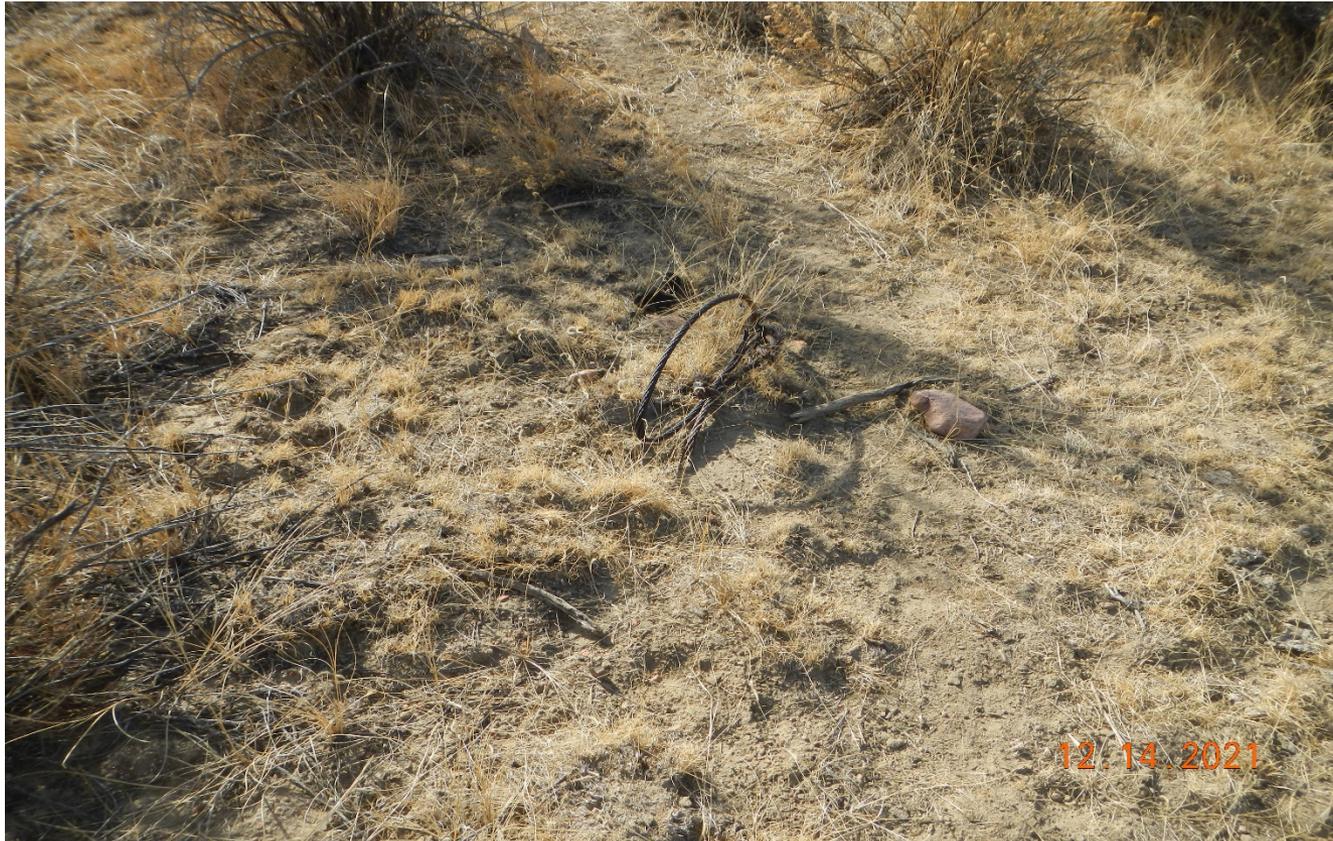
Photo 6. There is another guyline anchor cable that remains at the southwest side of the location.
