Final Reclamation Inspection

Operator: PDC ENERGY INC - 69175

Location ID: 322783

Inspection Document #: 701900267

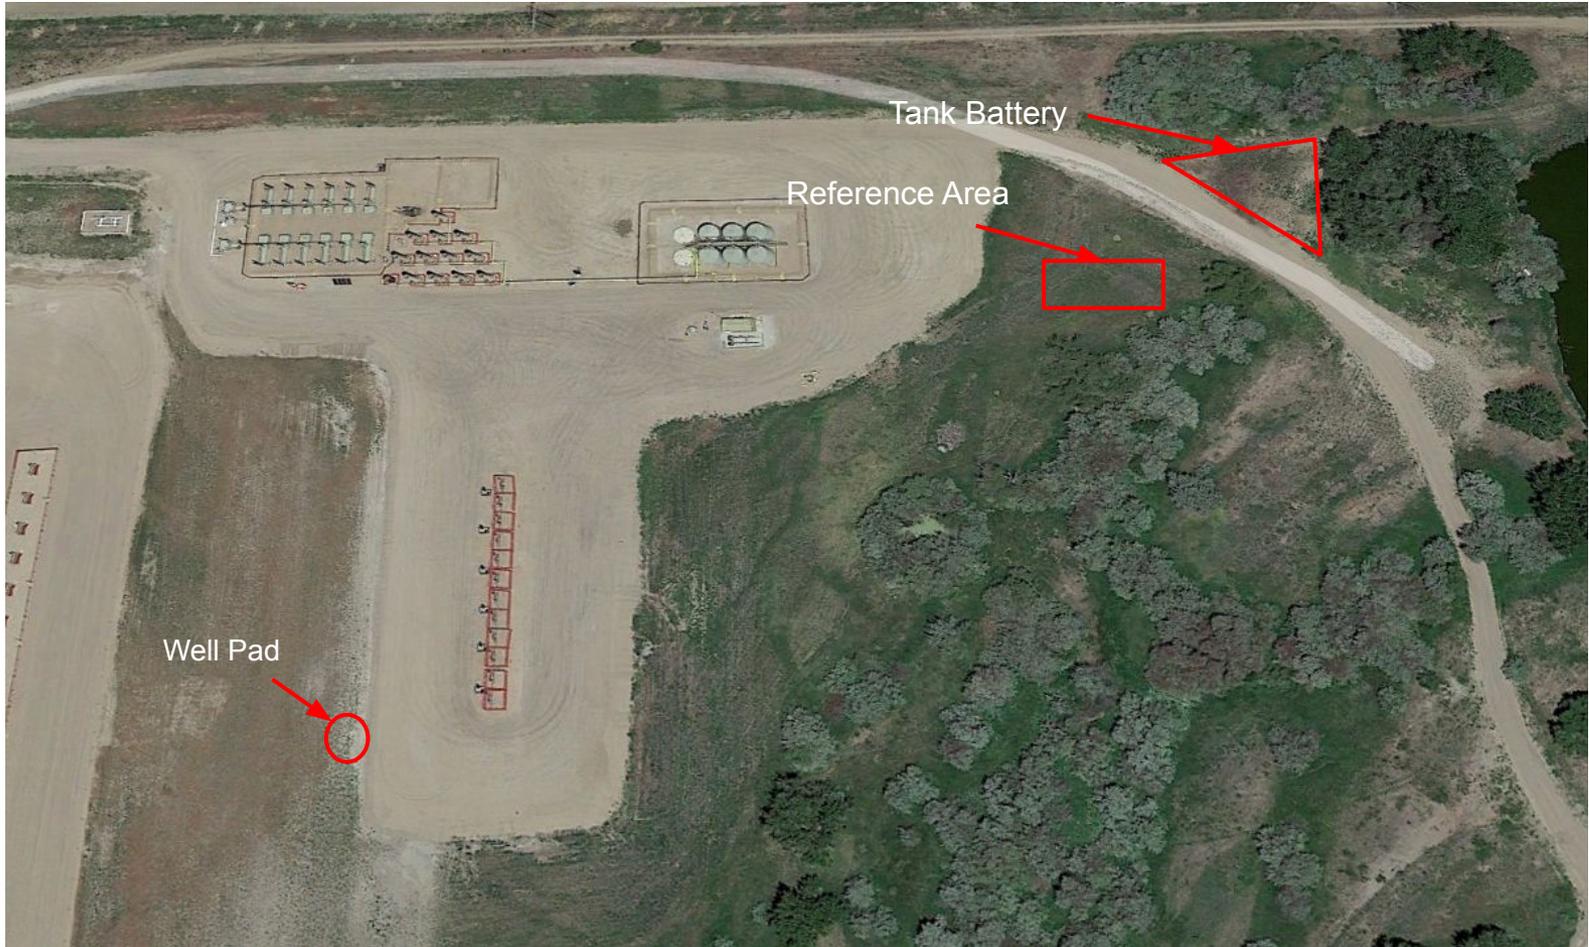
Photo 1. 2021 aerial imagery of the well pad, tank battery and reference area (north is up).

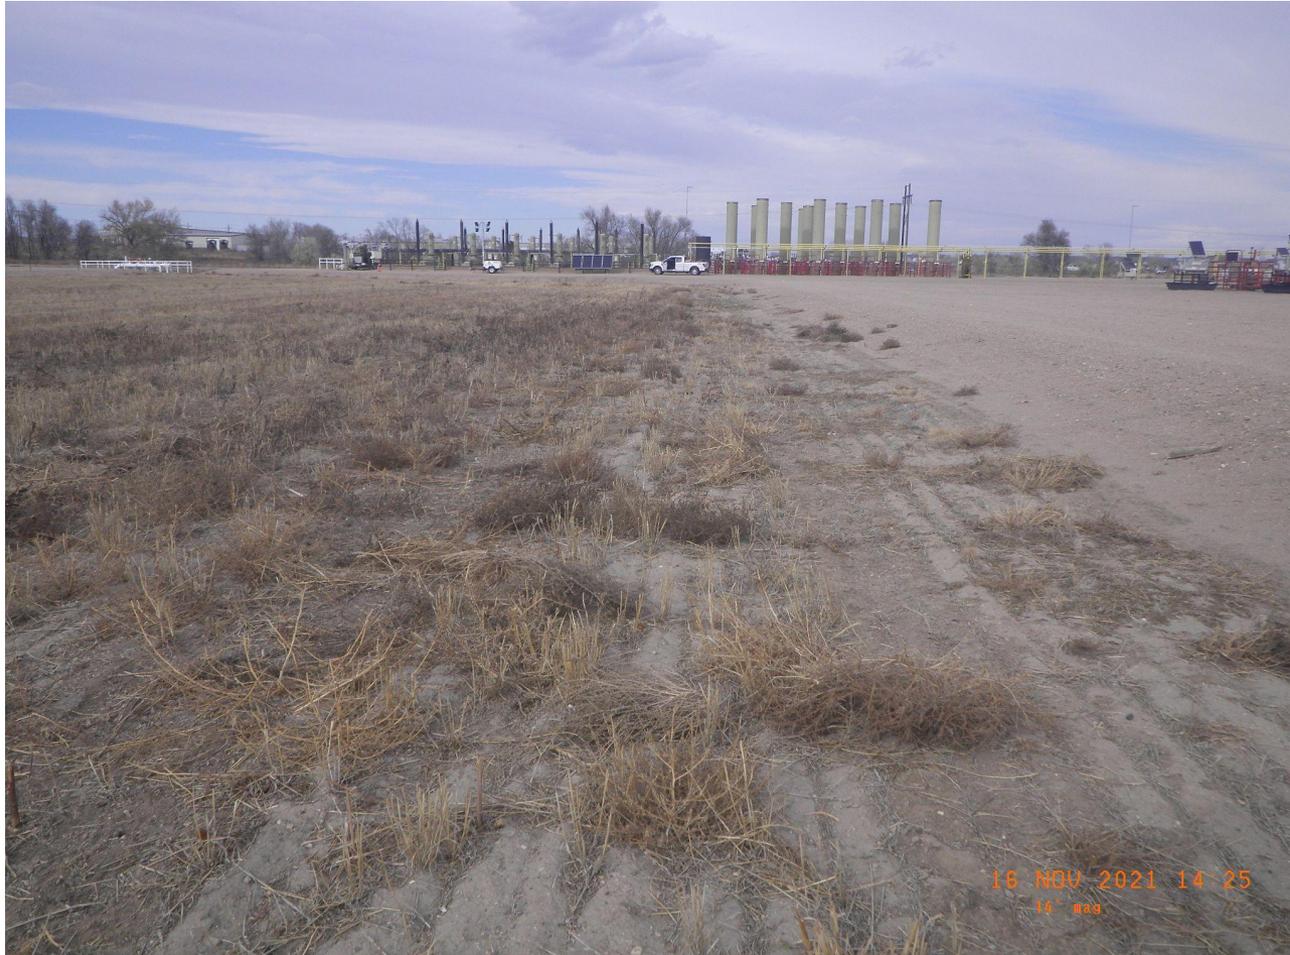
Photo 2. Overview photo of the reclaimed well pad taken at ground level from the southern edge looking north. Note: well pad vegetation could not be identified but appeared to be some sort of agricultural crop.

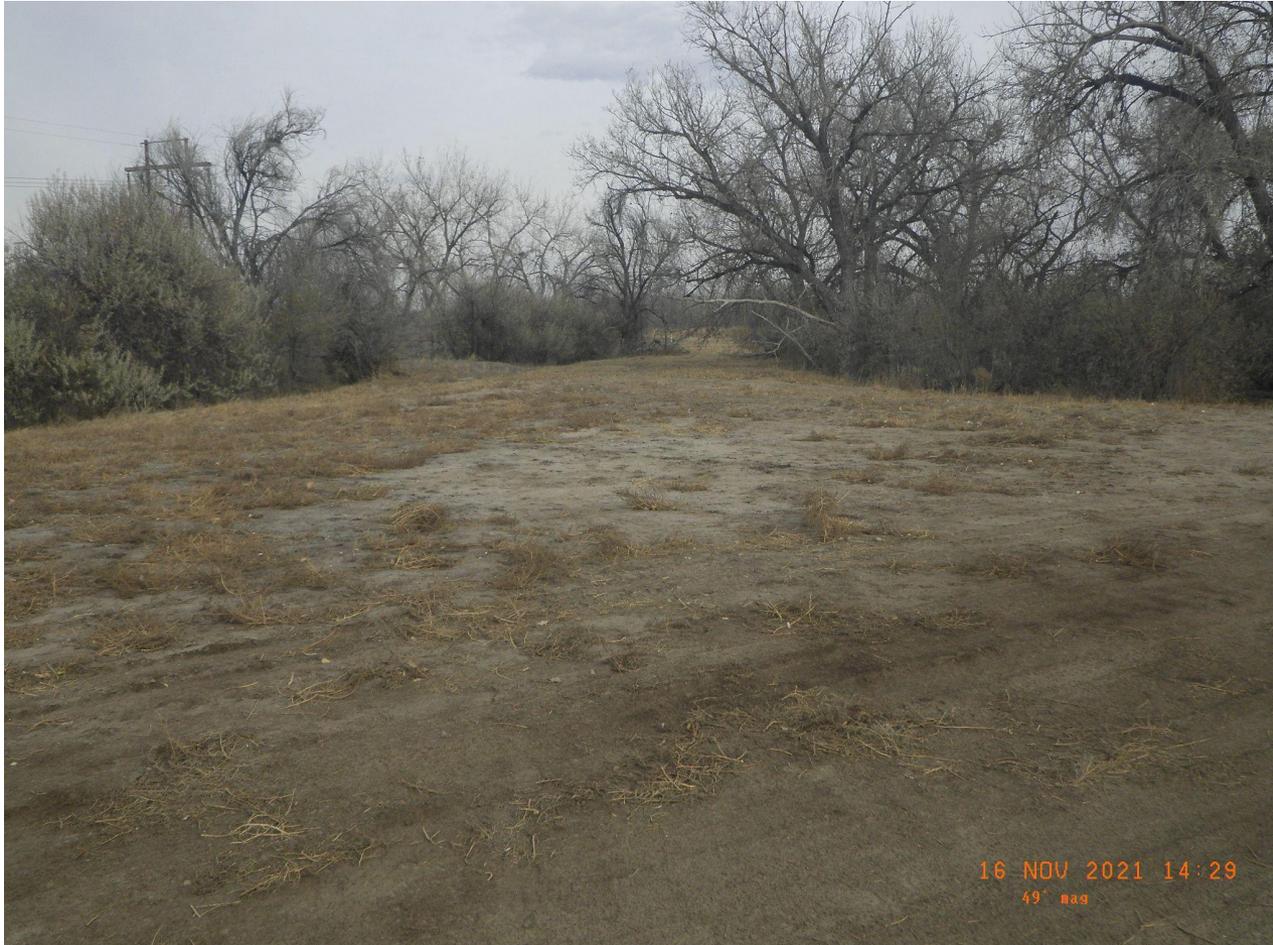
Photo 3. Overview photo of the reclaimed tank battery taken at ground level from the southern edge looking north.

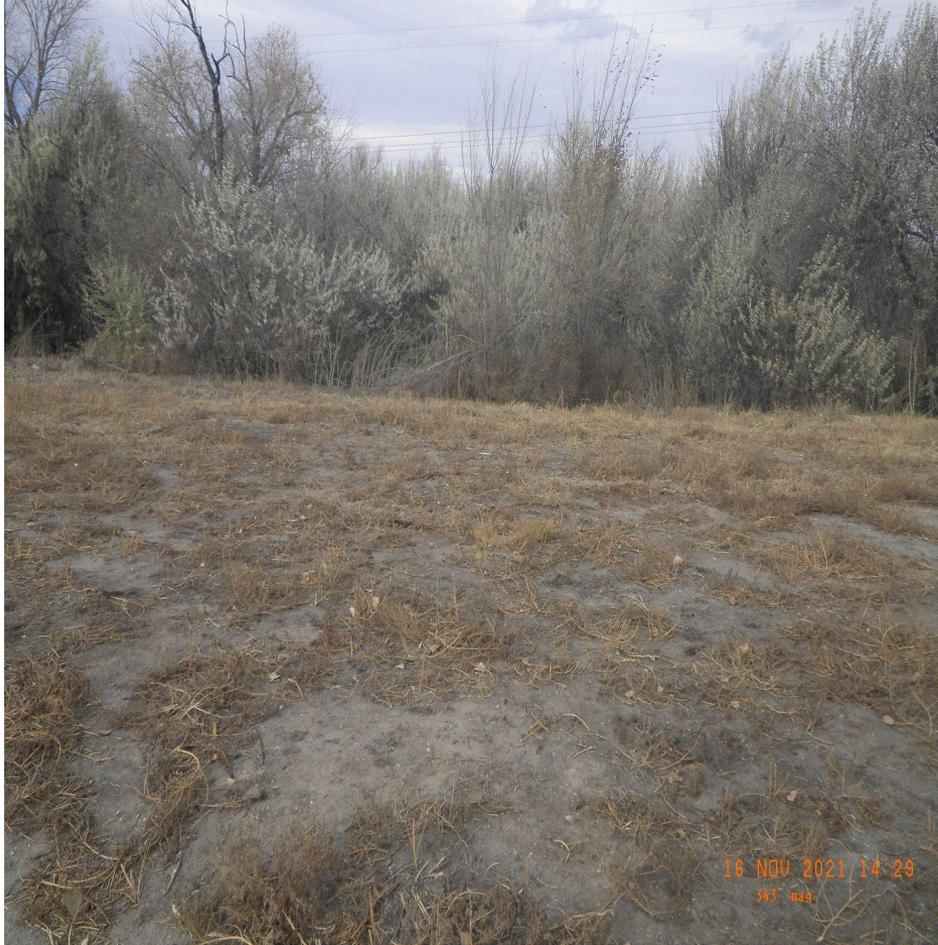
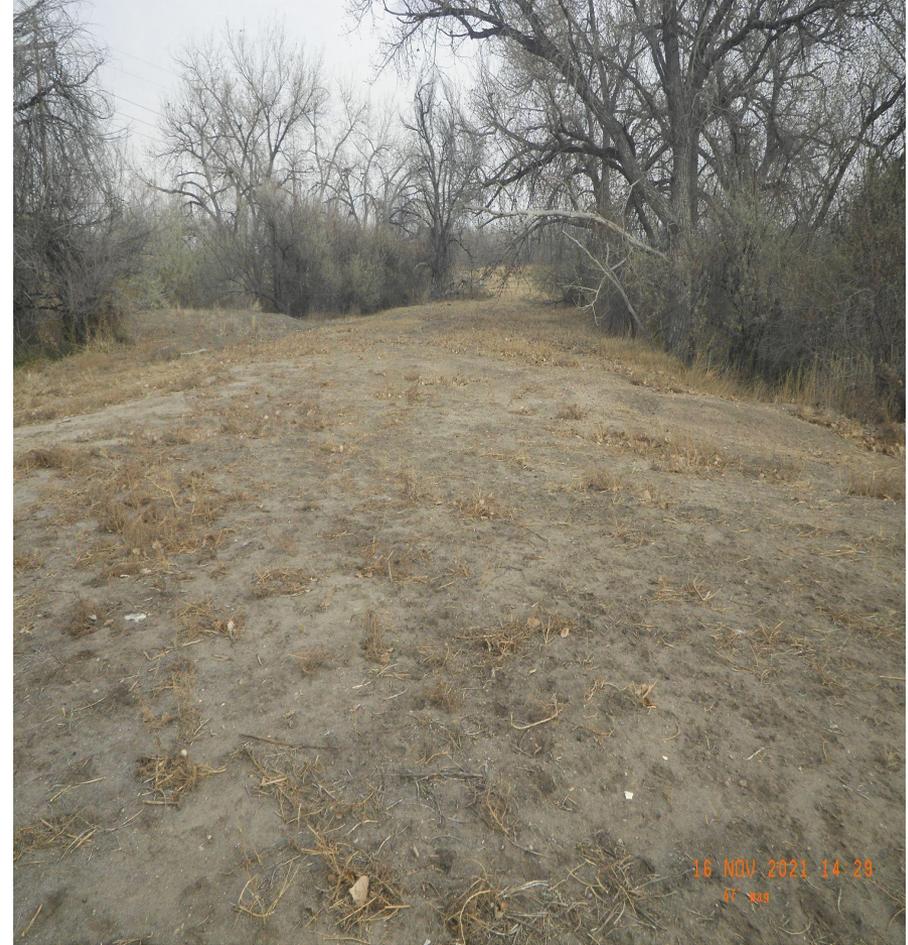
Photo 4. Photos taken from the middle of the tank battery. Left photo facing north and right photo facing east. See photo descriptions under photo 5.

Photo 5. Photos taken from the middle of the tank battery. Left photo facing south and right photo facing west. The photos show that the tank battery shows minimal vegetation/desirable species compared to the reference area, see photo 6.

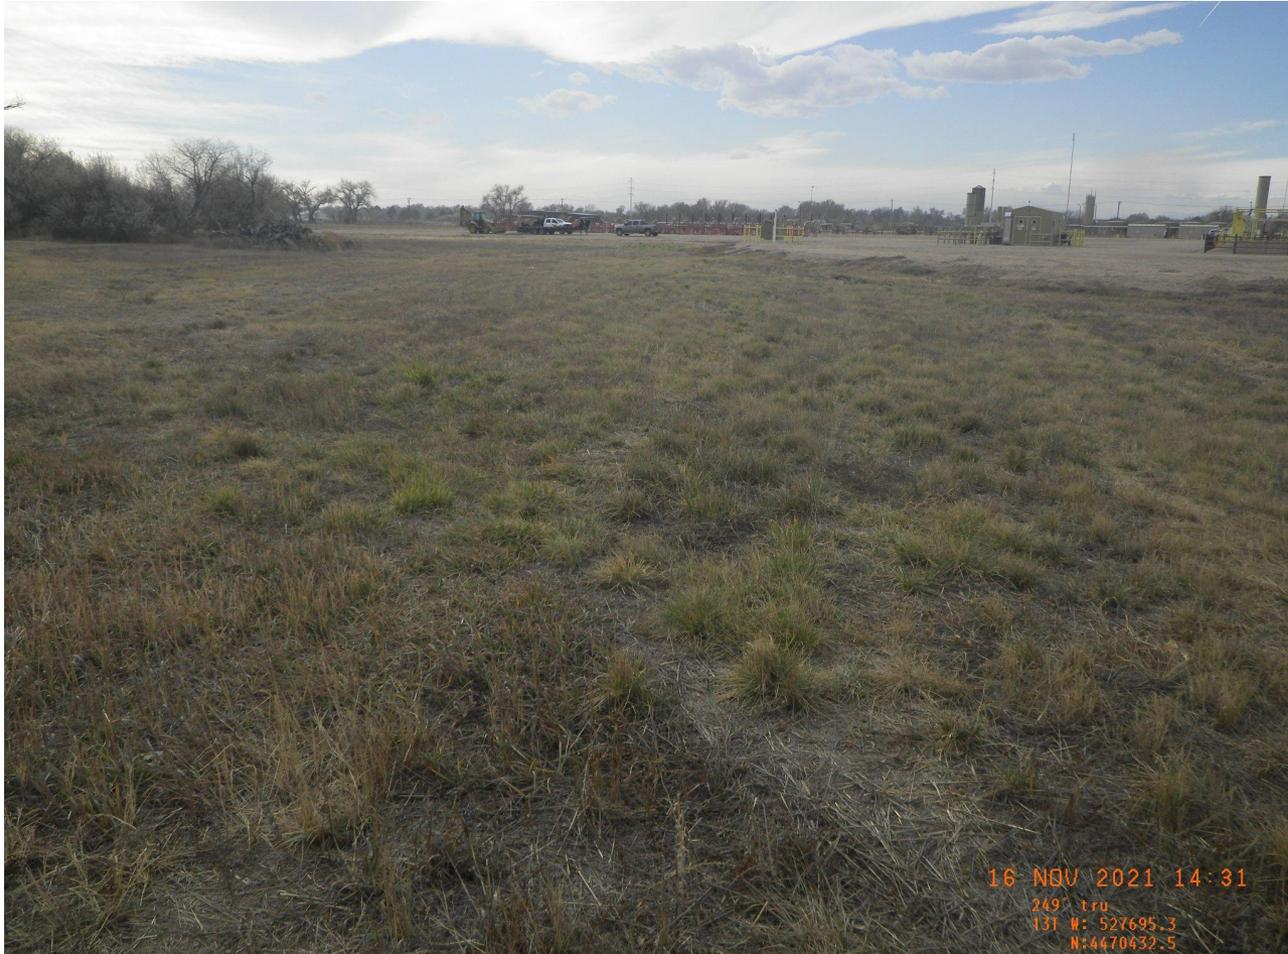
Photo 6. Reference area to the south of the tank battery.
