APACHE CANYON 13-11 API# 05-071-08482 – TIMBER CREEK OPERATING  
OGCC OPERATOR NUMBER 10758 - DATE: NOVEMBER 05, 2021  
CORRECTIVE ACTIONS COMPLETED REGARDING COGCC FIR DOCUMENT # 690202034

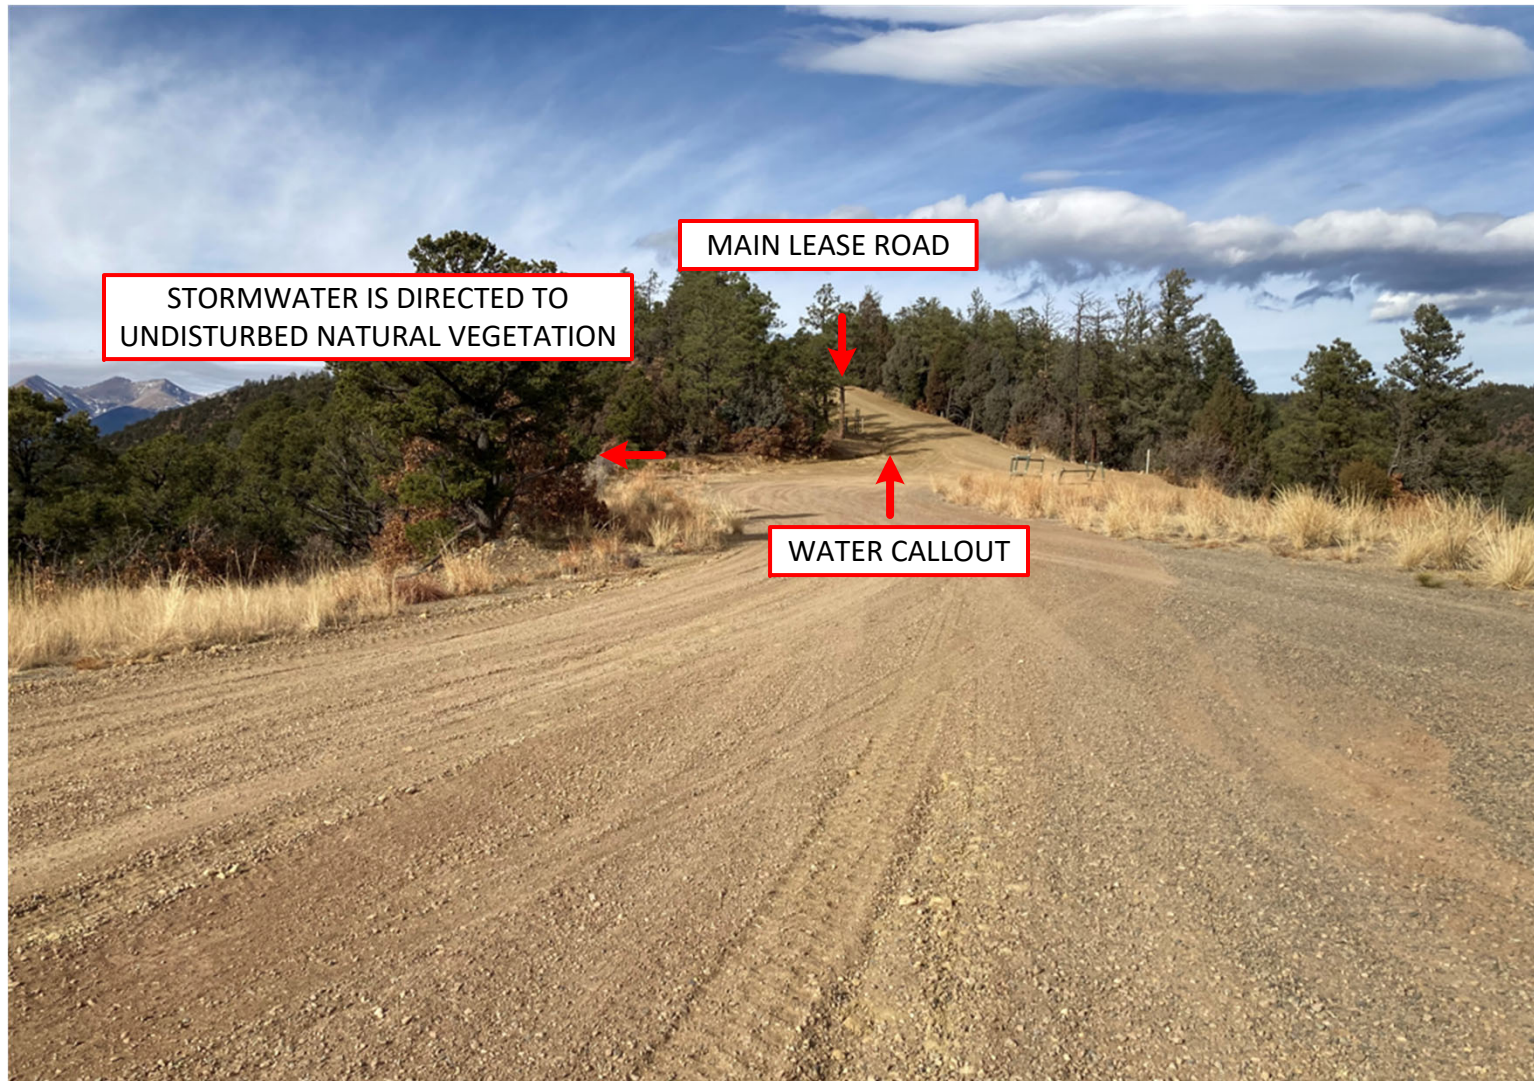
THE WATER CALLOUT AT THE ENTRANCE TO THE WELL PAD HAD FILLED IN WITH SEDIMENT PREVENTING RUN OFF TO FLOW TO THE UNDISTURBED NATURAL VEGETATION. THE CALLOUT WAS DOMINATED TO RECEIVE STORMWATER FROM THE BAR DITCH ALONG THE MAIN LEASE ROAD. THIS WILL DIRECT STORMWATER AWAY FROM THE ACCESS ROAD TO THIS LOCATION AND PREVENT THE SURFACE EROSION/RILLS.

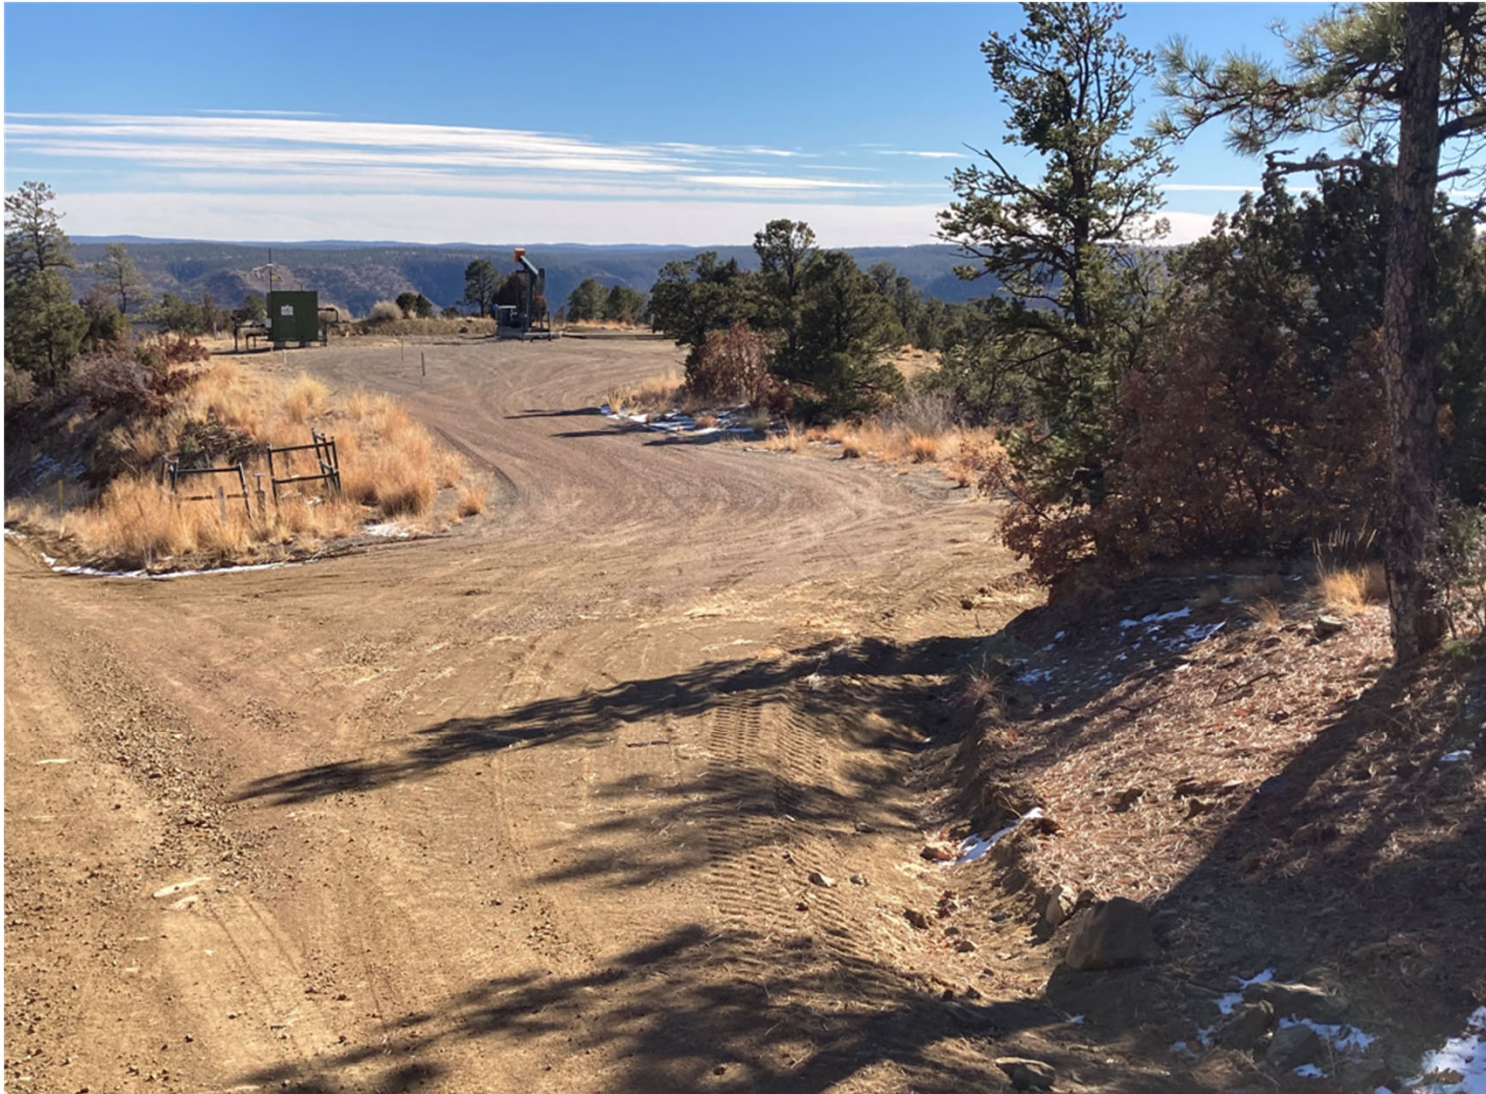
THE WATER CALLOUT AT THE ENTRANCE TO THE WELL PAD WAS DOMINATED TO RECEIVE STORMWATER FROM THE BAR DITCH ALONG THE MAIN LEASE ROAD. THIS WILL DIRECT STORMWATER AWAY FROM THE ACCESS ROAD TO THIS LOCATION AND PREVENT THE SURFACE EROSION/RILLS.

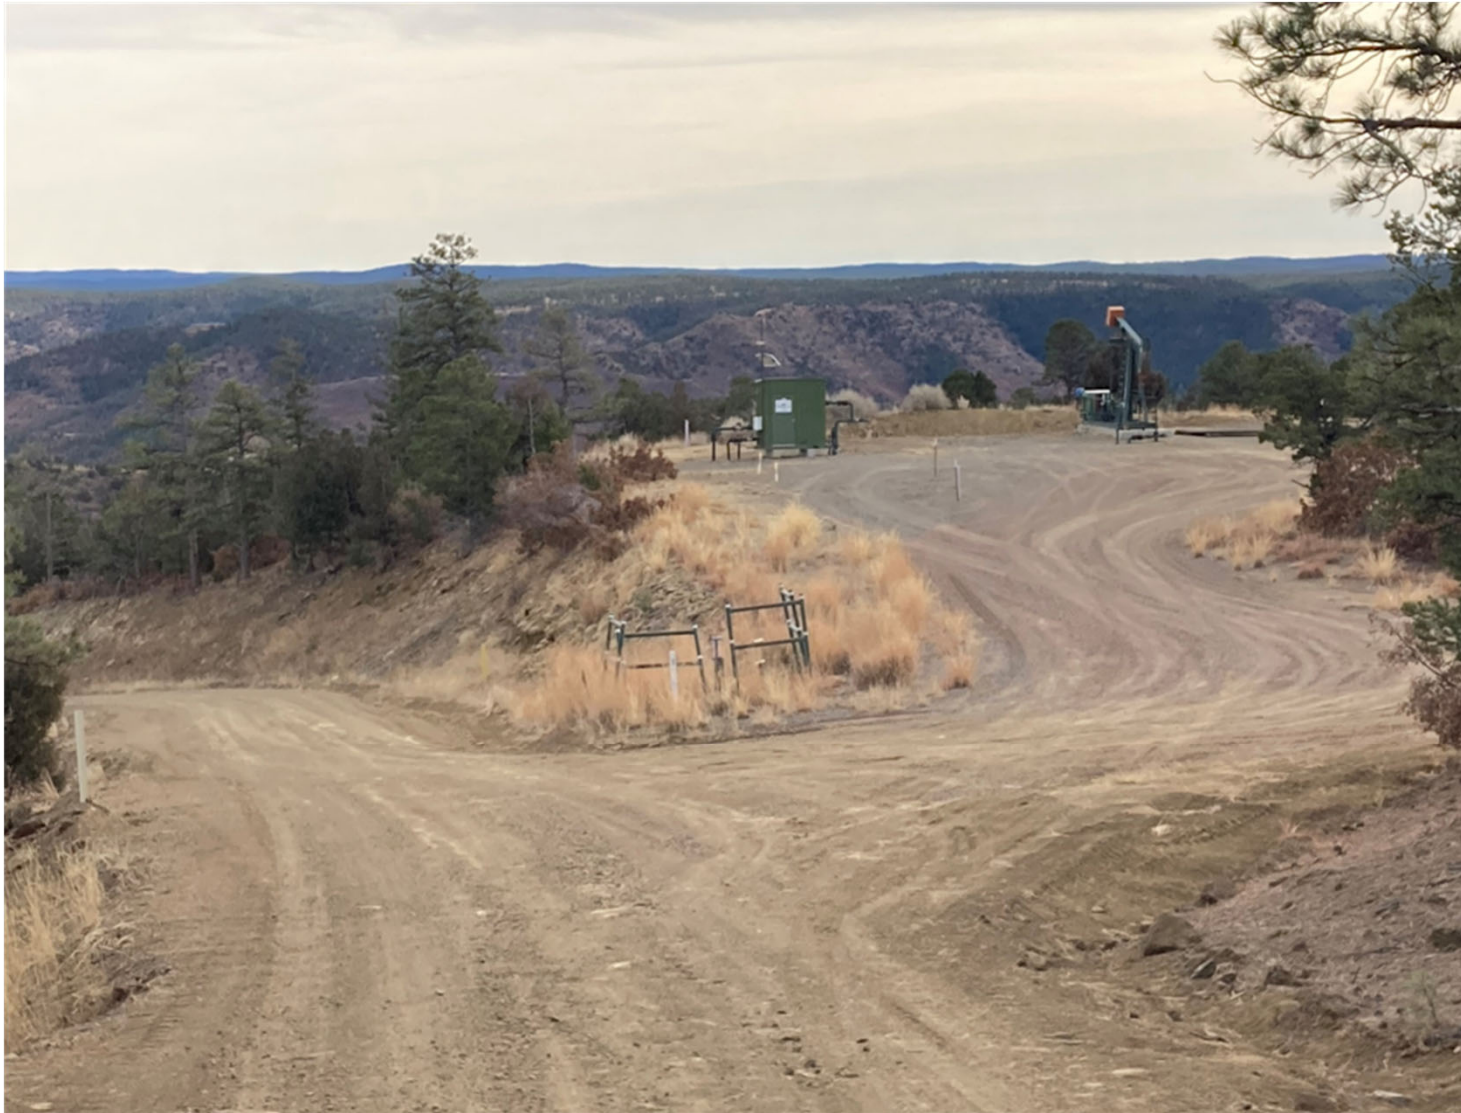
THE PIECE OF REBAR WAS REMOVED FROM THE ROADWAY. THE ROAD SURFACE WAS REGRADED AND CROWNED. THIS CONFIGURATION WILL CREATE SHEET FLOW AND ELIMINATE THE TIRE RUTS/SURFACE EROSION. THE ROAD SURFACE WAS COMPACTED BY UTILIZING A VIBRATION SOIL COMPACTION ROLLER TO PROVIDE STABILIZATION.
