Inspection Photos  
Operator: Simcoe  
API: 067-07557  
Date: 12/17/2021

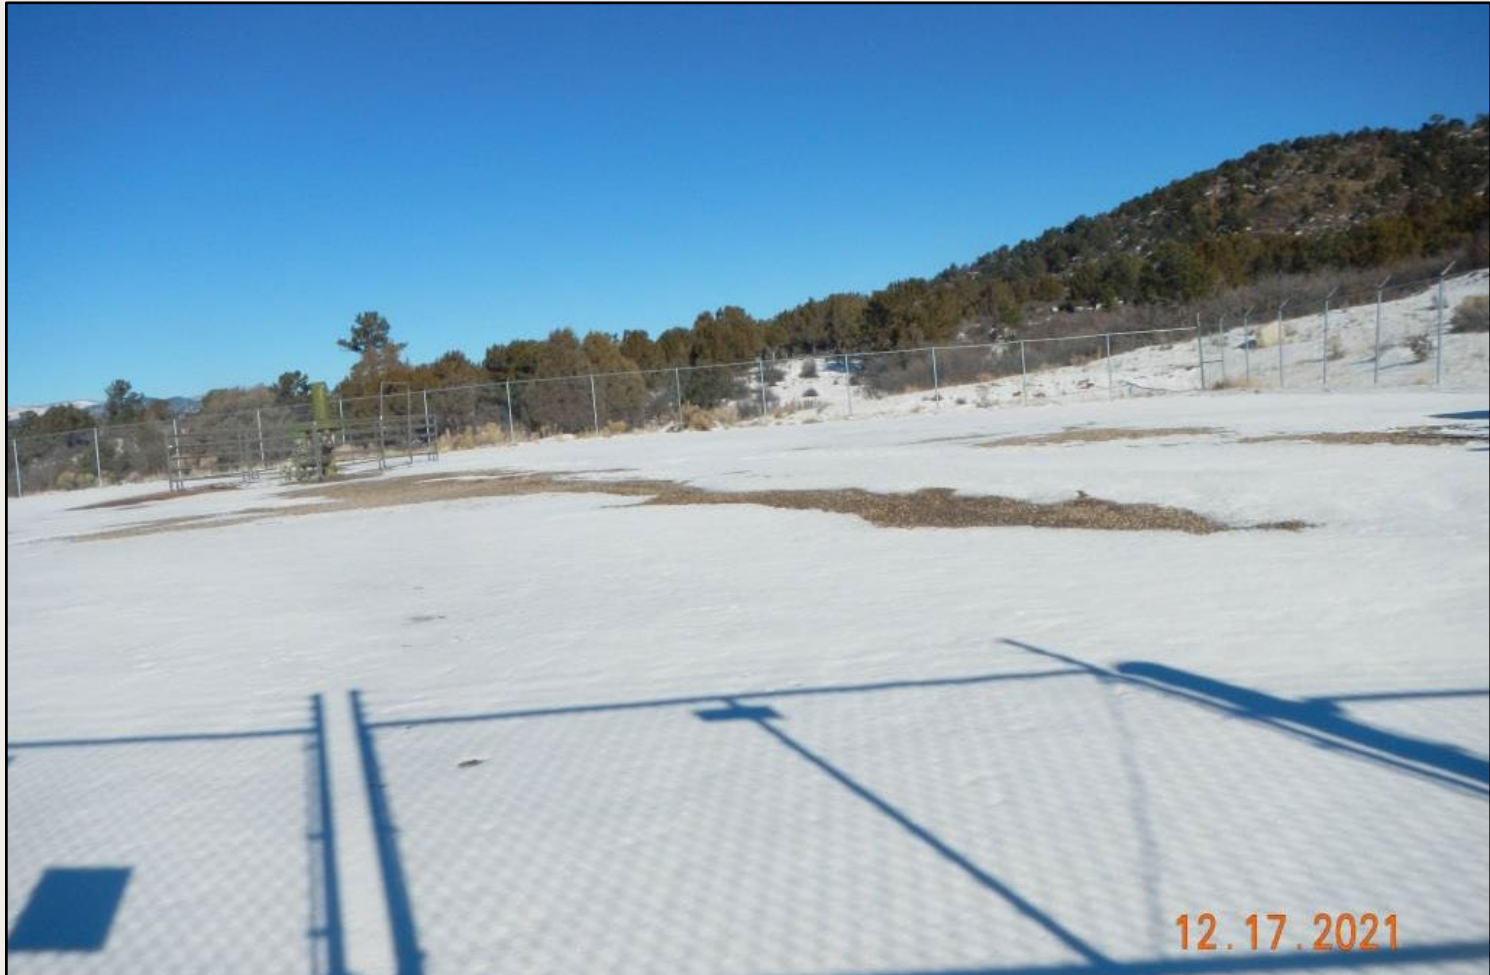
Photo 1. View of the project area from the well pad entrance facing center.

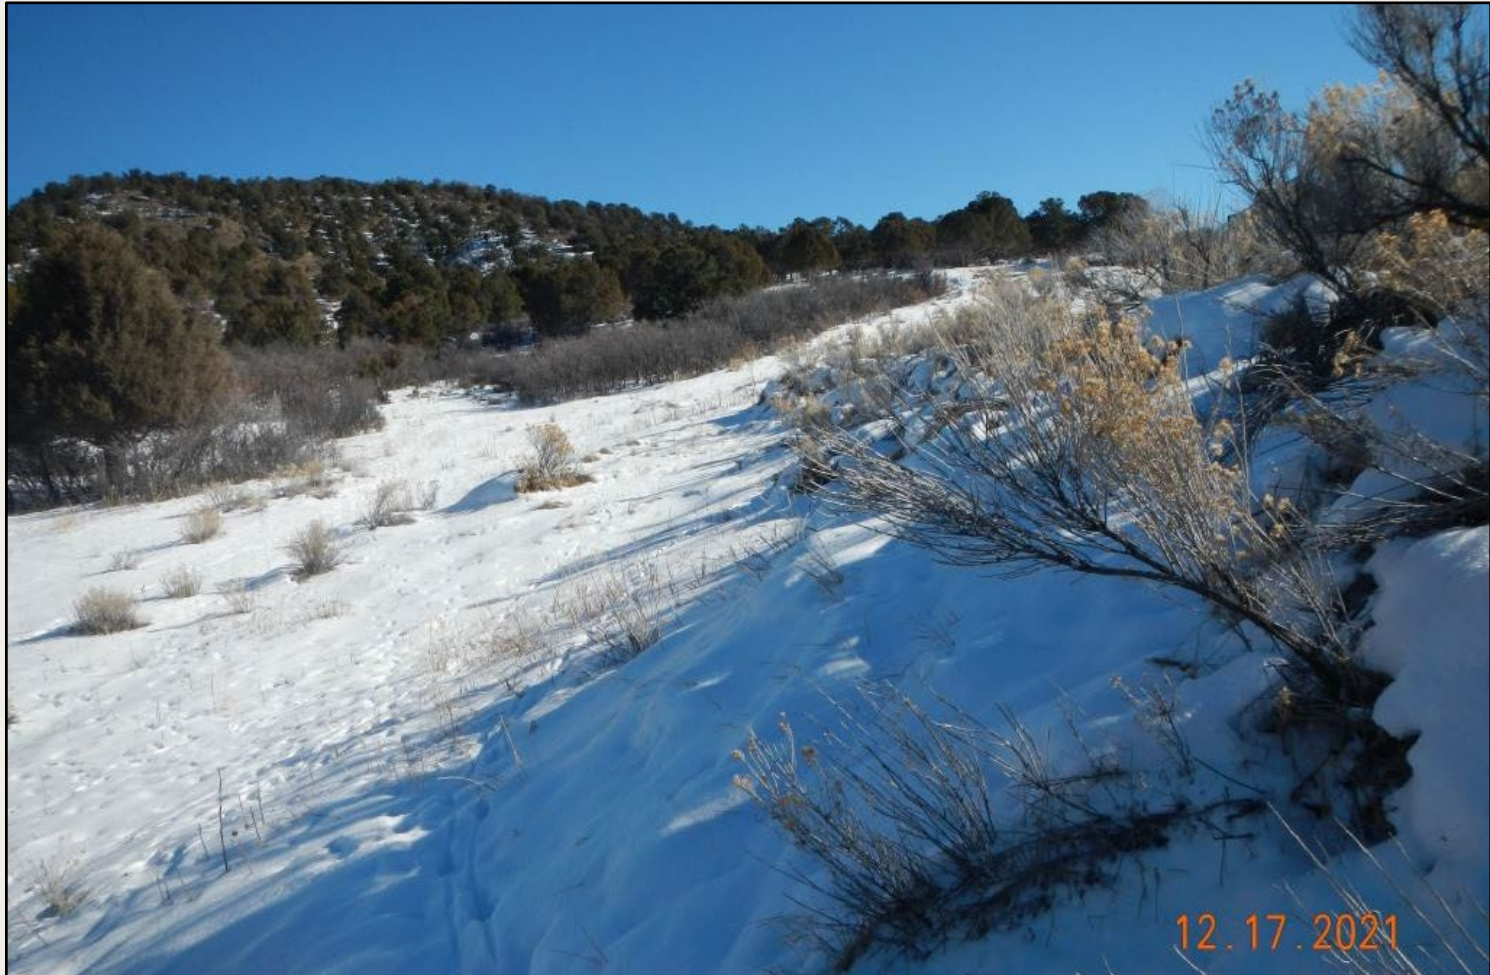
Photo 2. View of the northern project area from the northwestern corner facing eastward. Revegetation is progressing with sagebrush, rubber rabbitbrush, smooth brome, and western wheatgrass.

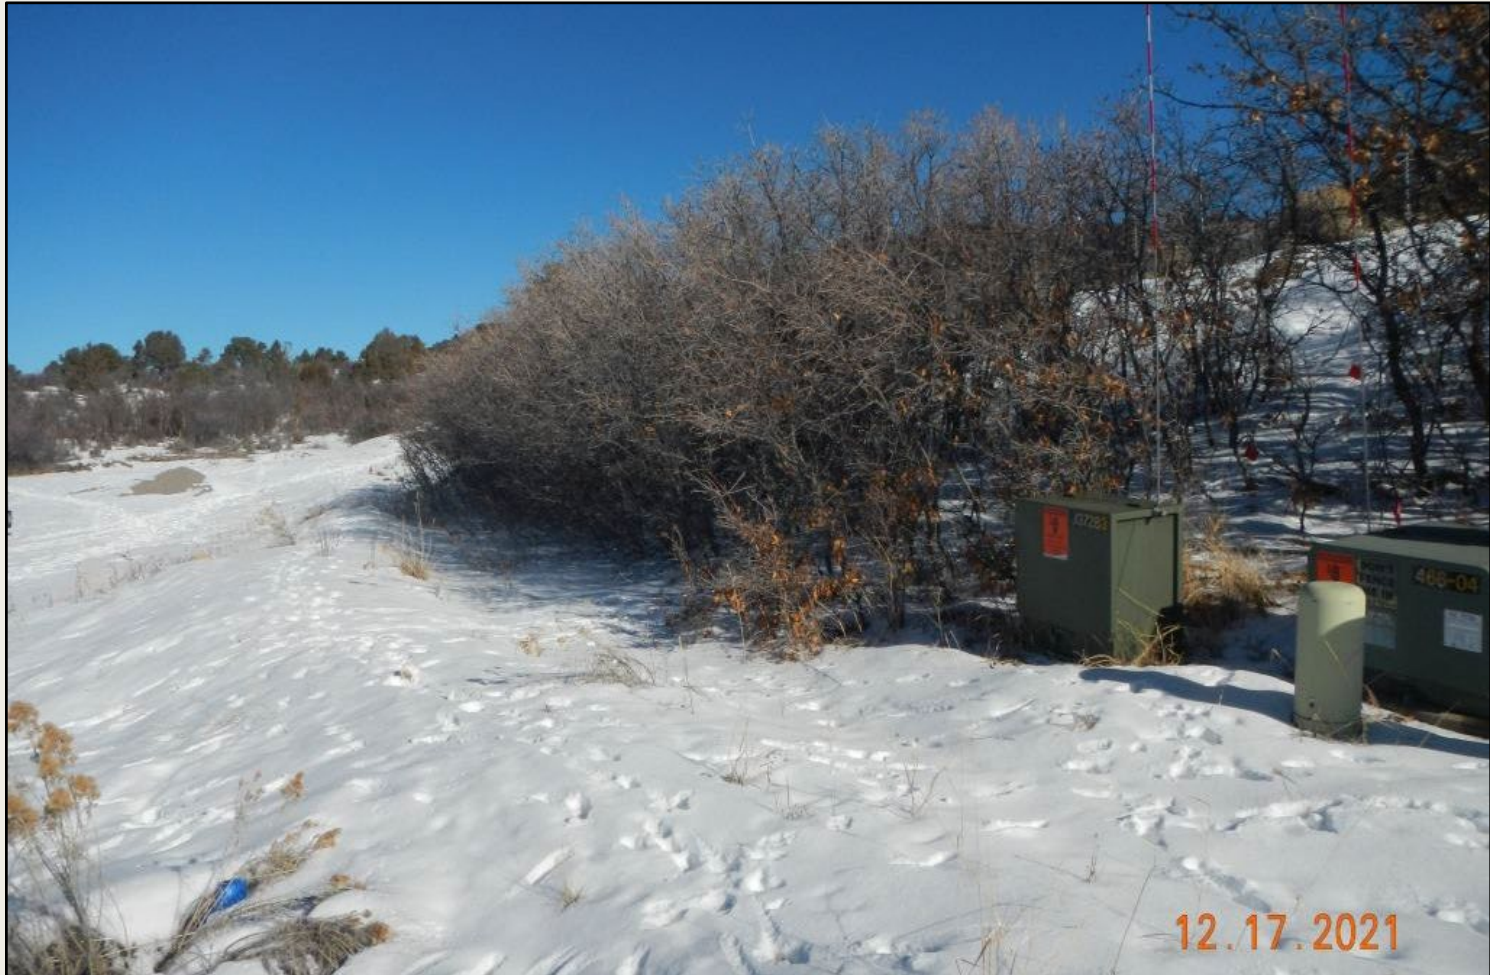
Photo 3. View of the western project area from the southwestern corner facing northward. Berm is in place along southern edge of the project area.

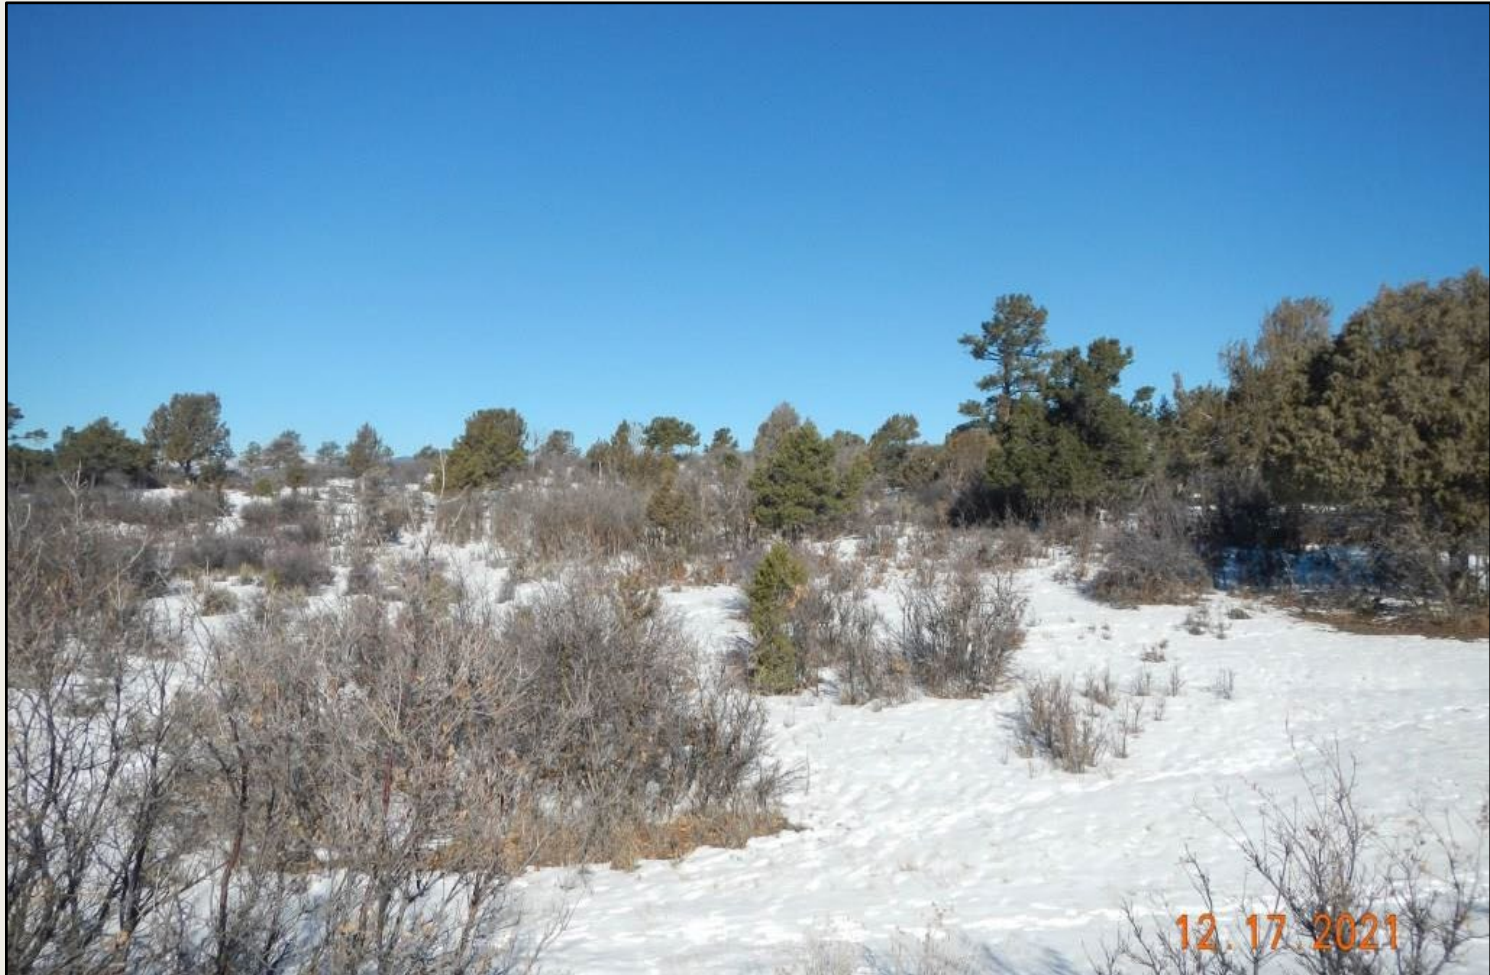
Photo 4. View of reference area comprised of gambel oak shrubland, with scattered pinyon and juniper trees, sagebrush, smooth brome, and mountain mahogany.
