Inspection Photos  
Operator: Simcoe  
API: 067-08296  
Date: 12/17/2021

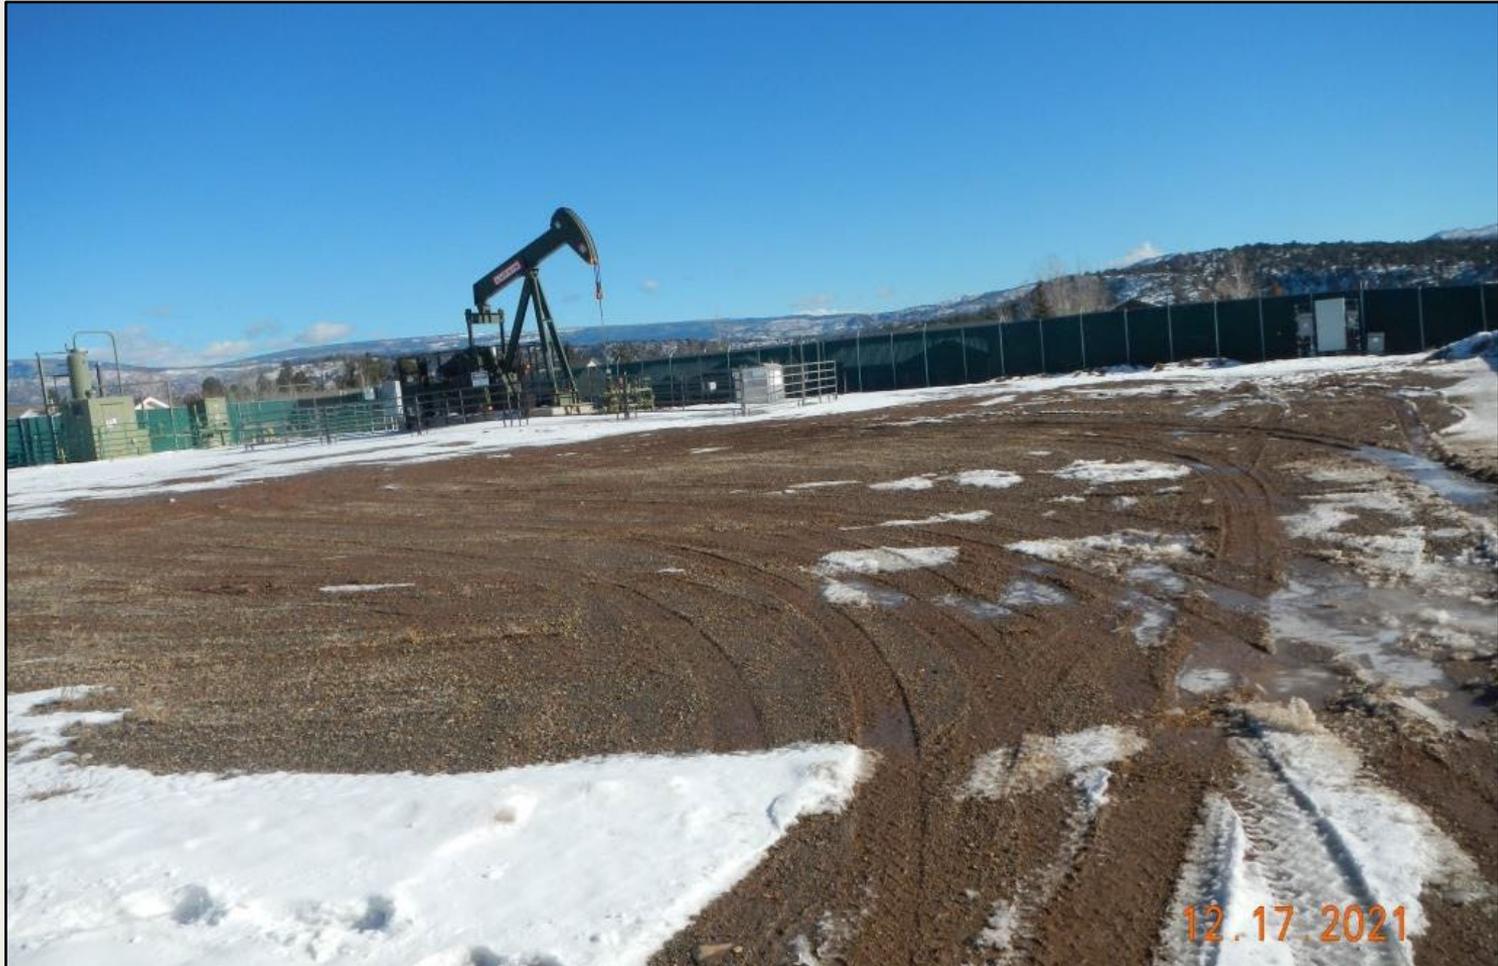
Photo 1. View of the project area from the well pad entrance facing center.

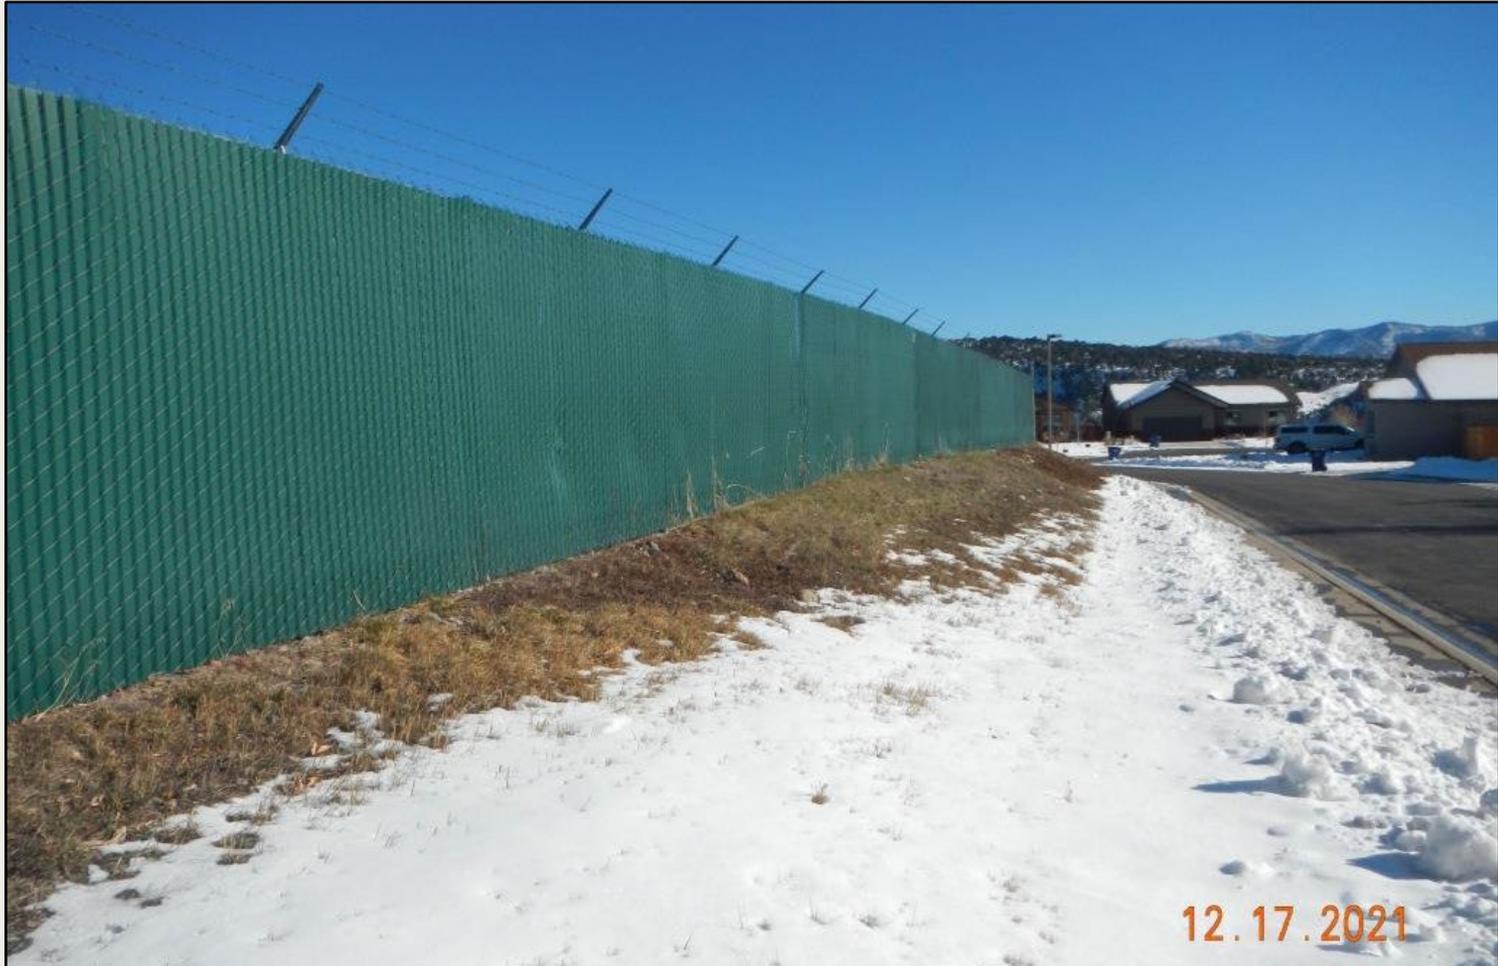
Photo 2. View of the southern project area from the southwestern corner facing eastward. Working area is fenced, outer reclamation areas are revegetating with western wheatgrass and smooth brome.

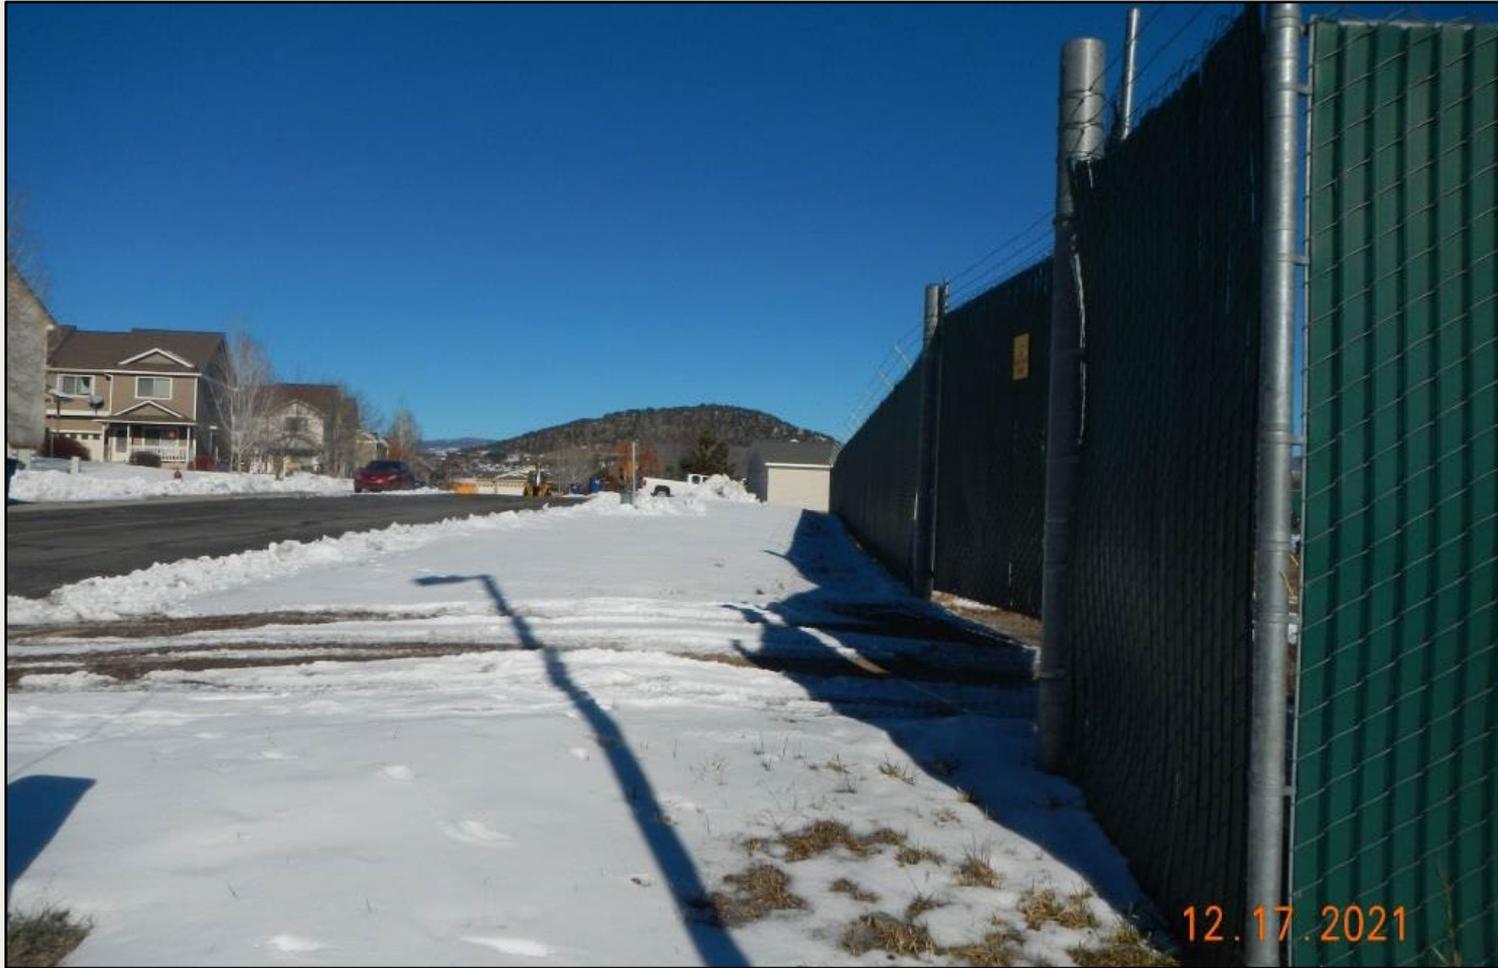
Photo 3. View of the western project area from the southwestern corner facing northward.

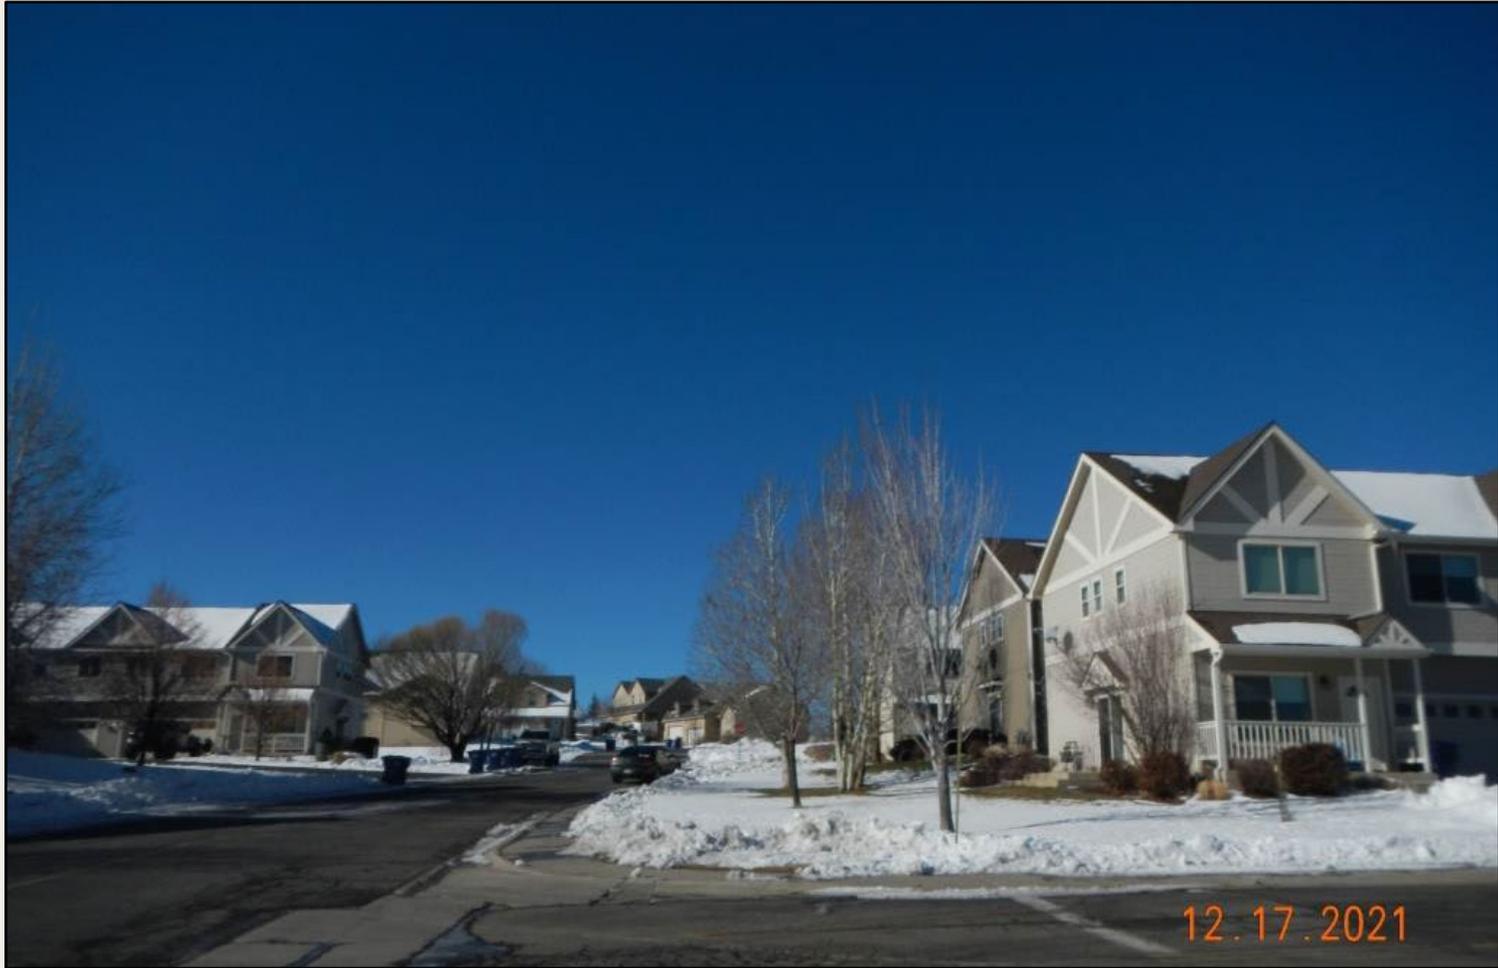
Photo 4. View of reference area comprised of developed neighborhood infrastructure. Park space is present east of project area.
