Inspection Photos  
Operator: Simcoe  
API: 067-08870  
Date: 12/17/2021

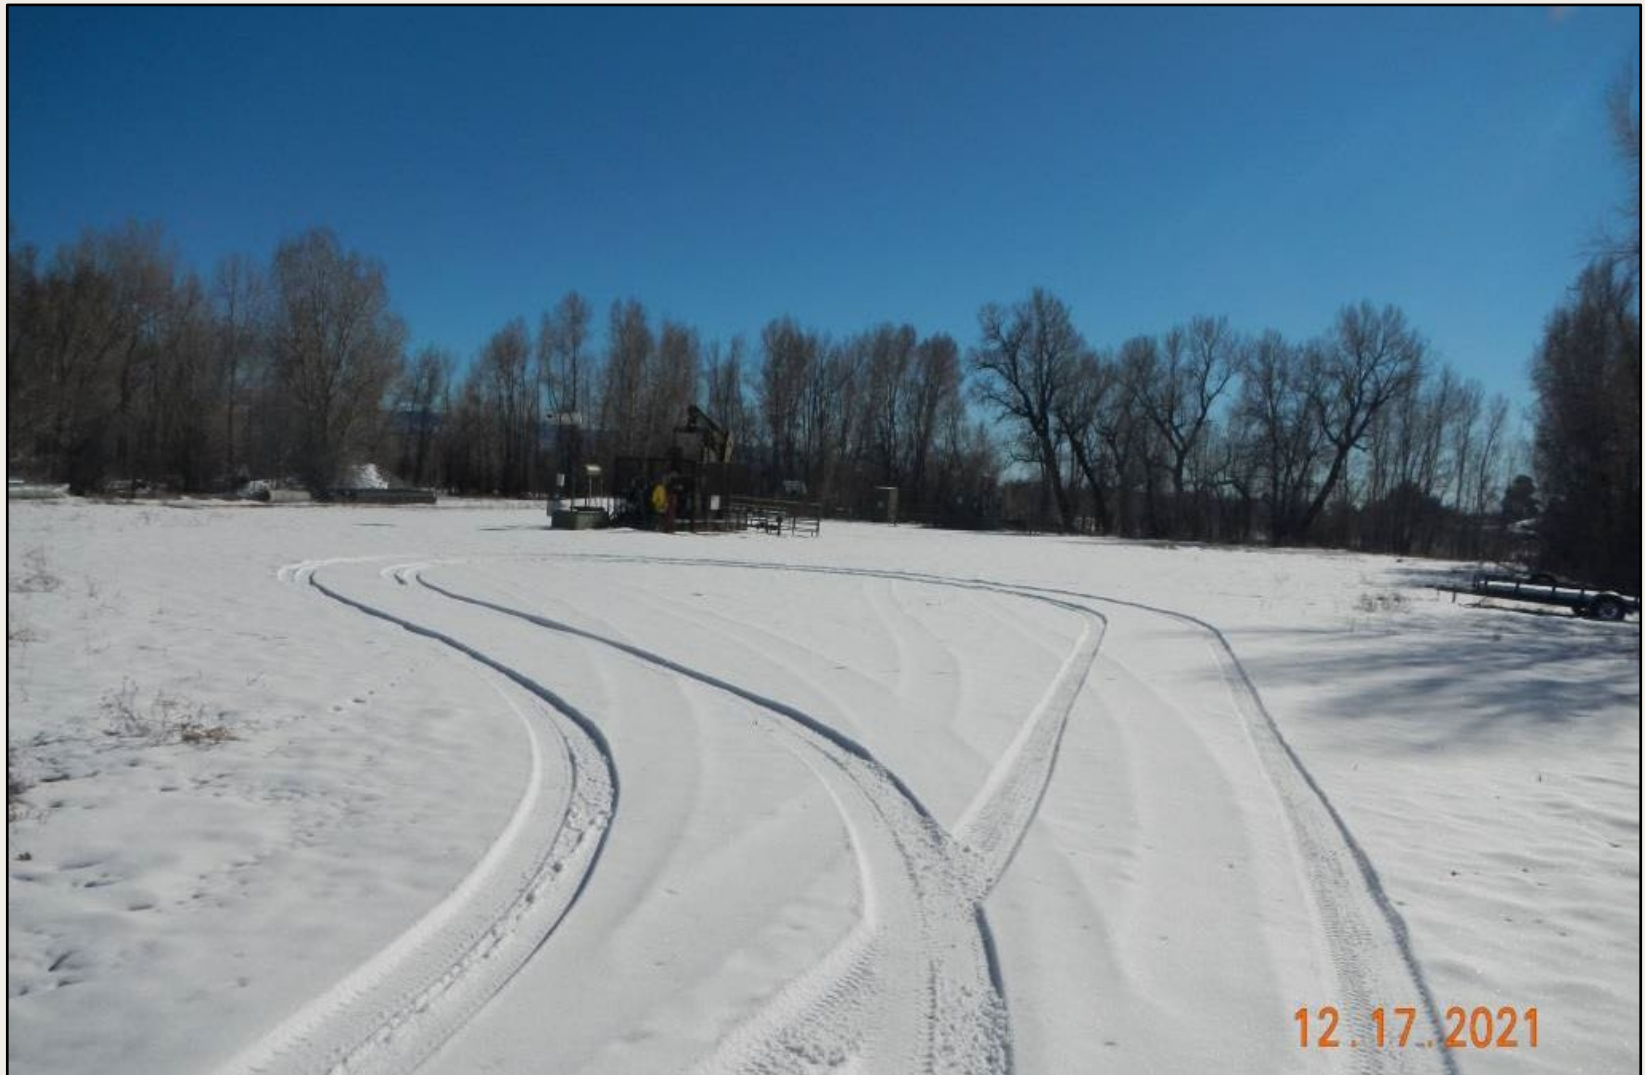
Photo 1. View of the project area from the well pad entrance facing center.

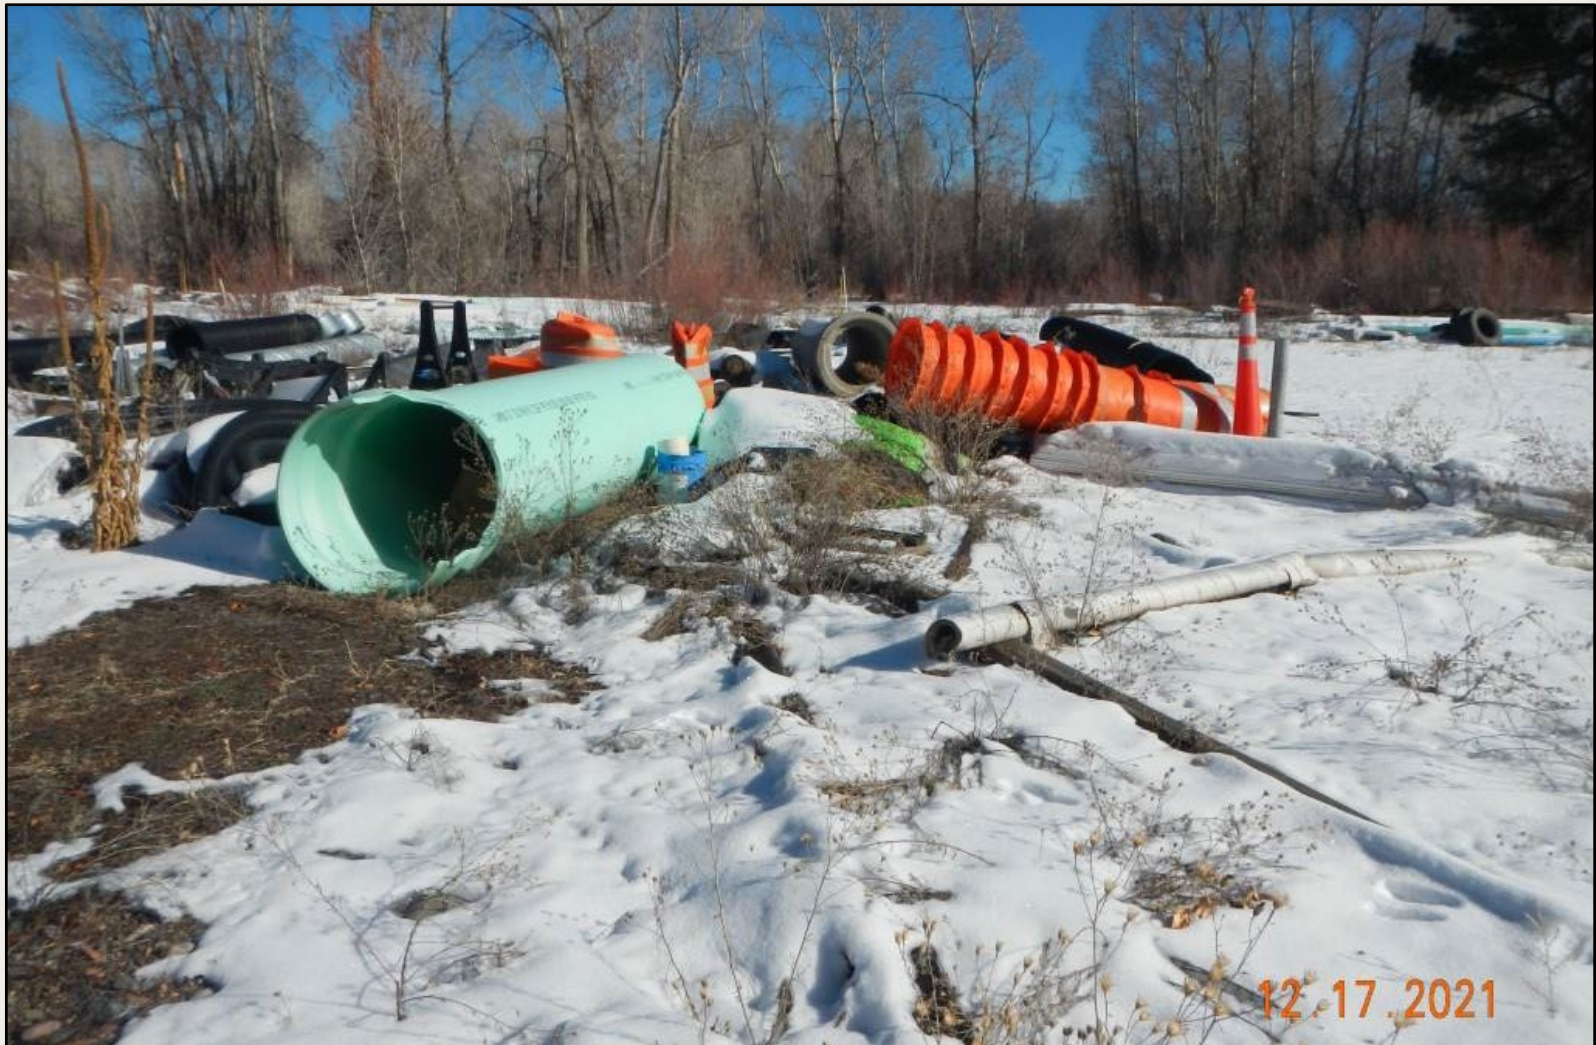
Photo 3. View of unused materials and debris stored within the northern project area.

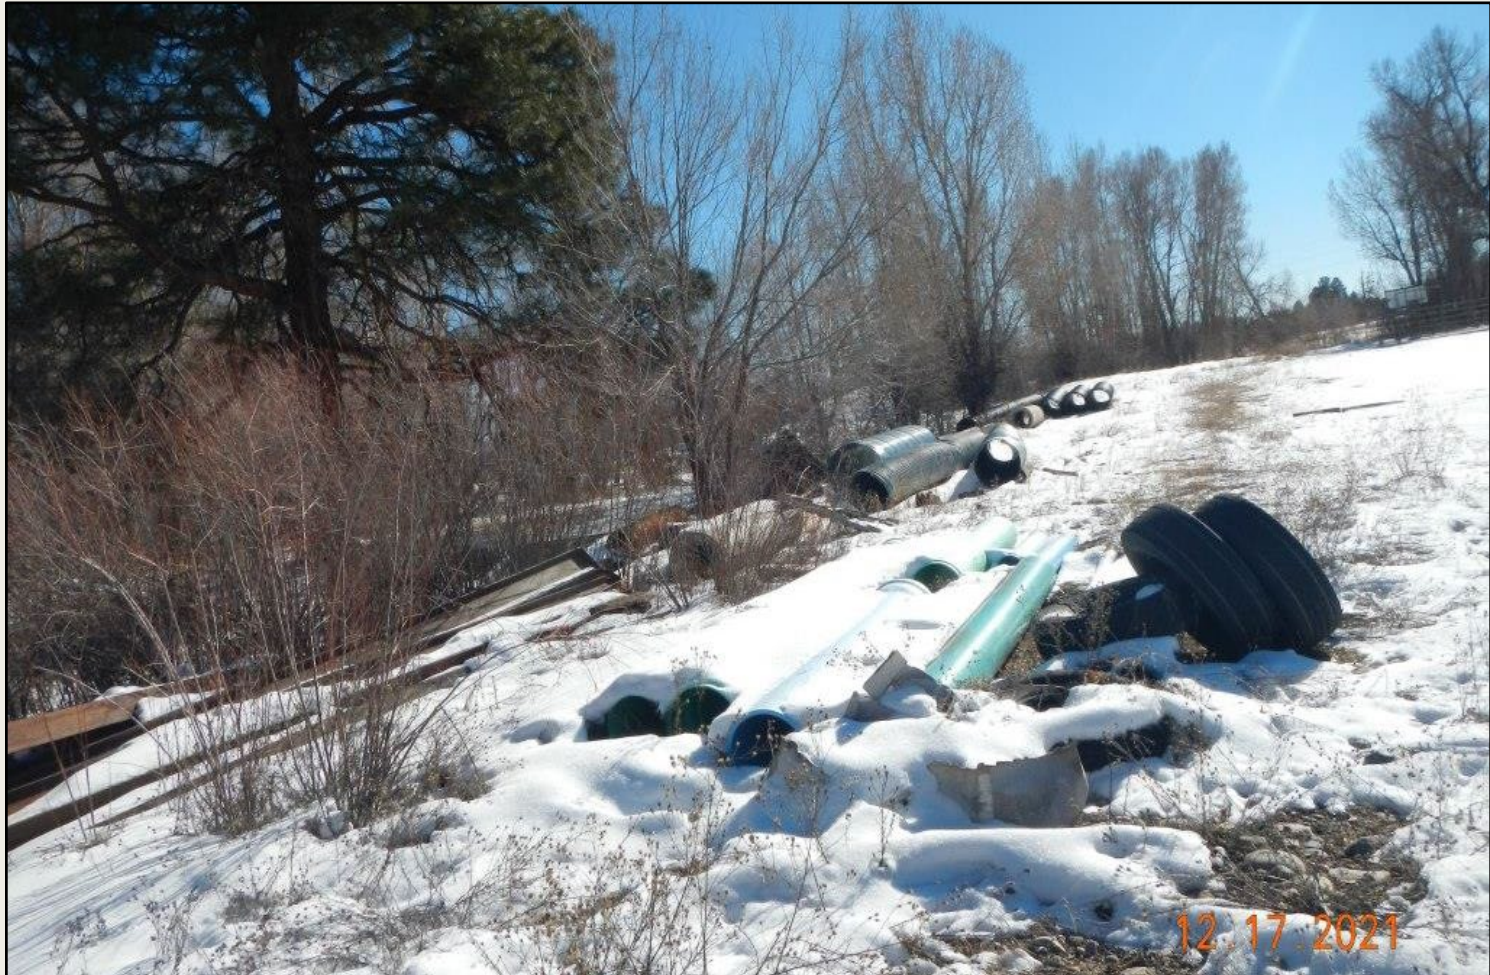
Photo 4. View of the eastern project area from the northeastern corner facing southward. More unused materials and debris observed here.

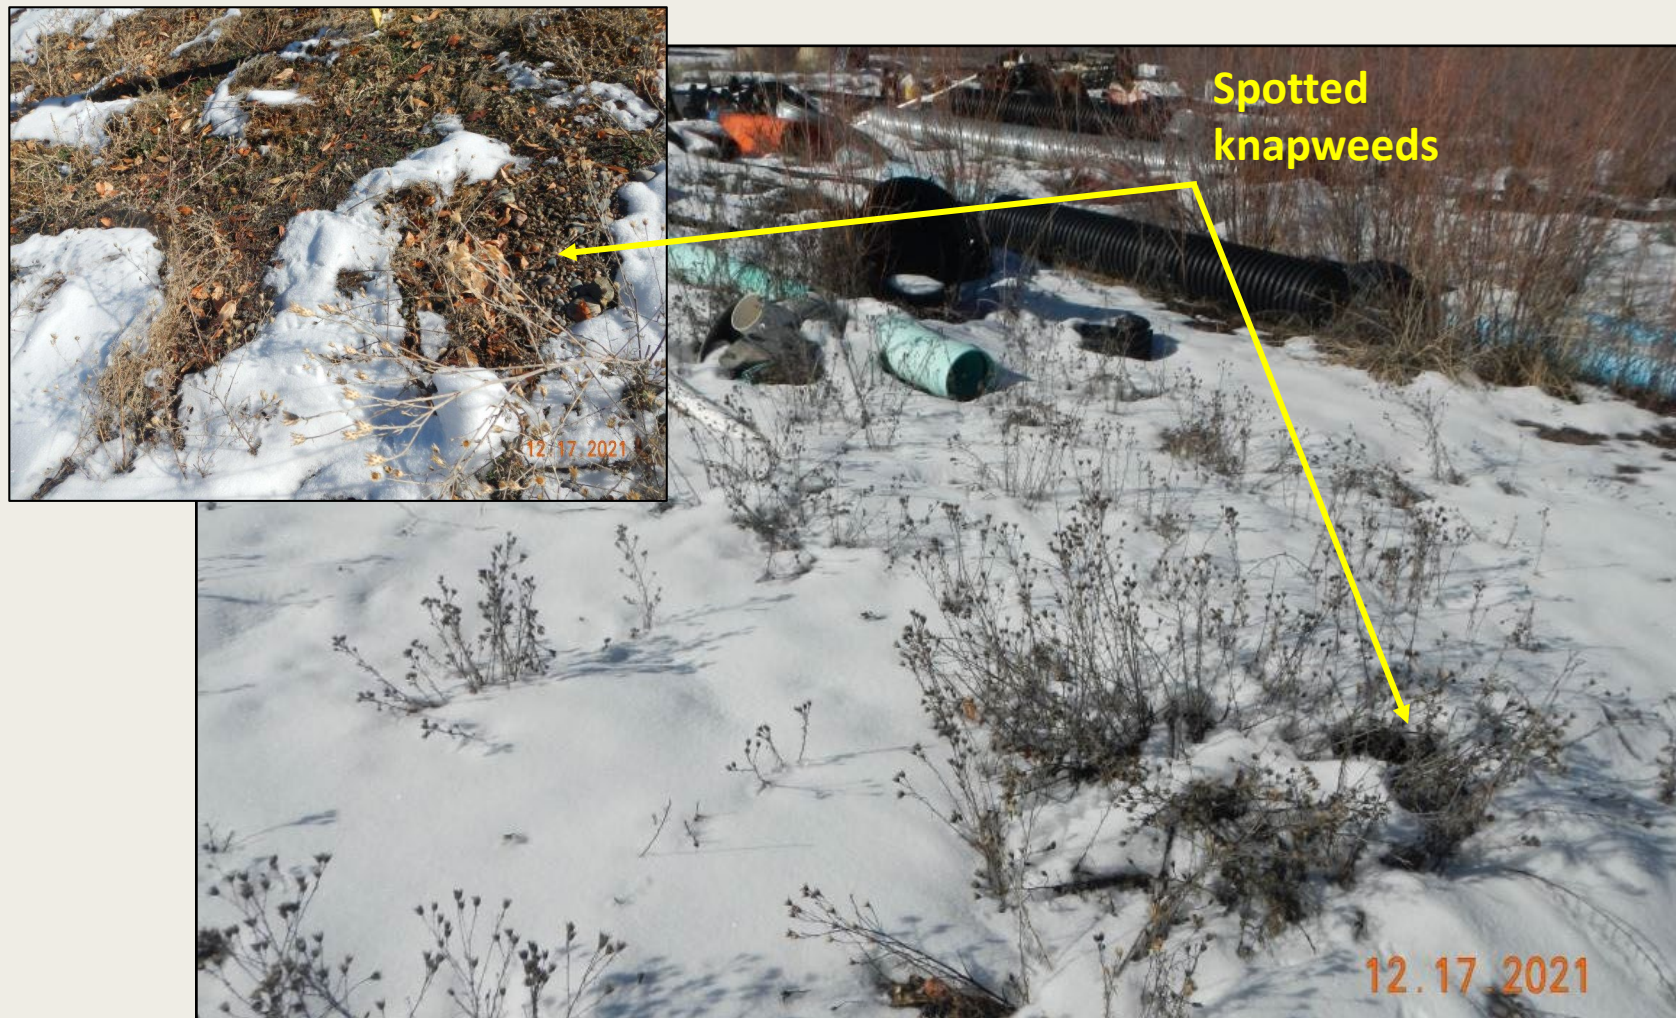
Photo 5. View of spotted knapweeds observed within the reclamation areas, and along the access road. Approximately 700 individuals observed (infestation).

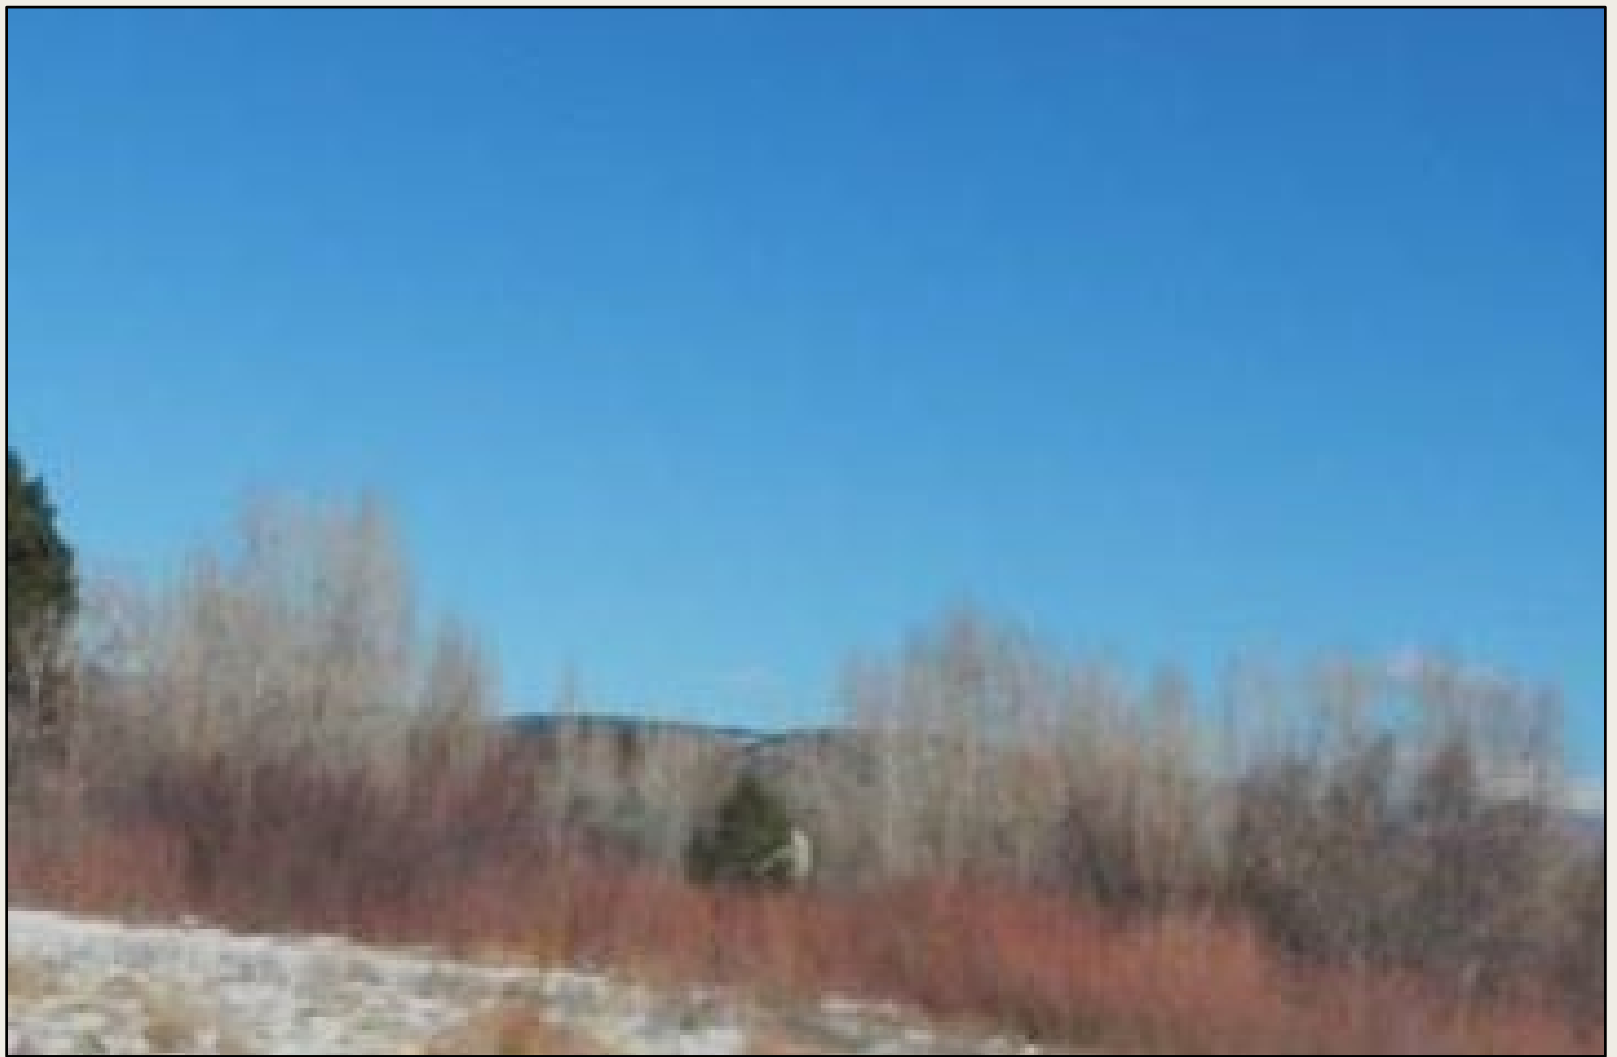
Photo 6. View of reference area comprised riparian shrubland with sandbar willow, cottonwoods, and rubber rabbitbrush. Understory grasses are snow covered at this time.
