Inspection Photos

API: 071-06811

Operator: WAPITI OPERATING LLC

Inspection Date: 12/27/2021

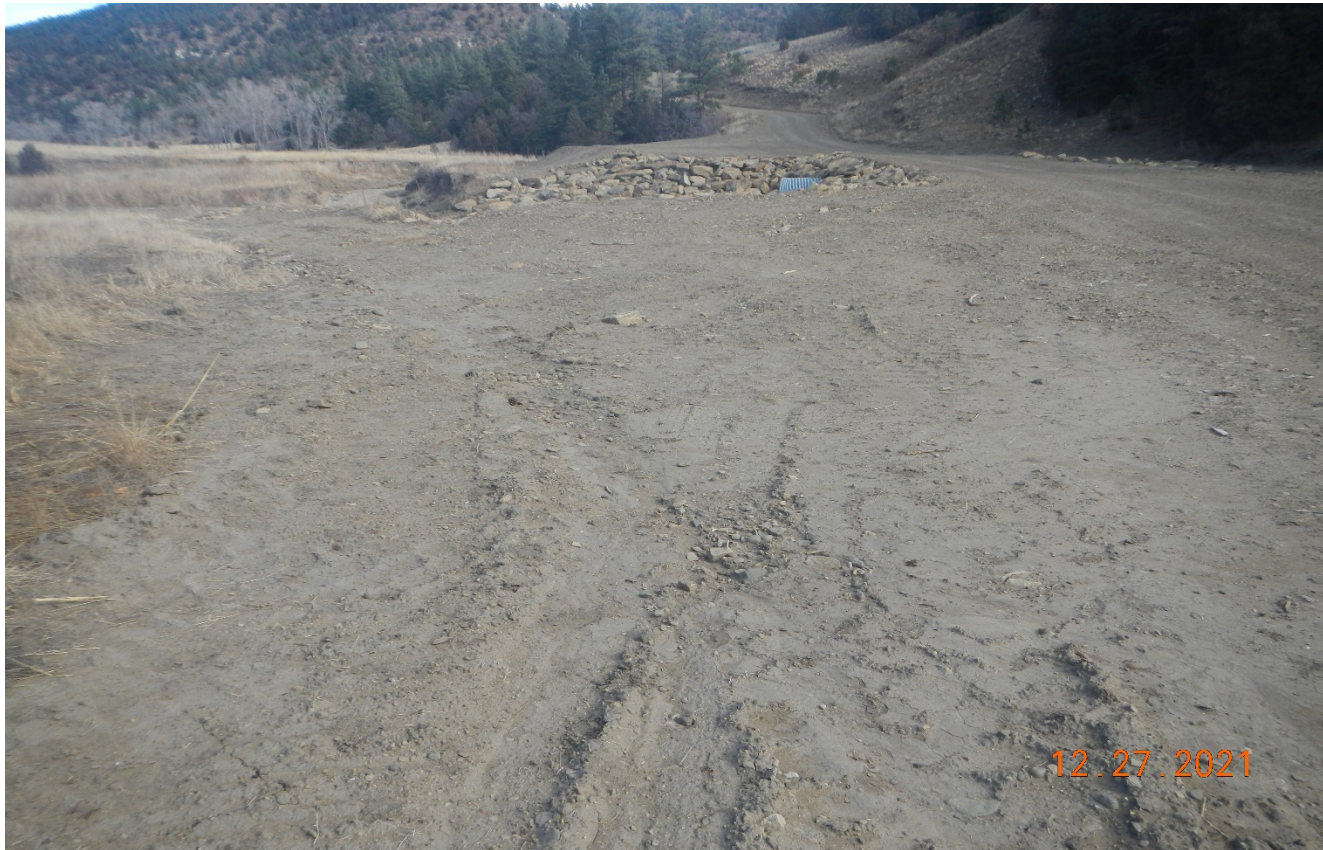
Photo 1. The disturbed bare soils along the roadside at the creek crossing have not been seeded and stabilized. Previous corrective action was not completed.

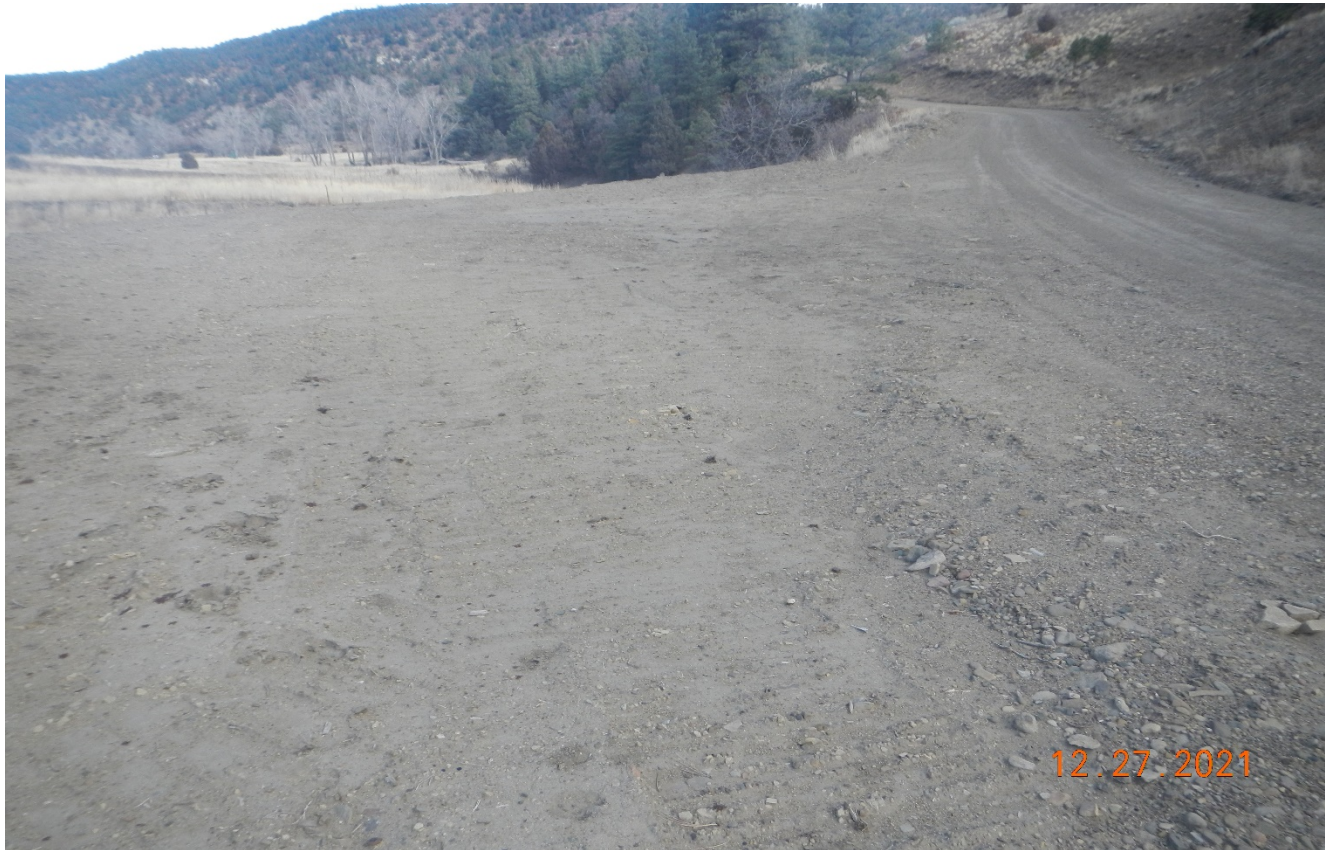
Photo 2. The disturbed bare soils along the roadside at the creek crossing have not been seeded and stabilized. Previous corrective action was not completed.

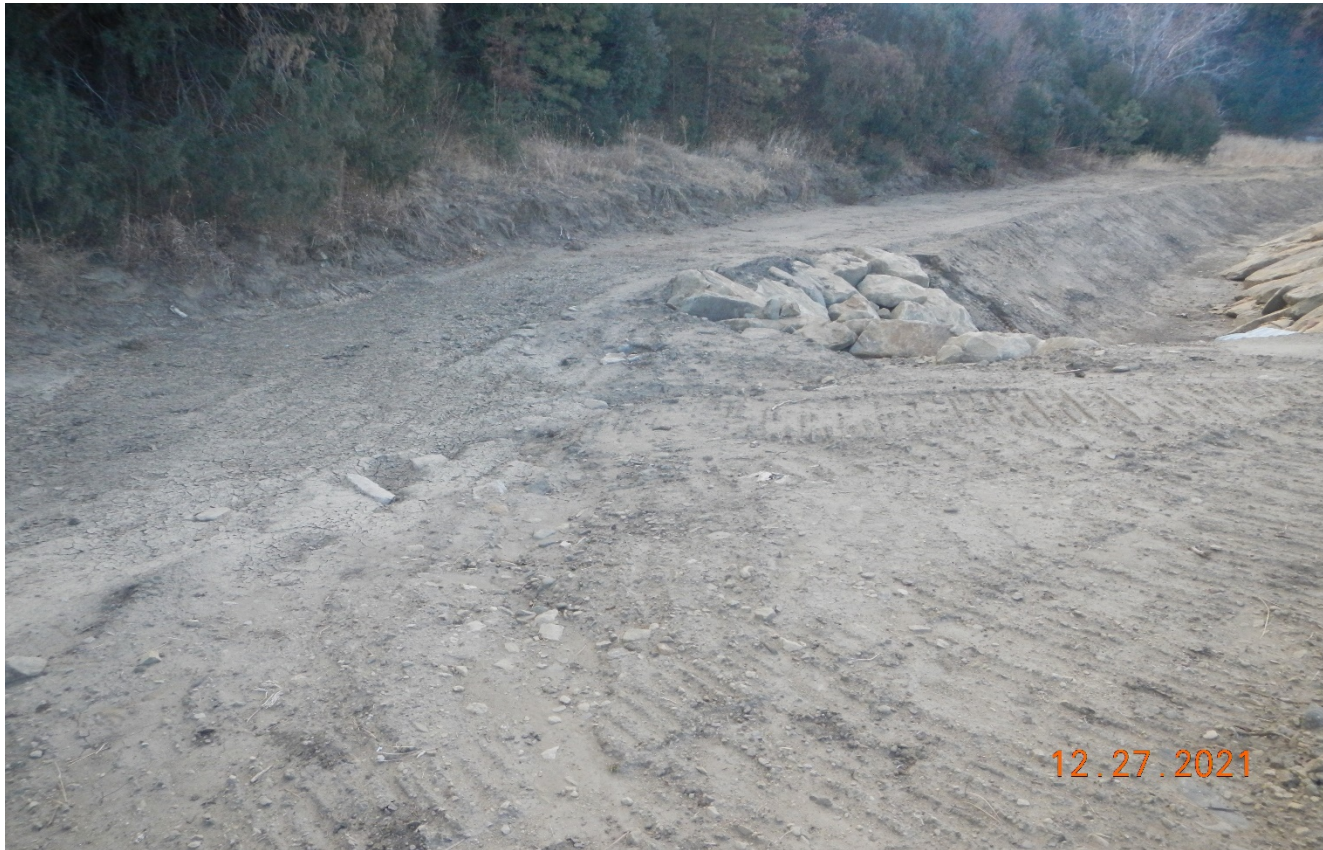
Photo 3. Facing at south side of the road at the additional culvert inlet. Disturbed bare soils have not been seeded and stabilized.

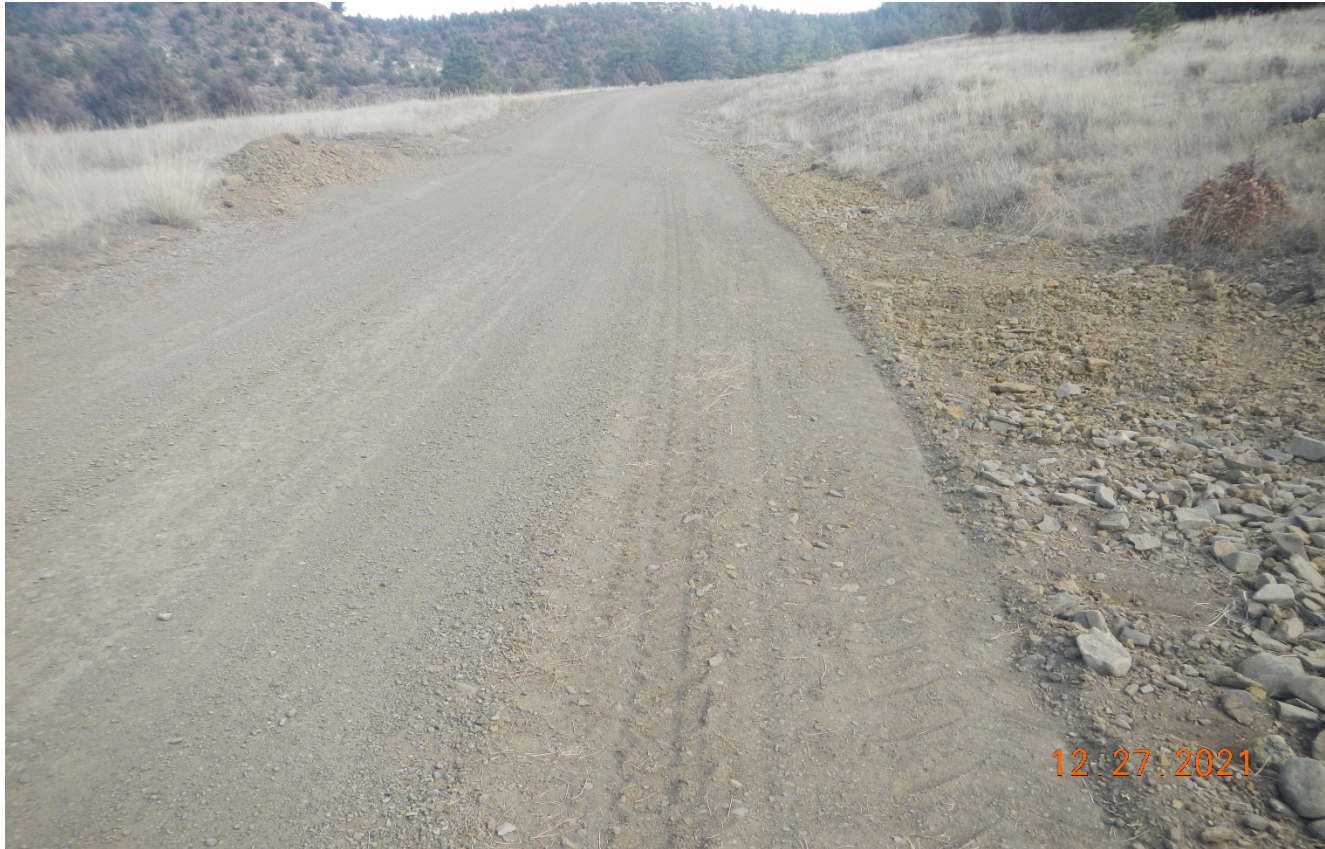
Photo 4. Facing northeast along the road. Areas of erosion along the road side have been filled in and repaired.

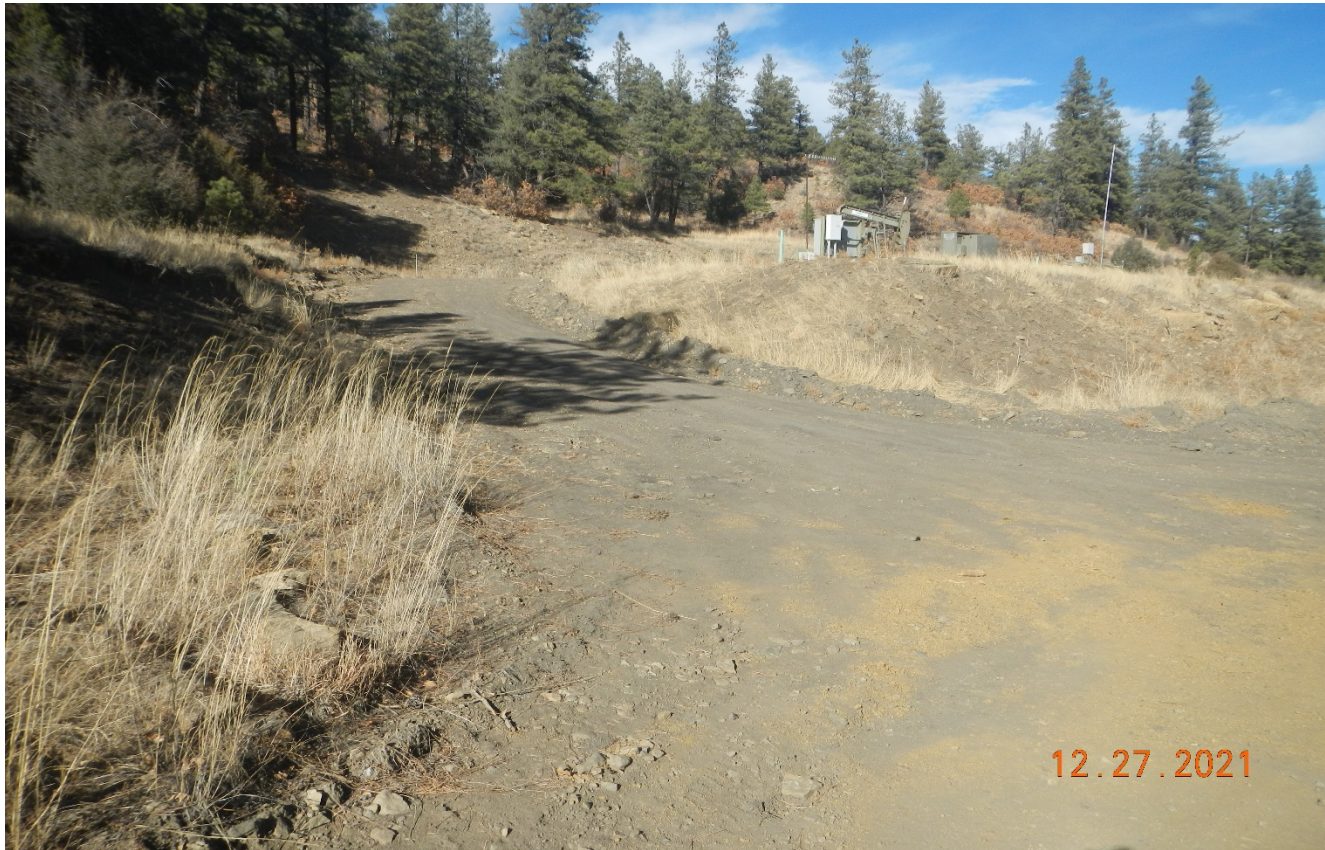
Photo 5. Facing northwest toward the well site.
