# Inspection Photos

API: 071-06815

Operator: WAPITI OPERATING LLC

Inspection Date: 12/27/2021

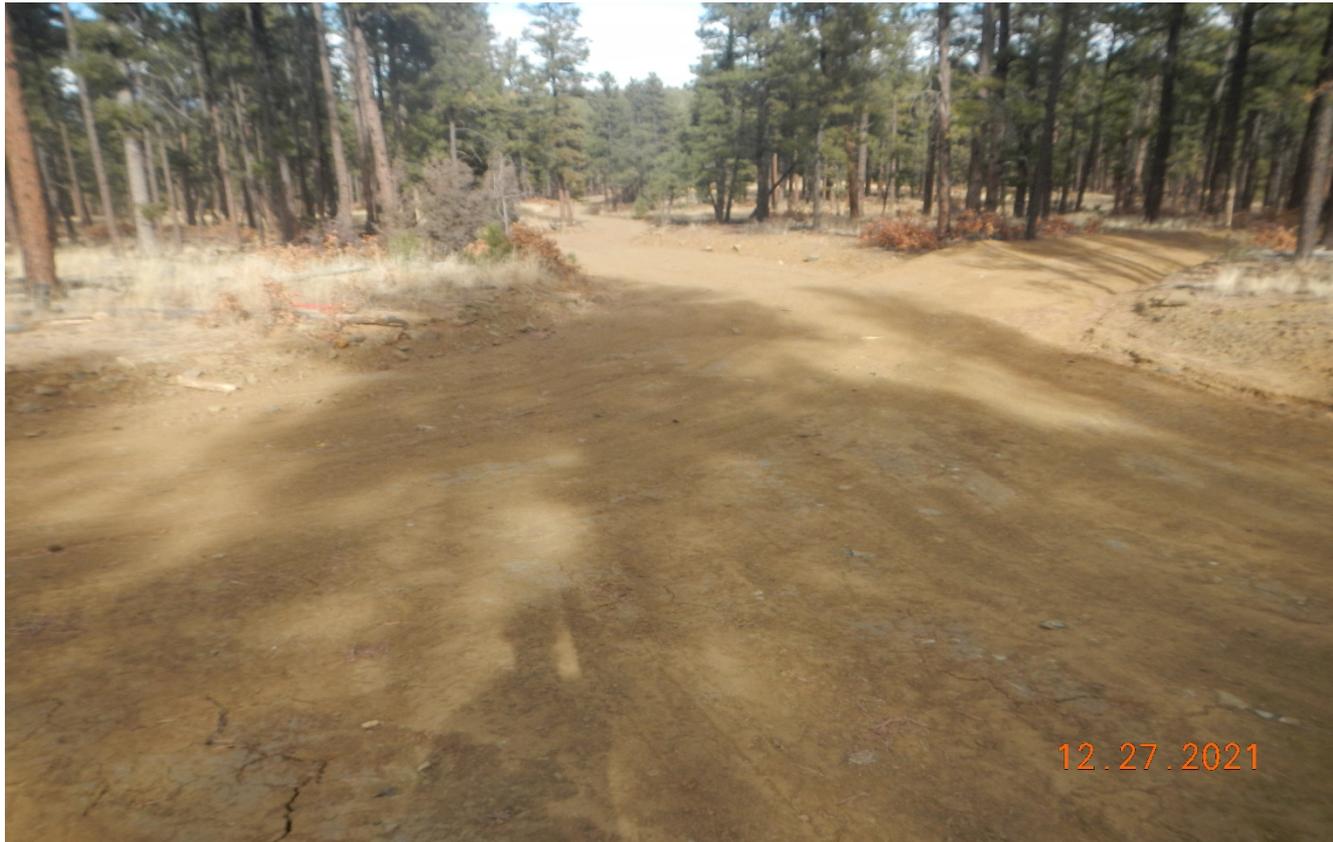
**Photo 1.** Facing north toward the access road. There is a berm and runoff ditch in this area of the road. The road has been regraded.

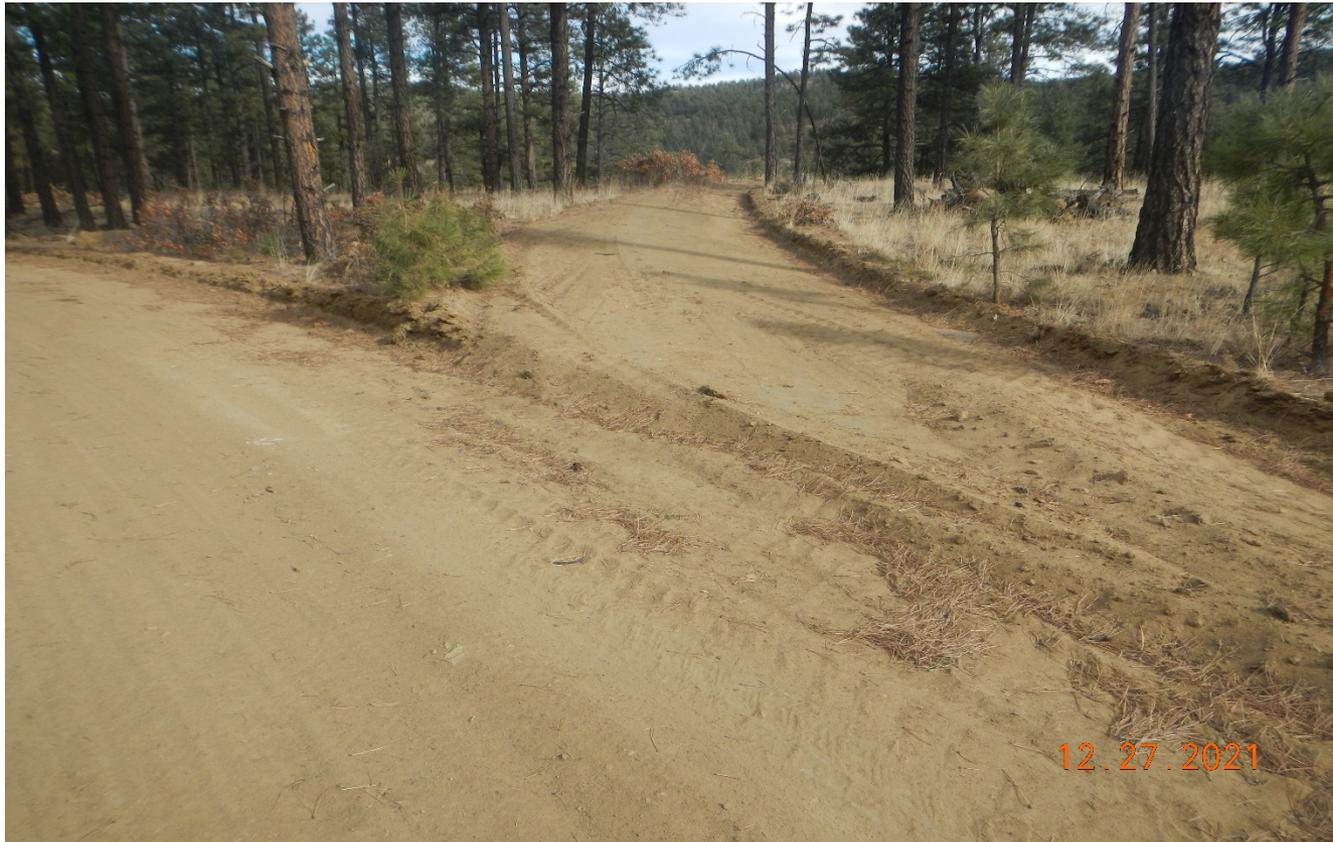
**Photo 2.** There are stormwater ditches carved away from the road. The disturbed loose soils are susceptible to erosion and need to be seeded and stabilized where the ditch disturbance has occurred.

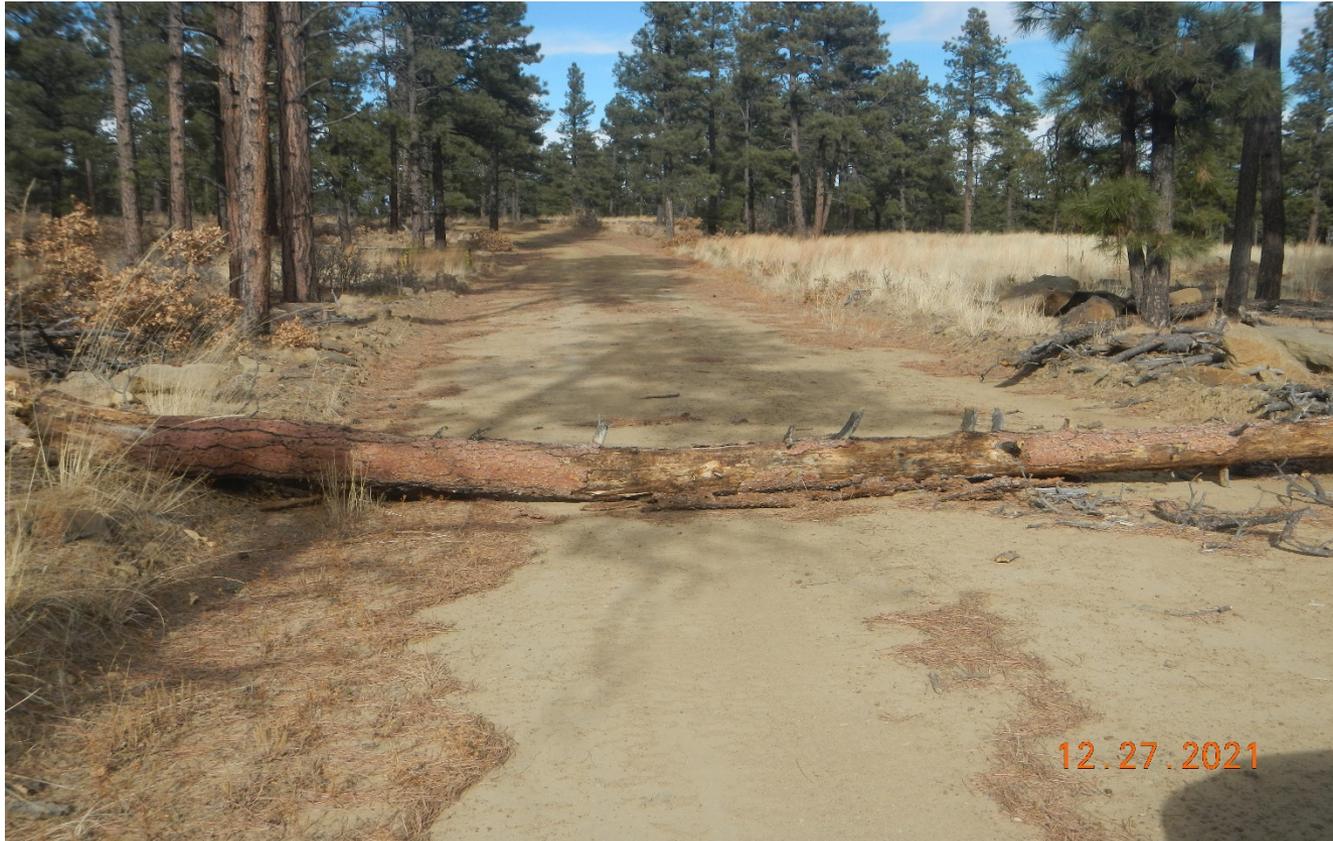
**Photo 3.** A tree has fallen across the road preventing access to the well site.
