Inspection Photos
Location Name: Roy Annala A #2
API: 05-067-08334

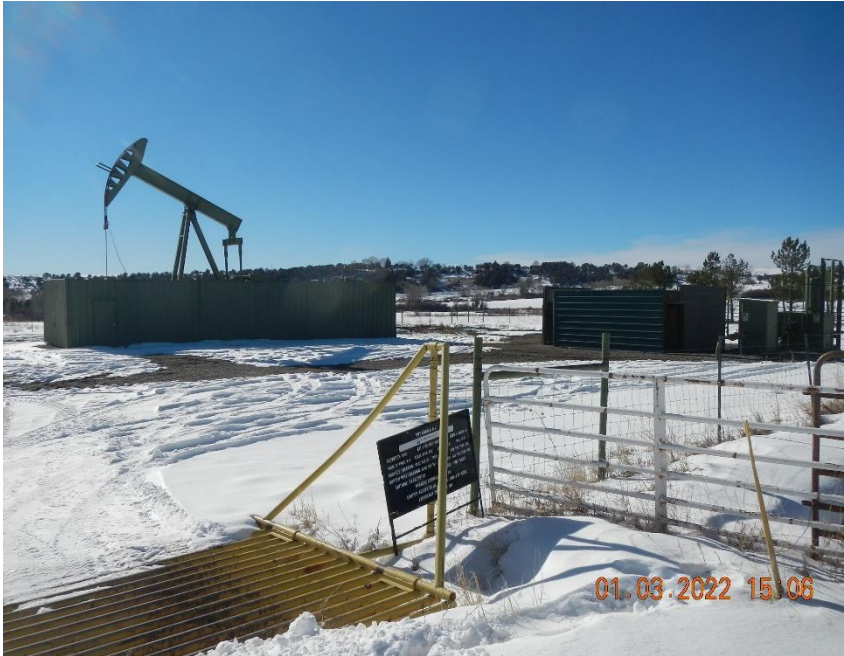
Roy Annala A #2 location photo.

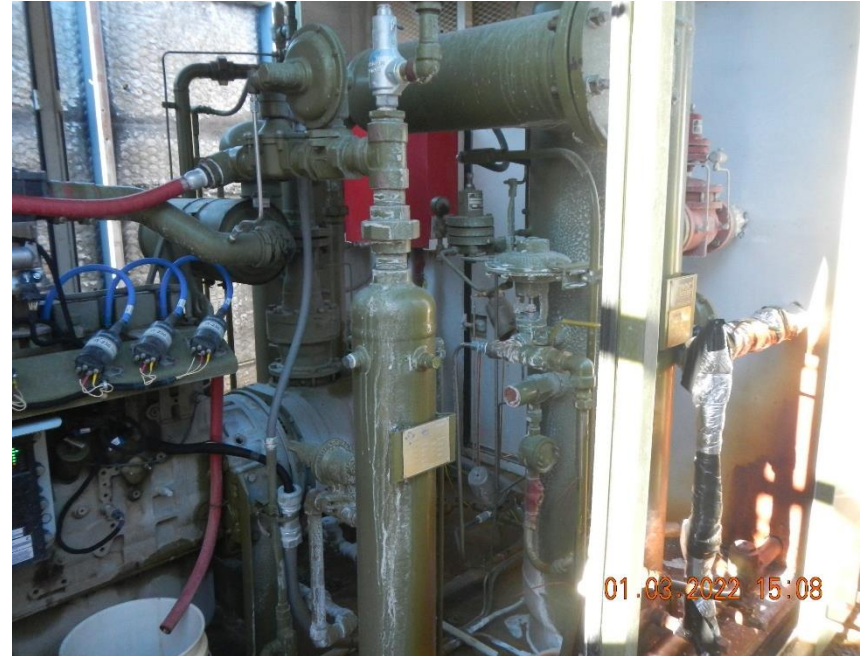
Equipment on compressor skid is stained with white residue.

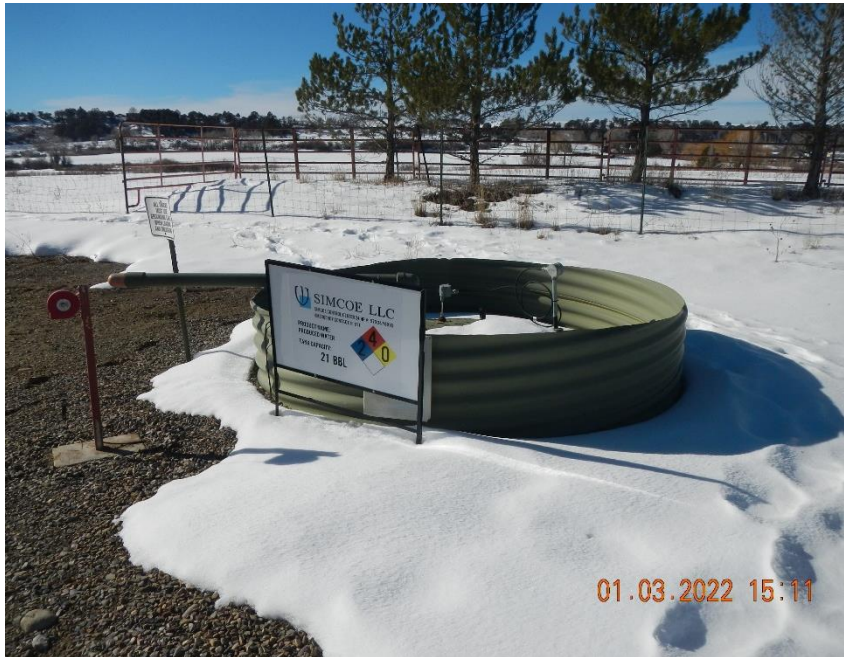
PBV on western edge of location. ASTs have been removed since last inspection with an equipment inventory..

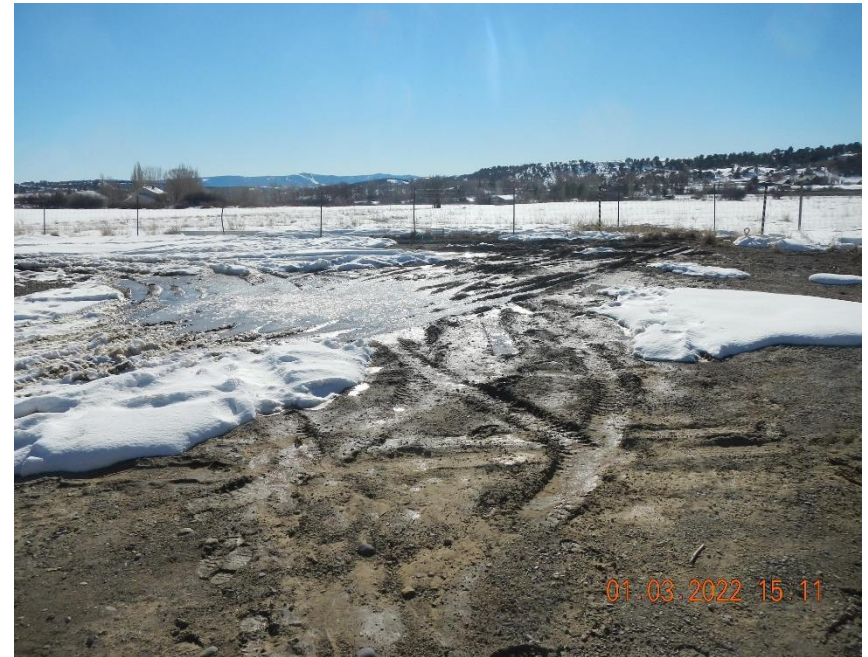
Reported direction of flow from Spill/Release Point ID #481340, towards the SW corner of the location.

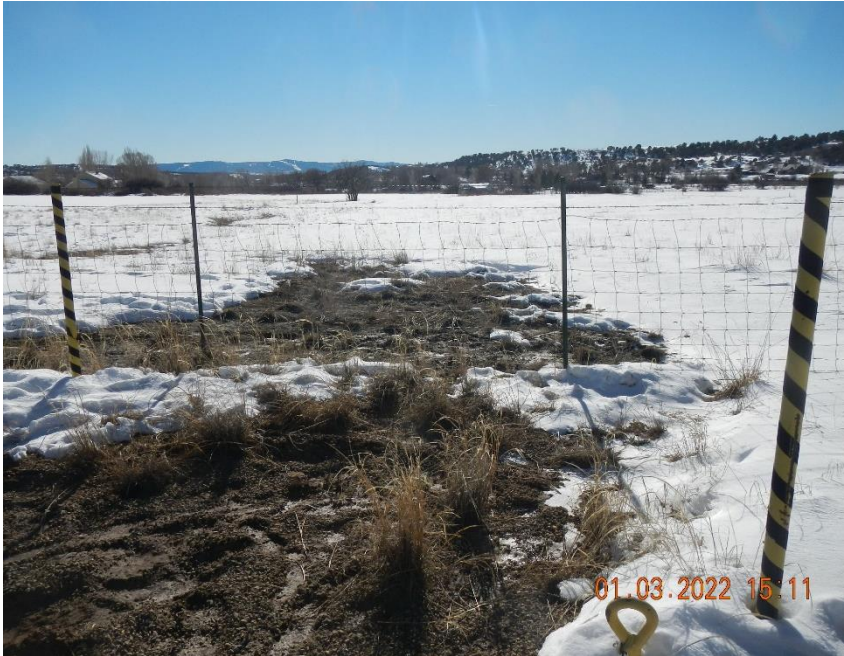
Produced water ran off of location into adjacent field.

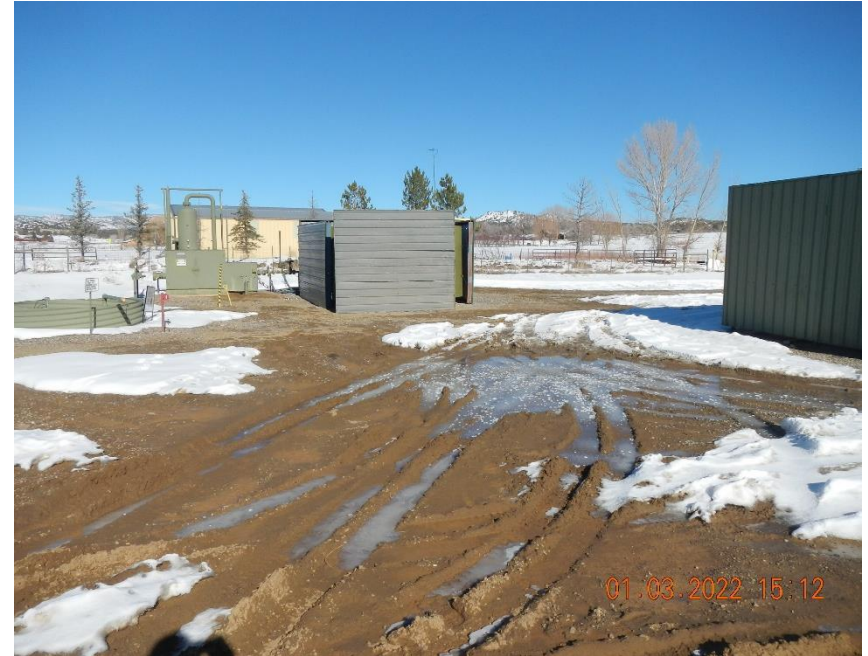
Photo taken from the edge of location looking back towards point source.

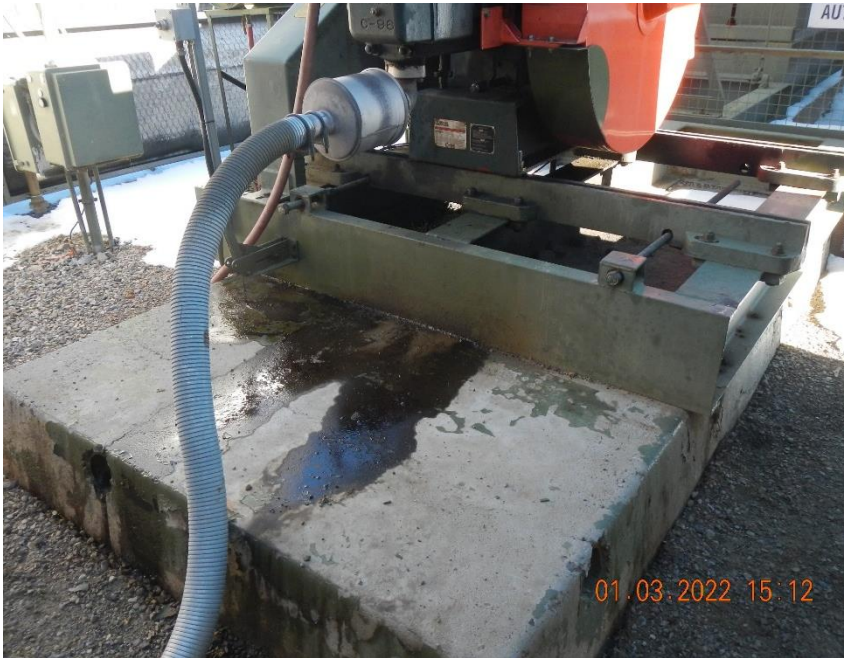
Concrete pad is stained and wet beneath prime mover.

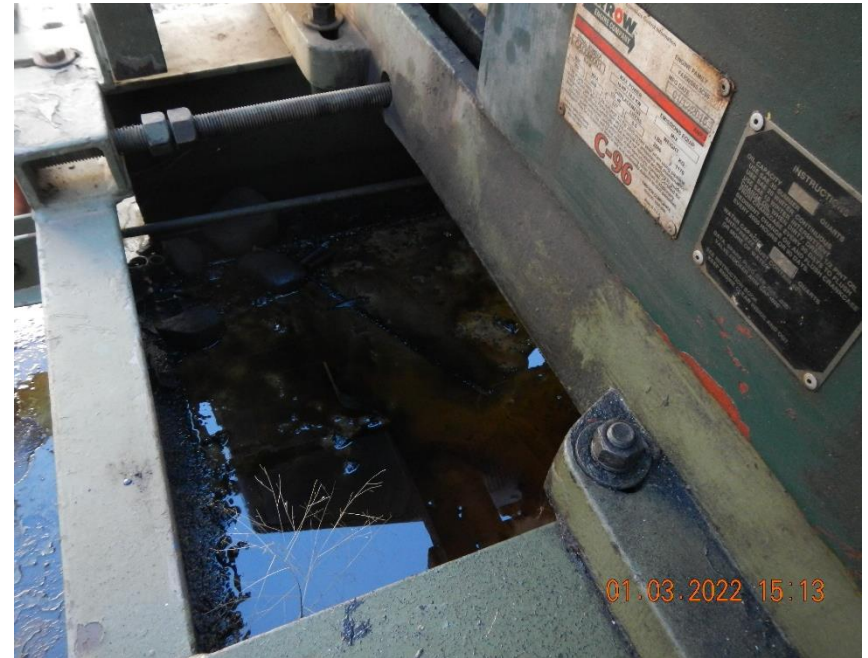
Fluid present beneath prime mover.
