**Inspection Photos**  
**Location Name: Fern Miller Wikstrand 2**  
**Location ID: 317738**

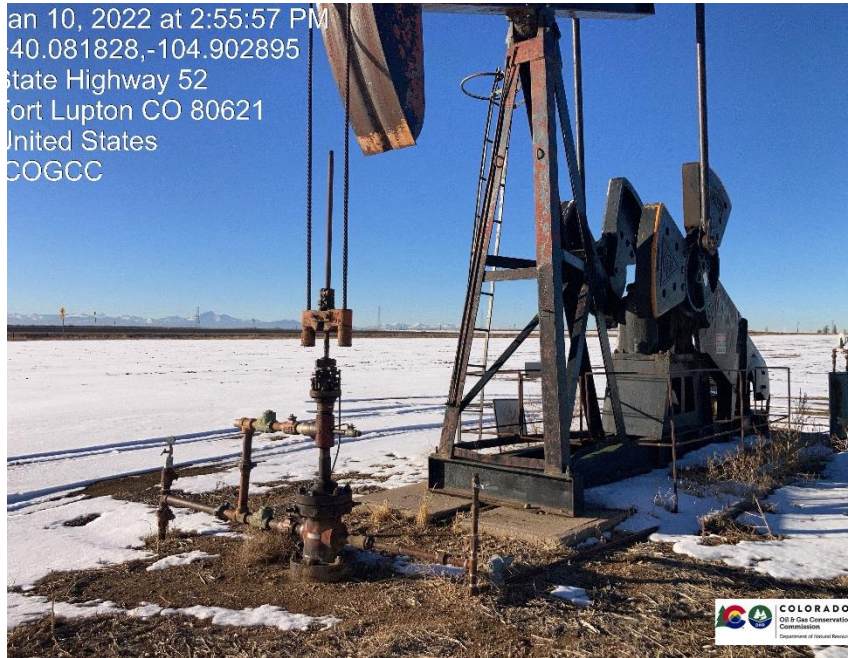
**Pic 1 wellhead / pump jack**

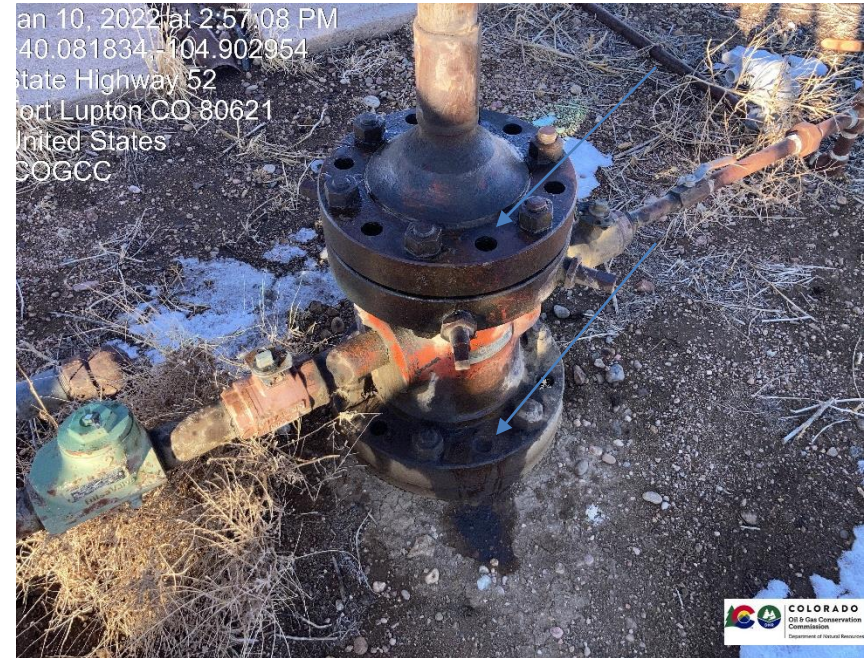
**Pic 2 wellhead. Wellhead bolts are missing on both tubing, and production casing hanger. Mechanical integrity issue are visible due to leaking wellhead on flanged connections.**
