Location Name: Becks 41-16 Location ID/API #: Spill 481394

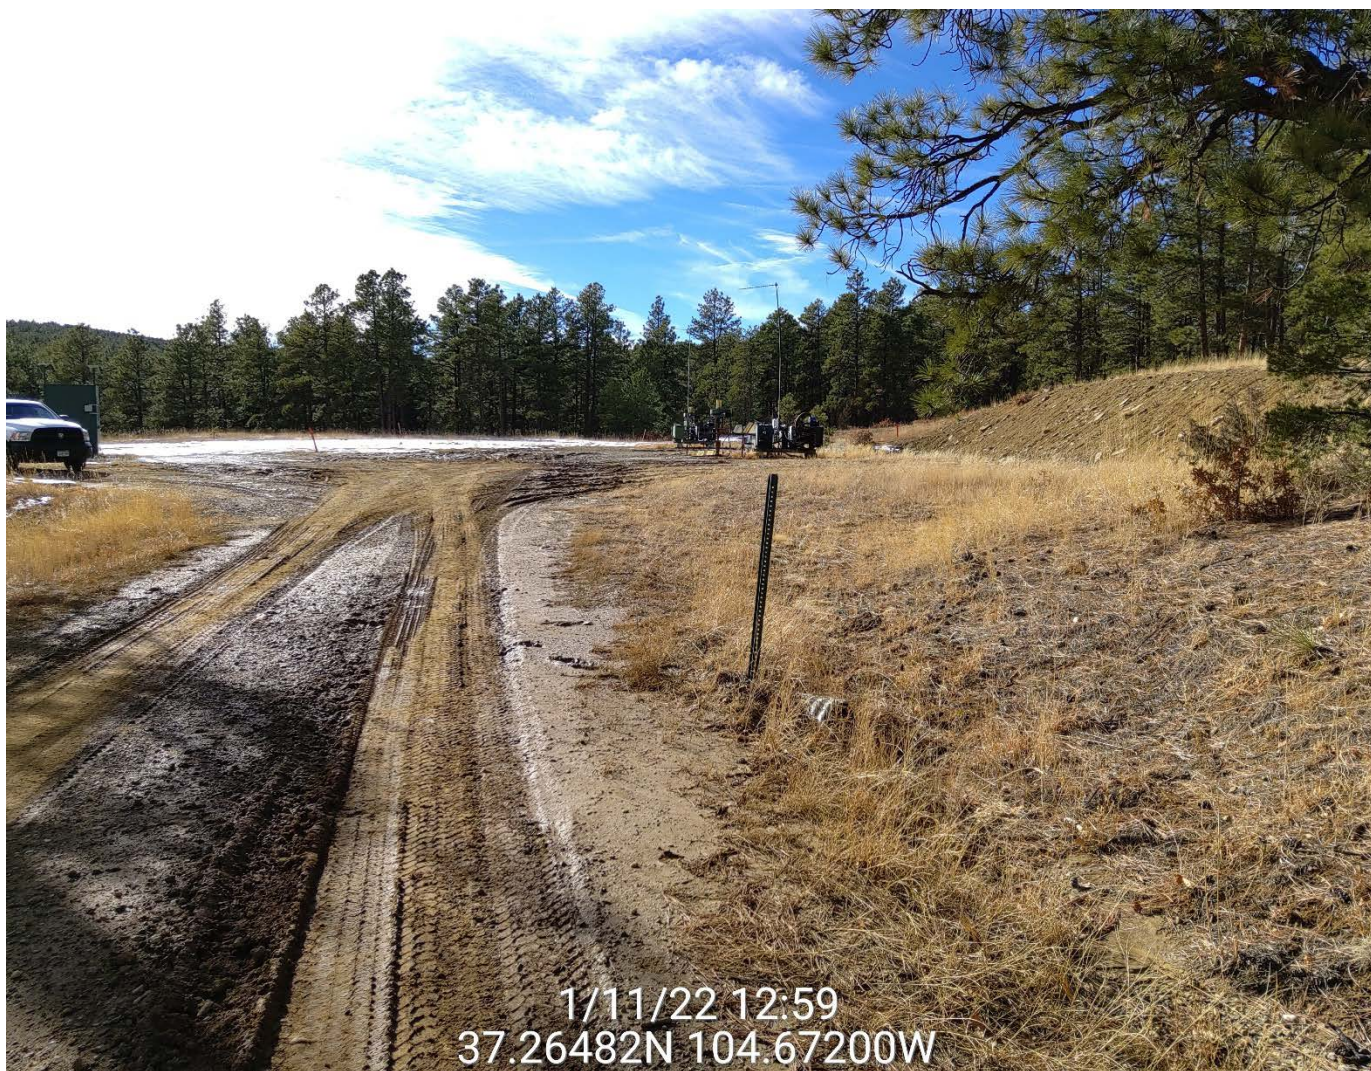
Spill path toward culvert. Culvert shown in photo.

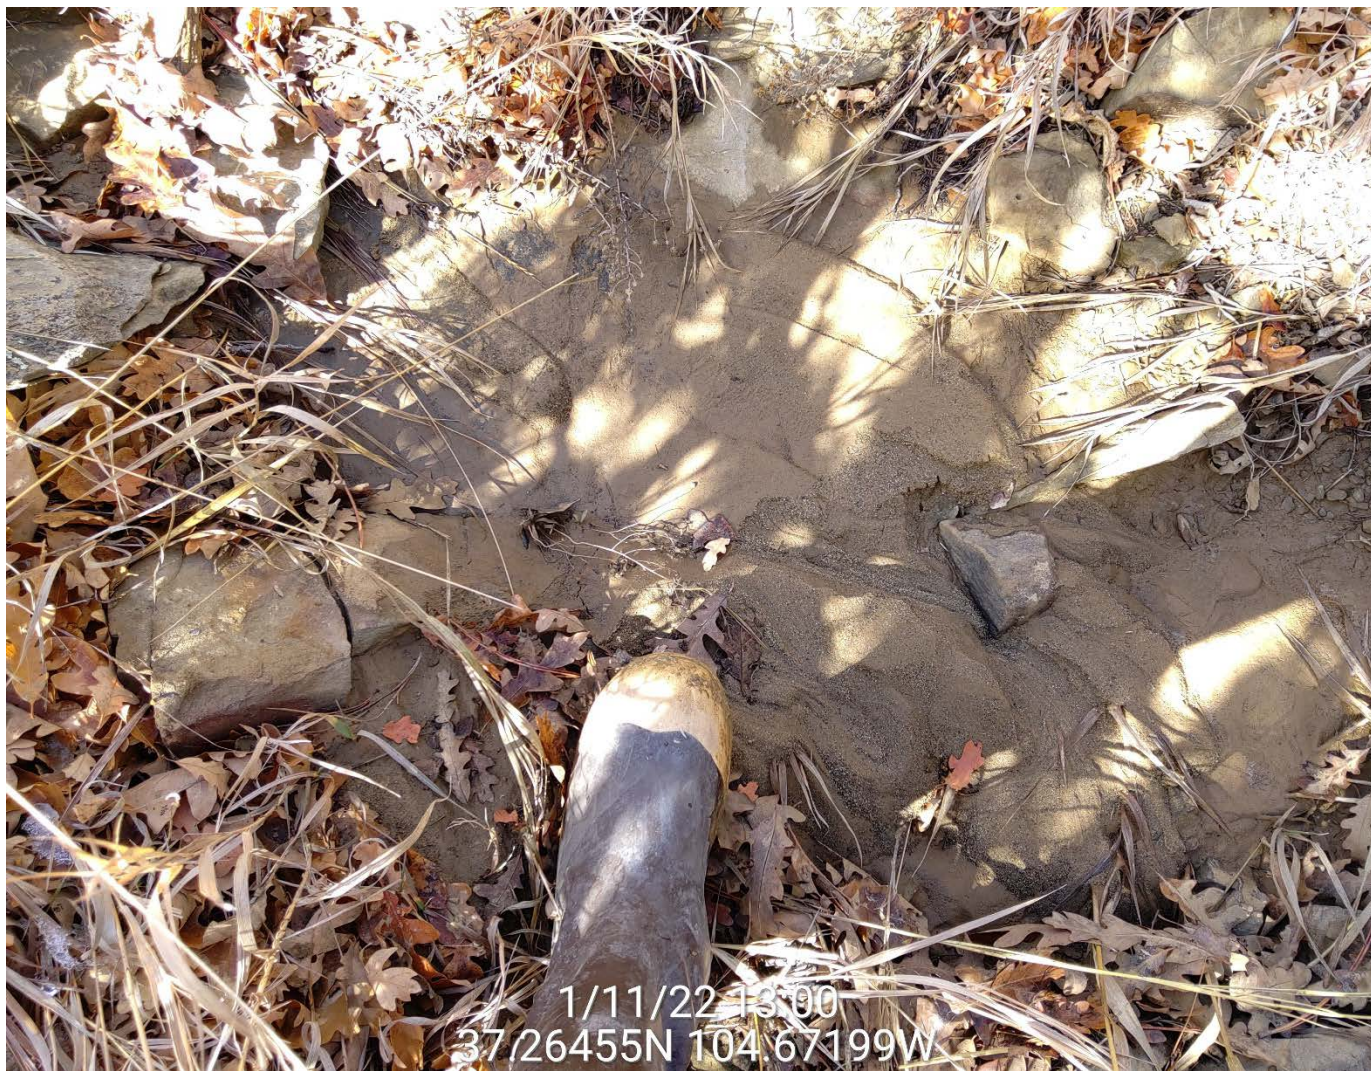
Evidence of flow of produced water in drainage.

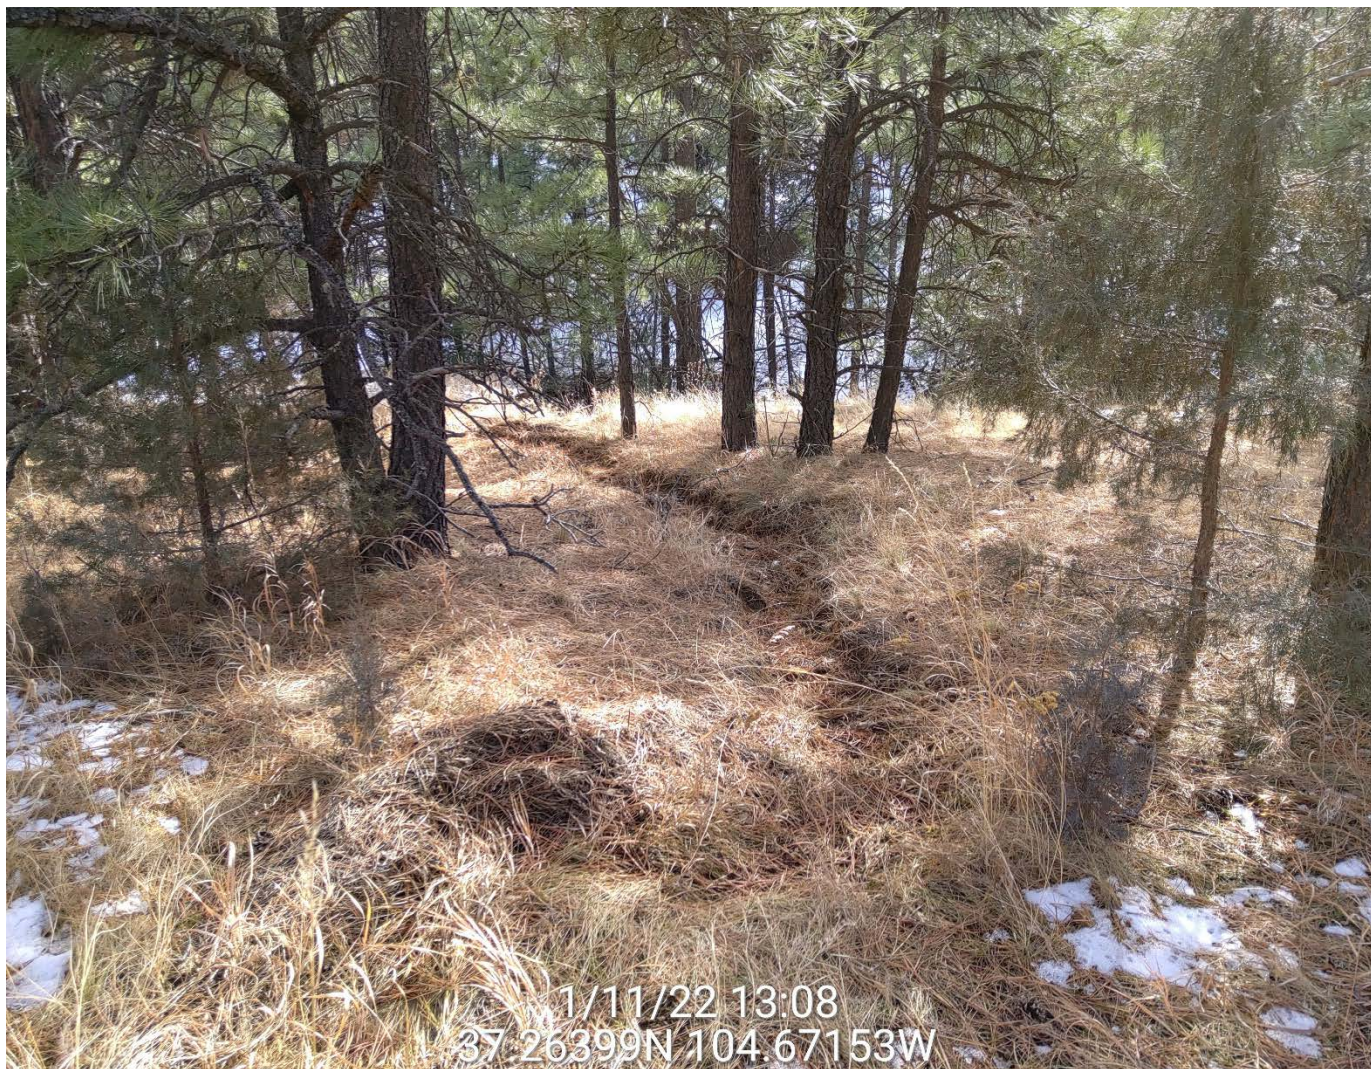
Photo of vegetation in spill path.

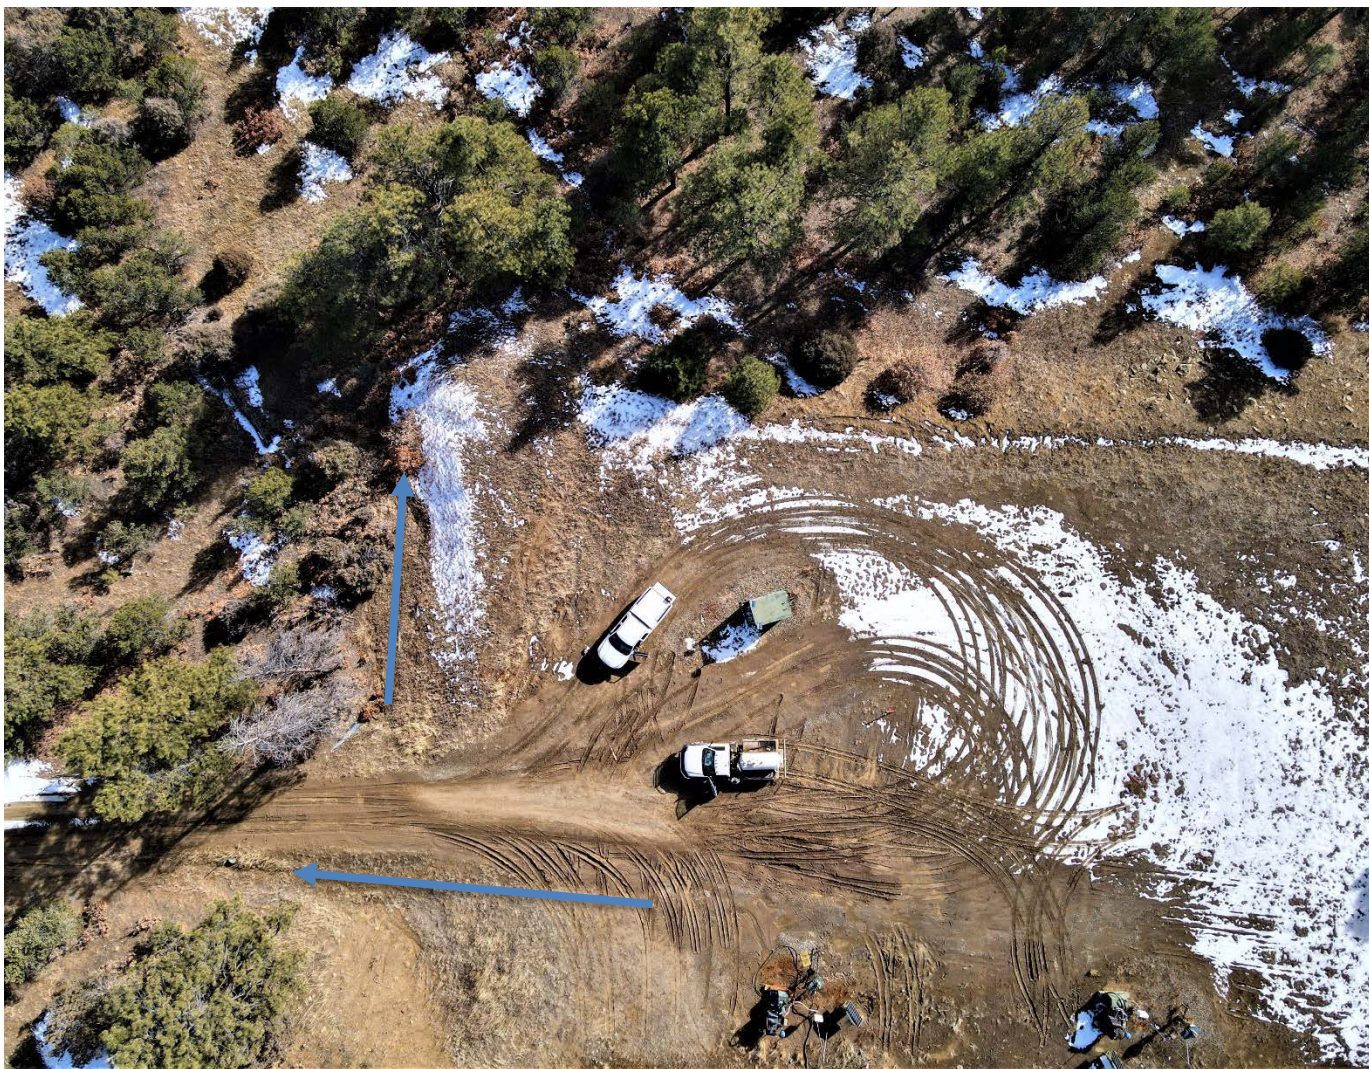
Spill path shown on aerial photo.

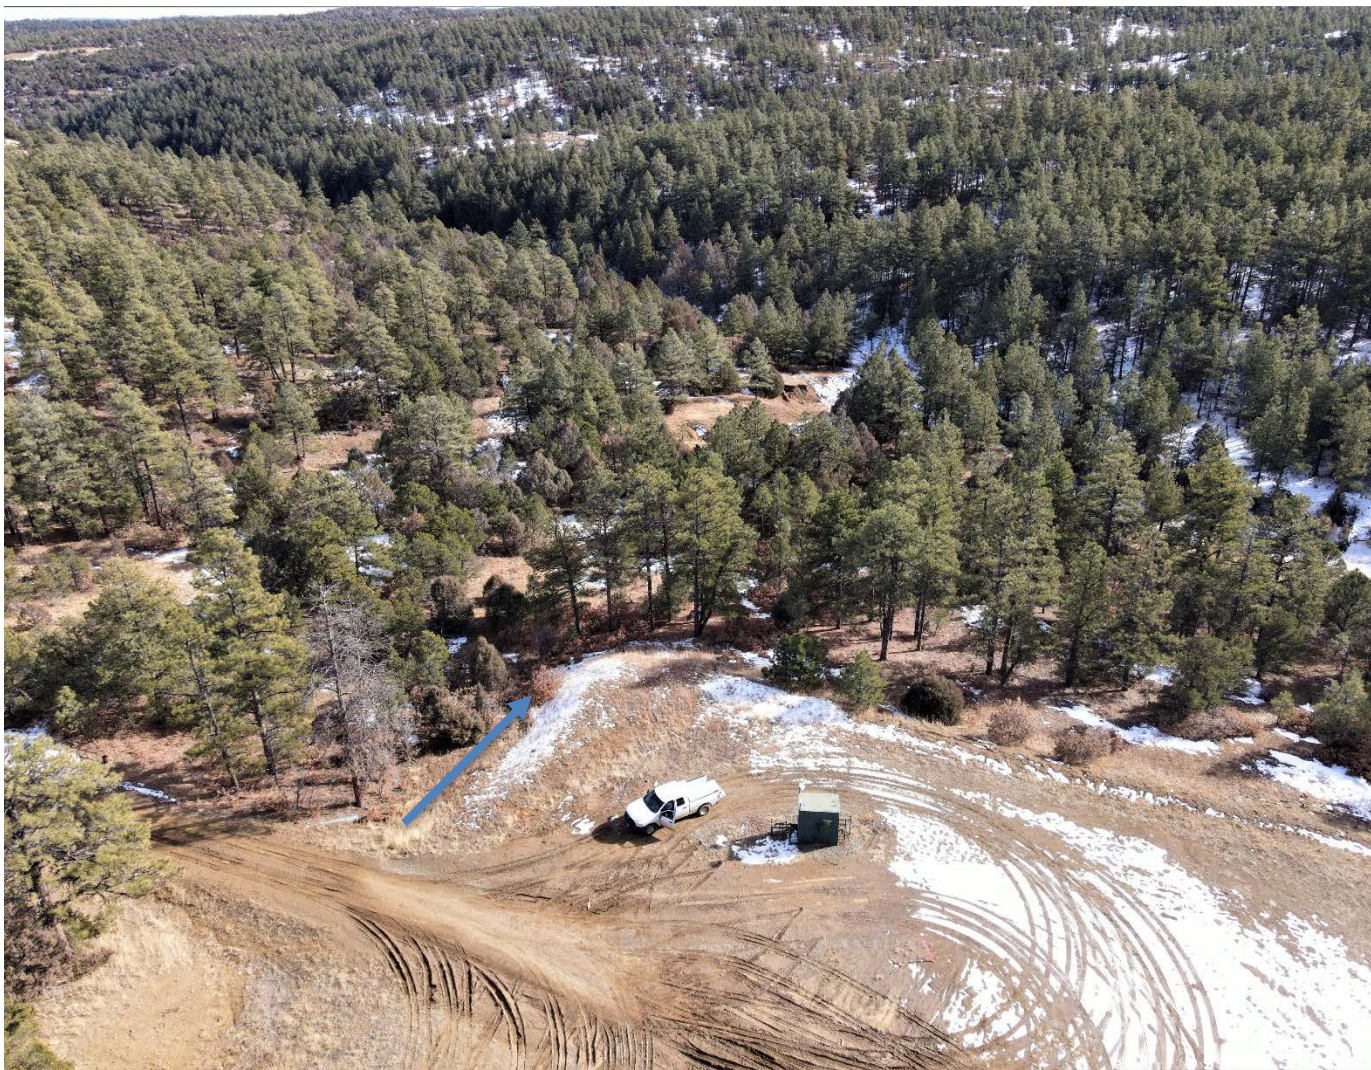
Spill flowed from culvert in direction shown by arrow.

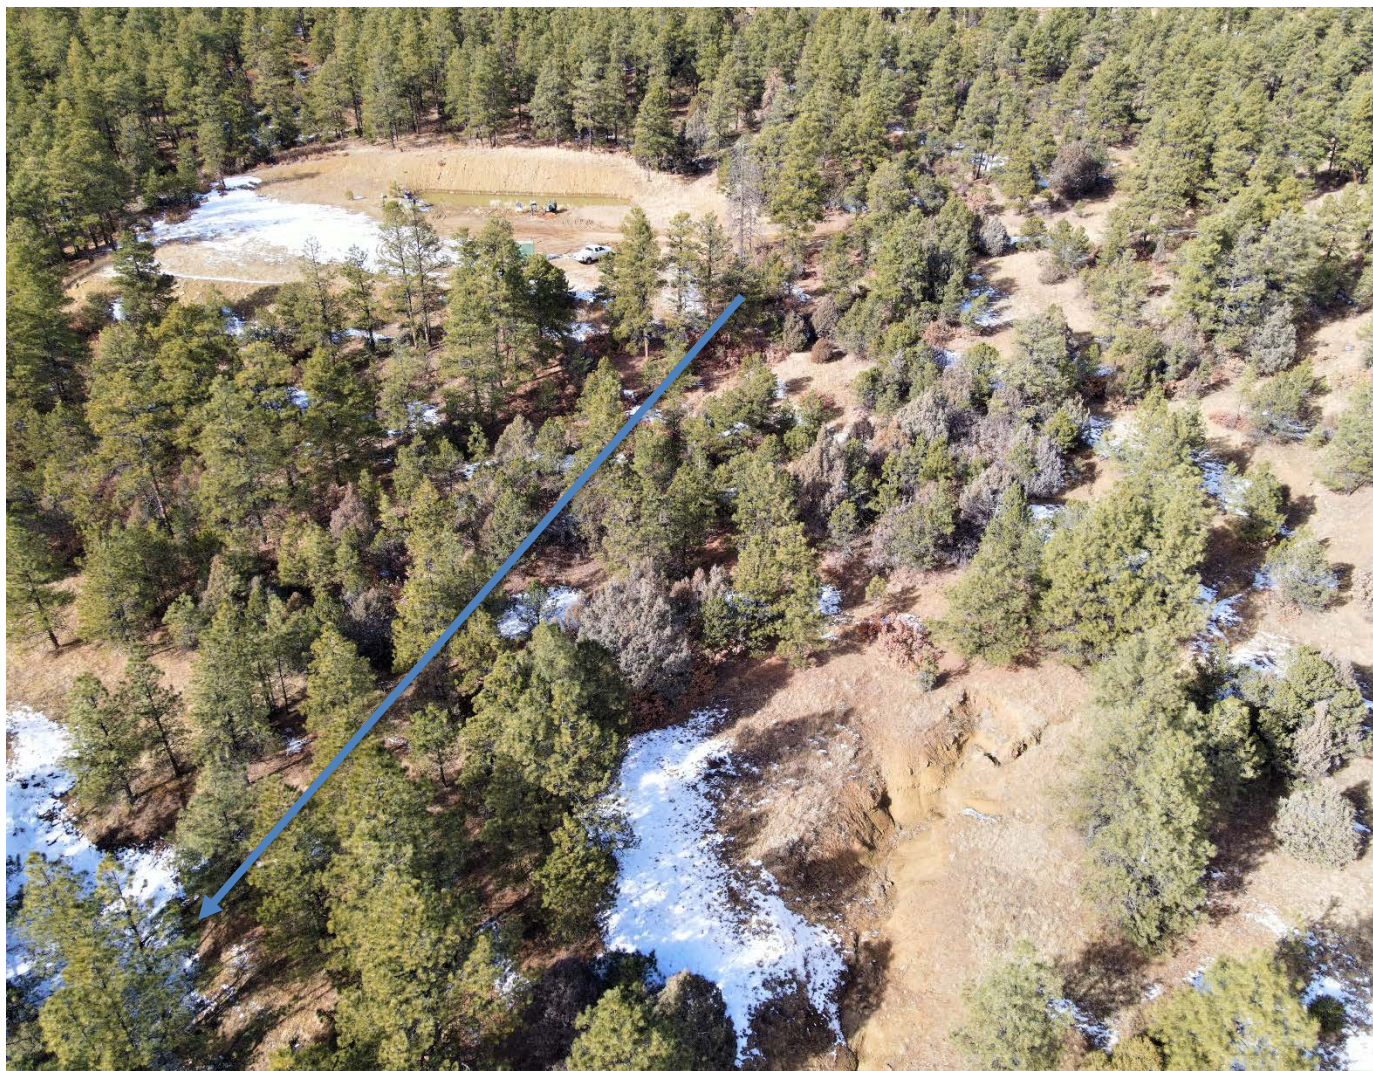
Approximate area of spill path.

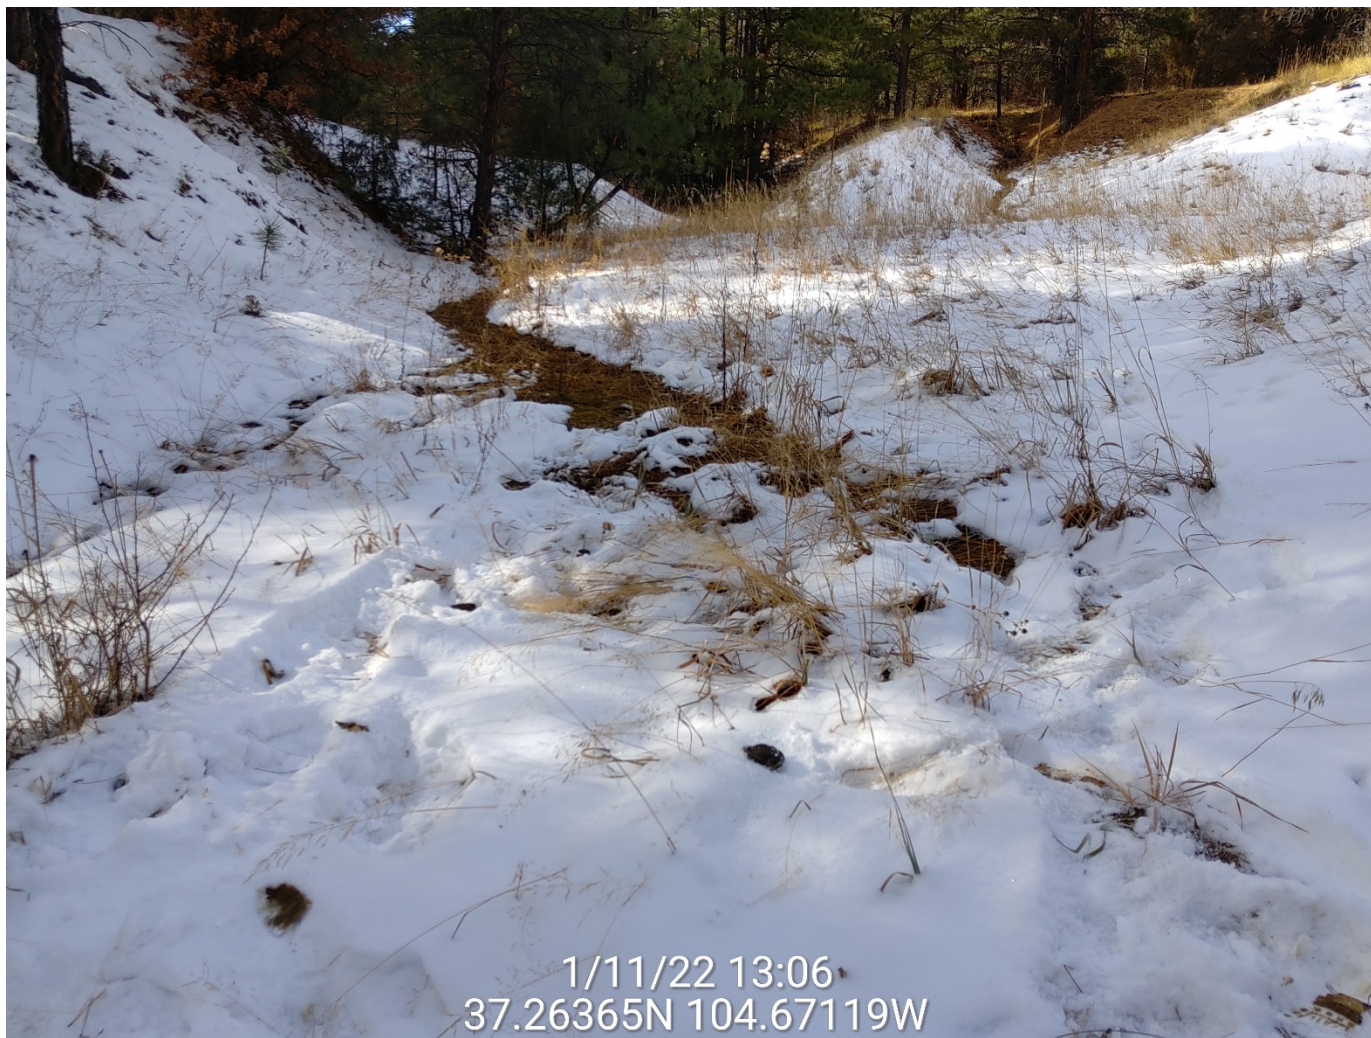
Likely area of spill terminus.
