EVERGREEN

BANITO FEDERAL 31-24

API 05-071-09806-0000

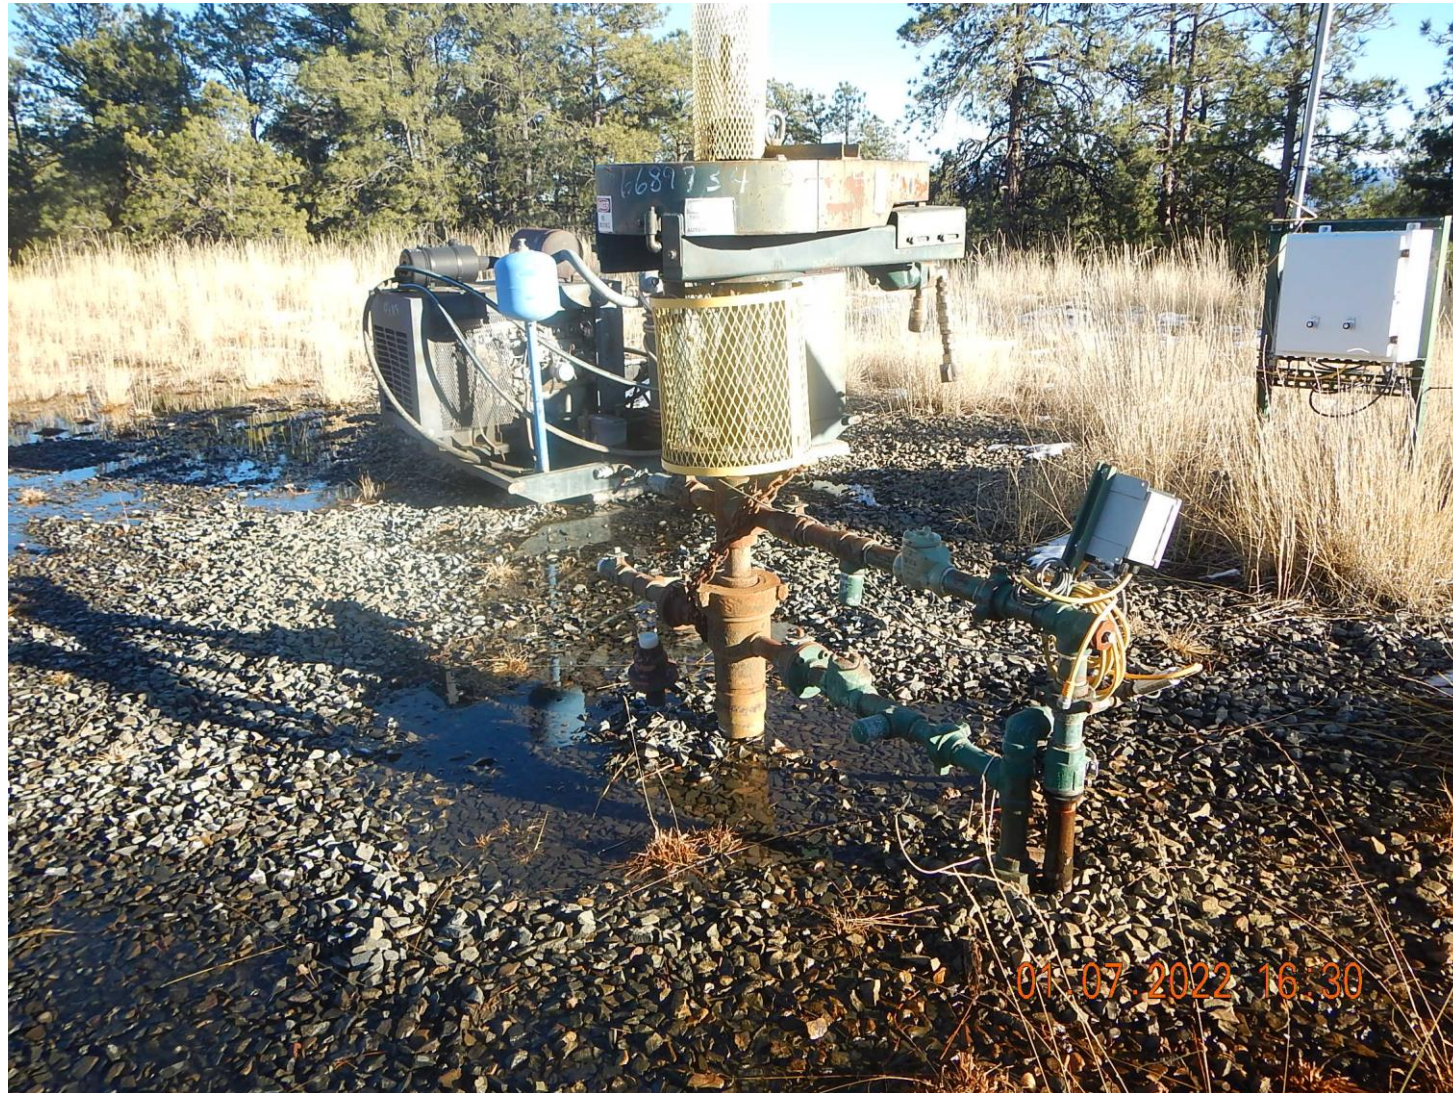
1. Spill source at the wellhead

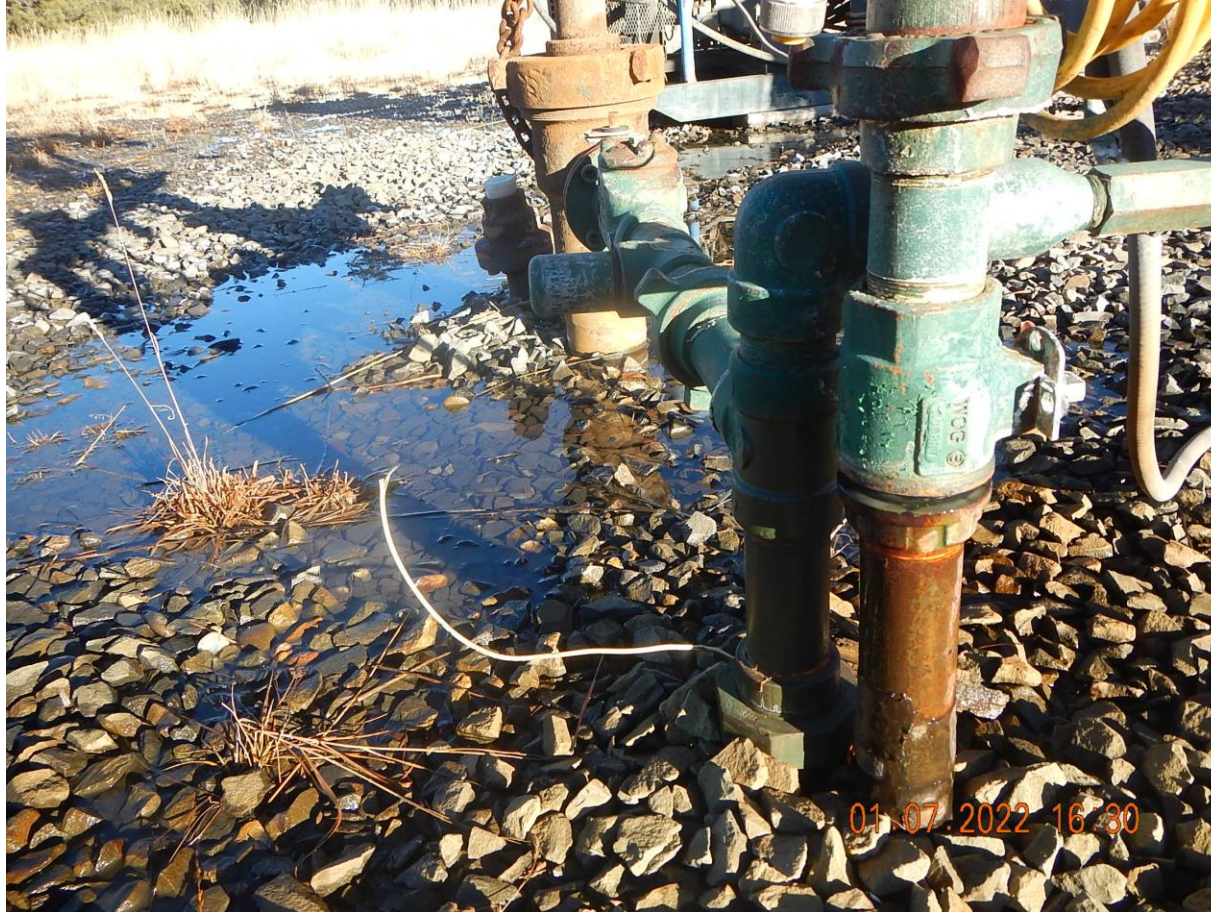
2. Spill source: Broken valve on wellhead waterline

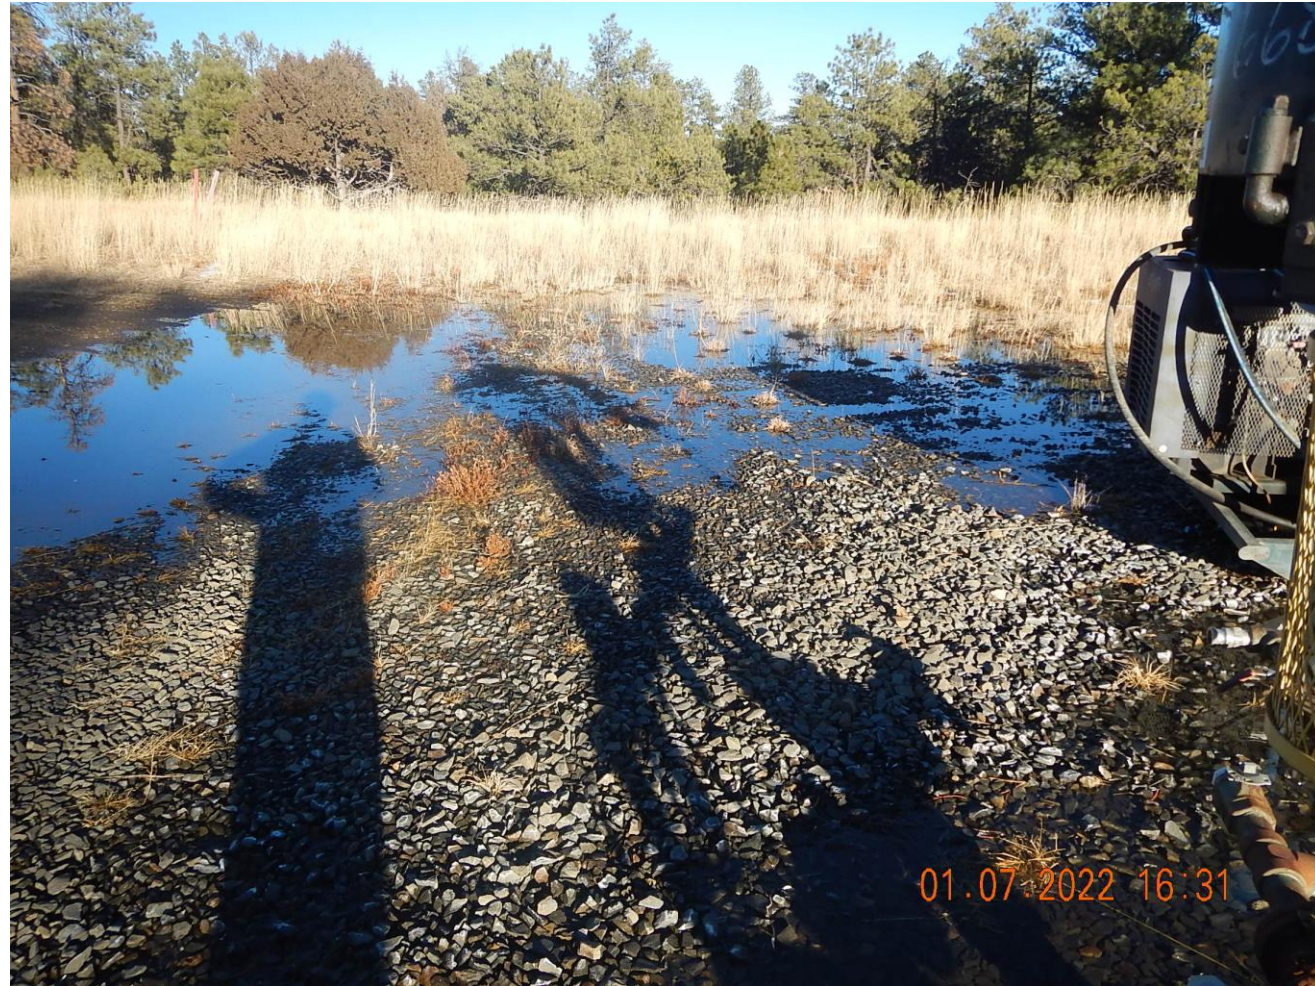
3. Spill path facing east from source

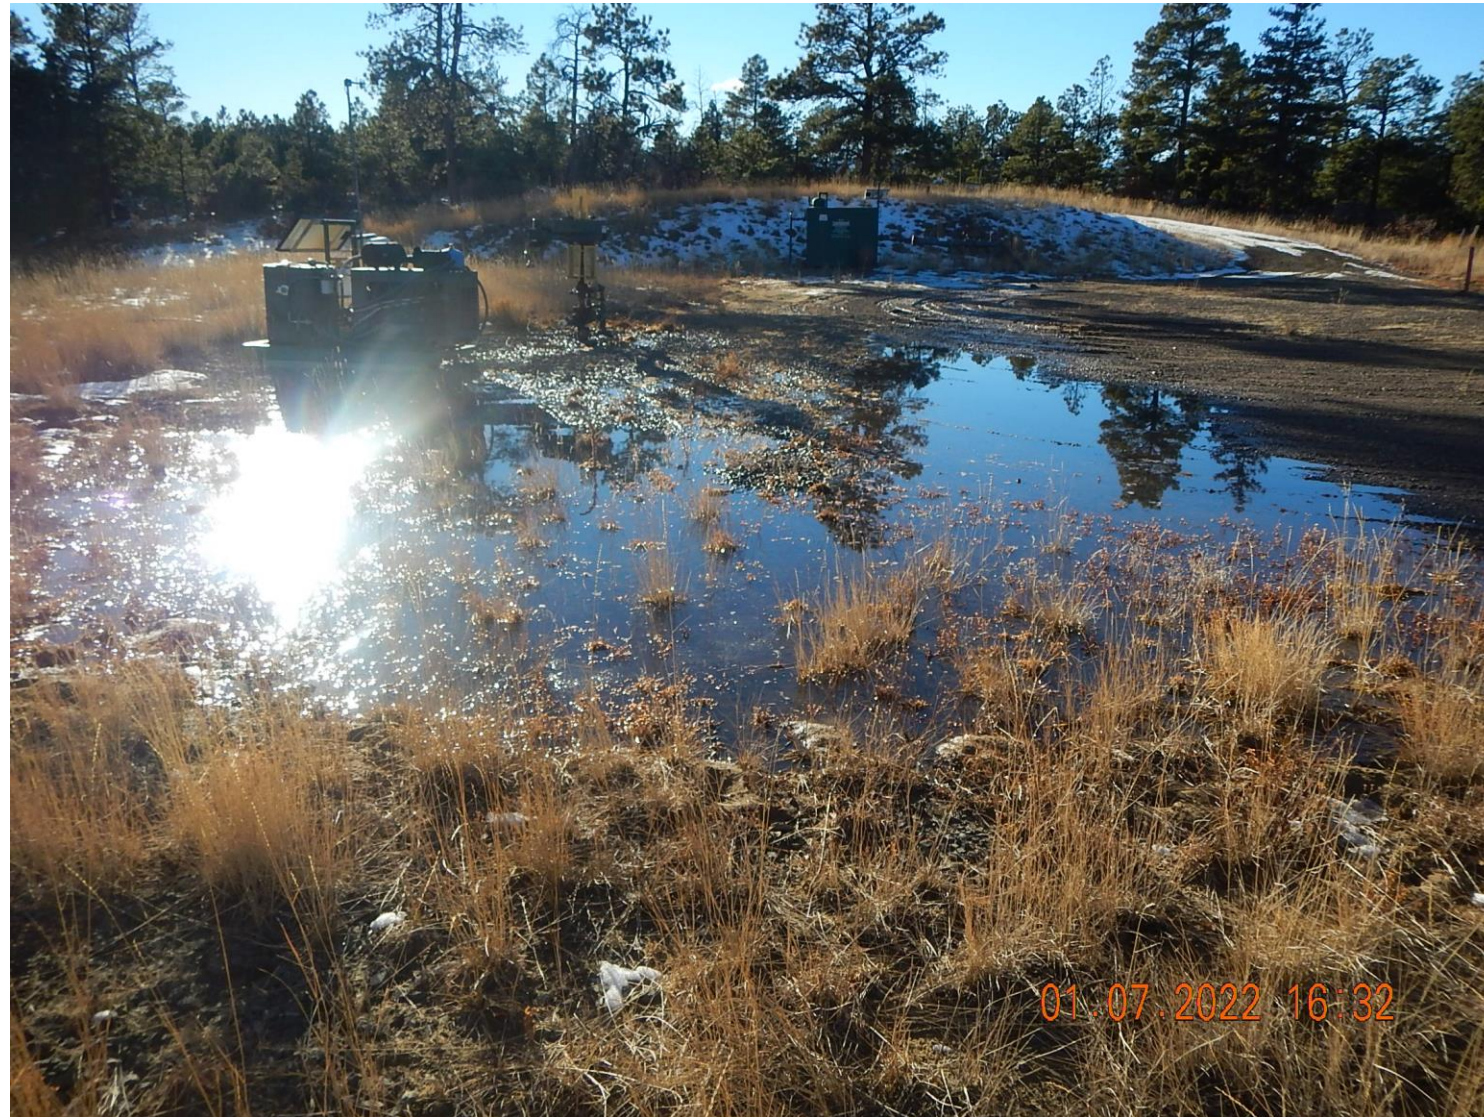
4. End of spill facing west toward source

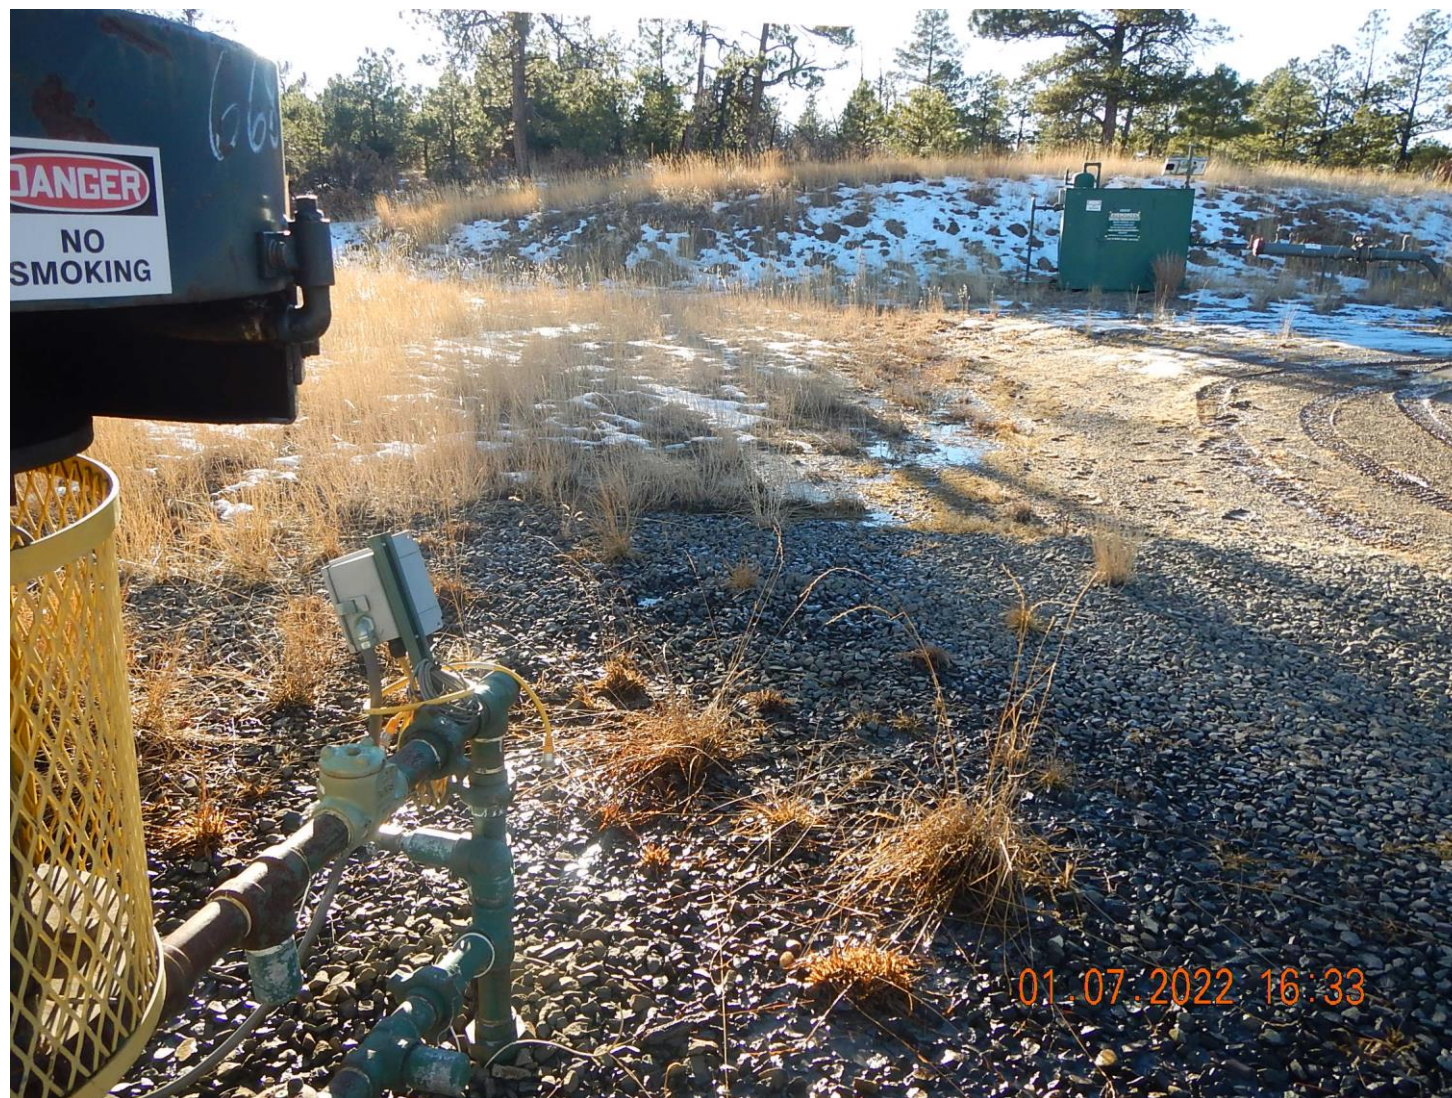
5. Spill path facing west from source

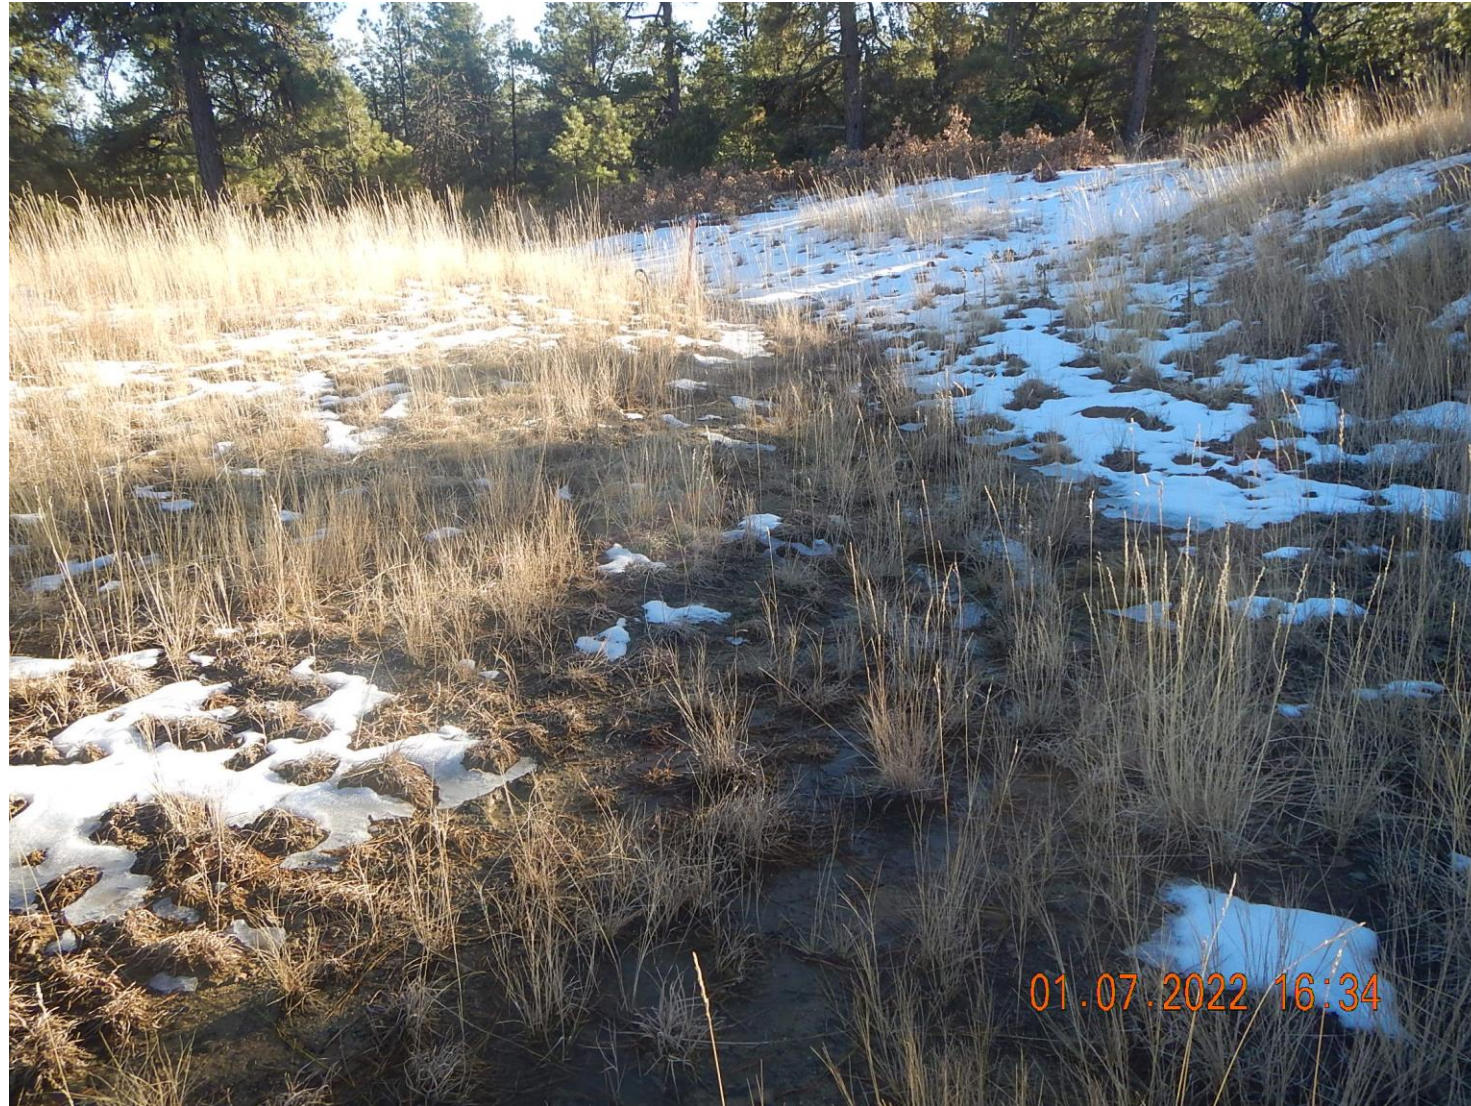
6. Spill path facing south at change of direction

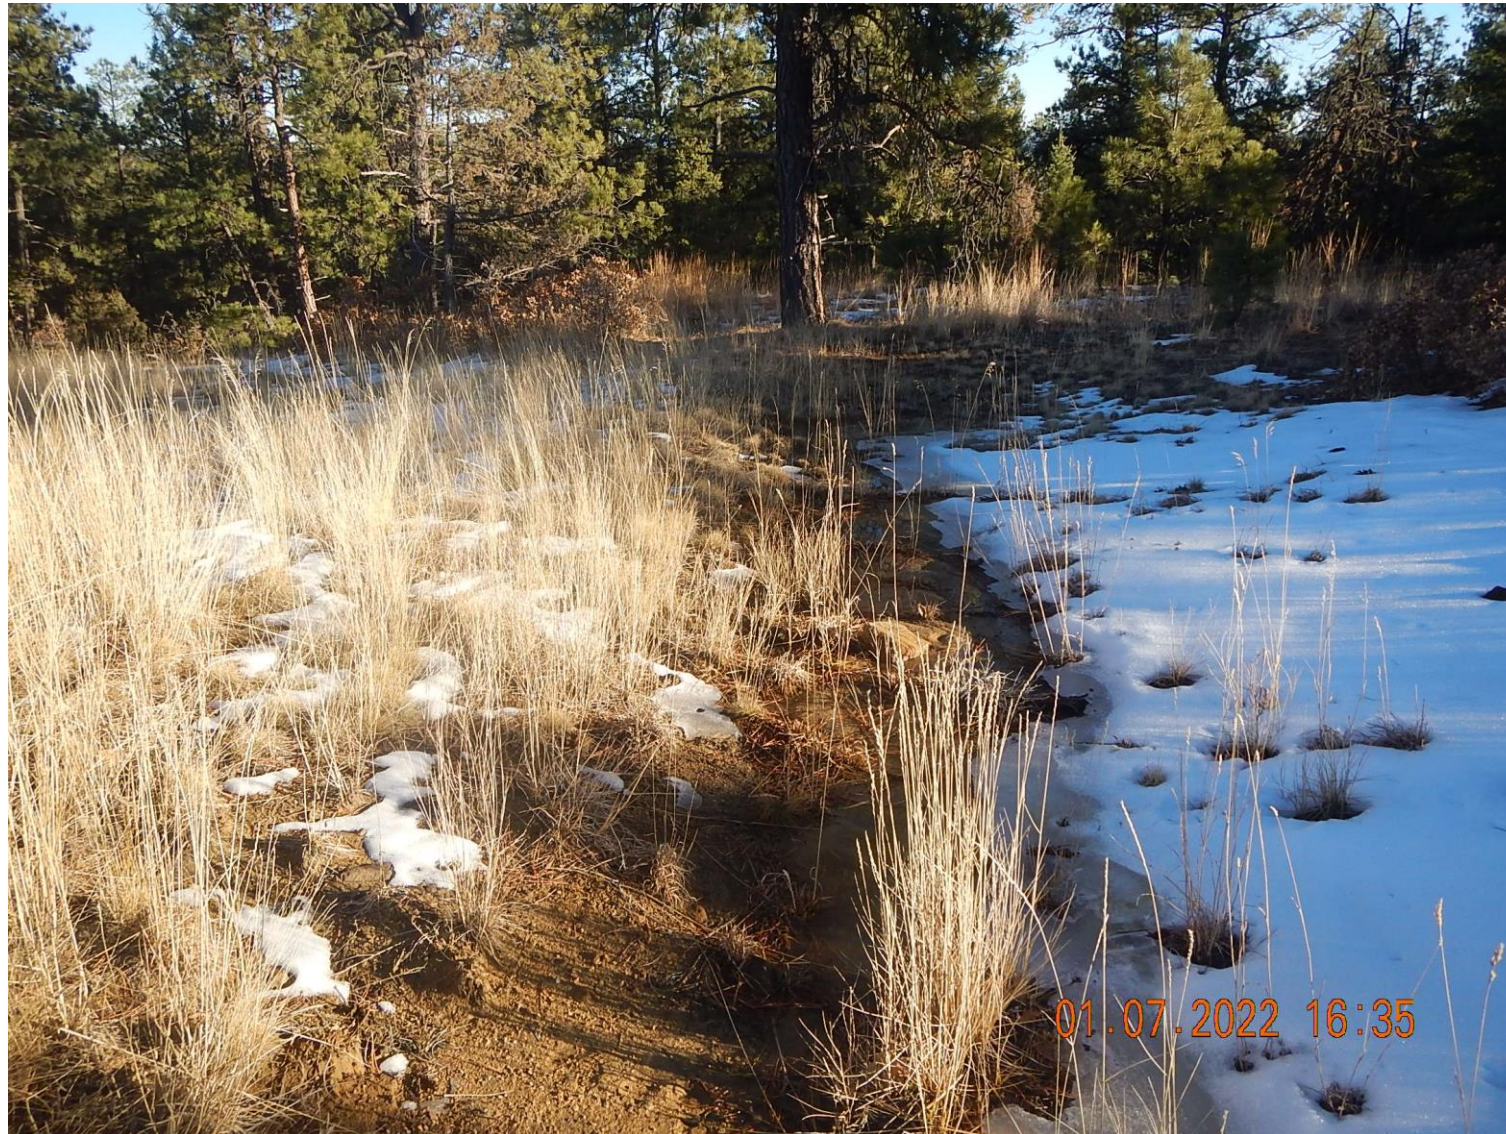
7. Spill path facing southeast at 2nd change of direction

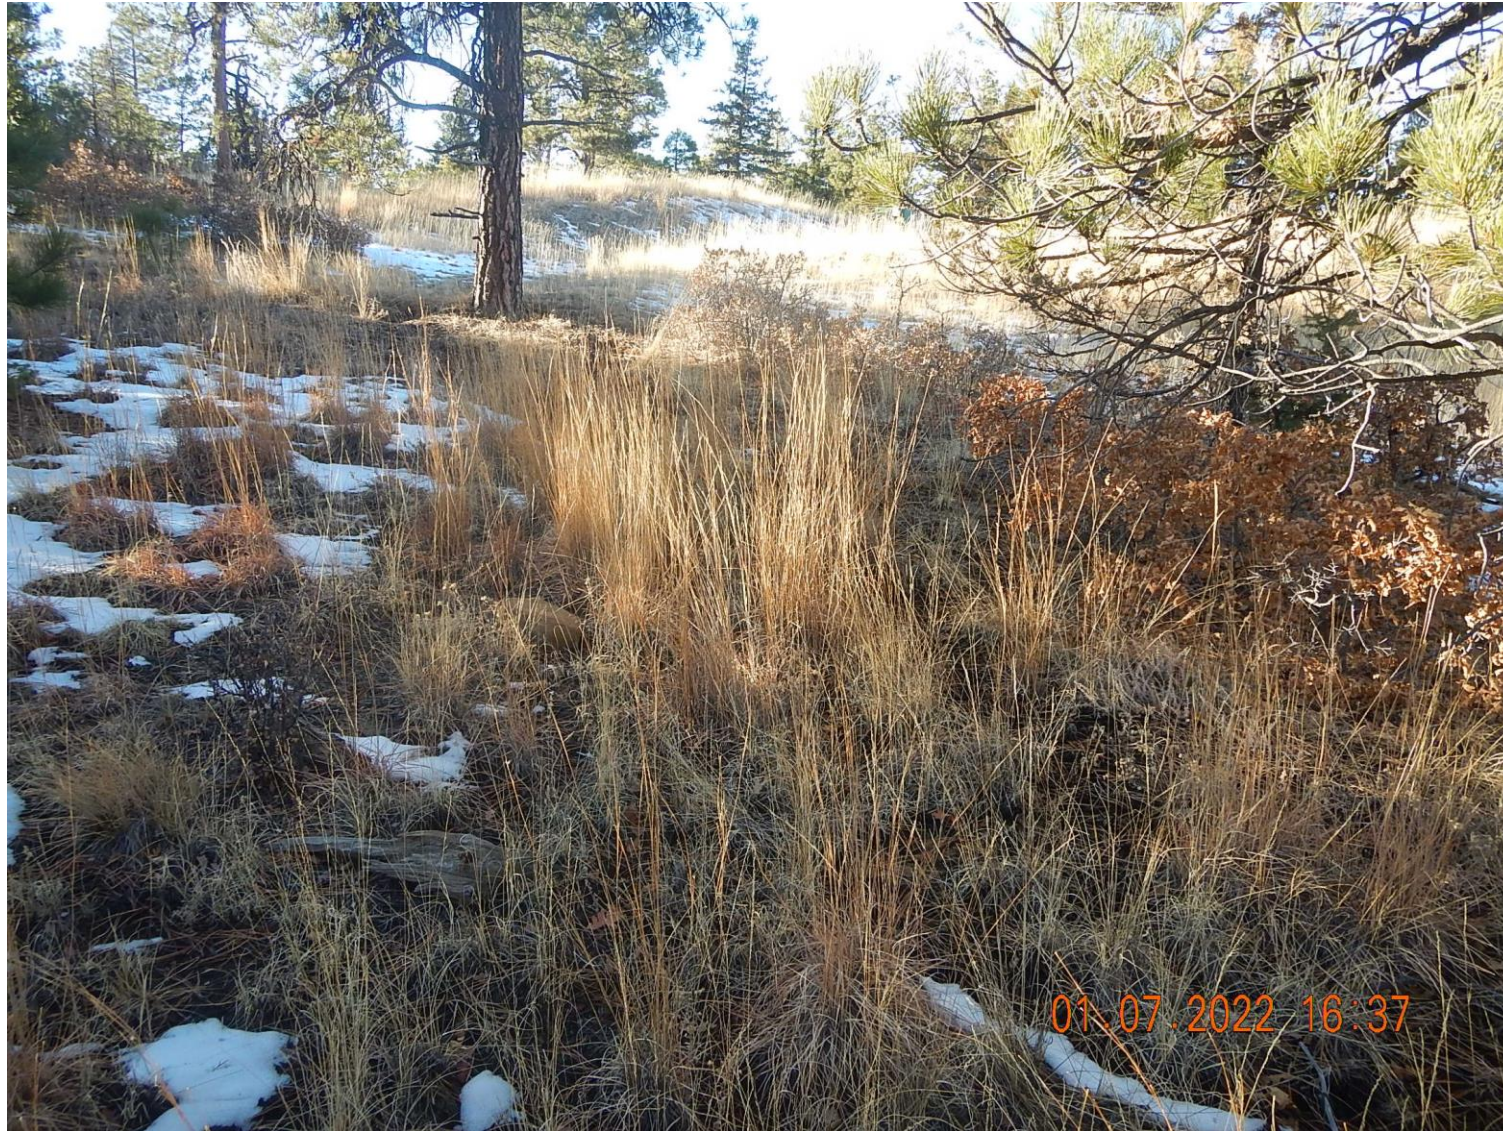
8. End of spill facing northwest toward spill path
