Inspection Photos

Location Name: TEP ROCKY MOUNTAIN LLC WILLIAMS-66S96W /36SWSE

Location ID: 335010

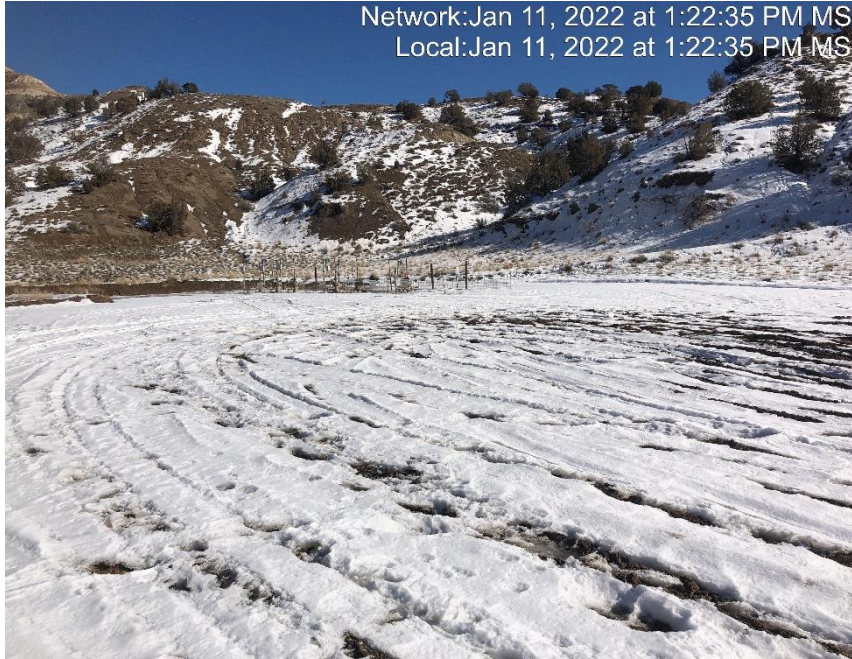
Photo #5643 from entrance to location.

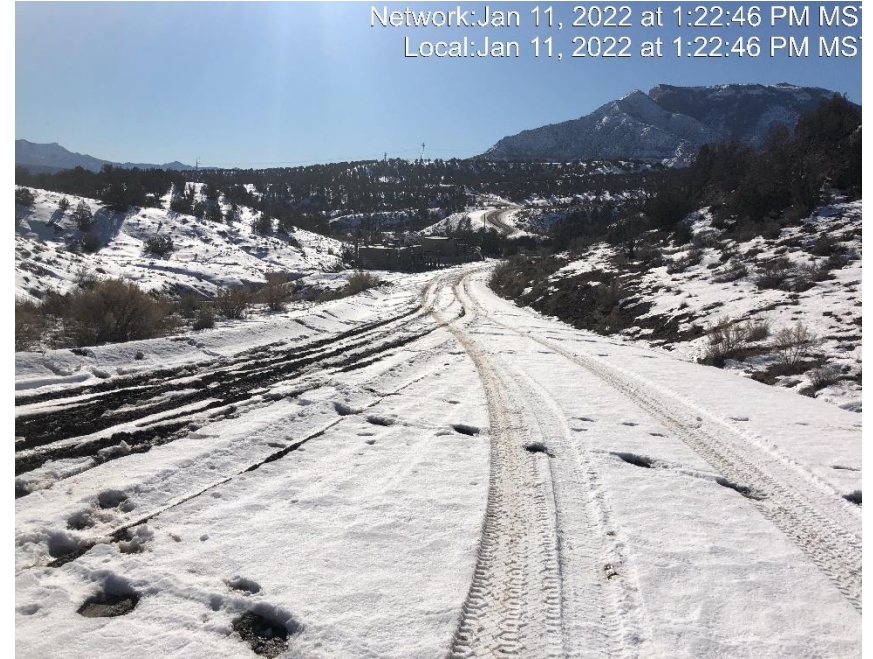
Photo #5644 from entrance to location.

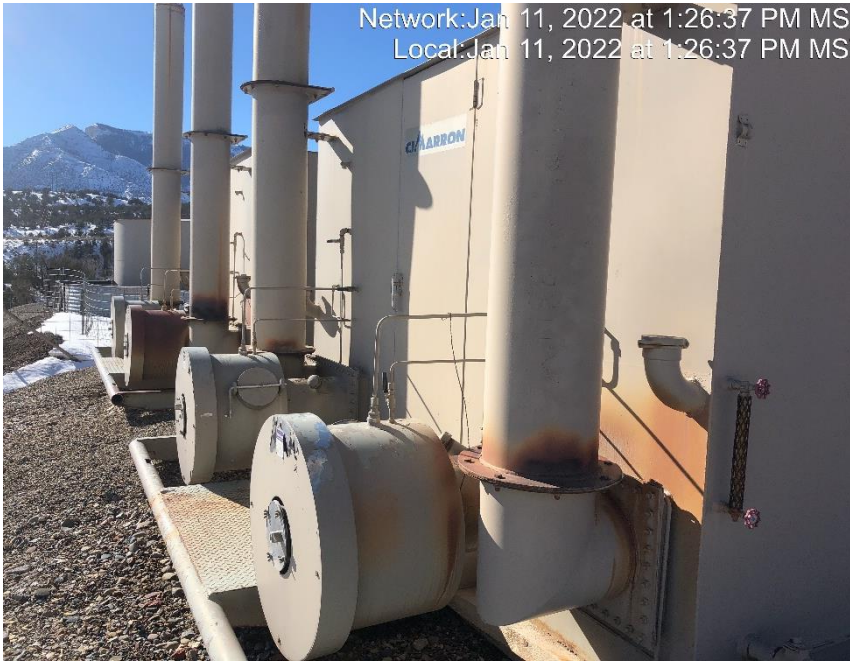
Photo #5647 Storage tanks not labeled.

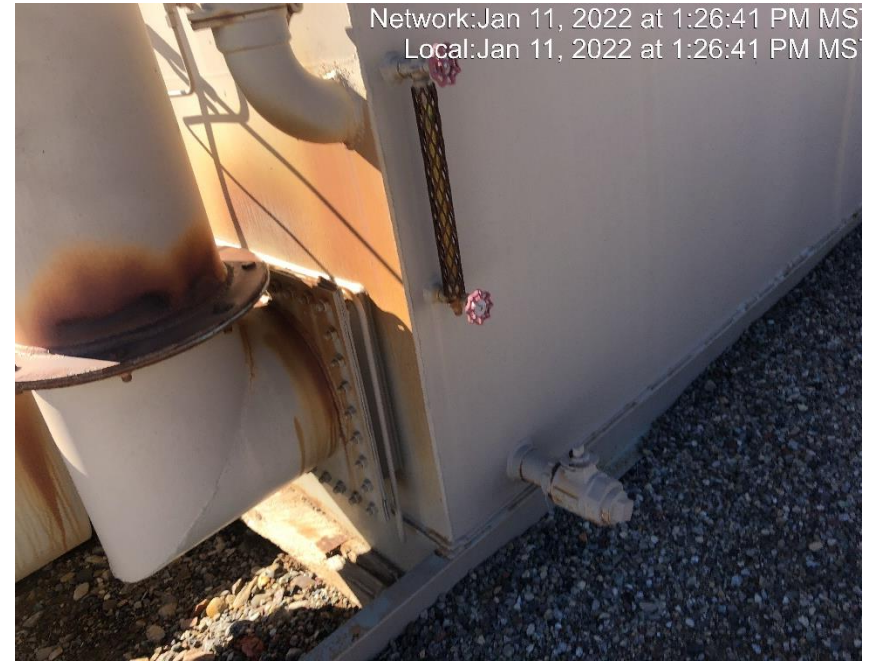
Photo #5648 Sight glass indicates the storage tank is full of an unknown fluid.

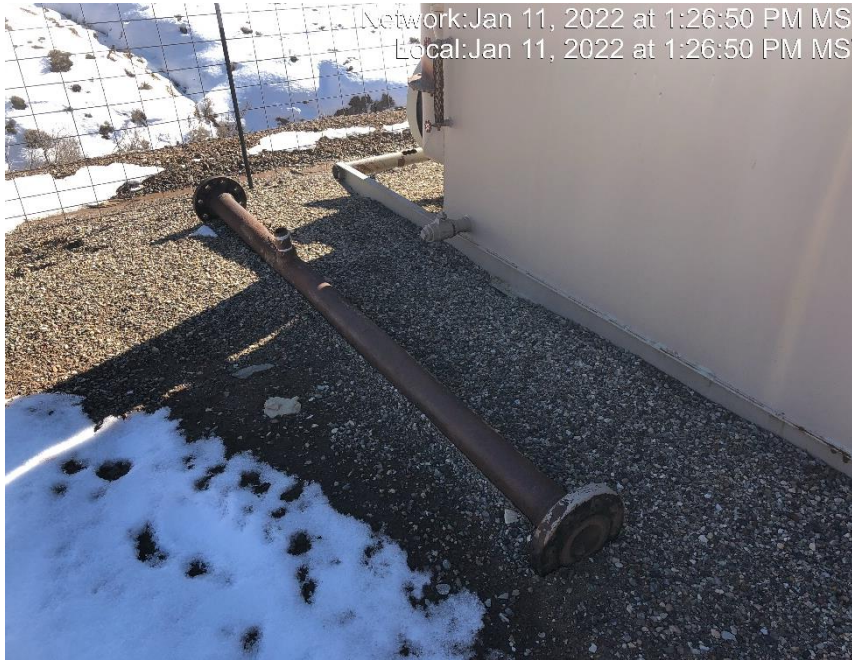
Photo #5649 Unused equipment.

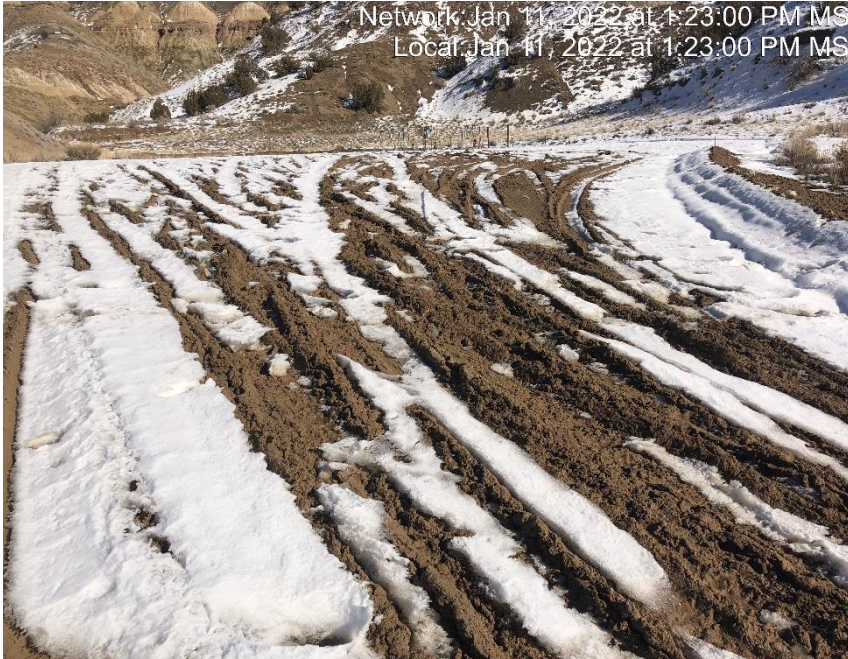
Photo #5645 Location lacks stabilization.

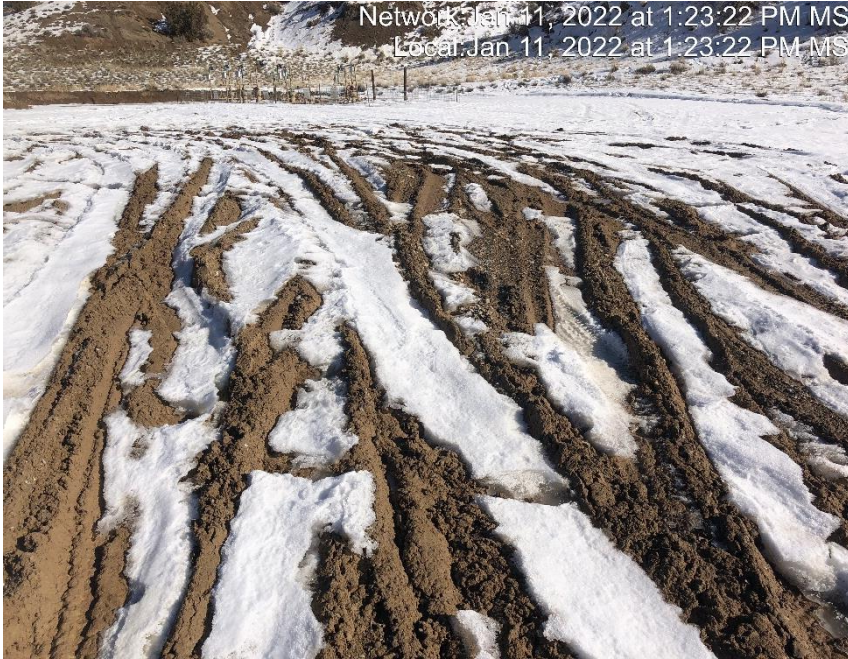
Photo #5646 Location lacks stabilization.

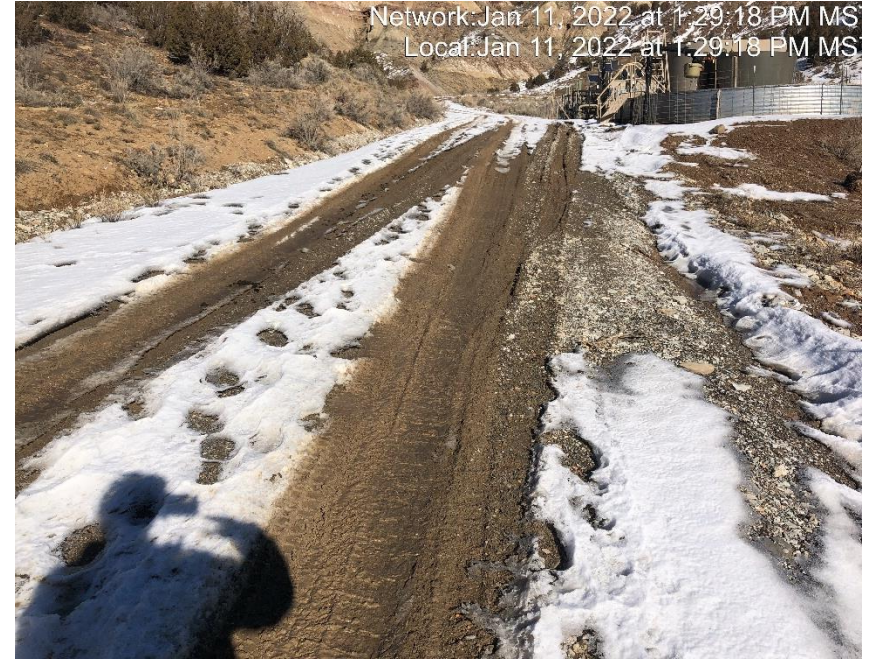
Photo #5650 Insufficient tracking BMP located at entrance to location.
